Robert F. Kennedy School

1602 Lucretia Ave., San Jose, CA 95122

Robert F. Kennedy Elementary School - Master Planning Evaluation

Evaluation Summary

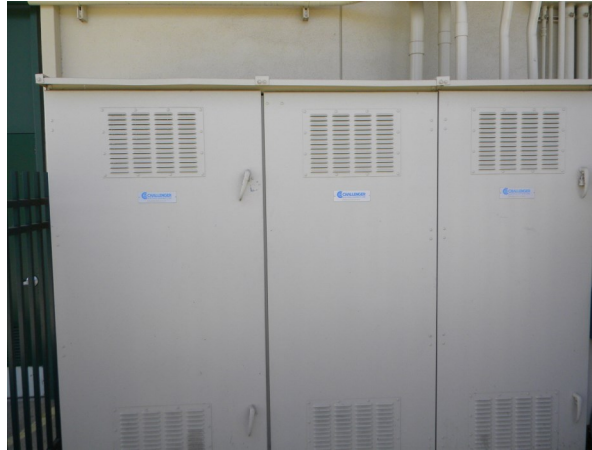
Underground utilities supplying gas and water to the site are over 40 years in age. The existing sewer system is composed of an antiquated clay piping system which allows tree roots to grip and break existing underground piping. These underground utilities have surpassed

their intended service life. Replacing the underground utilities will drastically reduce the need for ongoing maintenance of these systems.

It is recommended that all existing underground utilities older than 40 years be replaced with new utility systems. Underground water, storm, sewer and gas lines should all be replaced entirely at this site.

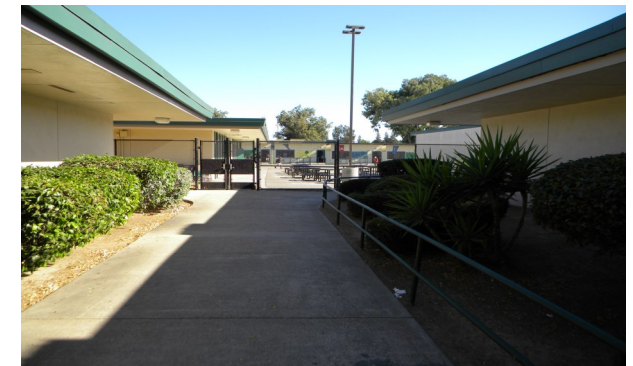
The area adjacent to Wing D is not lit enough as when the additional of the charter school created a darker outside area at this location.

It is recommended that additional exterior LED lighting be added adjacent to Wing D.

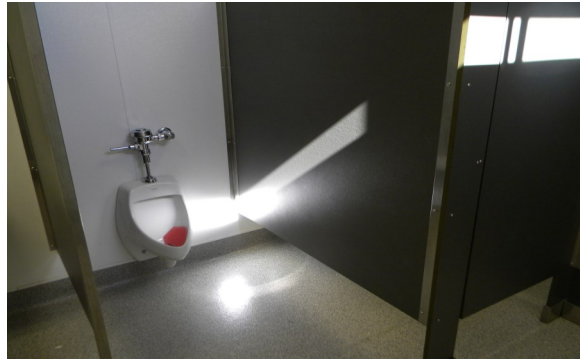
The existing bathrooms are in good condition however the terrazzo or epoxy flooring in the bathrooms have been patched over the years from prior renovations.

It is recommended that all restroom flooring be removed and replaced with new flooring that meets the District Standards.

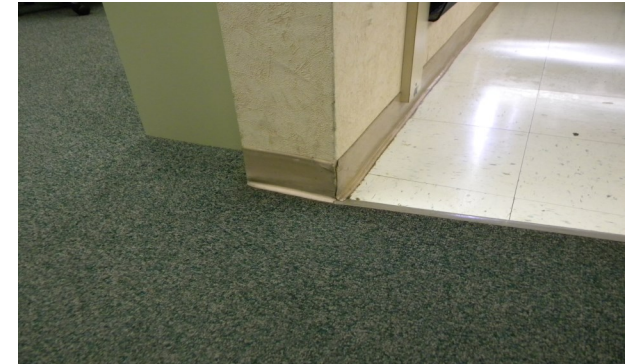
Most of the flooring is getting older. Floor carpeting can last for about 15 years. All carpeting at this site is approaching its useful lifecycle.

It is recommended that all floor carpeting and associated VCT be replaced in the next three years.

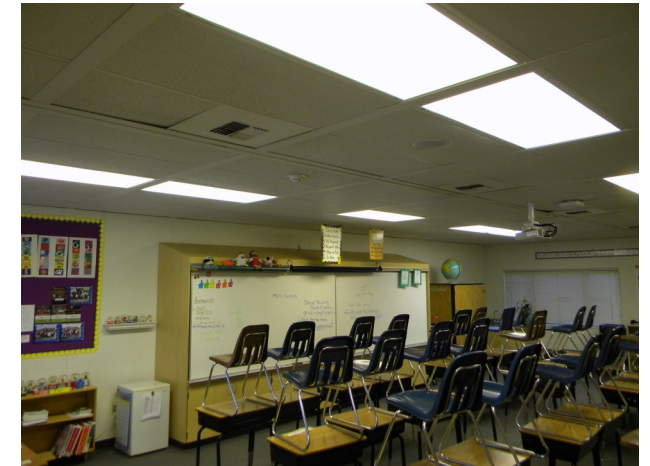
The existing HVAC system is in fair condition. Although these units have not yet surpassed

their useful lifecycle, it has been reported that several units at this campus are in need of constant repair and alterations. The existing units may no longer be useful as the demand for maintenance is exceeding their usefulness.

It is recommended that all units at this campus be replaced with a new system that meets the District standards.

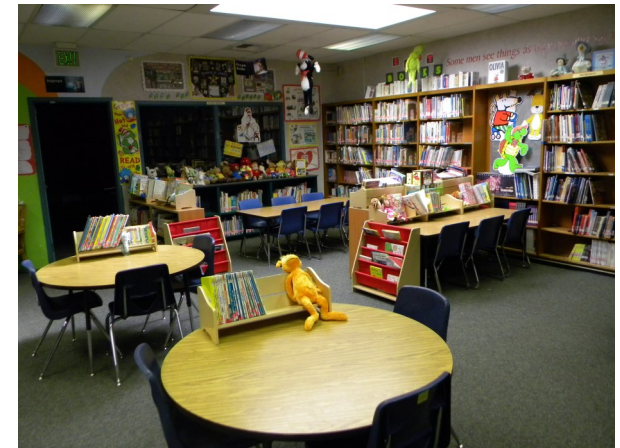
The current Library space is in poor condition and does not meet the requirements of the FMSD. There are unused adjacent spaces to the library that are not efficiently used.

Book storage should be rearranged to be housed along the perimeter of the existing space whereas the old library becomes transformed to become a more desirable open space with clusters of seating spaces more conducive of the “new” library. The adjacent spaces should be better incorporated into the library to make the library more functional.

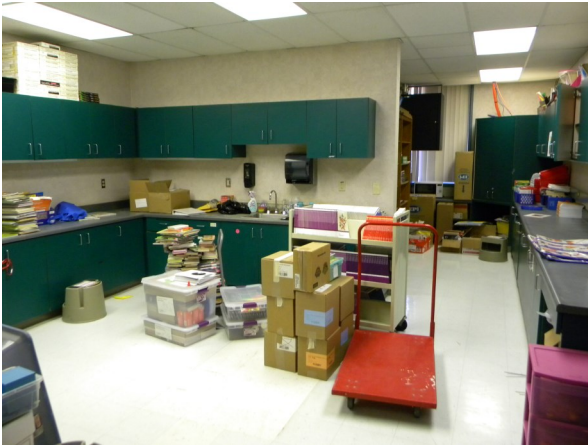
The current work room is in poor condition and is not an efficient use of space. There is no adjacent outdoor space for the teachers at the lounge area.

It is recommended that the existing administration support spaces be renovated and altered to meet the District current needs at this site. It would be desirable to create an outdoor space for the teachers.

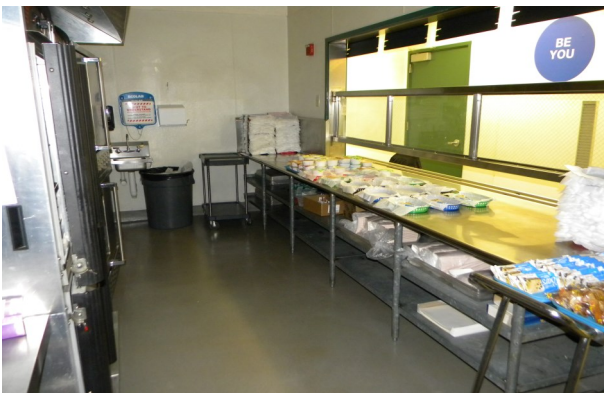
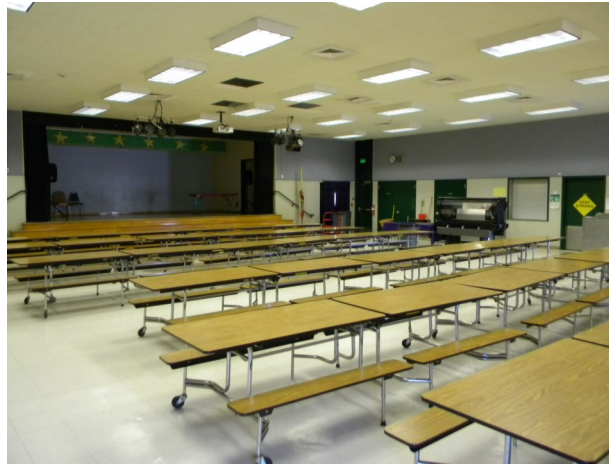
The existing Kitchen is in satisfactory condition. The countertop of the serving line is in need of replacement.

It is recommended that the serving line countertop be replaced.

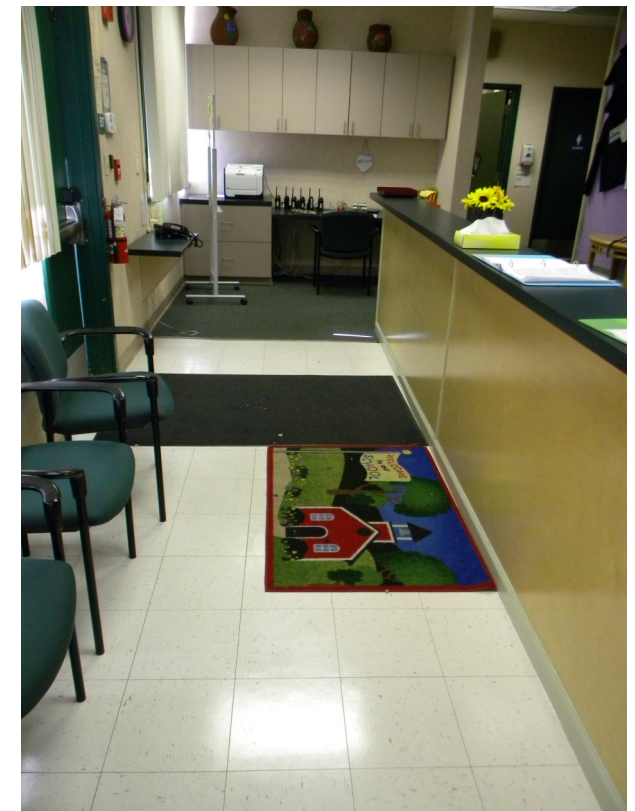
The existing administrative space is not designed to meet the current needs of the administration and student services. The needs of the students have changed over the years. The

space is in need of renovation. There is a need for a lockable safe.

It is recommended that the existing administrative spaces be renovated into a functional space that meets the needs of current usage. It is recommended that a locking safe be added.

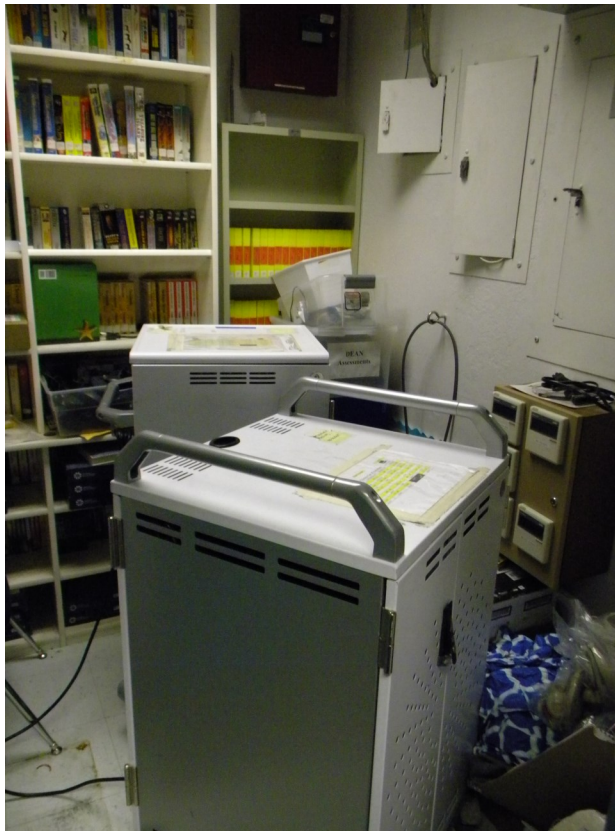
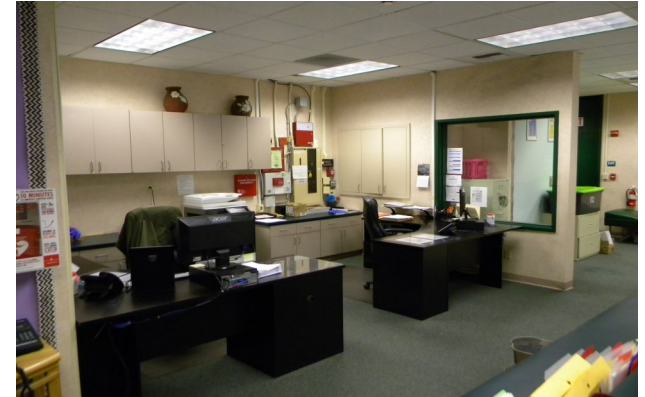
The existing administration space is not conducive of the campuses needs at this time. The entry to the administrative area is poorly de-

finied. The space is old and should be gutted and reworked to meet the needs of the campus.

It is recommended that the existing administrative space be gutted and reconfigured conducive of the campus needs.

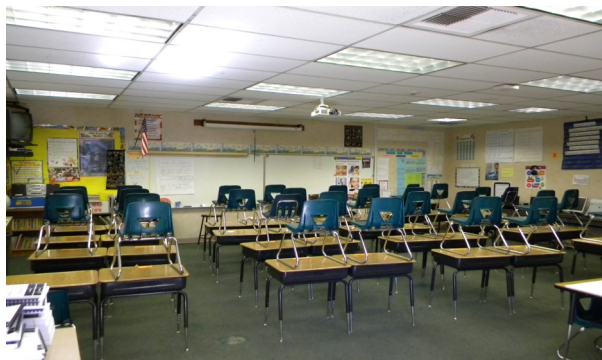
This Campus has older furnishings that do not

meet the current District standards.

It is recommended that the entire campus be retrofitted to receive all new furnishing.
