# Los Arboles Elementary

455 Los Arboles Avenue, San Jose, CA

## Los Arboles Literacy & Technology Academy - Master Planning Evaluation

### Evaluation Summary

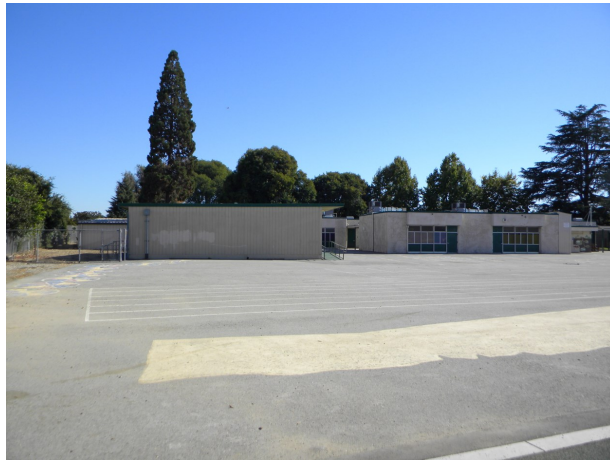
The District has been adding outdoor learning spaces at some of their more recently renovated campuses. The weather in San Jose makes for an ideal outdoor learning environment whereas teaching can be a desirable event should the design allow for a covered shade structure, appropriate furnishings and technology. Currently there is no covered outdoor learning areas at this campus.

It is recommended that an outdoor learning space be designed to allow for teachers the flexibility of choosing alternative learning, based on program needs. It would be desirable to add existing outdoor furnishings.

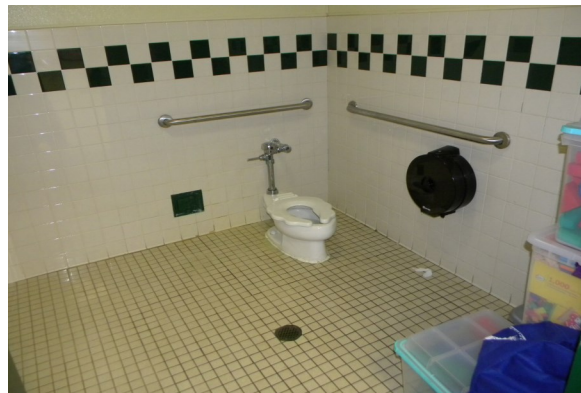
Most of the flooring is in good condition. There is no need for upgrades to the flooring at this time.

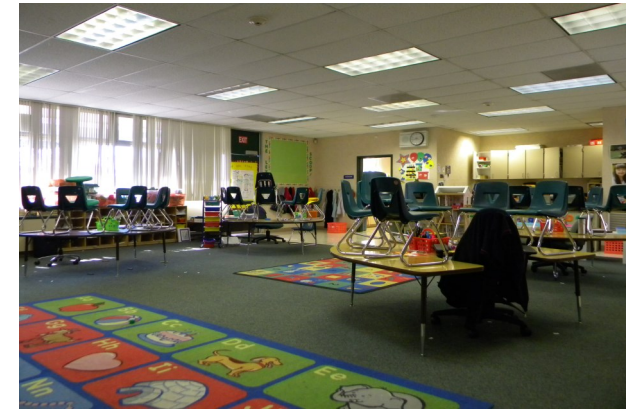
This school does not have tackable walls.

It is recommended that at least one wall be retrofitted with new tackable wall material.

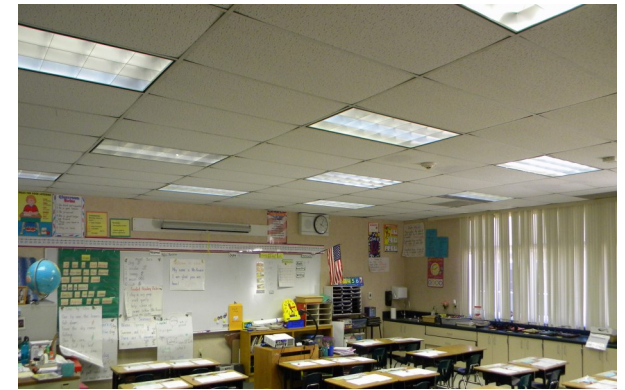
Currently, the existing power distribution is modest in the classroom locations. Class learning is relying more on technological teaching tools. Most classroom spaces are in need of additional electrical outlets.

It is recommended that additional electrical outlets be installed in walls throughout the classrooms.

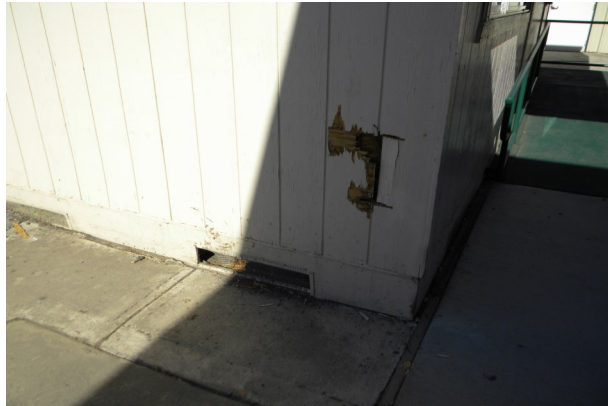
The existing portable classroom appear to have been added to the most convenient location on campus whereas they are located far from most of the campus.

It is recommended that the portables be removed from the site and incorporated into a new classroom building.

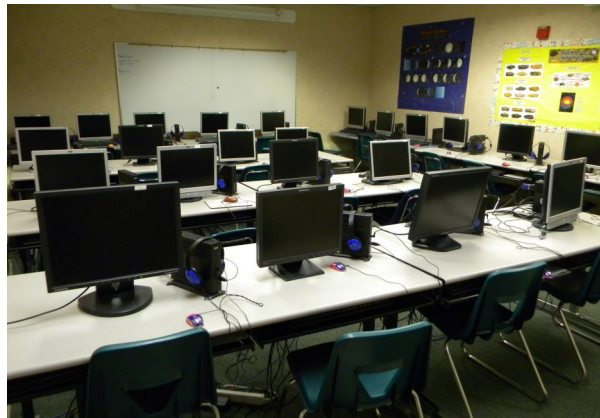
The existing computer lab is not used as it was originally intended as technology and teaching has changed over time.

It is recommended that the computer lab be converted to an teaching space conducive of what is needed to meet educational specifications.

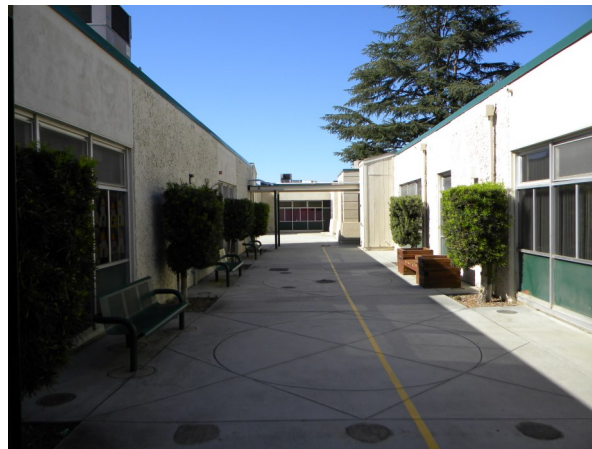
There is no covered eating structure nor an outdoor learning area at this campus.

It is recommended that a new covered shade structure be installed adjacent to the cafeteria area equipped with Wi-Fi and outdoor furnishings.
