# McKinley Elementary

## McKinley Elementary School - Master Planning Evaluation

### Evaluation Summary

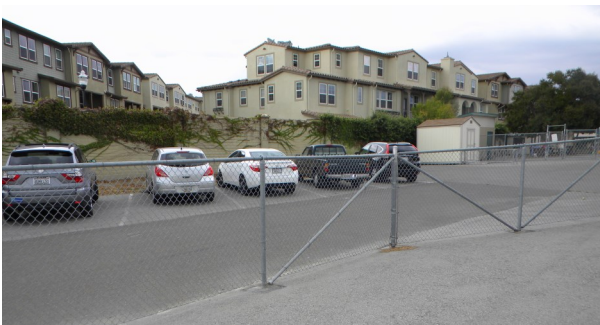
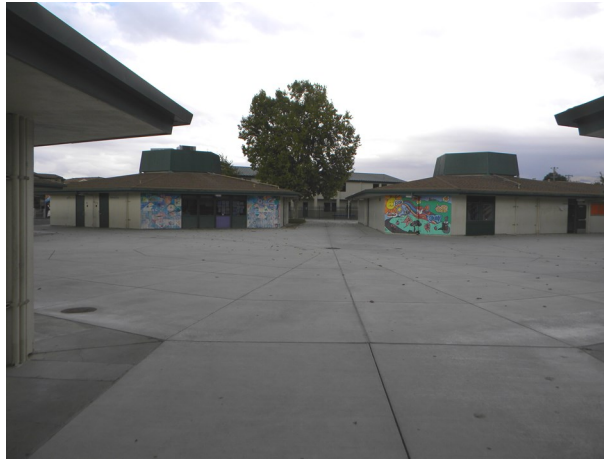
Some of the main quad area flatwork and walkways were upgraded in 2011 and 2012 to eliminate cracks and tripping hazards. The expansion to the existing parking lot replaced many cracks and tripping hazards at the front of the school. There is one remaining drinking fountain that needs to be upgraded. A bottle filler station should be installed in the cafeteria to meet ADA compliance.

It is recommended that the ADA parking spaces

be restriped and signage added.

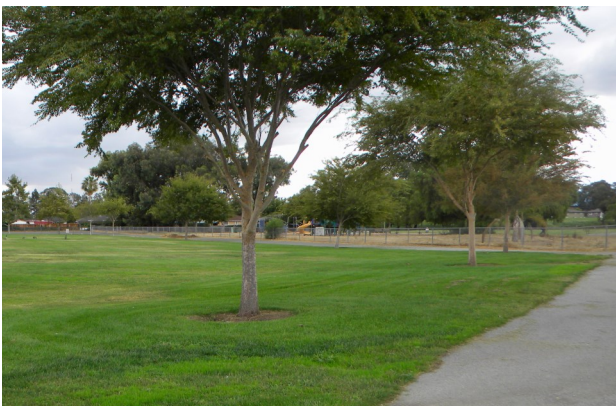
This school age level is not conducive of receiving a synthetic track, however the District has been installing walking tracks at some of the other campuses. The turf area is in fair condition.

It is recommended that a walking track be installed at this campus.

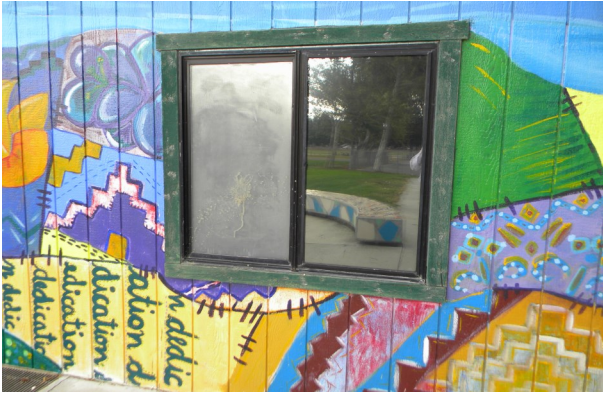
in an era when natural resources such as natural gas and electricity were inexpensive. Windows are single glazed throughout and insulation does not currently meet new construction standards. This campus has very few windows.

It is recommended that insulation be added to all exterior walls and added to all ceiling cavities. Windows should be replaced with double glazed window systems.

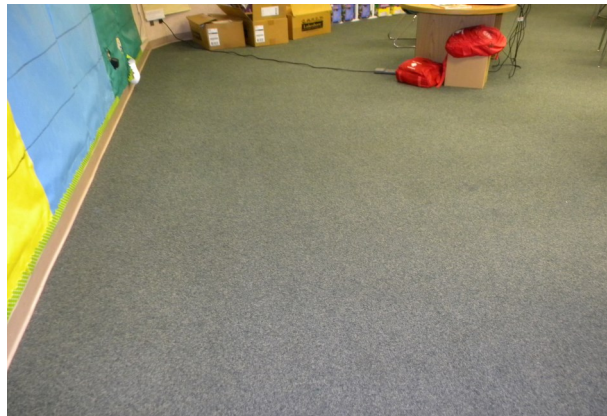
Most of the flooring is getting older. Floor carpeting can last for about 15 years. All carpeting at this site is approaching its useful lifecycle.

It is recommended that all floor carpeting and

associated VCT be replaced in the next three years.

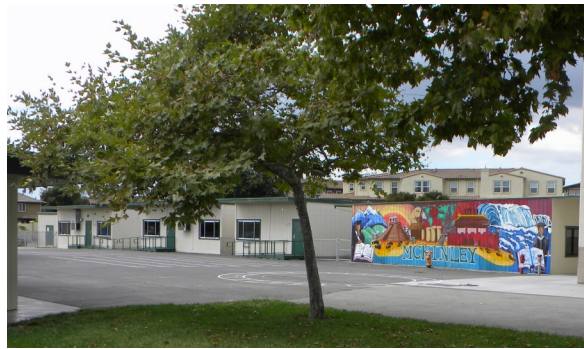
The existing portable classrooms are in fair condition but will need to be replaced soon. The location of the portables are not located close enough to the rest of the campus. The

existing portable appear to be in the path of a potential expanded staff parking lot.

It is recommended that the portable classrooms be removed from the site and rebuilt as new permanent classroom buildings, likely as a two story complete similar to the other two story building.
