1250 Taper Lane, San Jose, CA

Jeanne R. Meadows Elementary School - Master Planning Evaluation

Evaluation Summary

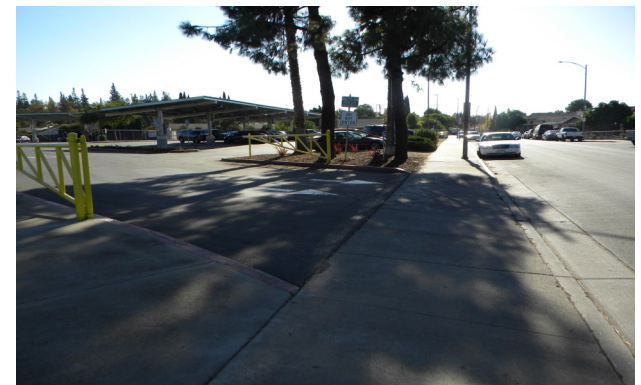
additional parking and is on the side of the campus. This parking lot is in good condition. The original front parking area is in fair condition but does not serve as a sufficient drop off zone.

It is recommended that the existing front parking lot be redesigned to be more effective to meet the needs of the District.

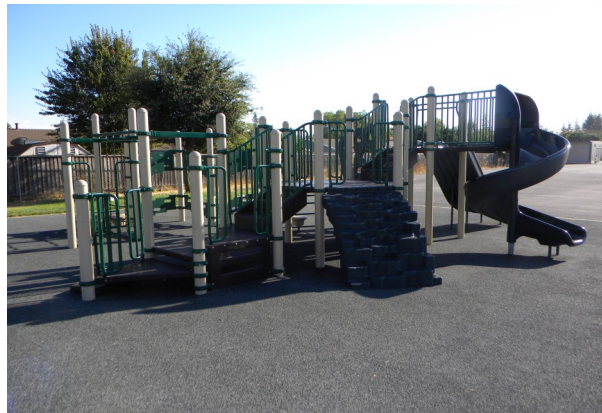
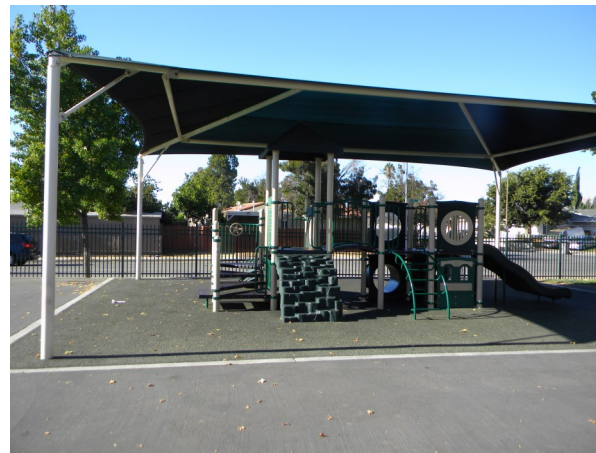
The play equipment is in good condition. The District has been adding shade structures over the existing play apparatus at other campuses.

It is recommended that new fabric shade structures be installed at the existing play structures.

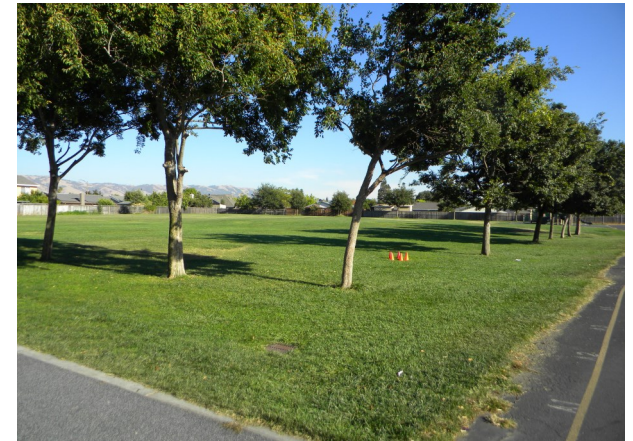
This campus does not have a synthetic track. The existing turf area is in good condition.

It is recommended that a walking track be added. There is no need for upgrades to the turf area at this time.

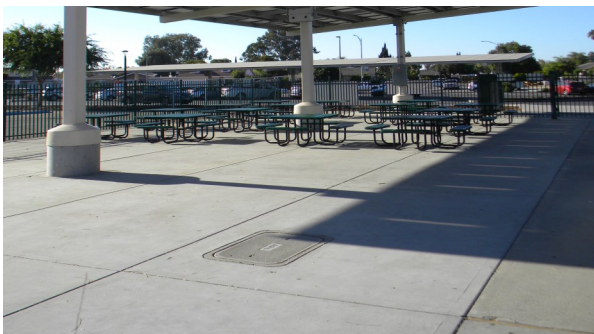
The District has been adding outdoor learning spaces at some of their more recently renovated campuses. The weather in San Jose makes for an ideal outdoor learning environment whereas teaching can be a desirable event should the design allow for a covered shade structure, appropriate furnishings and technology. Currently, there are no outdoor learning areas at this campus.

It is recommended that an outdoor leaning space be designed to allow teachers the flexibility of choosing alternative learning based on program needs. It would be desirable to add to the existing outdoor furnishings.

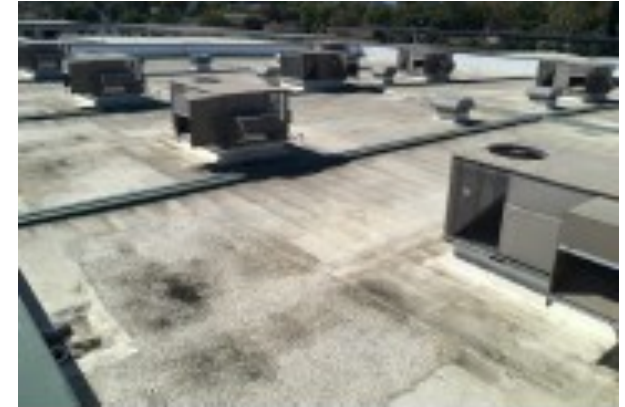
This campus meets the minimal seismic needs and may not need any voluntary seismic upgrades. A structural engineer will need to review all main structure during the next large modernization as requirement of the Division of the State Architect and its process for review.

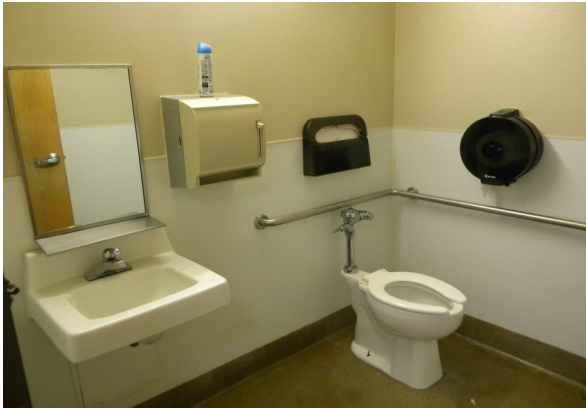
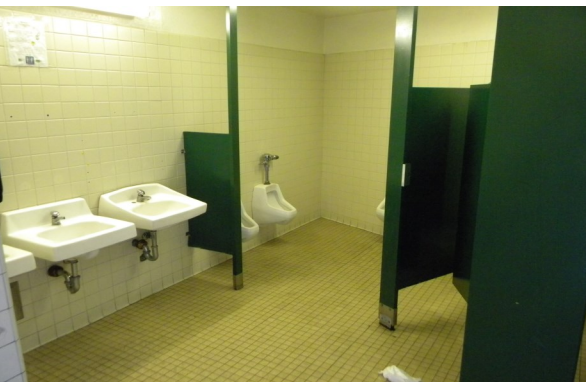
The existing toilet rooms finishes are in fair condition.

There is no need for restroom upgrades at this time.

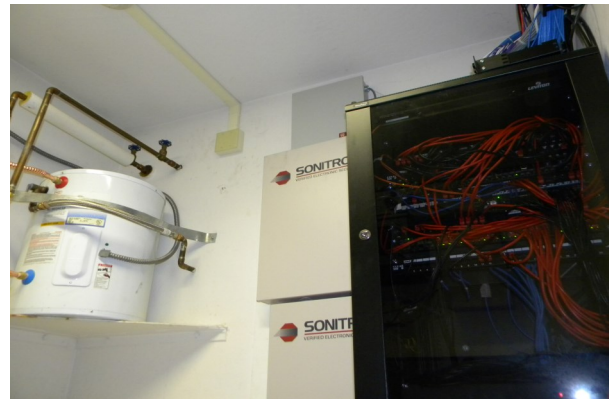
It has been reported that the ceiling projectors do not currently meet District Standards, the IDF needs to be relocated from the stage area, the office IDF is in a custodial closet above a sink and a water heater, several IDFs have been wired incorrectly, and the MDF in the kitchen has an AC unit mounted directly above the rack.

It is recommended that all IDFs and the MDF's

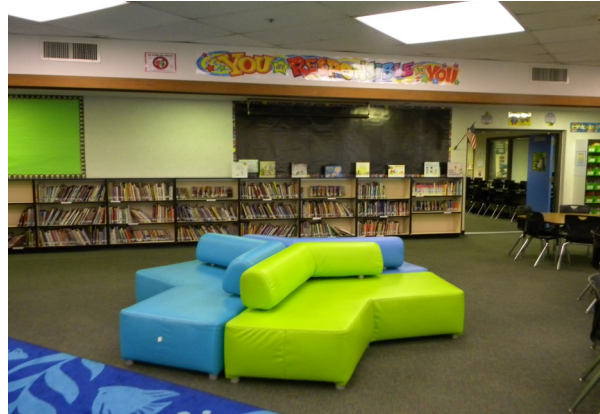
The current Library space is adequate and meets the minimum size for the Franklin-McKinley School District. The computer lab is in a smaller community space. Library space is now a more social learning space and computer labs are not a function of a classroom space.

It is recommended that the computer lab be dis-

persed and blended into a new student social center whereas laptops be incorporated into the space. Book storage should be rearranged to be housed along the perimeter of the existing space whereas the old library becomes transformed to become a more desirable open space with clusters of seating spaces more conducive of the “new” library.

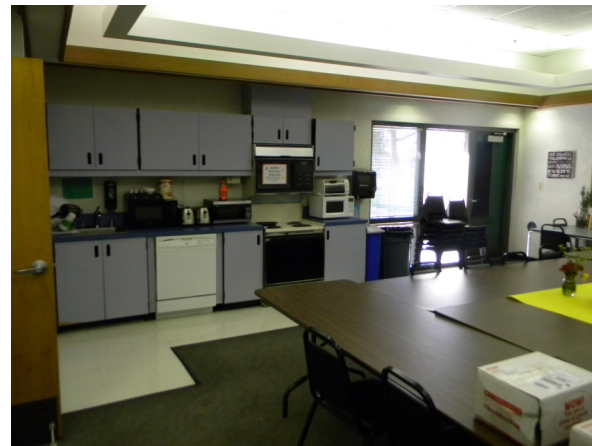
The current work room and lounge need to be modernized and expanded.

It is recommended that the existing administration support spaces be renovated and altered to

meet the District current needs at this site.

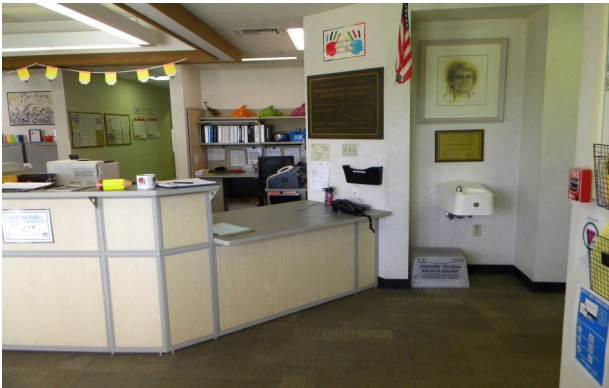
The existing administrative spaces are in fair condition but are showing signs of wear, A clear pathway to the campus through the administration area is not available when the campus is locked down.

It is recommended that the administration area be fully renovated to meet the needs of the campus.

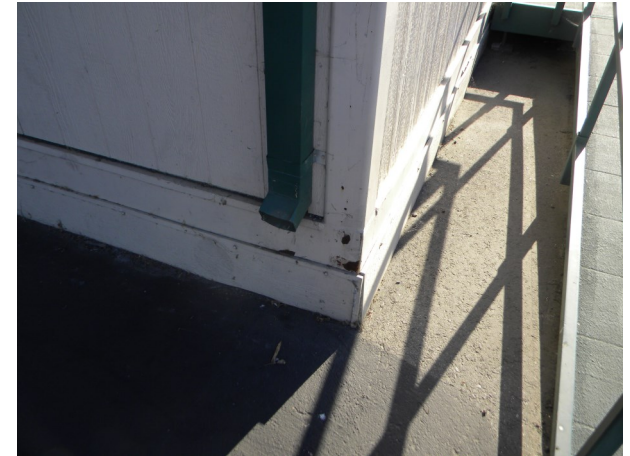
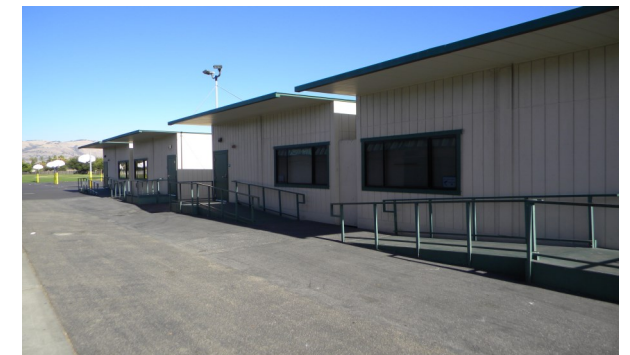
The portable classrooms is intended to serve a school for fifteen years. Many of the existing portables have migrated from other sites.

It is recommended that the portable classrooms be replaced with a new permanent classroom building.

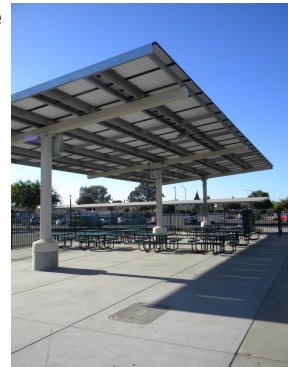
This campus has older furnishings that do not meet the current District standards.

It is recommended that the entire campus be retrofitted to receive all new furnishing.
