Santee Elementary

1351 Lightland Road, San Jose, CA

Santee Elementary School - Master Planning Evaluation

Evaluation Summary

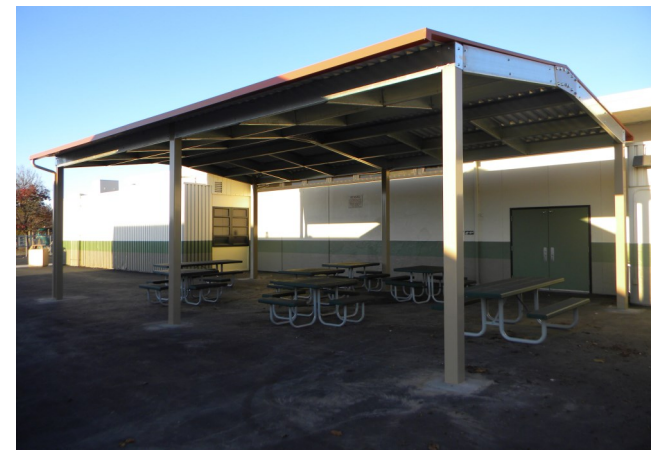
17. Existing Covered Eating Structure

There is an existing covered eating structure at this site.

There is no need for upgrades at this time.

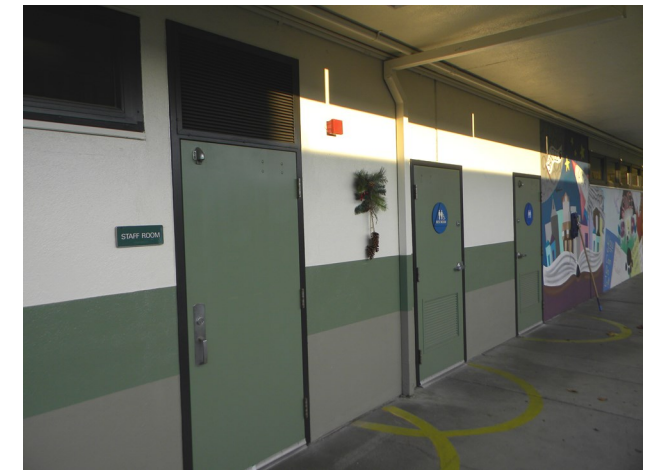
25. Exterior Doors and Hardware

The existing doors and hardware meet the needs of the District at this time.

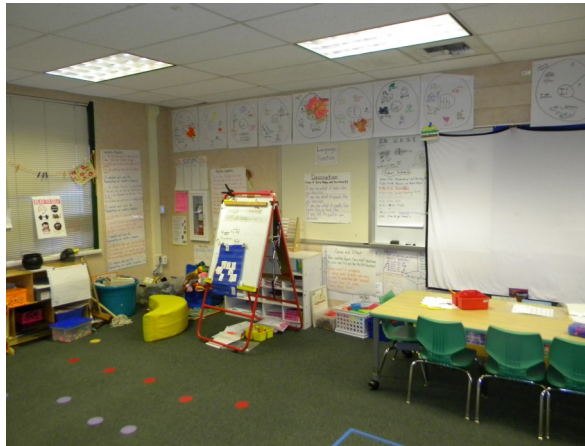
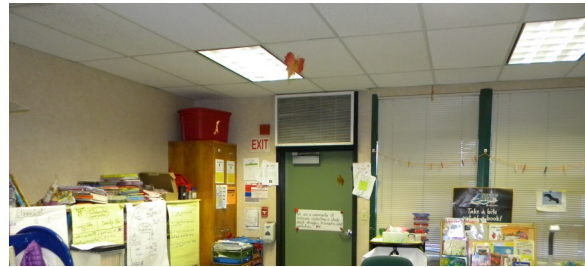
30. Ceilings

All ceilings are in fair condition. When the

HVAC was replaced in 2008, the ceiling tiles were replaced in the suspended ceiling.

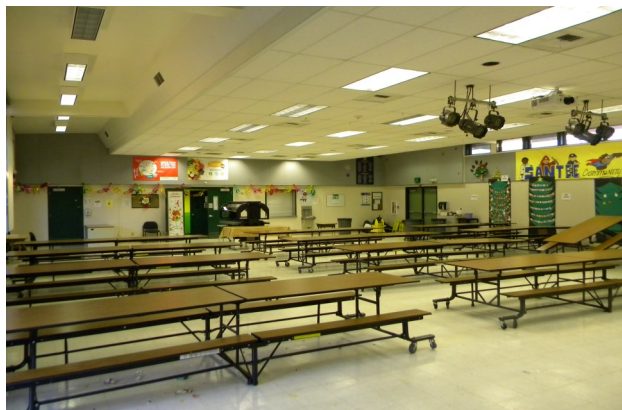
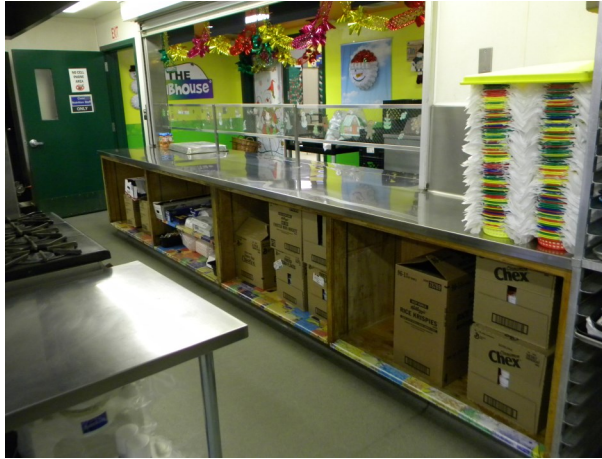
44. Cafeteria/Kitchen/Gymnasium/Music/Weight Room

The existing Kitchen and Cafeteria are in satisfactory condition. The lighting in the cafeteria is in need up upgraded.

It is recommended that the lighting system be replaced with new LED lighting.

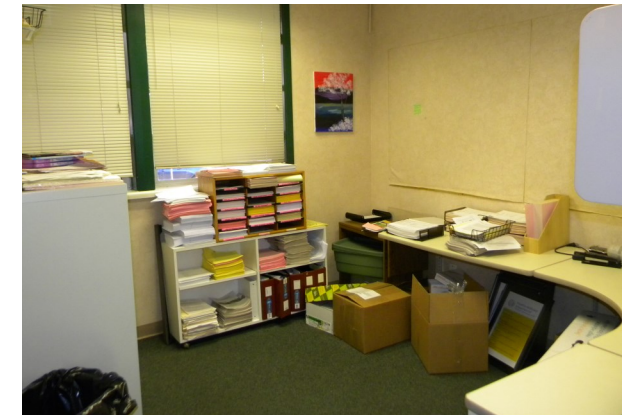
49. Renovation of Administration

The front area of the administrative spaces were renovated in 2018 to allow for a more secure campus. The rest of the administrative spaces were not renovated and are in need of new finishes.

It is recommended that the existing administrative spaces be renovated into a functional space that meets the needs of current usage.
