Shirakawa Elementary

665 Wool Creek Drive, San Jose, CA

Shirakawa Elementary School - Master Planning Evaluation

Evaluation Summary

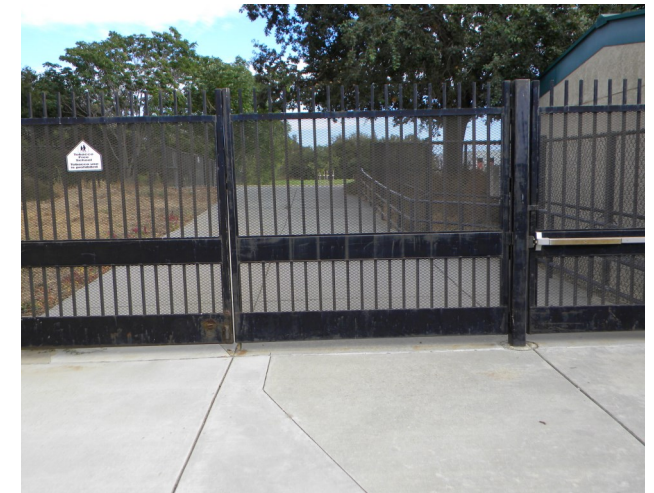
7. Fencing and Security

New decorative fencing was added at the perimeter of the entire campus. There is no need for upgrades to the existing fencing at this time.

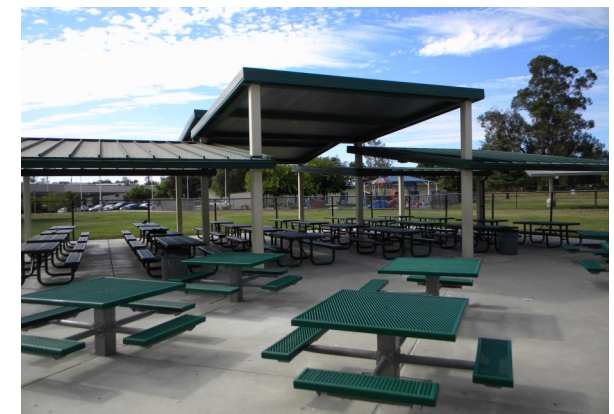
17. Existing Covered Eating Structure

This campus currently has a large covered eating structure adjacent to the Cafeteria area that was installed in the few years. There is no need to upgrade the existing covered eating structure.

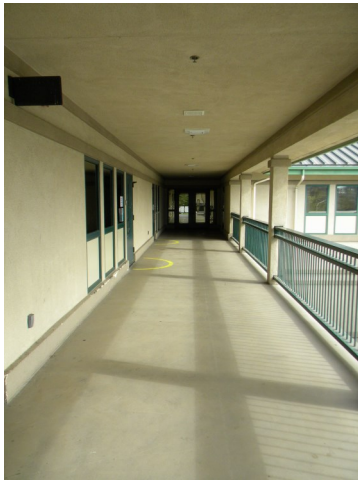
18. Existing Covered Walkways

This campus is a two story complex with outlying portable wings. The area of the outdoor covered walkways at the second floor are in good condition.

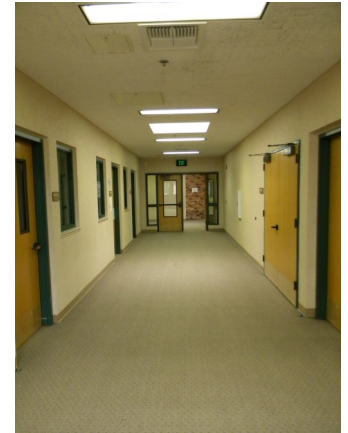
25. Exterior Doors and Hardware

The existing doors and hardware meet the District Standard requirements at this time.

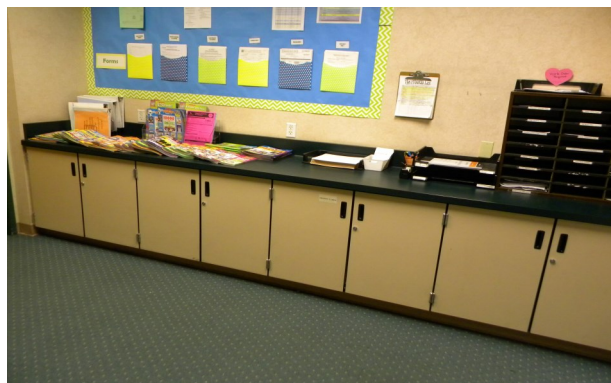
31. Cabinetry

The cabinetry is original and although the cabi-

netry is in good condition, the new standard of the District is to have teaching walls which this campus does not have.

It is recommended that teaching walls be installed at this campus.

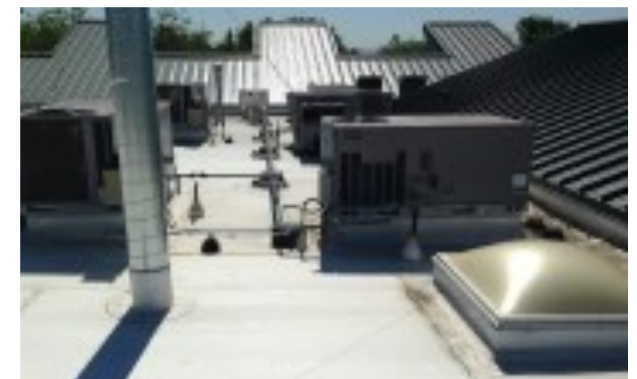
33. Heating Ventilating and Air Conditioning

The existing HVAC system is in good condition. There is no need to replace the HVAC at this time.

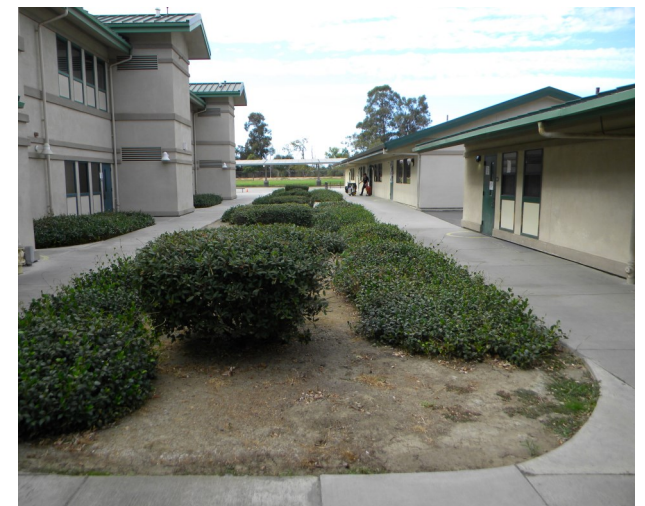
41. Relocation of Existing Portable Buildings

The existing portable classrooms clusters are located in a ideal location to the campus. There is no need to relocate the portable cluster at this time.

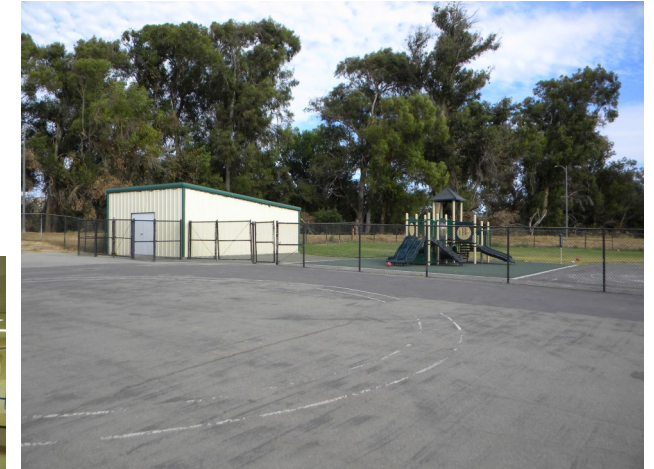
Although staff will argue that there is never enough storage, currently, there appears to be enough storage available. There is an existing metal storage building adjacent to the existing portable classrooms.

There is no need for additional storage.

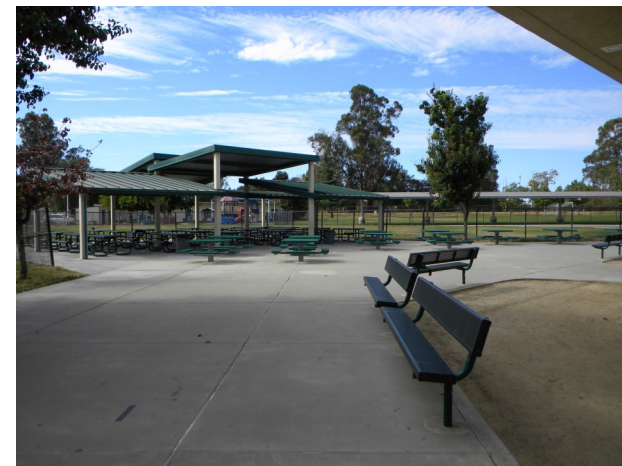
56. Covered Eating Structure or Outdoor learning

The existing covered eating structure adjacent to the Cafeteria is too small for this large K-8 school.

It is recommended that an additional large covered shade structure be added to this campus to house additional student for eating and as an outdoor learning space.

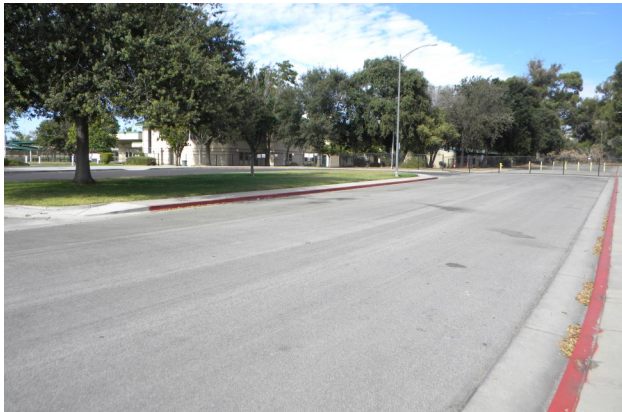
This large k-8 campus should have a gymnasium building. The cafeteria is too small. The outdoor covered eating area is too small. The drip off area needs to be improved for better traffic flow at the front of the school. The paved play area with the large basketball courts area is divided by a roadway. This K-8 should have a synthetic track.

It is recommended that a new Gymnasium be constructed at this site. The cafeteria should have a large addition to this campus. It is recommended that a new covered eating and outdoor leaning area be added to this campus. The fencing should be relocated to block off the roadway separating the paved play area and the campus. The paved play area can relocate toward the campus and a new synthetic track added to this site.
