Stonegate Elementary

2605 Gassman Drive, San Jose, CA

Stonegate Elementary School - Master Planning Evaluation

Evaluation Summary

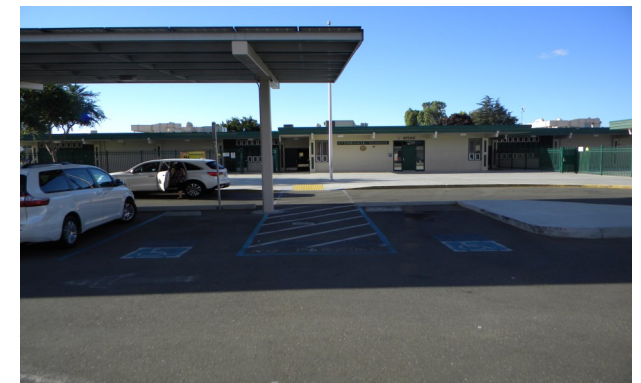
The staff parking lot shows signs of cracking and damage likely due from heavy vehicle trucks because of the trash enclosure location and kitchen loading area.

It is recommended that the staff parking lot be resurfaced and overlaid with new AC pavement and striping in the next two years.

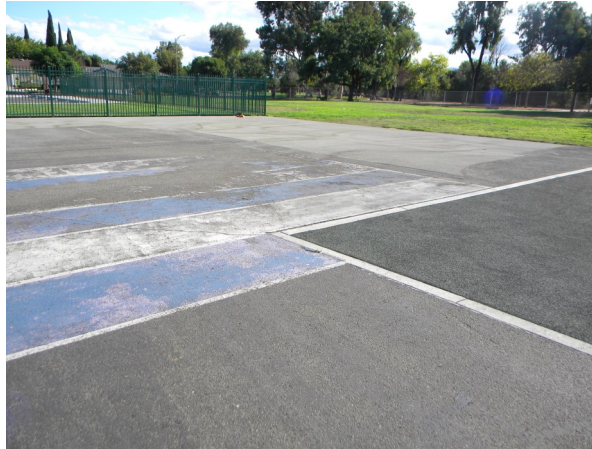
Overall there is ample paved play area at this site. The upper playground was expanded in 2014 and the remaining play area was not addressed at that time and is showing signs of failure from water intrusion. The lower playground is in in good shape.

It is recommended that the entire play area be replaced and restriped in the next 10 years.

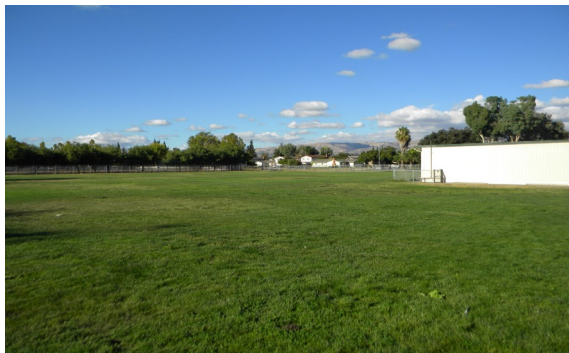
In 2017 the existing play field was leveled, re-seeded, and new irrigation. There is no synthetic or decomposed granite walking track at this campus.

all of its campuses, therefore it is recommended that a new DG walking track be added to the play area.

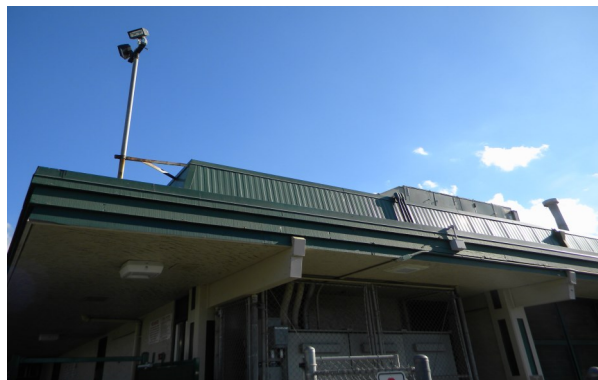
Exterior lighting was replaced with LEDs during the PV installation in 2014. The upper playground is dark at night and would benefit from brighter or the addition of new site lighting.

It is recommended that additional LED lighting be added to brighten the upper play area.

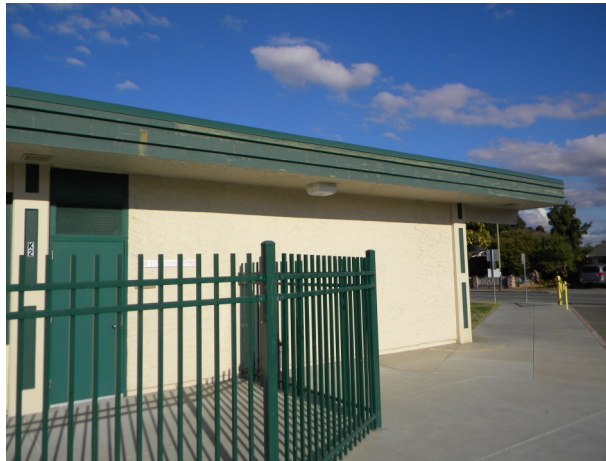
Based on the roofing report, it is reported that the roof surface throughout this campus has developed blistering which are beginning to crack and should be repaired right away. The existing curb flashing and seams have some deterioration.

It is recommended that preventative maintenance and repairs recommended by the roofing report be initiated.

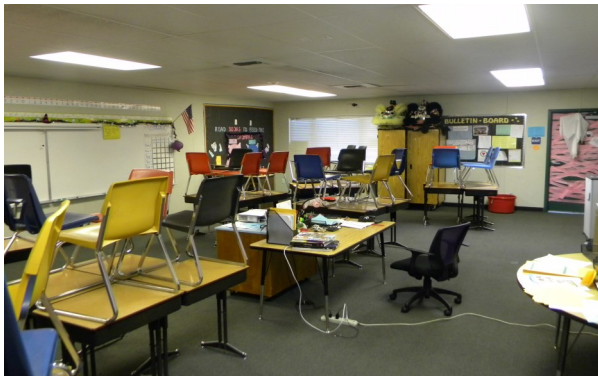
Floor carpeting can last for about 15 years. All carpeting at this site is approaching its useful lifecycle.

It is recommended that all floor carpeting and associated VCT be replaced in the next three years.

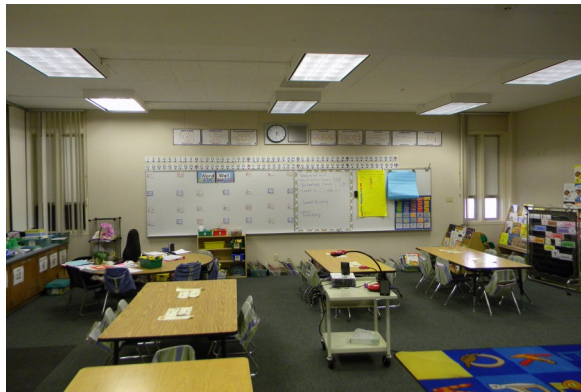
Most of the interior walls have vinyl wall coverings. Many walls tear or discolor at the seams or edge conditions.

It is recommended that walls be stripped of vinyl wall material and be replaced with other op-

tional wall materials such as impact resistant paintable surfaces.

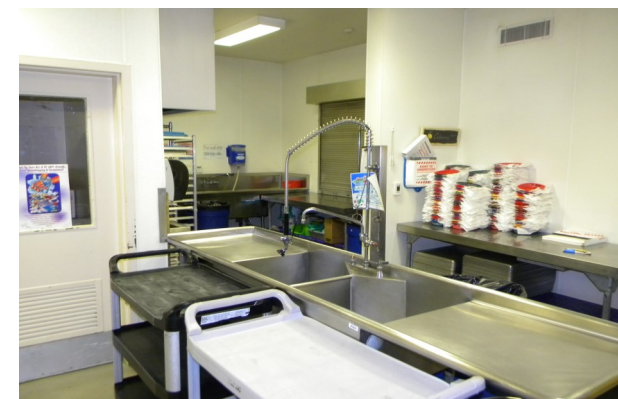
The existing Kitchen is in fair condition however the storage room and sink location are poorly designed. The cafeteria is in good condition.

It is recommended that the kitchen area be fully altered and renovated to meet the needs of the District.
