Sylvandale Middle School

653 Sylvandale Avenue, San Jose, CA 95111

Sylvandale Middle School - Master Planning Evaluation

Evaluation Summary

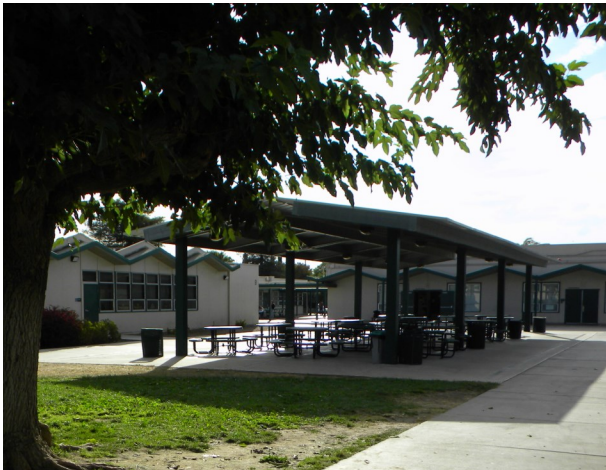
The District has been adding outdoor learning spaces at some of their more recently renovated campuses. The weather in San Jose makes for an ideal outdoor learning environment whereas teaching can be a desirable event should the design allow for a covered shade structure, appropriate furnishings and technology. There is an existing covered eating structure at the center of the campus.

It is recommended that the existing covered

eating area be designed to allow for teachers the flexibility of choosing alternative learning based on program needs. It would be desirable to add new outdoor furnishings for the alternative learning.

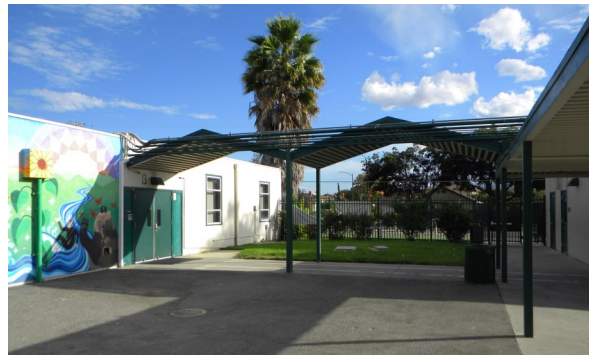
18. Existing Covered Walkways

This campus currently has covered walkways connecting all buildings together except the gym and the locker room. The existing structures are in adequate condition.

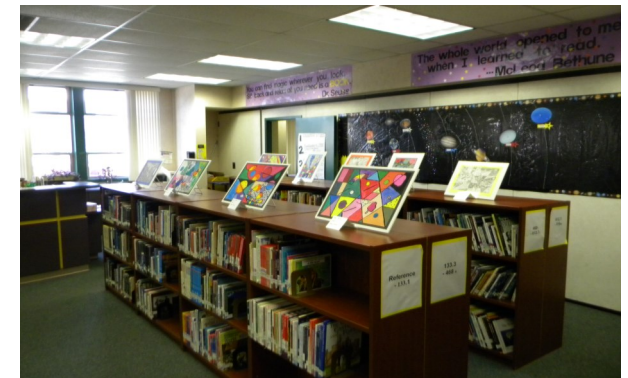
35. Electrical Power Distribution

Currently, the existing power distribution model at the classroom locations. Class learning is relying more on technological teaching tools.

It is recommended that during the next renovation the outlets be relocated from surface mounted Panduit race ways to in wall routing.

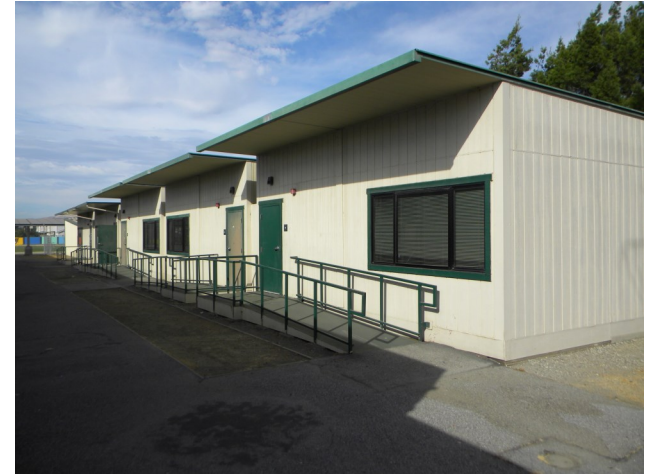
41. Relocation of Existing Portable Buildings

The location of the portable classrooms is ade-

quate but should be removed from the site if possible.

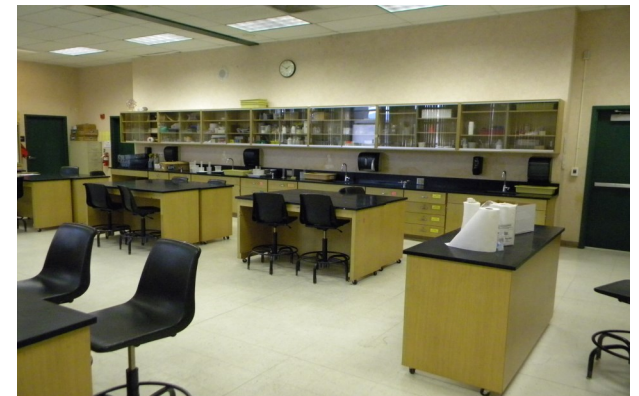
50. STEAM Lab

There is one STEAM lab at this campus. Some of the science classrooms or computer labs

may not function as originally designed.

It is recommended that all existing science classrooms and computer labs be renovated into spaces conducive of current teaching style incorporating the latest ideas related to STEAM methodology.

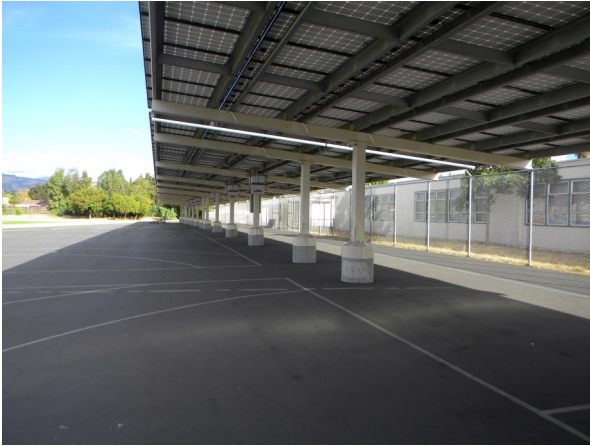
Overall the campus layout appears to be adequately supporting the campus curriculum. There are some supervision and viability issues based on the overall size of asphalt playground and play field areas. The drop off parking lot should be expanded to include additional parking spaces especially since the back parking lot is not be utilized. The entry to the campus needs improvement.

It would be desirable to add one outdoor learning space to the campus. The front of the campus should be altered to have a more desirable

entryway from the street. A new sidewalk and covered canopy should be considered.
