# Windmill Springs School

2880 Aetna Way, San Jose, CA 95121

## Windmill Springs School - Master Planning Evaluation

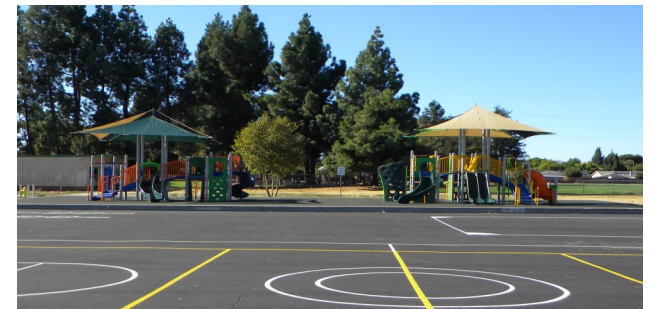
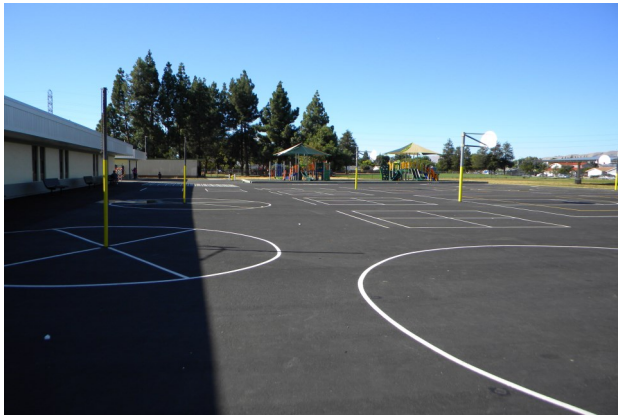
Some flat work on the interior of the campus was replaced during the modernization. The drop off area and ADA curb cuts were replaced with new ADA compliant, reinforced concrete.

Replacing the remaining concrete would be cosmetic only and is not necessary.

There is no need for upgrades related to ADA compliance.

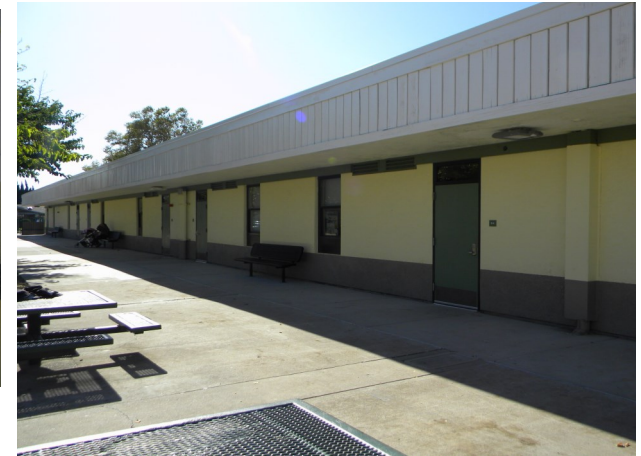
#### **18. Existing Covered Walkways**

This campus does not currently have existing

covered walkways but instead has large overhangs.

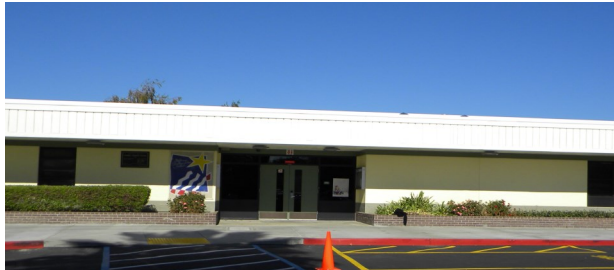
The existing exterior of this campus was painting in the summer of 2019.

There is no need for exterior painting at this site.

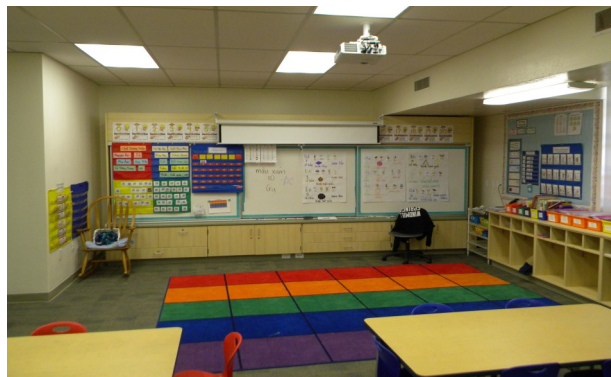
The existing flooring finishes are in good condition.

There is no need to replace floor finishes at this time.

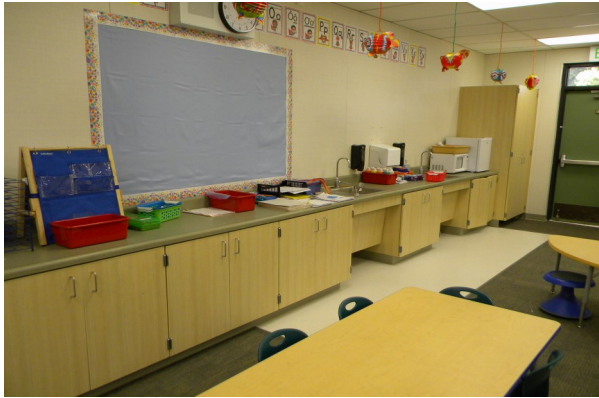
All cabinetry at this campus were replaced in the 2018-2019 modernization with the exception of the staff lounge casework and the mail slots.

It is recommended that the mail slot and all cabinetry in the staff lounge area be replaced with new cabinetry.

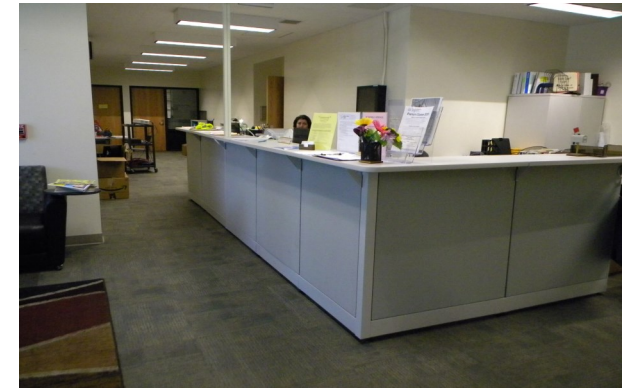
#### **49. Renovation of Administration**

The existing administration space was renovated during the 2018-2019 modernization.

No work is needed to the administration area.

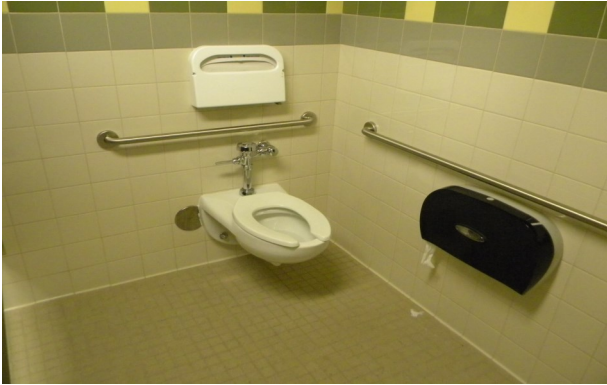
#### **52. Restrooms**

There is a need for additional toilet facilities at

this site as the campus has grown without the additional of toilet facilities in the past.

It is recommended that new toilet rooms be constructed at this site.
