# FACILITY CONDITION ASSESSMENT

February 2018

FACILITY CONDITION ASSESSMENT

PIONEER HIGH SCHOOL  
601 WEST STADIUM DRIVE  
ANN ARBOR, MICHIGAN 48105

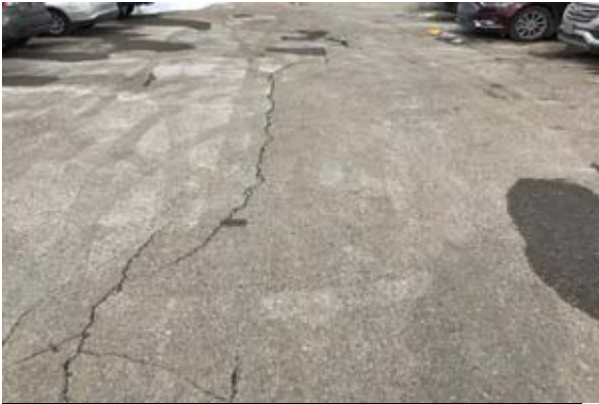
#7:	ASPHALT PARKING LOT
-----	---------------------

**Site :**  
 The Drive isles and parking lots is in poor condition. The asphalt lots and drive isles have numerous failed areas and should be repaired to prevent further degradation. A cost allowance to repair , replace the failed asphalt is also included in the cost tables
