FACILITY CONDITION ASSESSMENT

129010.18R000-032.354

March 6, 2018

PRESCHOOL AND FAMILY CENTER (BALAS II AND III)
2725 BOARDWALK STREET
ANN ARBOR, MICHIGAN 48104

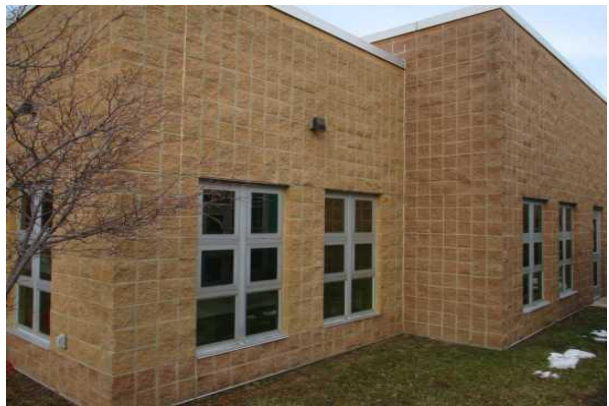
#10:	CMU WALL AND WINDOWS
------	----------------------

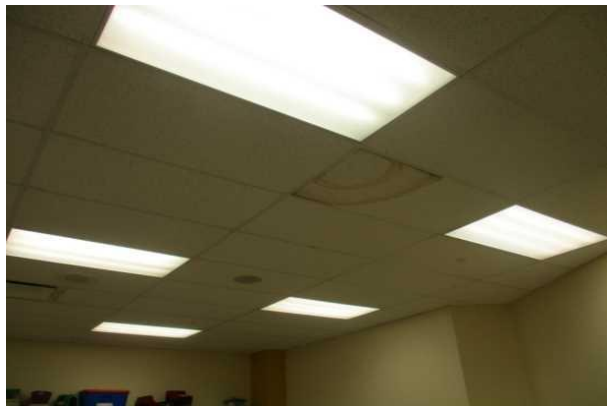
#22:	INTERIOR CEILING FINISH
------	-------------------------

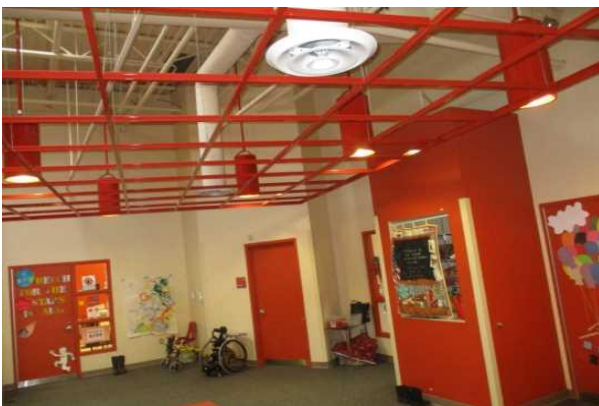
#23:	PAINTED CEILING GRID
------	----------------------

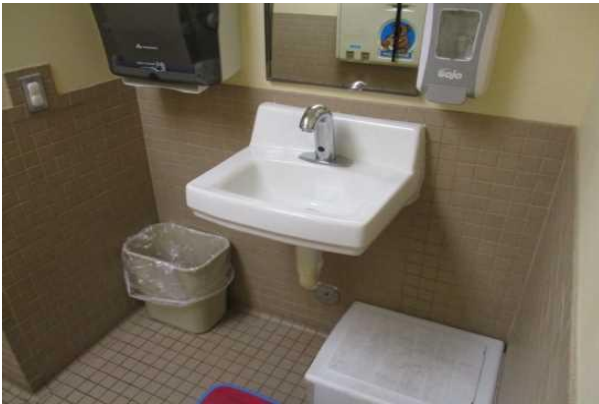
#33:	SINK WITH WRAPPED PIPE
------	------------------------
