| FIVE-YEAR CAPITAL FACILITIES PLAN | | | | | | | | | | | | | | |
| Facility Name: | Woodstock Elem. School | | | | | | | | | | | | | |

**2021 BUILDING CONDITION SURVEY - 2021 Building Condition Survey - WOODSTOCK ES**Building Information

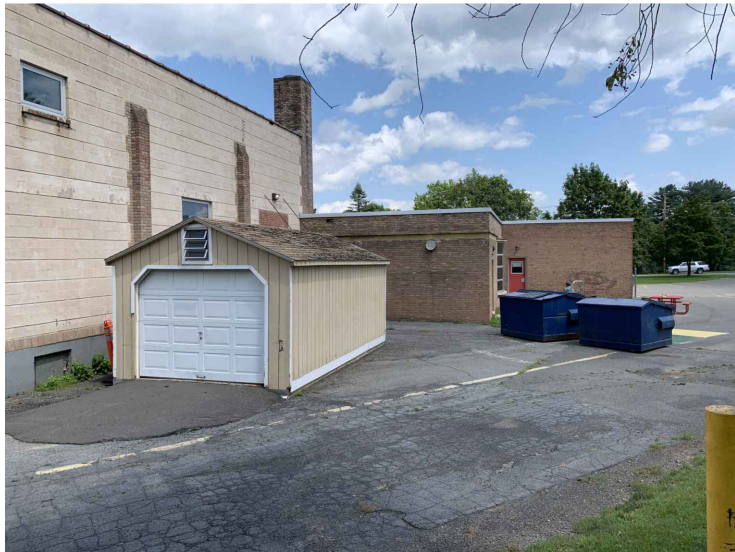
| FIVE-YEAR CAPITAL FACILITIES PLAN | | | | | | | | | | | | | | |
|---|---|---|---|---|---|---|---|---|---|---|---|---|---|---|
| WES-055-01-21 | 1 | AP | S | Asphalt paving - Boiler/kitchen area. - Install new sewer main and storm drain | Replace paving at Boiler/Kitchen area. Add catch basins, replace clay drainage line; replace sewer main. | C4 | ALT | Y* | | \$ 200,000 | \$ 20,000 | \$ 40,000 | \$ 20,000 | \$ 286,000 |

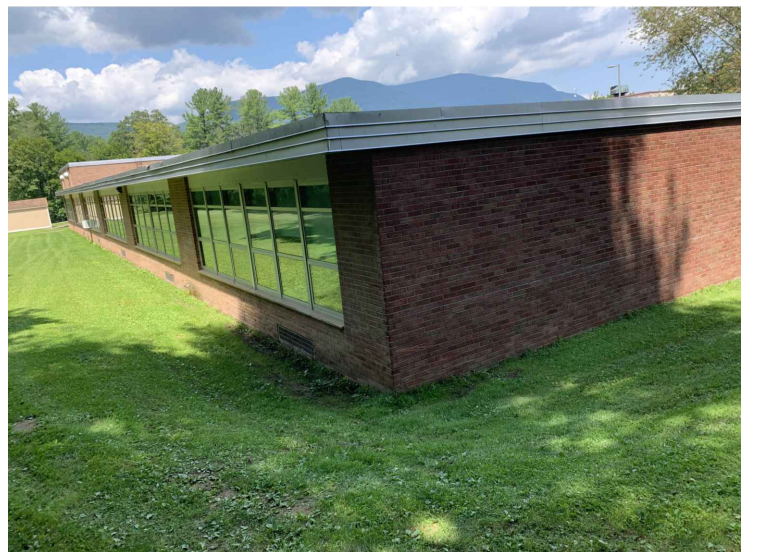
C7

| WES-056-01-21 | 5 | AP | S | Asphalt sidewalk to Riseley Lane | Replace (full depth) Asphalt sidewalks from school to Riseley Lane. | C6&C7 | REP | Y* | | \$29,120.00 | \$2,912.00 | \$5,824.00 | \$2,912.00 | \$40,768.00 | | | | | | | | | |
