## FIVE-YEAR CAPITAL FACILITIES PLAN

| Facility Name: | | Bus Garage | | | | | | | | | | | | | |

**2021 BUILDING CONDITION SURVEY - 2021 Building Condition Survey - Bus Garage-BCS**Building Information

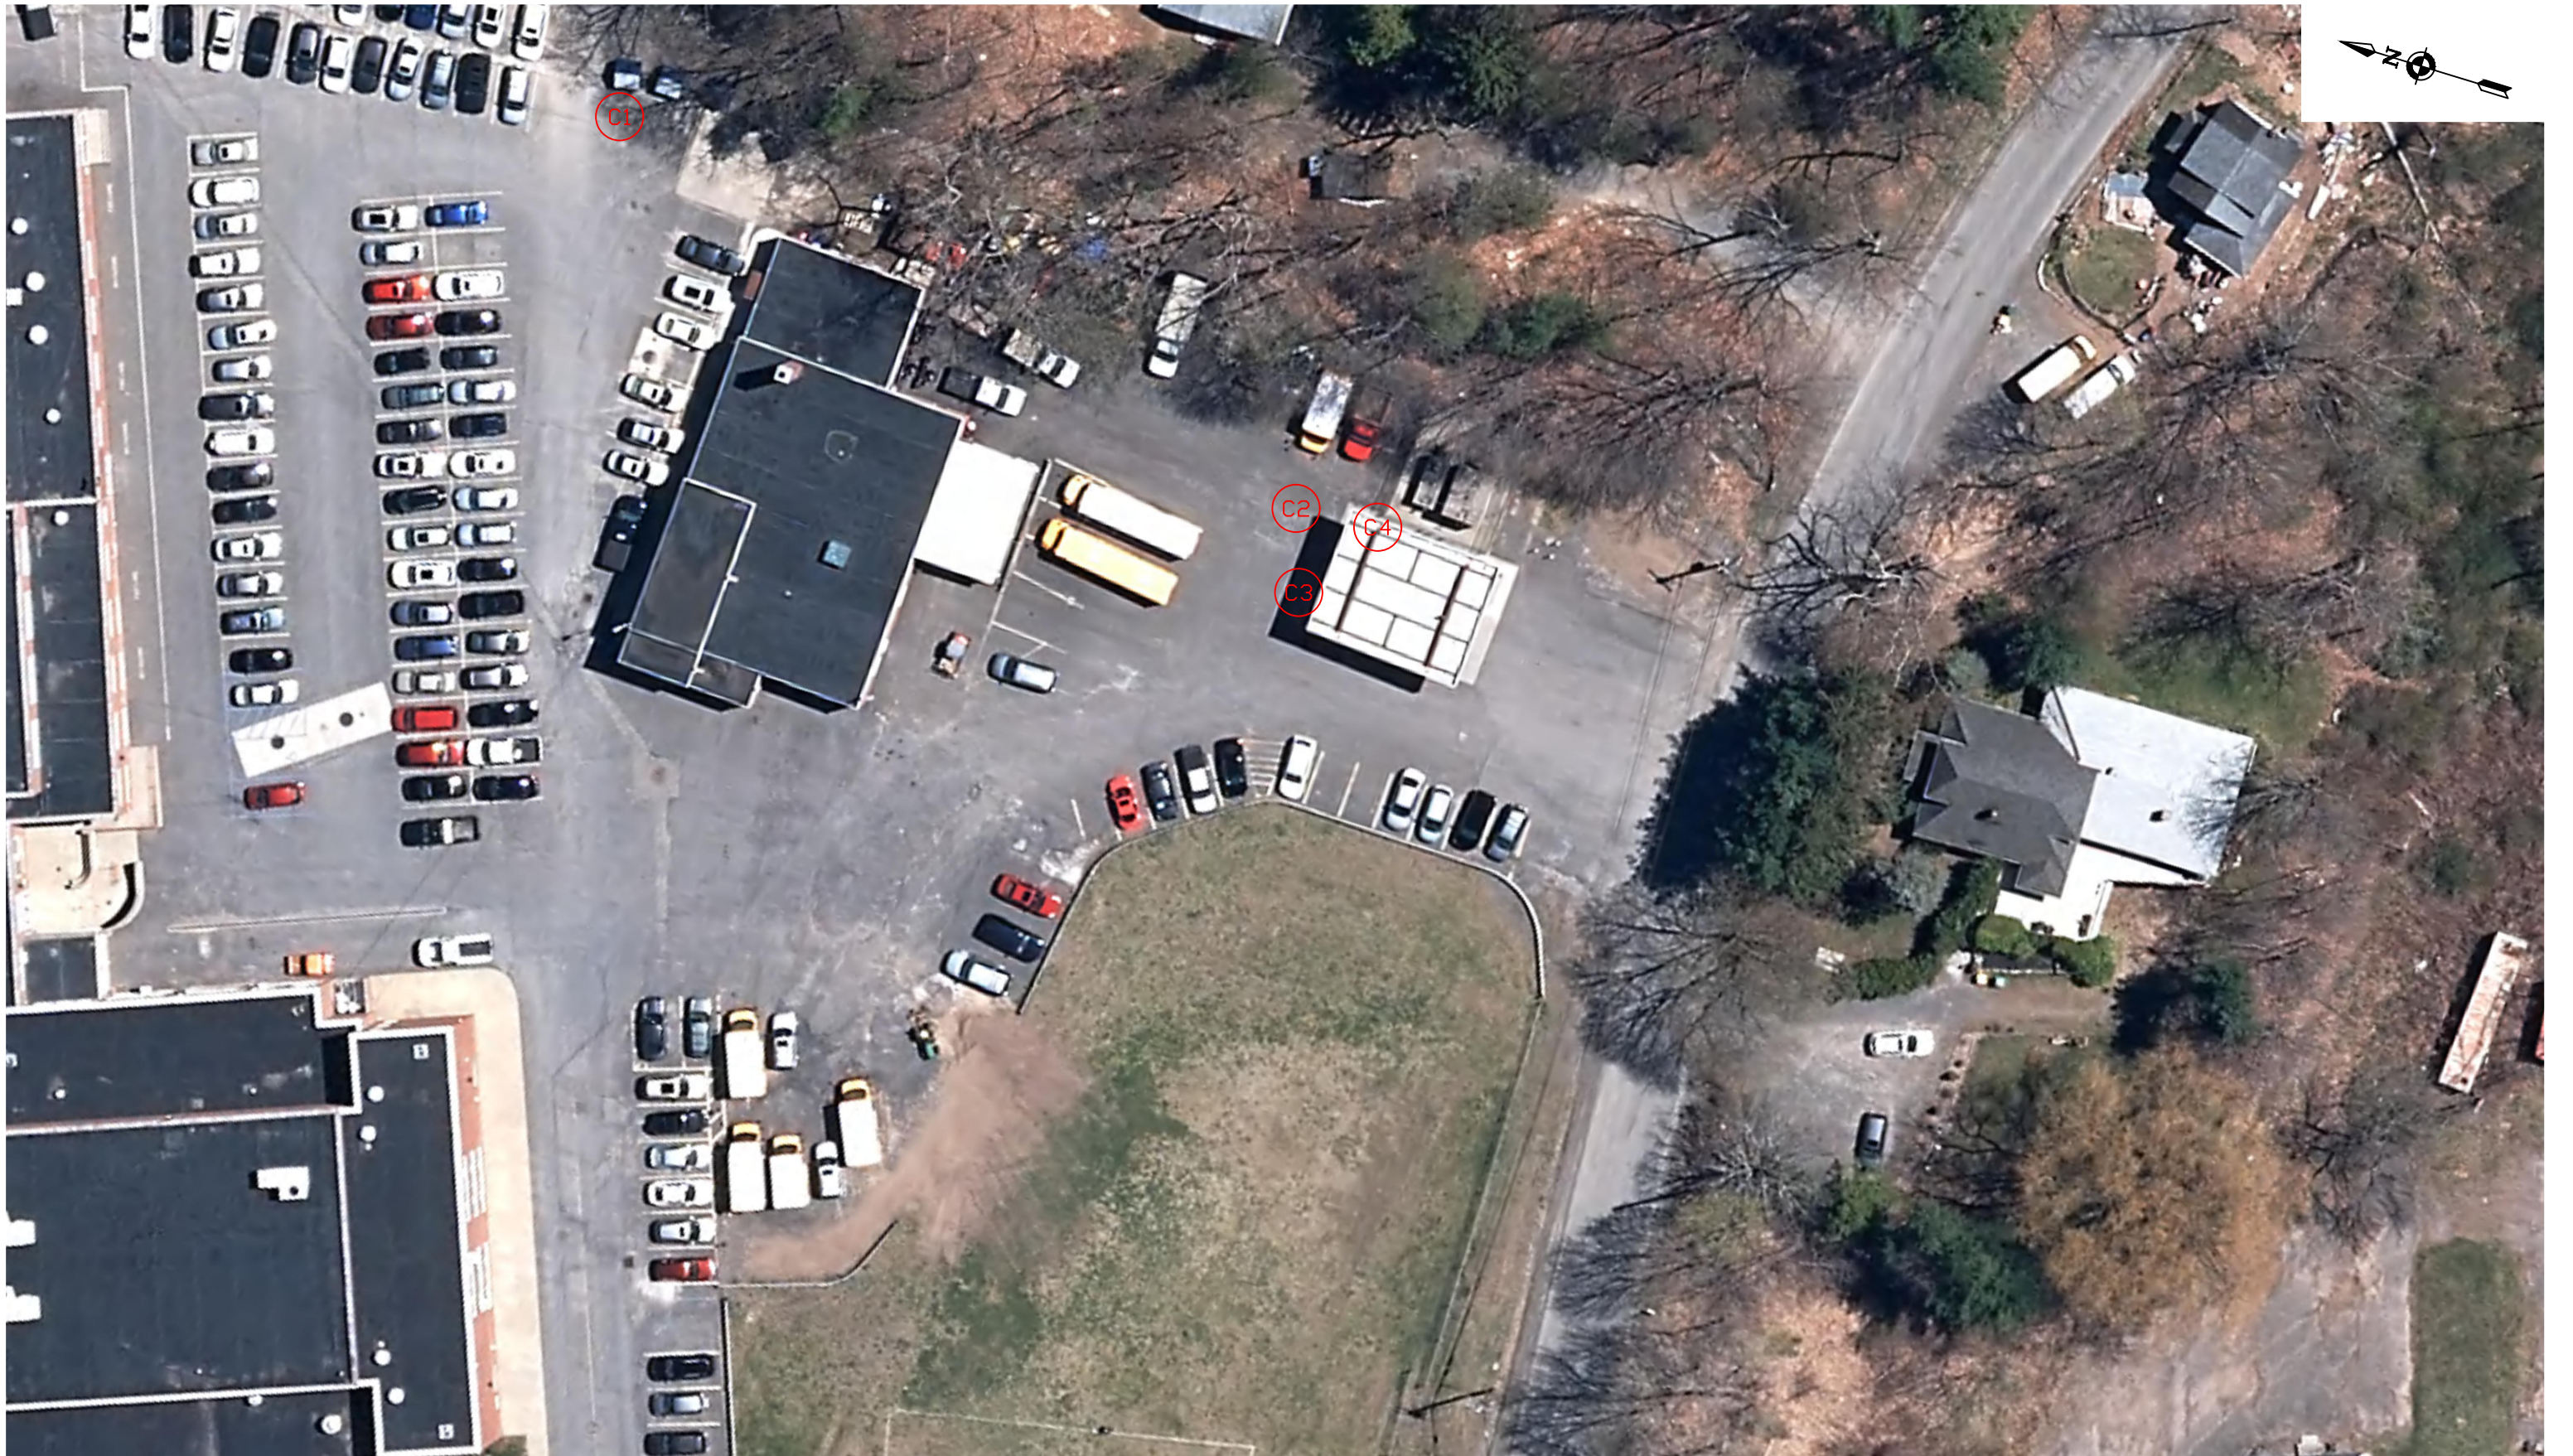
| BG-055-01-21 | 5 | AP | S | Concrete slab | Remove concrete slab in dumpster area and replace with asphalt drive | C1 | ALT | Y* | | \$ 17,000 | \$ 1,700 | \$ 3,400 | \$ 1,700 | \$ 23,800 | |
