Roanoke County Schools

Three Year AHERA Reinspection

Arnold R Burton Vo-Tech
Facility 001

Reinspection Date: January 30, 2008

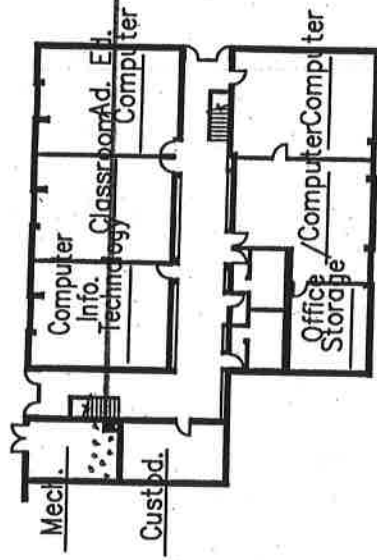
• Ground Floor Plan – Building "A"

The thermal system insulation (TSI) on the breeching for the gas fired hot water heater in the Building A Mechanical Room is an ACM. Some damaged areas were noted. We recommend the damaged areas be repaired.

Repair the damaged areas. Once the damaged areas are repaired, an asbestos warning sticker should be applied to the flue pipe.

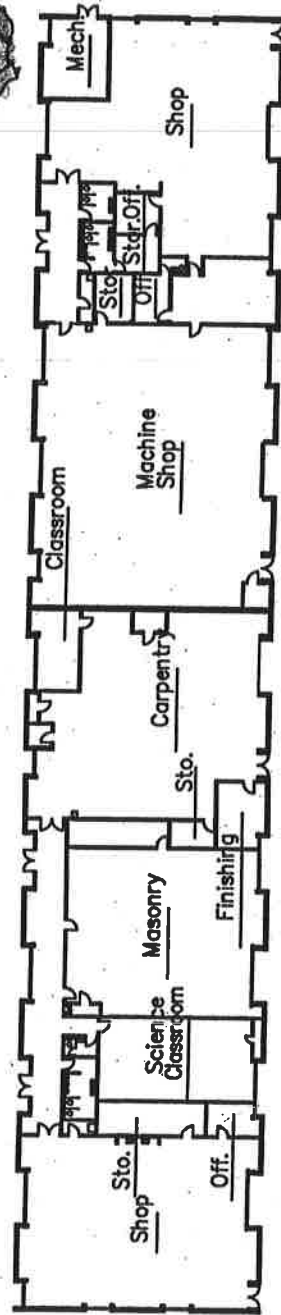
• Floor Plan – Building C

No ACMs were found to exist in Building C (West Shop)
