ATHLETIC FACILITIES CONDITION ASSESSMENT

Roanoke County Public Schools
Roanoke, Virginia

July 30, 2018

Draper Aden Associates
Engineering • Surveying • Environmental Services

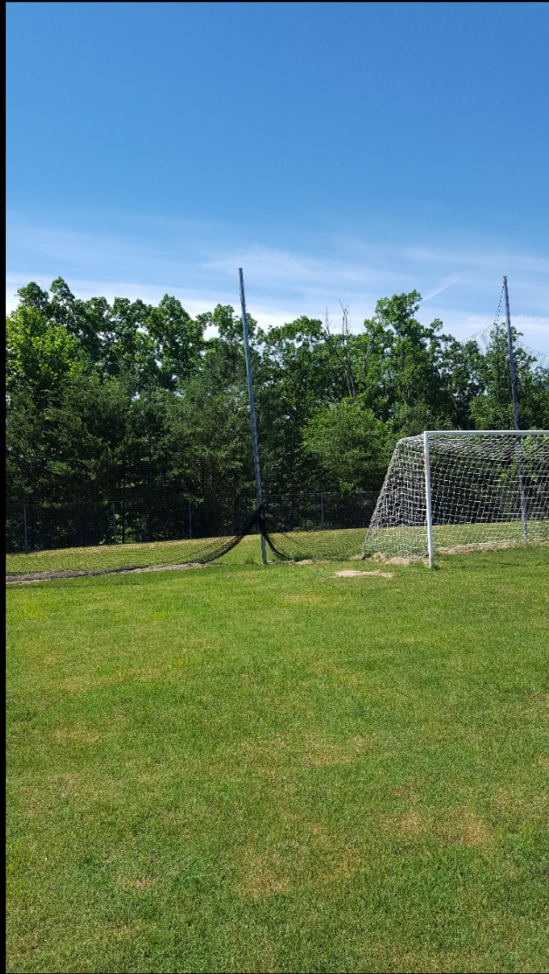
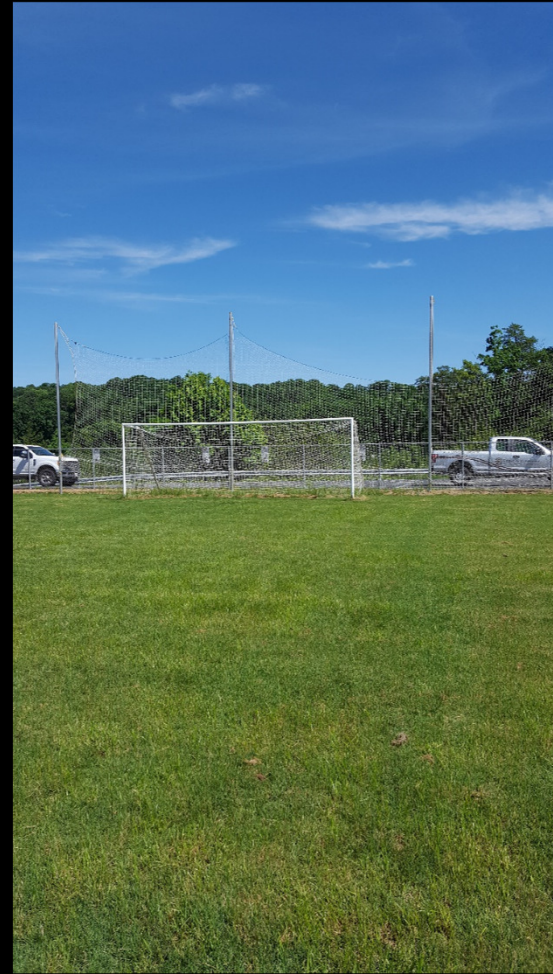
03. End Netting Sag

04. End Netting Sag

- ◆ Maintenance Needs
 - Repair end netting behind each goal.
 - Aerate, seed, and fertilize the field regularly to provide a good stand of grass and even playing surface.

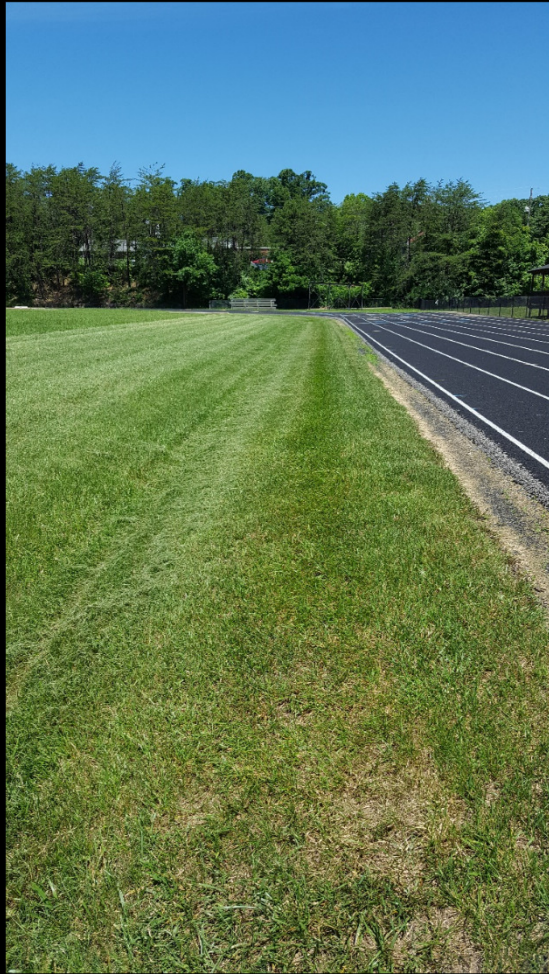
01. Large Drainage Ditch

02. Large Drainage Ditch

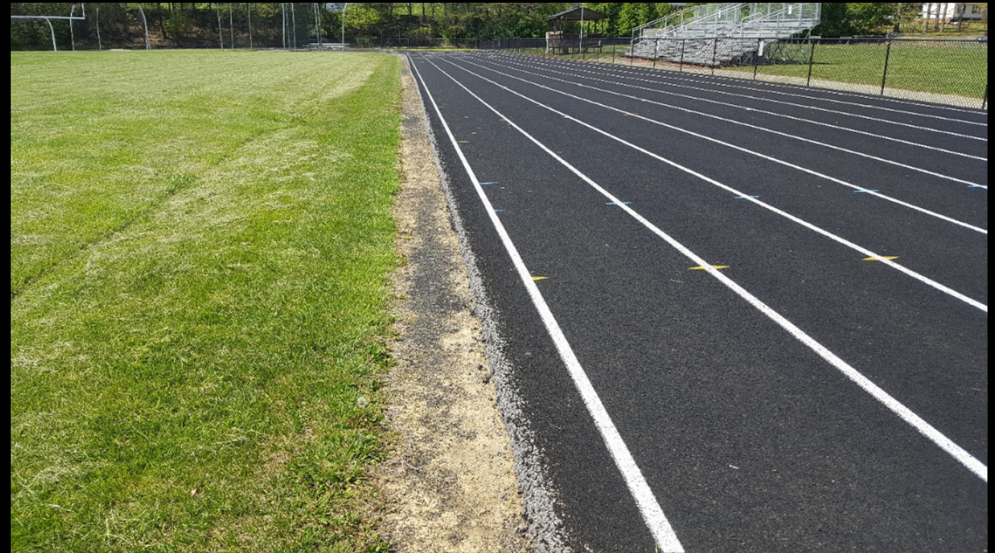
- 4-6" high lawn/soil on both outside and inside
 - No drain at inside perimeter, this could cause ponding inside Lane 1 and at field edge.
- Oval and field Event conformance with NFHS standards

04. Track Edge Where Water Collects

- Install trench drain along sides of field at inside edge of track
- Remove and replace synthetic surfacing within approximately 3-5 years
- Relocate or reorient shot put landing area to avoid football goal post.
- Regrade the field with laser grading equipment to ensure acceptable planarity.

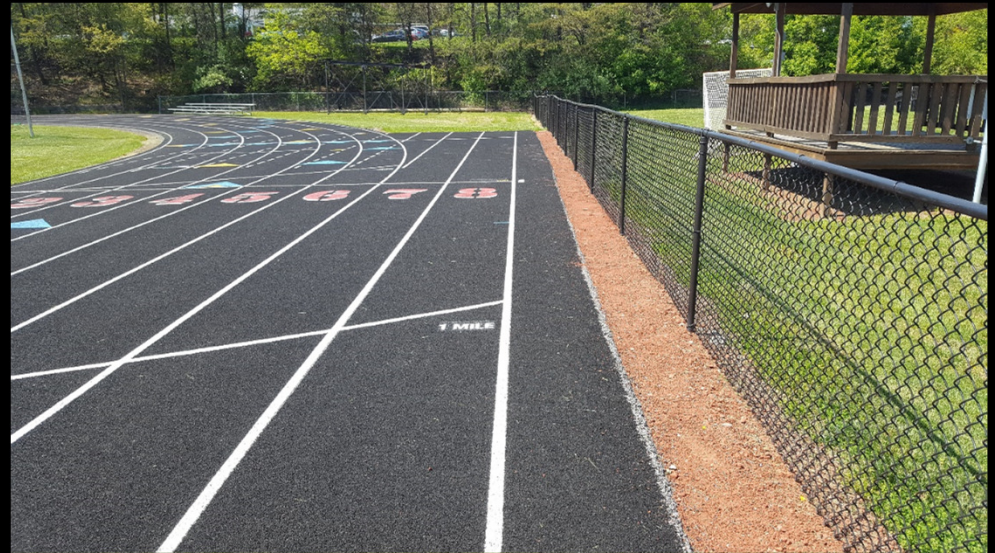
- Asphalt at long/triple jump in good condition
 - Asphalt at pole vault and high jump in good condition
- Perimeter
 - No curbs, stone/dirt edge around outside and inside perimeter

06. No Perimeter Curb

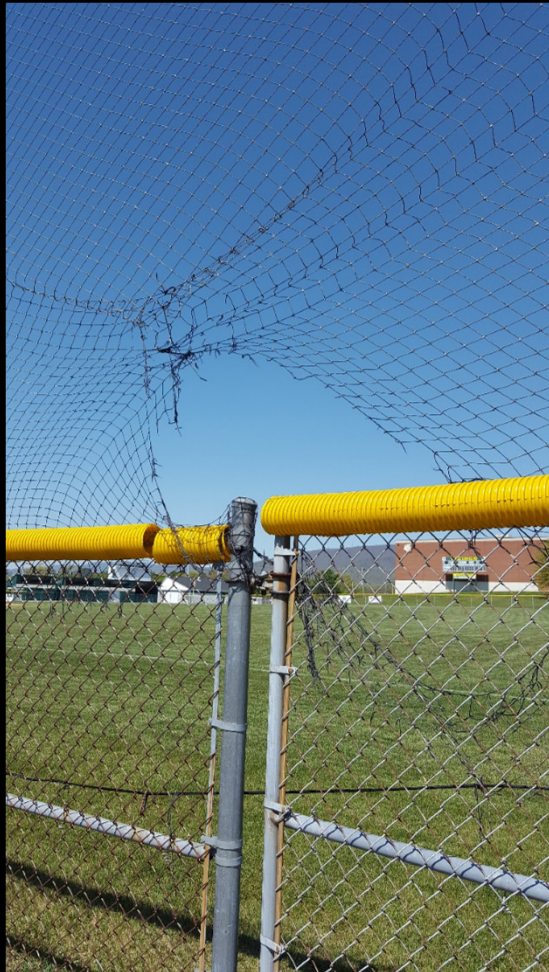
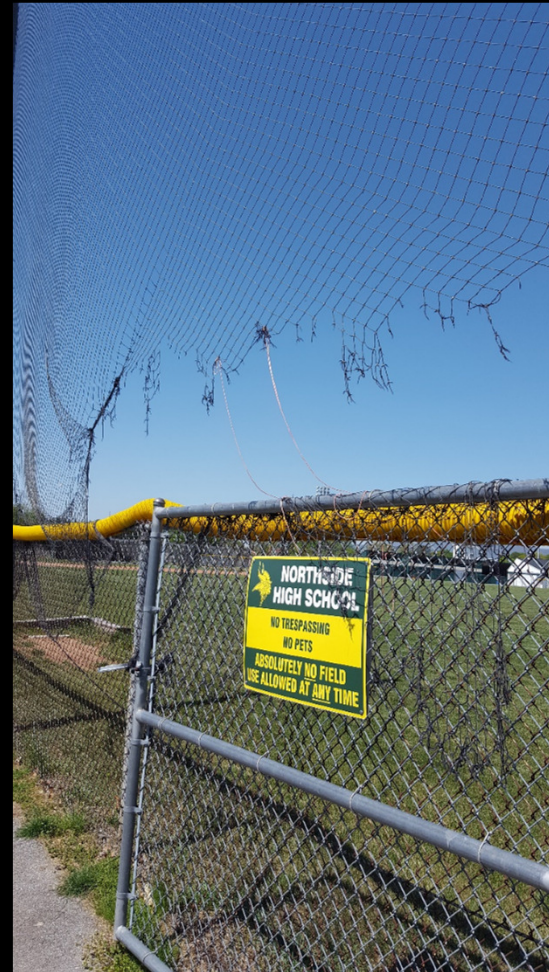
01. Safety Netting Along Right Field

02. Safety Netting Along Right Field

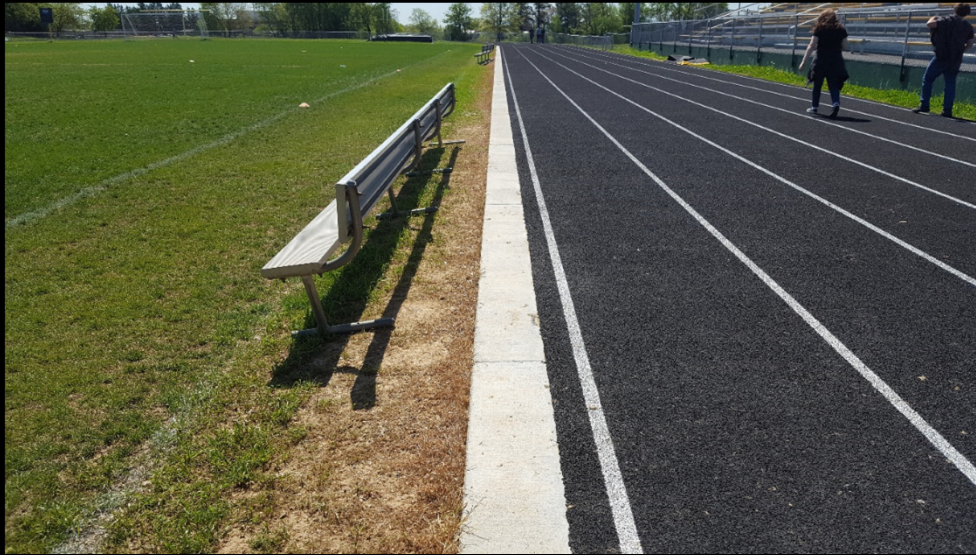
01. No Drain on Inside Perimeter and Elevation Change

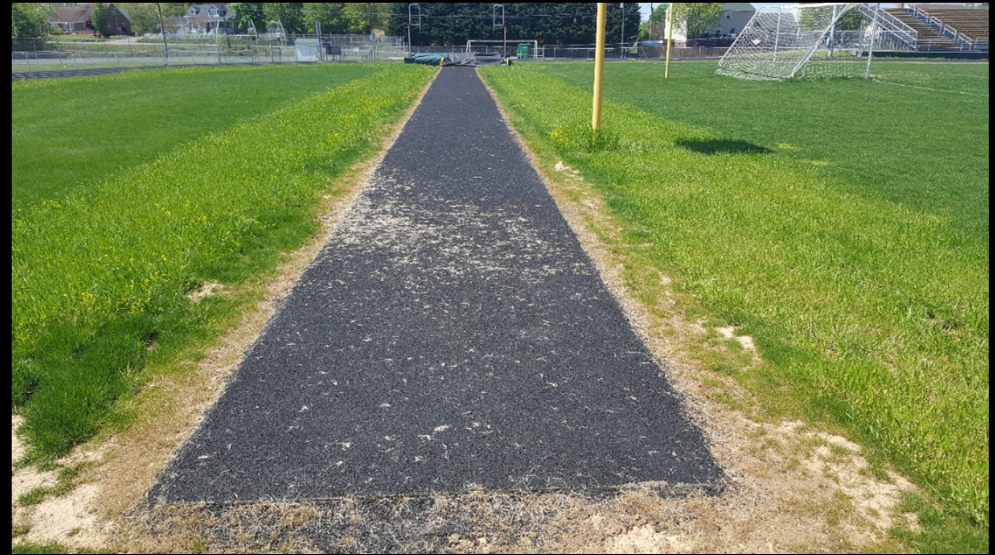
02. Debris on Surface

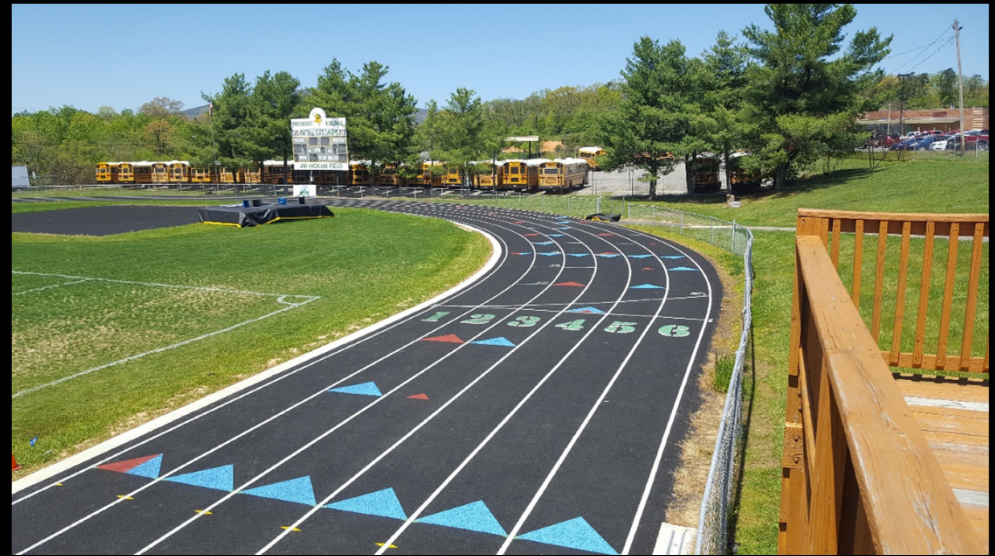
04. Limited Space Outside Lane 6

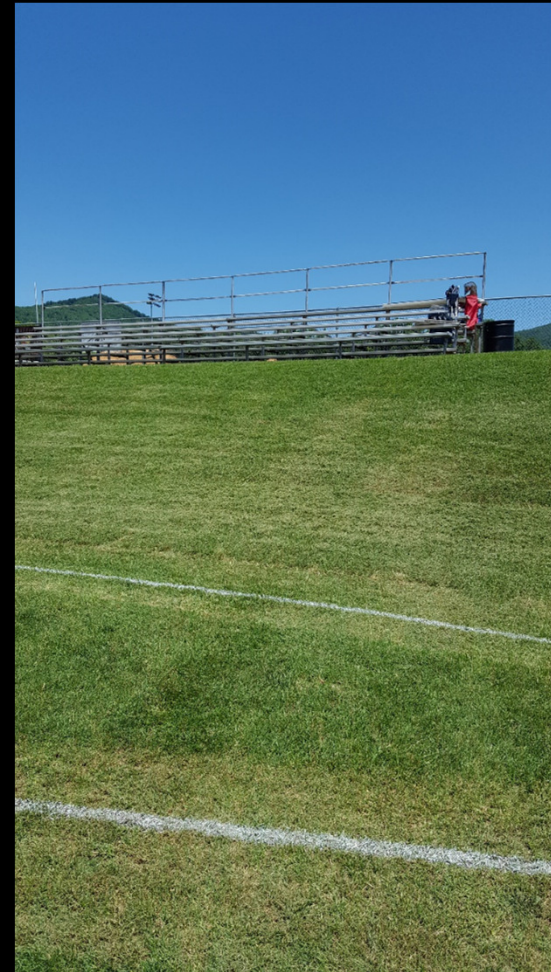
04. Extend Retaining Wall Down Left Field Line

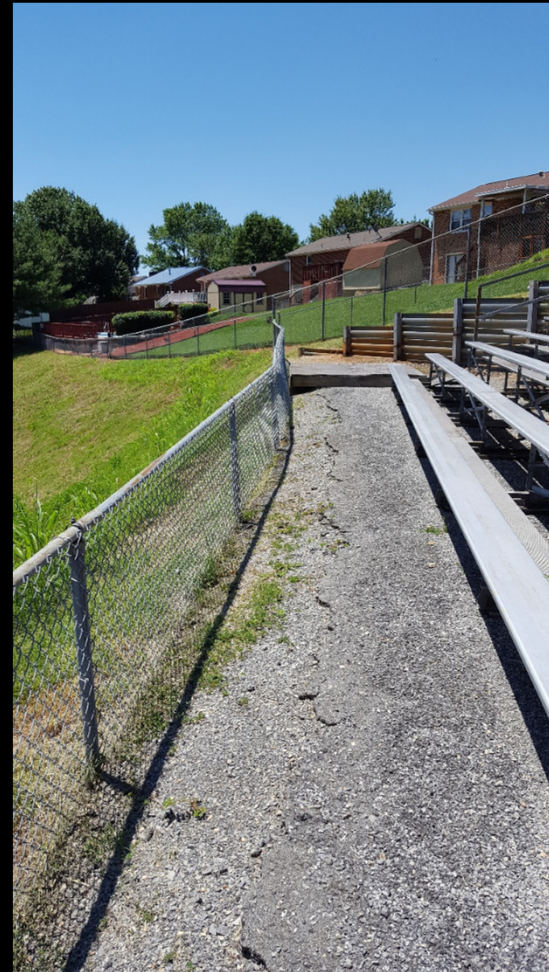
02. Upper Level Fence Sagging

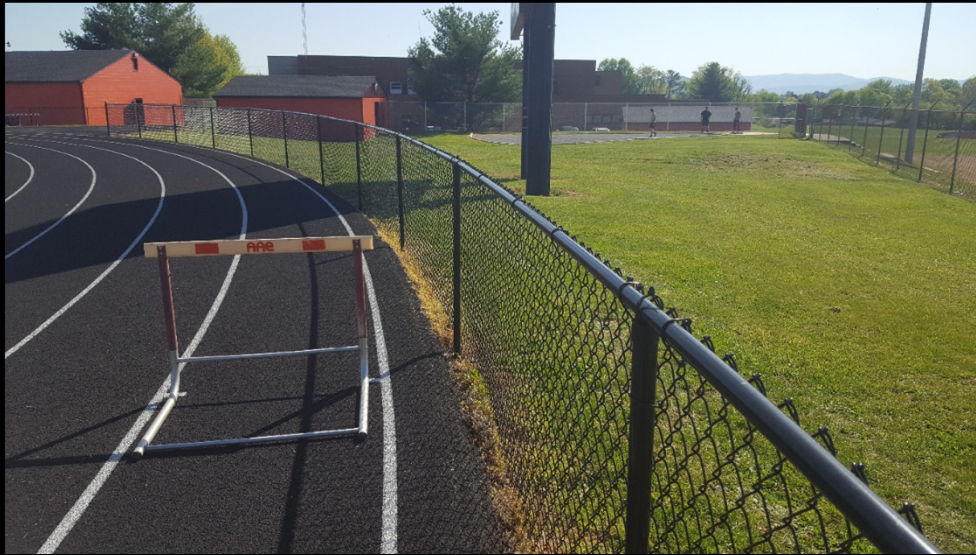
01. Fence Too Close to Track

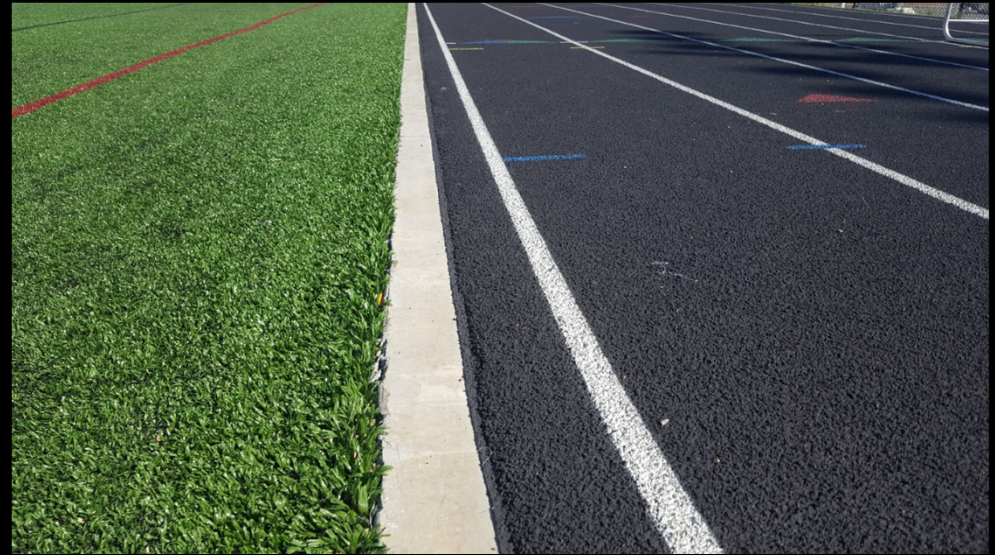
02. No Trench Drain

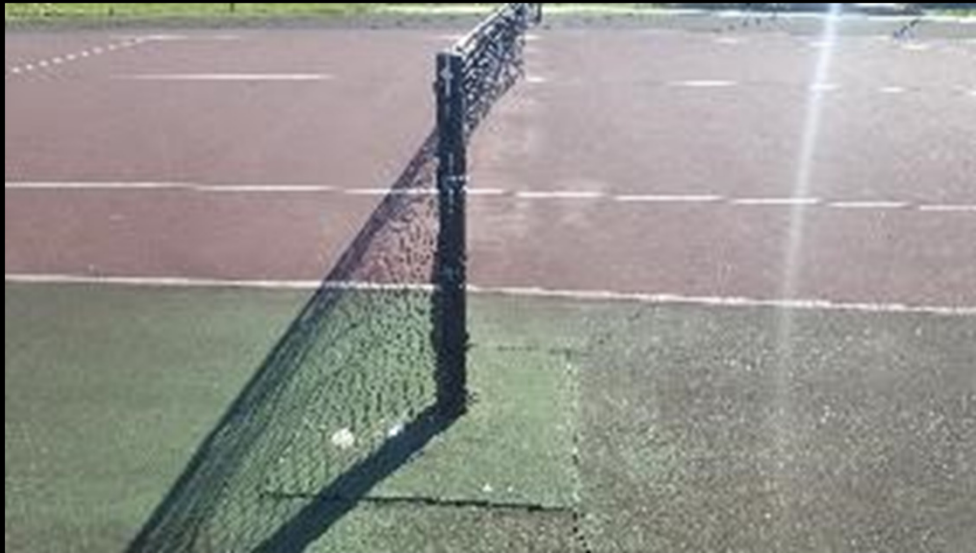
01. Net Post Anchor Heaving

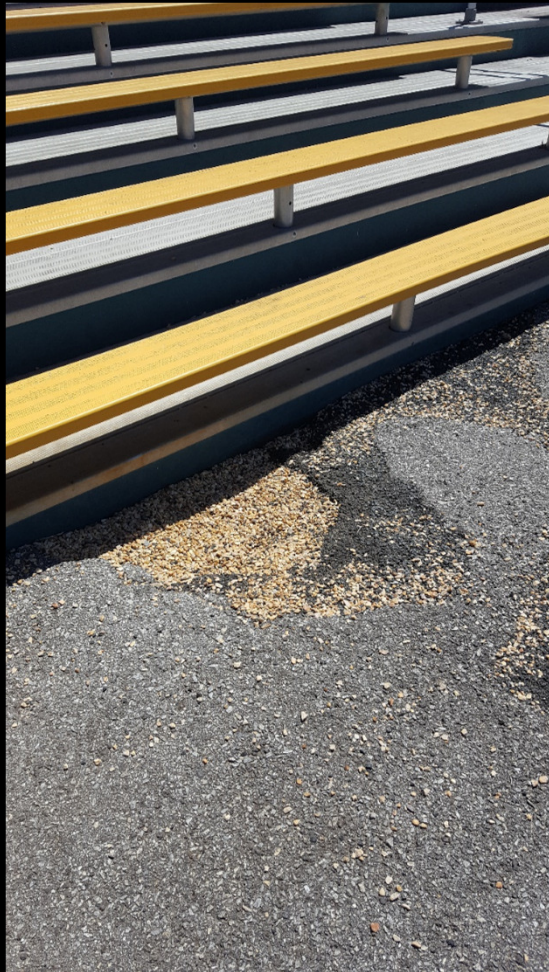
05. Wash Out at Visiting Bleachers

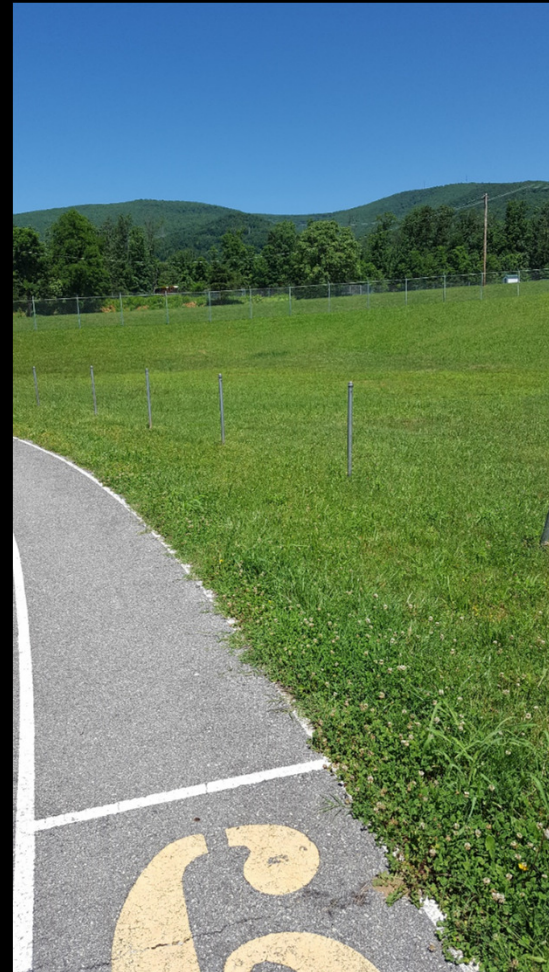
06. No Fabric on Perimeter Fence

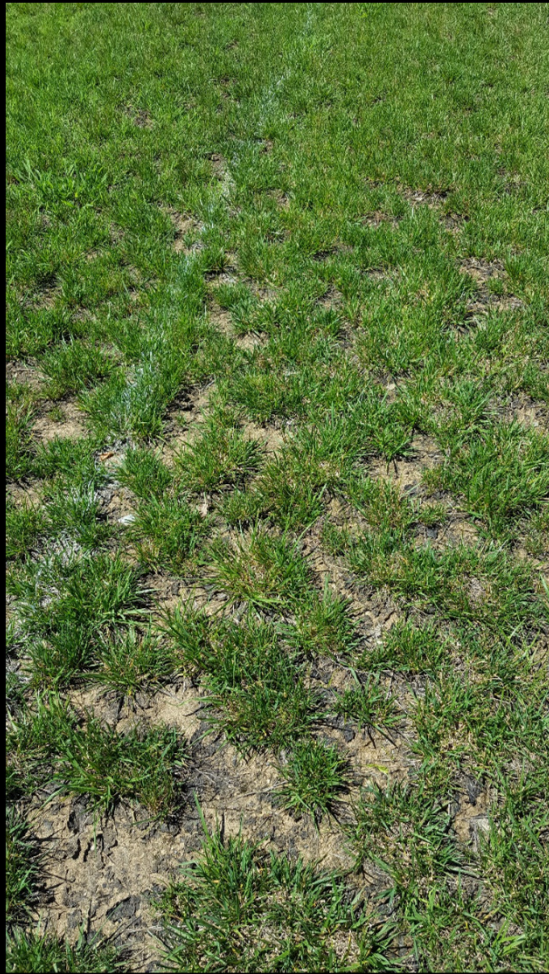
01. Barren Areas and Signs of Ponding

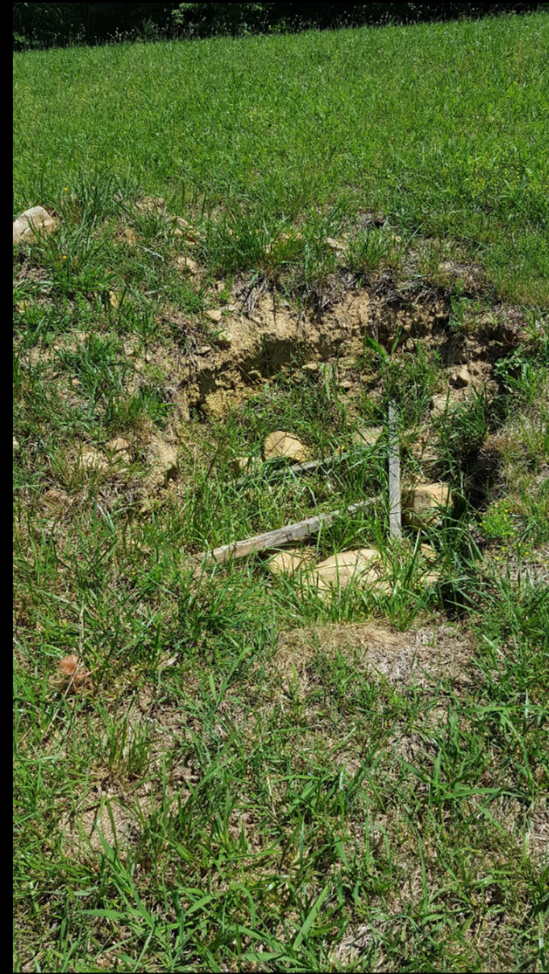
02. Sink Hole Outside Perimeter Fence

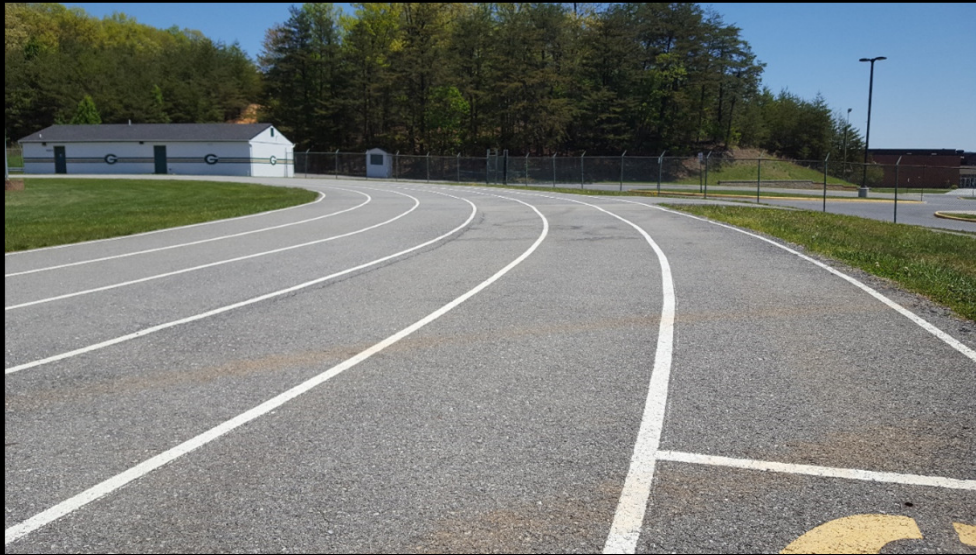
01. No Surfacing, Asphalt Only

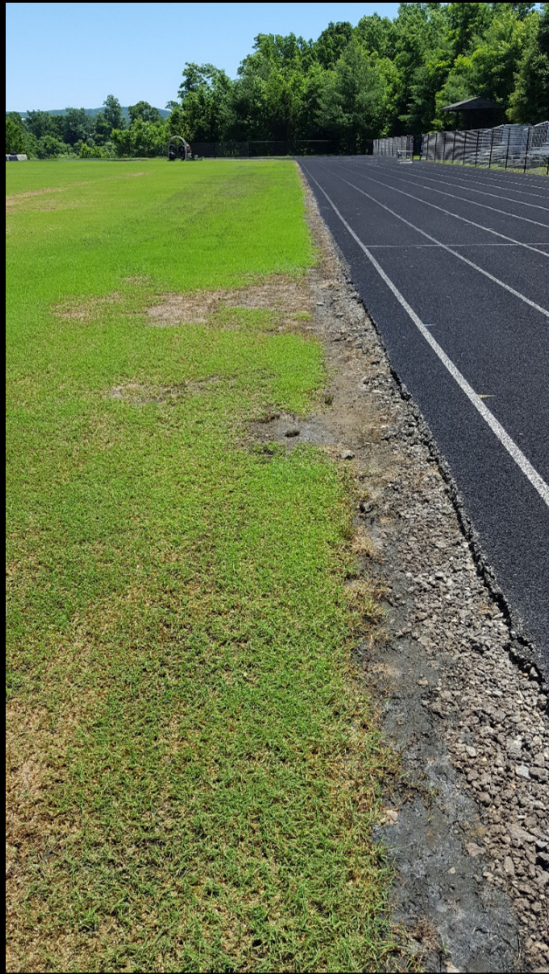
03. Water Ponding Along Edge of Track

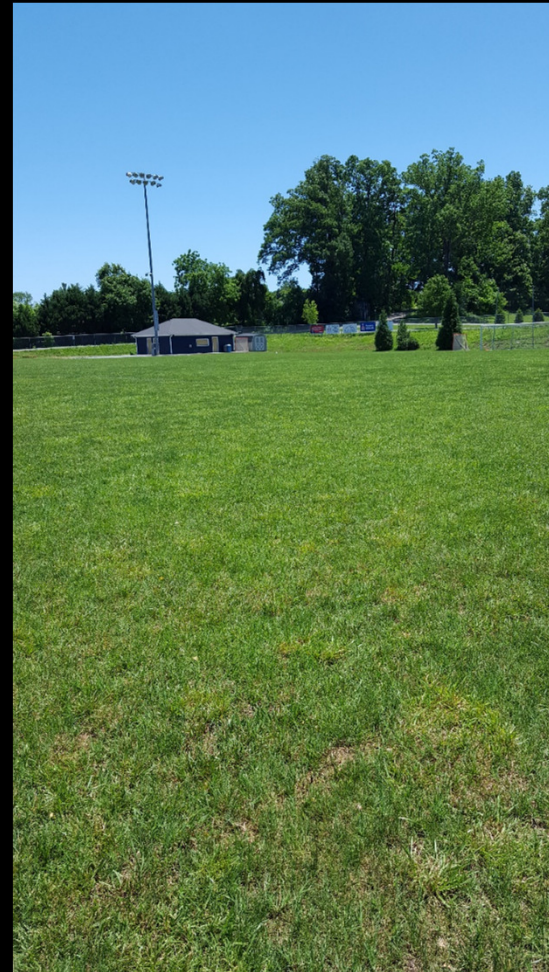
02. No Drop Inlets Around Perimeter

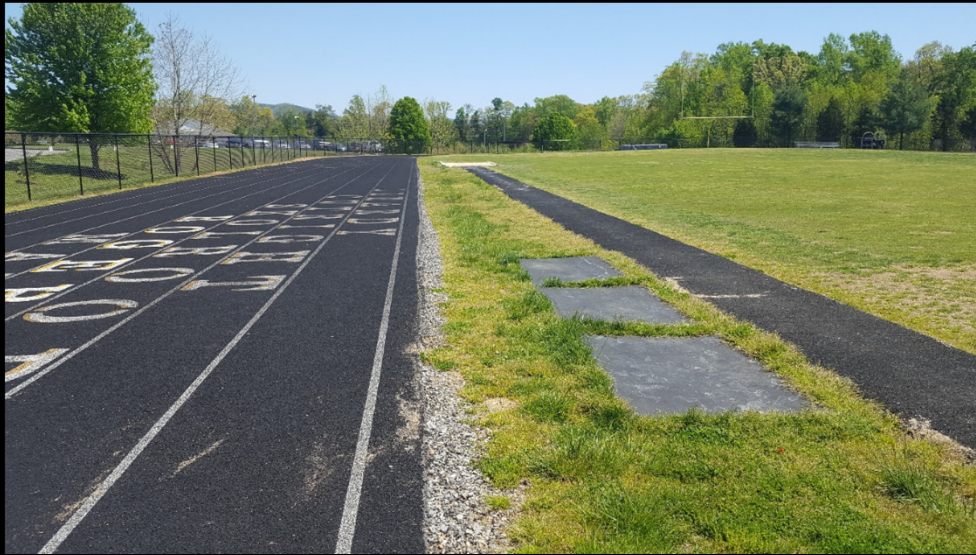
01. Exposed Inside Edge

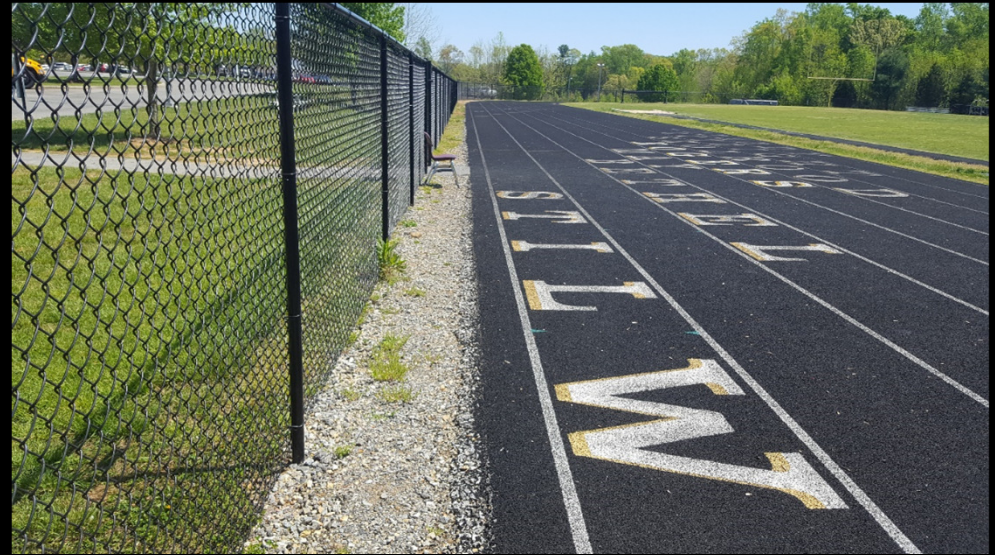
02. No Outside Curbing

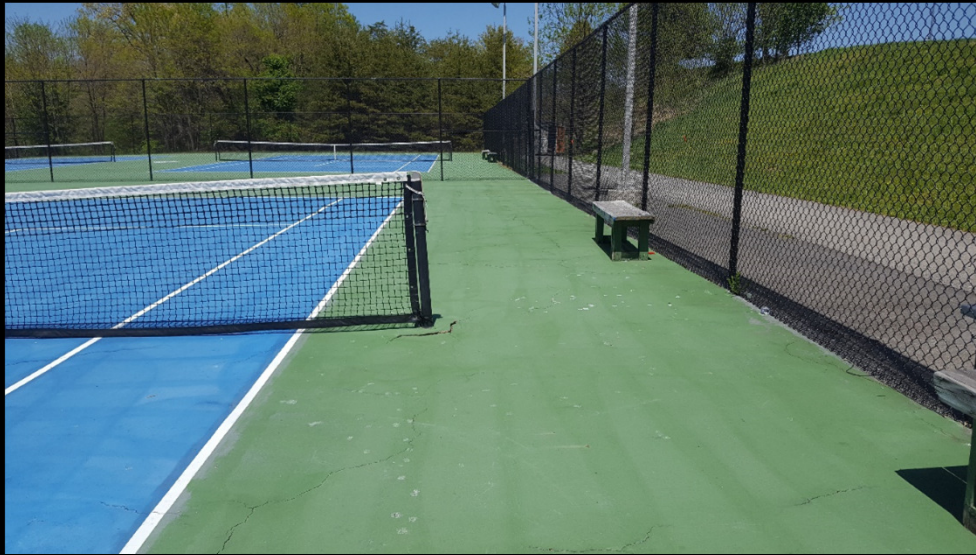
01. Streaks and Surface Delamination
