WILLIAM BYRD MIDDLE SCHOOL

ARCHITECTURAL

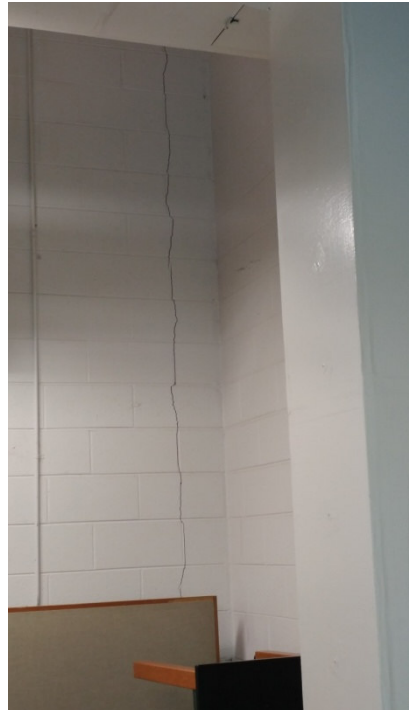
Cracks in Many Mechanical Room Walls

While searching for a crack observed by the architectural team, many, if not all, of the mechanical rooms were visited. Each room visited exhibited significant cracking in the masonry walls. Where the exterior of the wall was investigated, the cracking did not appear in the exterior face brick. Most of the cracks appeared to be settlement cracks. Cracking in adjacent areas was not reported. It is assumed that this cracking is isolated to the mechanical rooms observed. These cracks, while somewhat unsightly, do not pose a threat to the structural integrity of the building. However, they should be caulked, painted and observed for additional movement. Due to the number of cracks, particularly in the second floor mechanical rooms, it would be wise to begin a monitoring program using crack gages installed across the most severe cracks. Monitoring on a quarterly basis with detailed documentation of readings is recommended. Further information regarding a monitoring program can be provided if desired.
