Medford Public Schools

Re: Statement of Interest - Medford High School - Core Program

Report of Findings: Focused Facility Condition Review

Medford High School

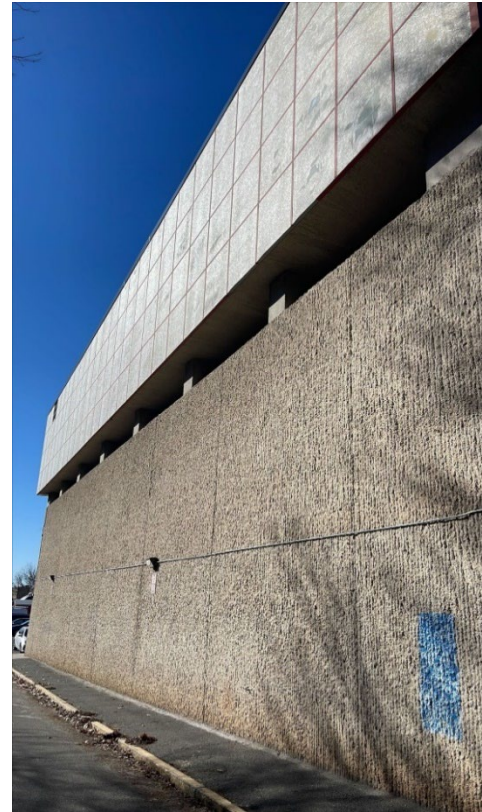
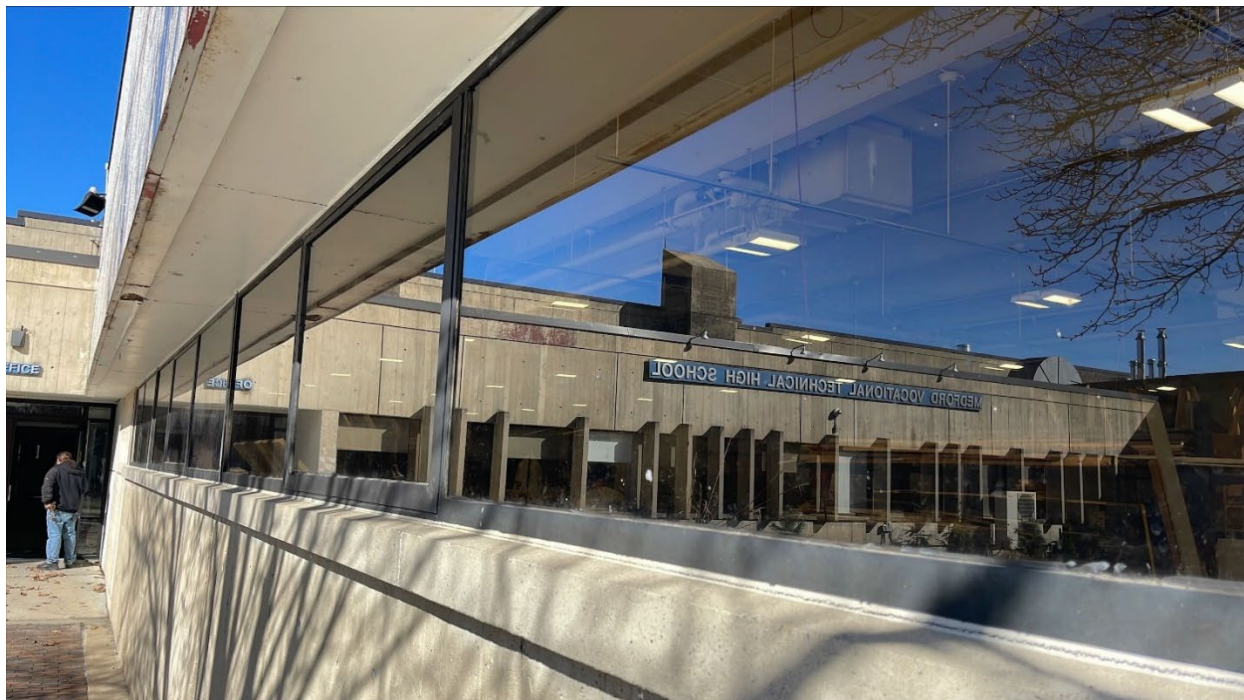
At the auditorium, pool and select areas of the Vocational School, the exterior assembly includes semi-opaque fiberglass panels which allow daylight into the interior of the building. These panels were installed during the original building construction and a 2007 study completed by Drummey Rosane Anderson, Inc., with assistance from Simpson Gumpertz & Heger, identified the panels to be "in very poor condition, and need replacement at this time"⁴. They are well beyond useful life expectancy.

Door openings are enclosed by a mixture of metal door and doorframe assemblies and are sealed with exterior caulking of several types. Most of the openings in the building exterior were constructed when the building was originally built in 1971.

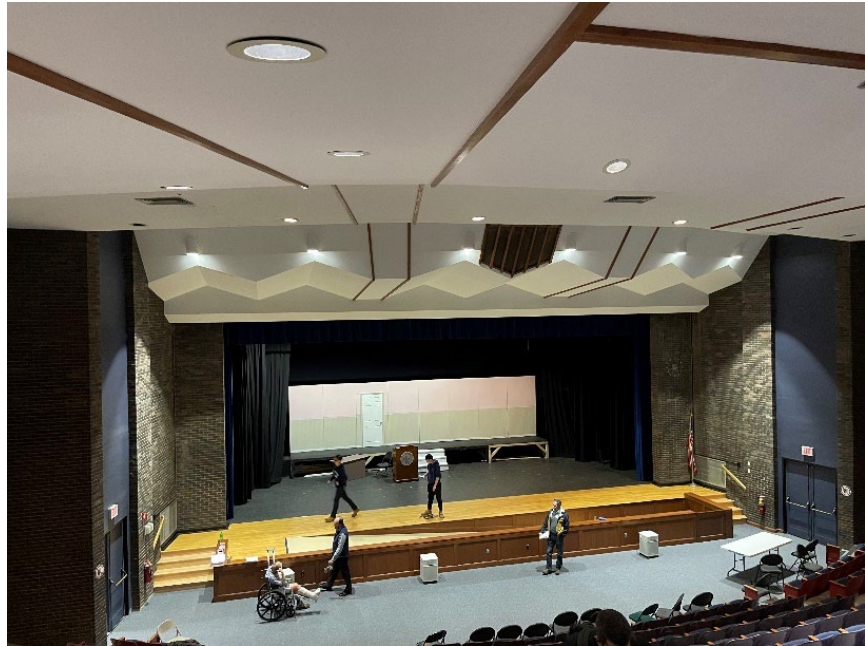
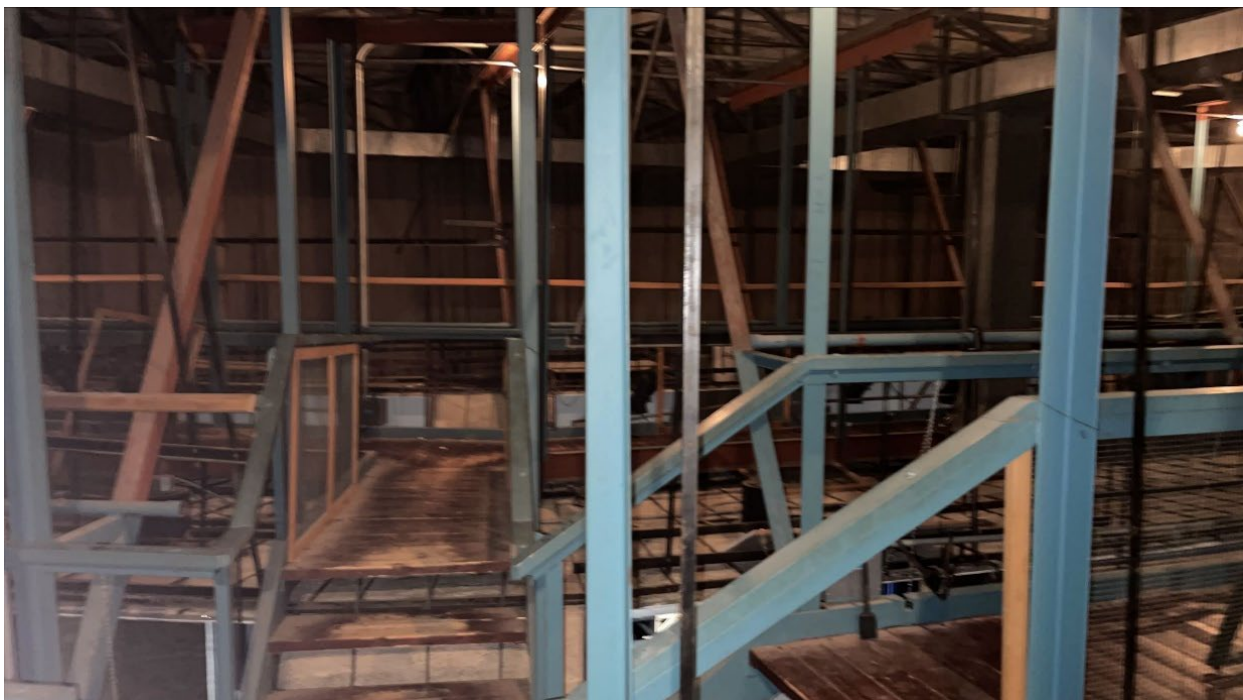
Auditorium

The main auditorium, located adjacent to the main lobby consists of wall elevations of polished brick and painted concrete. The walls were observed to be in well maintained condition. The main auditorium floor consists of a broadloom carpet assembly which was installed as an improvement to the original flooring. The carpet appears to have been installed

within the last 10-20 years. The walls consist of painted concrete and CMU with fabric wrapped acoustical panels. The timing of the installation appears to be within the last 10-20 years. The ceiling assembly consists of a finished GWB suspended ceiling which sits below a composite steel and wood framed catwalk assembly.

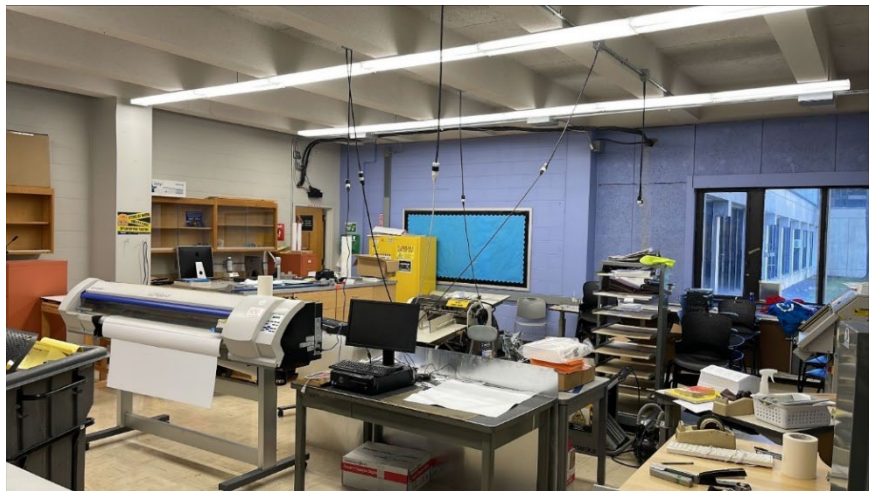
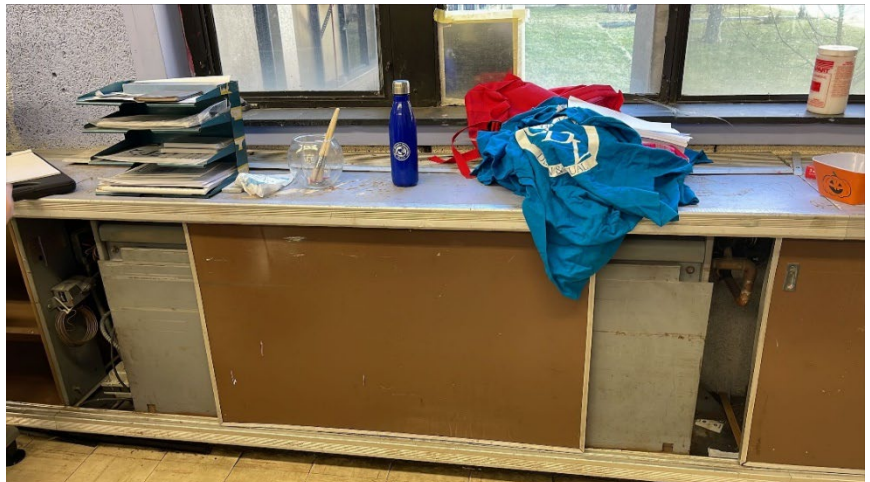
Classrooms and Unit Ventilation

Univents (Unit Ventilators) were observed in each classroom and function as the primary ventilation. The ventilators were installed during the original school construction and were observed to be in poor condition, and well beyond useful life expectancy. In most of the classrooms the exhaust did not appear to function. **The ventilators are of particular**

concern, as they are not only a significant factor of the buildings' HVAC performance, but also are part of the exterior opening assembly. Both interior and exterior sealants and caulking were in poor and most cases failing condition and in need of immediate abatement, improvement and/or replacement. It should be noted that the staff has found it exceedingly difficult to find parts for these obsolete units.

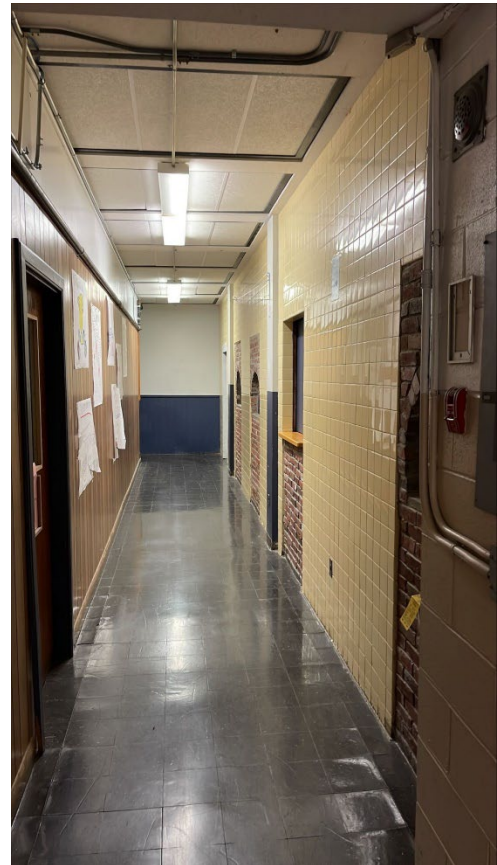
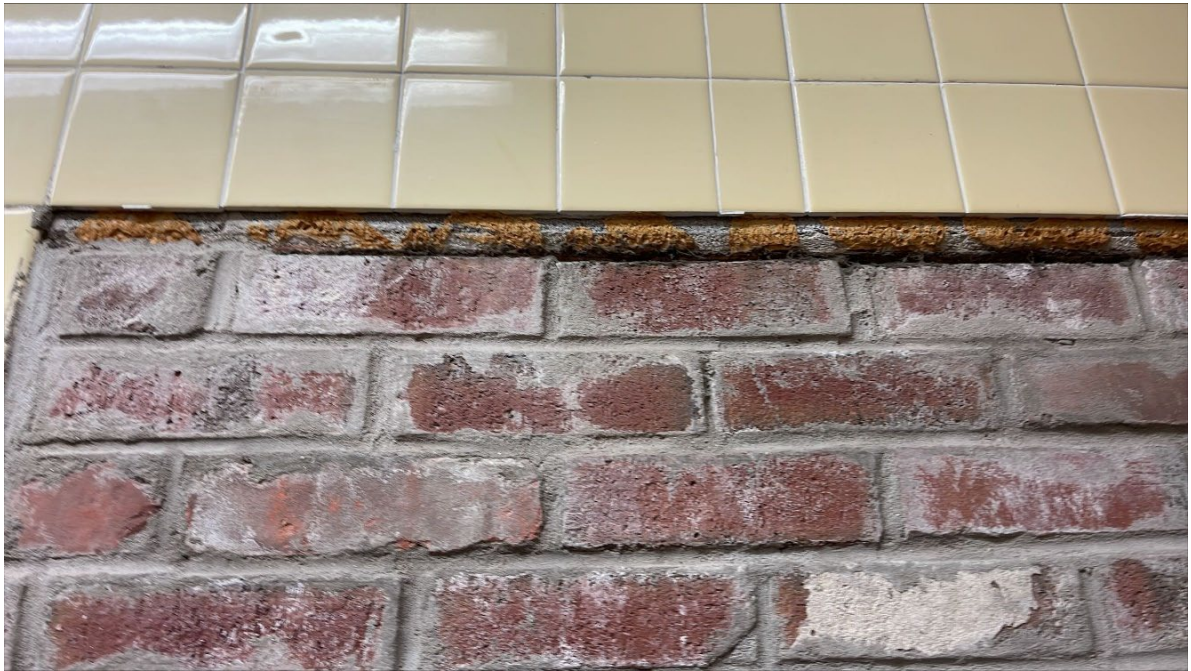
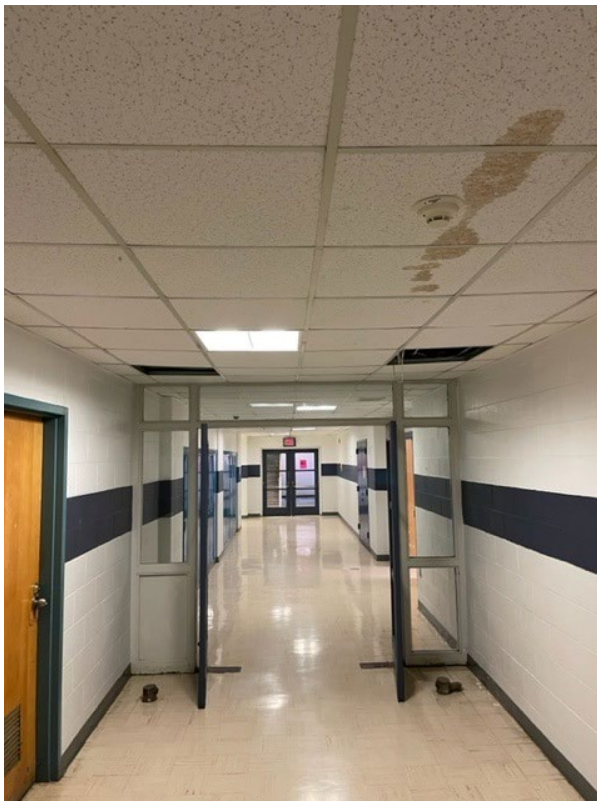
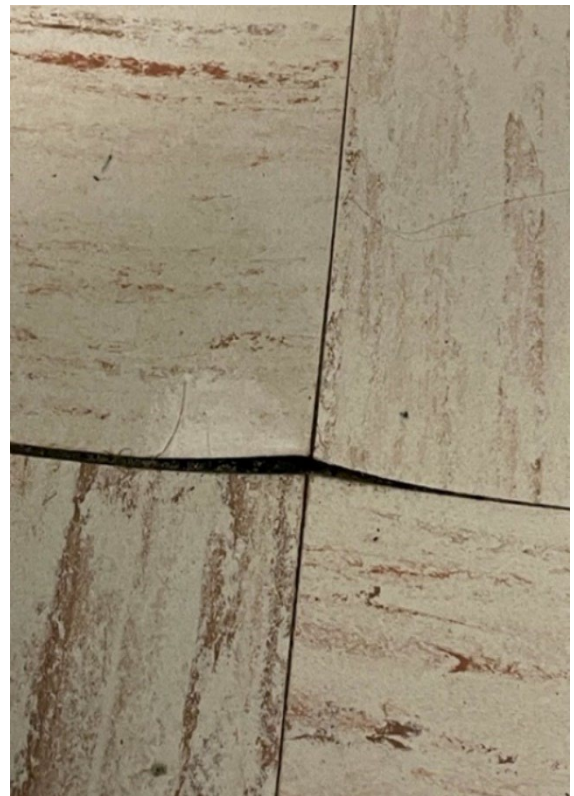
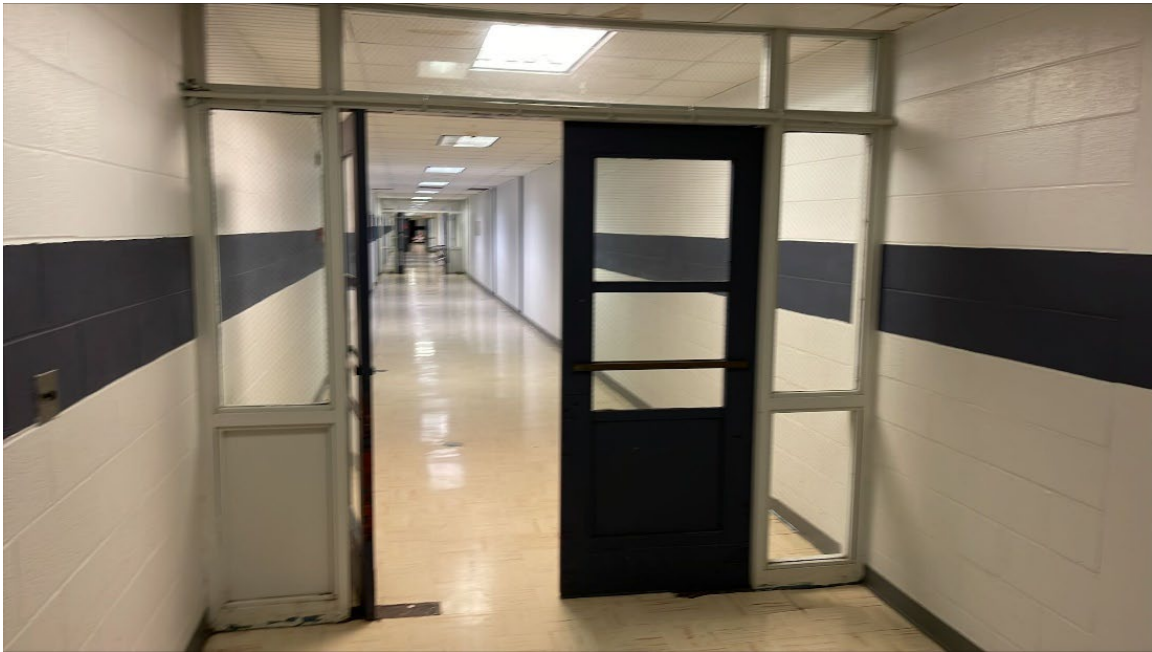
Corridors

Several corridors within the high school were inspected as part of the survey. Wall assemblies were observed to be painted CMU and concrete, some of which had ceramic tile and wood panel finishes. Interior sealant joints were observed where painted CMU and concrete walls abut. **Flooring observed in all locations consisted of 9" x 9" flooring tiles installed during the original building construction.** A variety of acoustic suspended ceiling tile assemblies were observed. Please refer to the EH&E Report (Appendix A) for more information on paint, sealants and caulking materials present in this location as it should be assumed that hazardous materials are present.

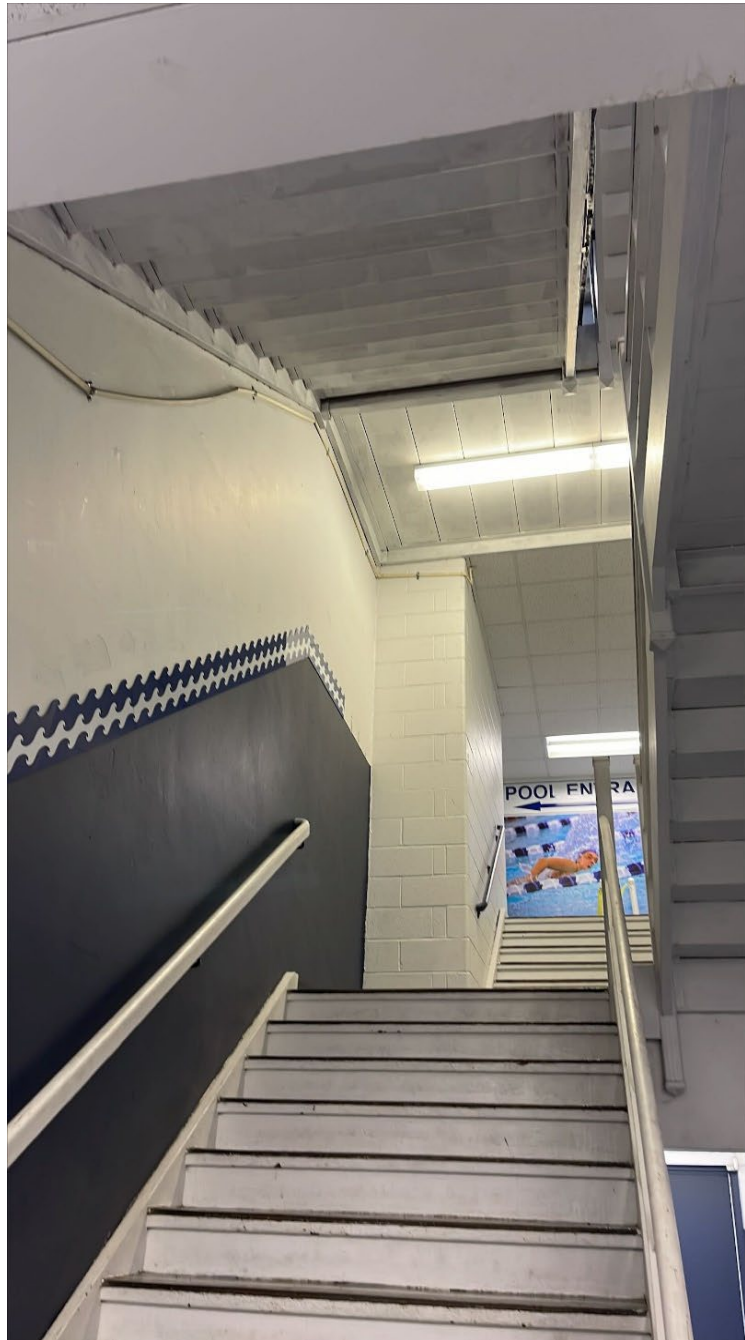
Administrative wall assemblies were observed to be painted CMU and concrete walls, some of which had ceramic tile and wood panel finishes. Interior sealant joints were observed where painted CMU and concrete walls abut. Flooring was observed to be a combination of red quarry tile and 9" x 9" flooring tiles which were installed during the original building construction. A variety of acoustic suspended ceiling tile assemblies were observed. Please refer to the EH&E Report (Appendix A) for more information on paint, sealants and caulking materials present in this location as it should be assumed hazardous materials are present.

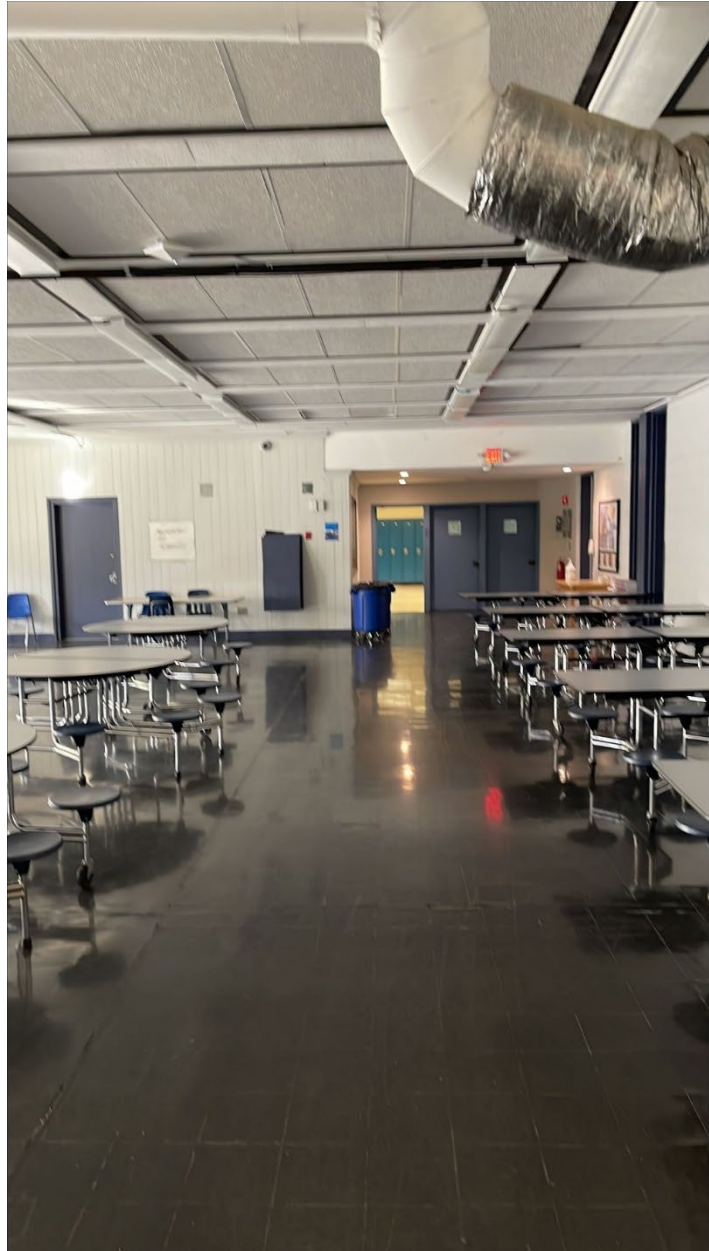
Cafeteria

Wall assemblies within the cafeteria were observed to be painted CMU and concrete walls, some of which had ceramic tile and wood panel finishes. Interior sealant joints were observed where painted CMU and concrete walls abut. Flooring observed in all locations were 9" x 9" flooring tiles which were installed during the original building construction. The cafeteria includes a suspended acoustical ceiling assembly.

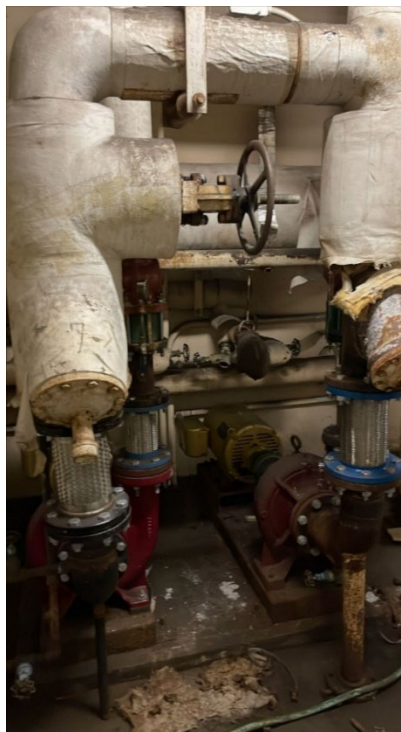
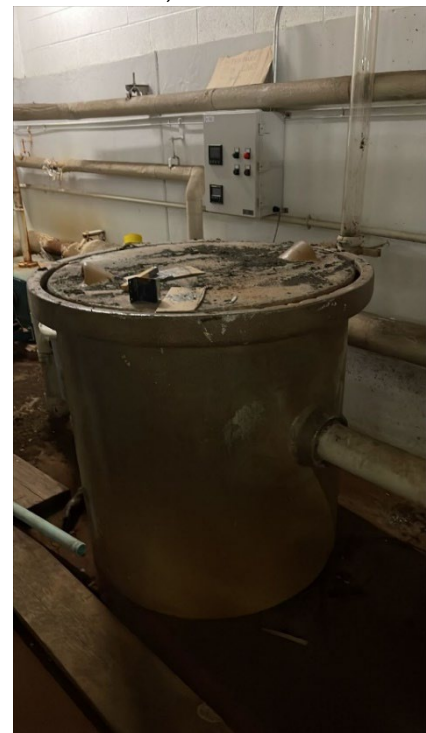
The main mechanical room located in Building D houses infrastructure for buildings A, B and D. The walls were observed to be painted concrete and CMU. Firestopping was observed to be incomplete on some of the wall elevations. The slab on grade is concrete with 3-4" equipment pads. On each day during the field inspection period significant amounts of

water had pooled on the floor. It was reported that the origin of the water was a combination of equipment leaks and ground water seepage. **This standing water is of particular concern. Its origin is possibly related to hydraulic pressure from below the slab system. The under-slab drainage system should be assessed to confirm whether pockets of water or artesian wells are present below the building and are a contributing factor to the standing water in the main mechanical room.** Key pieces of equipment within the room included heat exchangers for buildings A, B and D; two decommissioned air tanks and pumps, boilers, electric motor control panels and transformers, the main chemical waste tank, the sprinkler standpipe servicing the new science wing on the third floor, and an obsolete pneumatic control system. All but the new domestic water equipment was observed to be installed at the time the Building was constructed, in poor condition and beyond useful life expectancy.

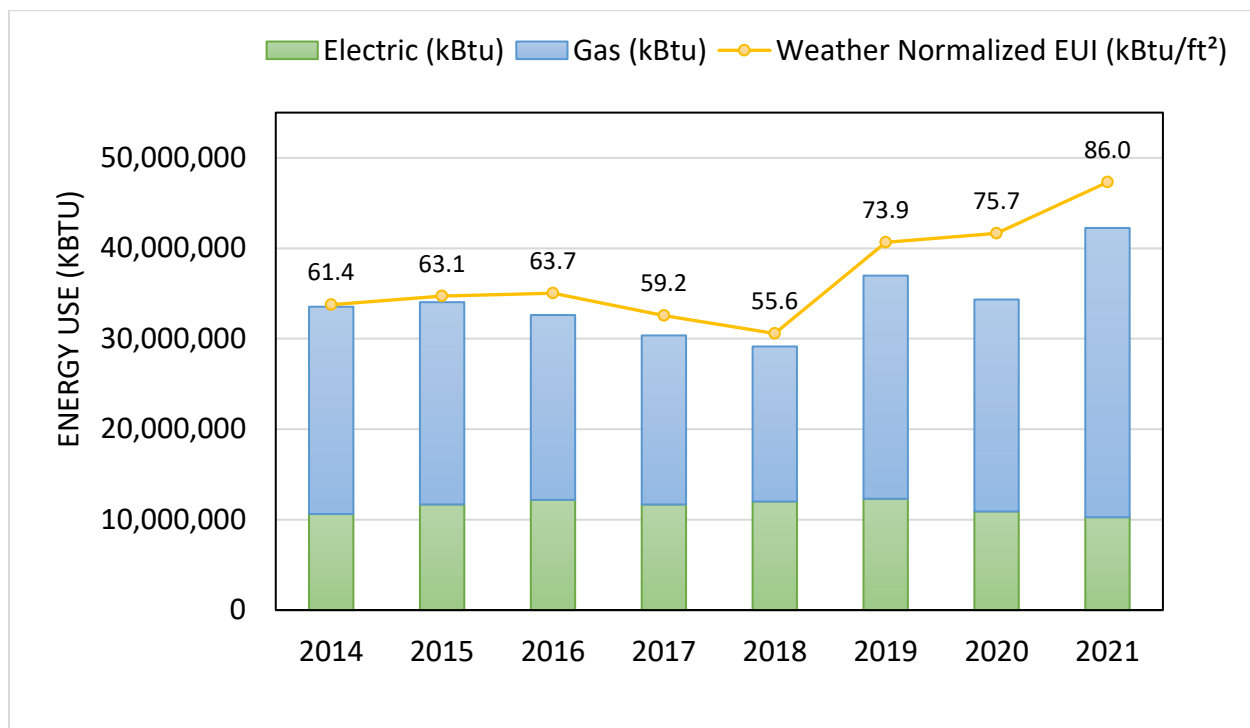
Figure 1 Energy Use and Weather Normalized Energy Use Intensity (EUI) for Medford High School from 2014 to 2021⁴

from 4.5 to 139.7 kBtu/ft², with an average of 52.7 kBtu/ft² (N = 137).³ In 2020, the Building was less efficient than 82% of Boston K-12 schools. In the past 3 years, the Building's EUI has increased from 55.6 kBtu/ft² in 2018 to 86.0 kBtu/ft² in 2021, possibly due to increased ventilation demands in response to the COVID-19 pandemic. The trends in Building EUI indicate that energy use is increasing, and the Building is less energy efficient than the national and regional averages.
