Existing Conditions Study
Cohasset Public Schools

Town of Cohasset, MA

Prepared by:
Ai3 Architects, LLC
526 Boston Post Road
Wayland, MA 01778

April 2022

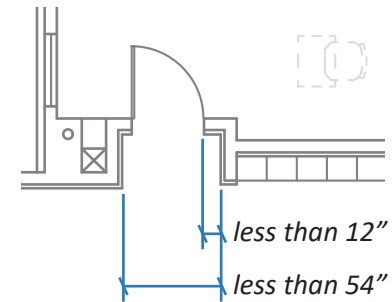
Doorways into classrooms that were part of the original 1954 construction are not compliant with push/pull clearances required today per MAAB 521 CMR. Push/pull clearances allow an occupant to open a door without the risk of getting hit by the door if another occupant was coming from the other side. All entries into classrooms require clear floor space adjacent to the latch side of the door for entry and exit.

For front approach, the pull side clearance is required to be no less than 18 inches and the push side clearance should be no less than 12 inches. On average, the push side clearance for the existing non-compliant doors is only 8 inches on average, and less in some instances.

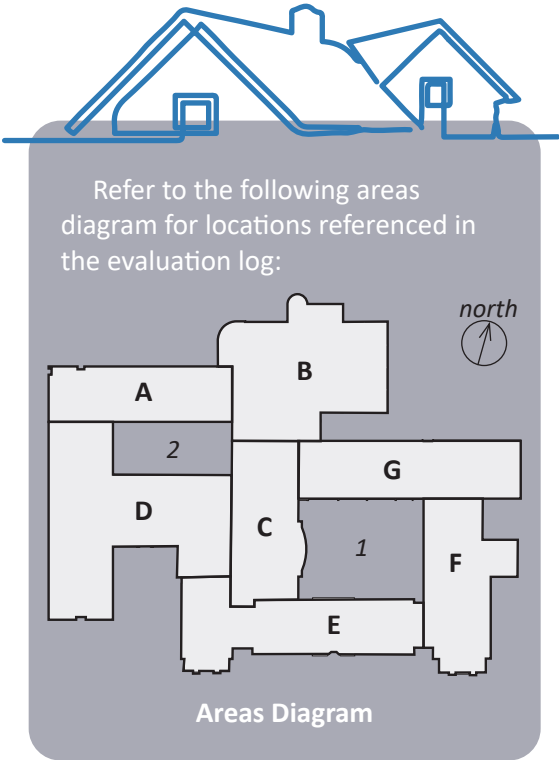
SCORE (1-6)	EVALUATION CATEGORY	SUBCATEGORY	LOCATION	DESCRIPTION	PHOTOS	ACTION
2	Exterior Envelope	Building Code Compliance	Area B	Three-tab shingles fallen and growing moss (IBC 1507.3.3.3 - High wind attachment & IBC 1511; see NCRA Roofing Manual Ch. 5 for reroofing)

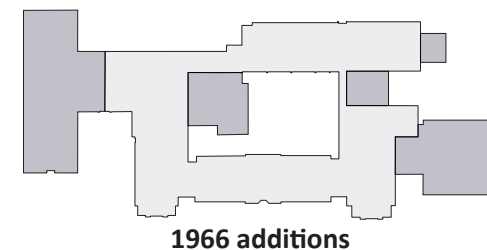
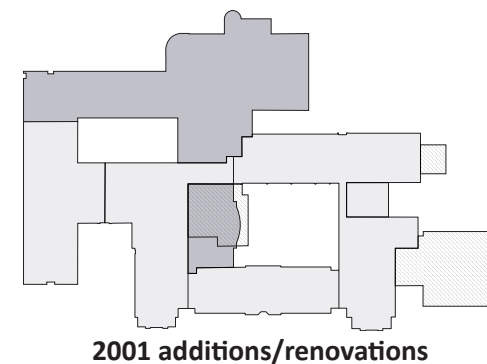
SCORE	EVALUATION CATEGORY	SUBCATEGORY	LOCATION	DESCRIPTION	PHOTOS	ACTION
6	Structure	Concrete	Foundations	No signs of foundation settlement

Continue maintenance practices
4	Structure	Concrete	Foundations	Small chunks of foundation walls have chipped off; not detrimental to structural integrity, but may cause moisture issues

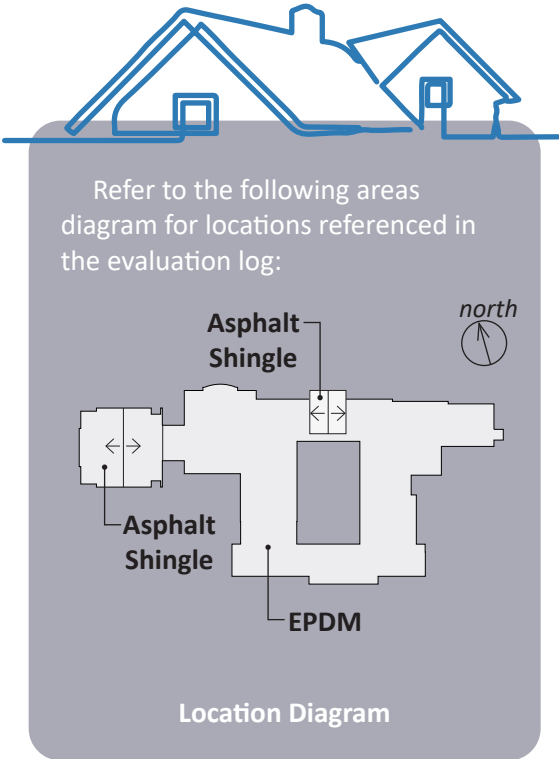
SCORE (1-6)	EVALUATION CATEGORY	SUBCATEGORY	LOCATION	DESCRIPTION	PHOTOS	ACTION
1	Exterior Envelope	Roofing	EPDM	Soft areas of roof present; decaying material or presence of moisture are possible causes - further investigation required

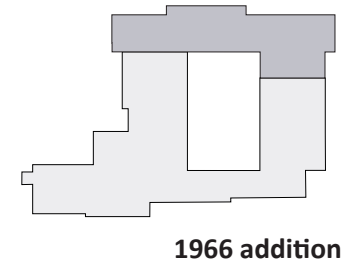
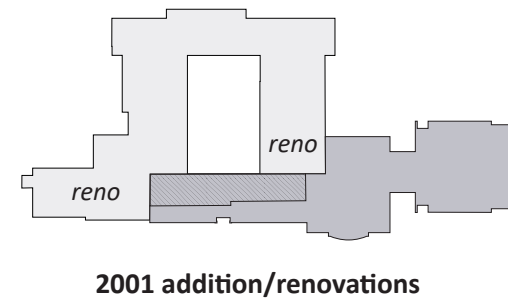
SCORE	EVALUATION CATEGORY	SUBCATEGORY	LOCATION	DESCRIPTION	PHOTOS	ACTION
6	Structure	Concrete	Slab on grade	No signs of undue vibrations on the supported floors

Fill cracks greater than 1/8" wide

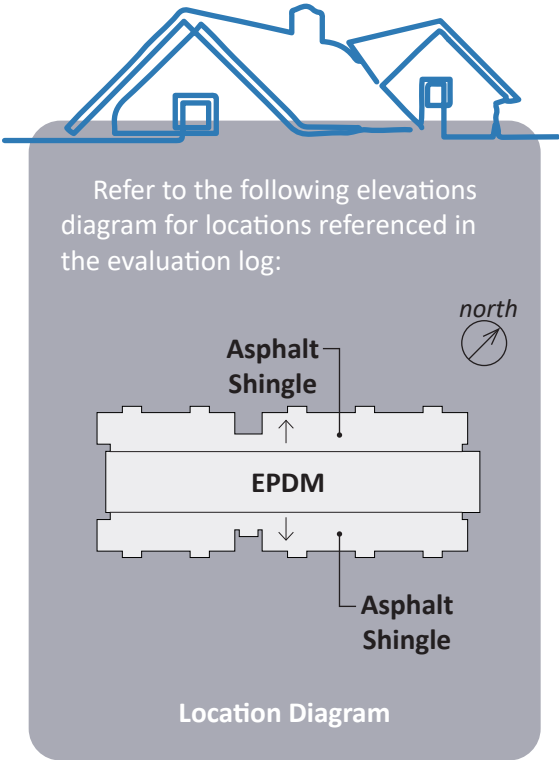
SCORE (1-6)	EVALUATION CATEGORY	SUBCATEGORY	LOCATION	DESCRIPTION	PHOTOS	ACTION
1	Exterior Envelope	Roofing	EPDM	Soft areas of roof present; decaying material or presence of moisture are possible causes - further investigation required

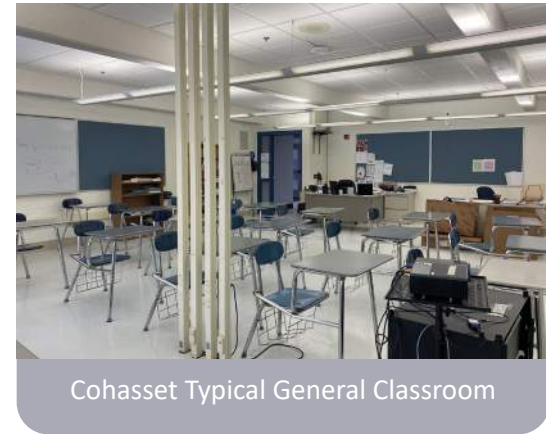
Cohasset Typical General Classroom

Over ninety-percent of classroom and lab instruction at Cohasset Middle High School occurs in the original 1950 and 1966 buildings within spaces that are grossly undersized and lack appropriate space for teaching and learning. Many of the academic classrooms are at least thirty-percent over student capacity based on their size (600-700 square feet) and generally accepted educational guidelines and standards for available space per student. Classrooms that are sized to accommodate 18-22 students are crowded with 24-28 students. The flexibility of some classrooms is additionally restricted by pipes or conduits in the center of the room.

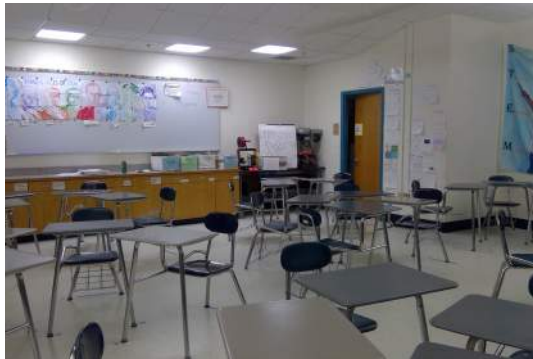
Cohasset Middle School STEM Classroom

There is minimal opportunity within the current school for project-based learning at either the middle or high school level. There is one former classroom that has been converted to a STEM room, but at 962 square feet, this is insufficient to act as a project-based learning lab and lacks any amenities that would set it apart from a general classroom. Its location is not within the academic wing, which does not support team teaching. The high school wood shop is the only vocational program available for grades 9-12. The existing space is not suited to act as anything other than a wood shop, which is limiting to the educational program, and furthermore lacks the proper ventilation system to fully function.

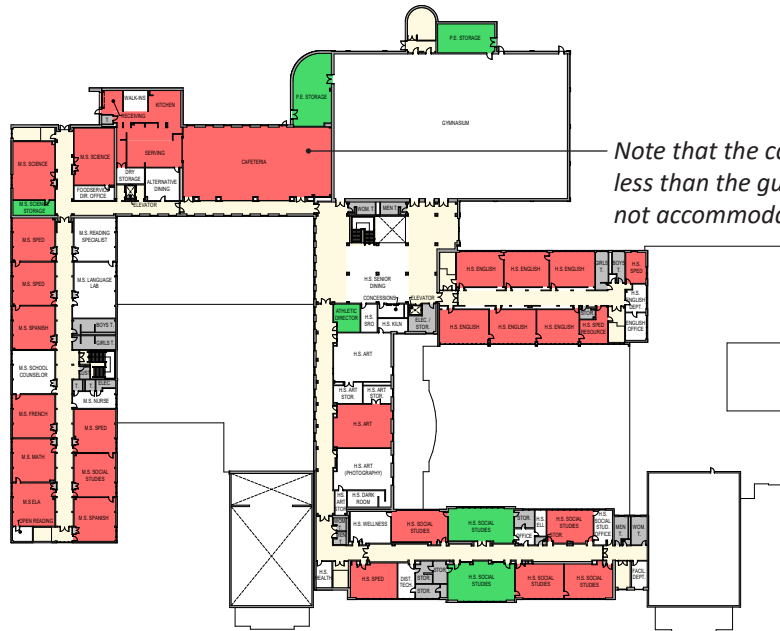
Floor 2 - Program

Note that the cafeteria is considered less than the guidelines because it does not accommodate the middle school

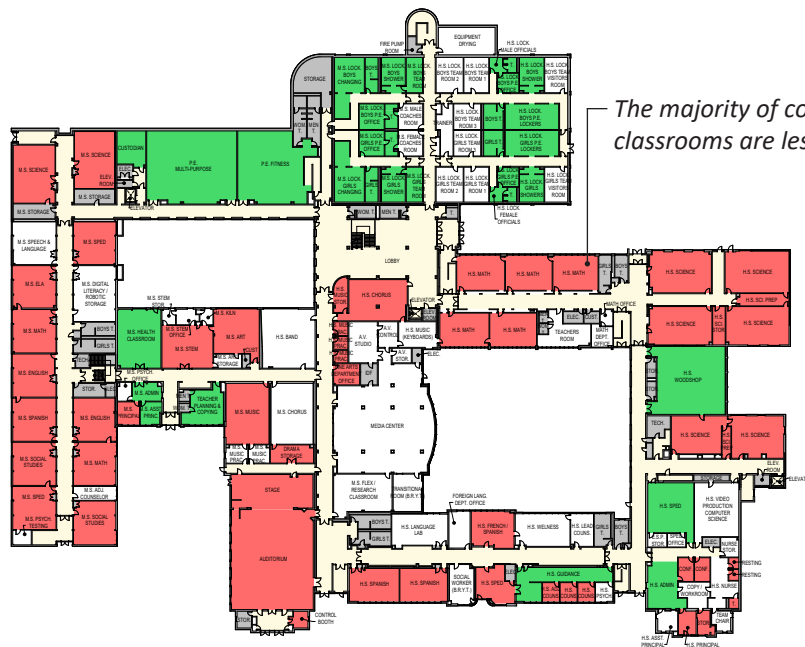
Floor 1 - Program

The majority of core academic classrooms are less than the guidelines

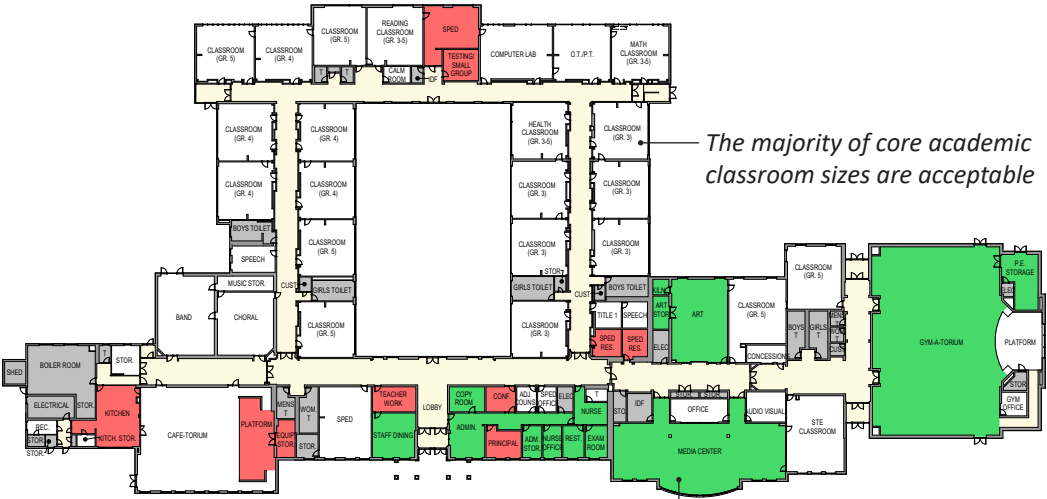
Floor 1 - Program

The majority of core academic classroom sizes are acceptable

The majority of shared spaces exceed the recommended sizes
