LONG RANGE FACILITY ASSESSMENT AND EDUCATIONAL ADEQUACY STUDY 2022

VOLUME 2C

FACILITY ASSESSMENT - INDIVIDUAL BUILDING INFORMATION:
MIDDLE SCHOOLS, HIGH SCHOOLS, AND OTHER BUILDINGS

A T S + R

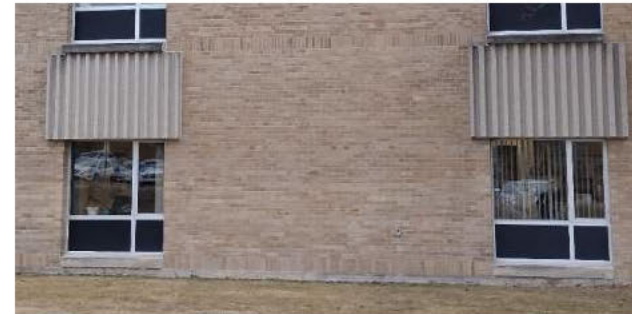
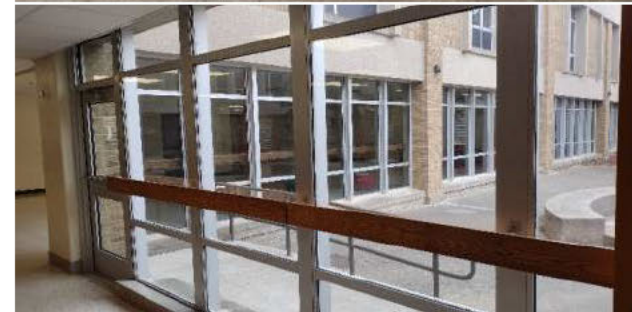
- Aluminum windows and storefronts leaky and worn.
 - Replace with new aluminum windows and storefronts

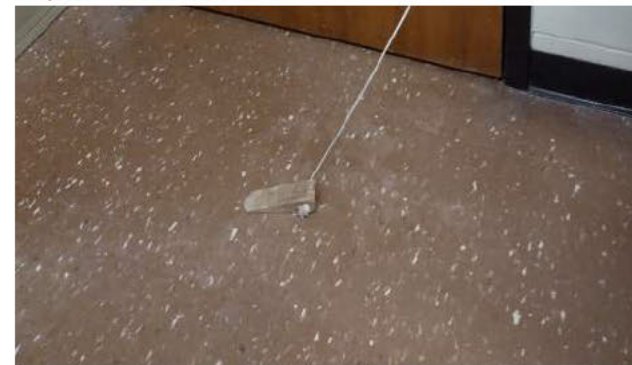
- Poor condition vinyl asbestos tile multiple rooms.
 - Replace with new VCT.

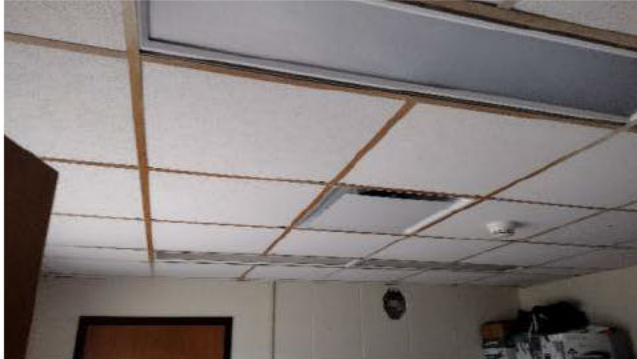
- Poor condition acoustic tile ceilings multiple rooms.
- Replace with new acoustic tile ceiling and grid.

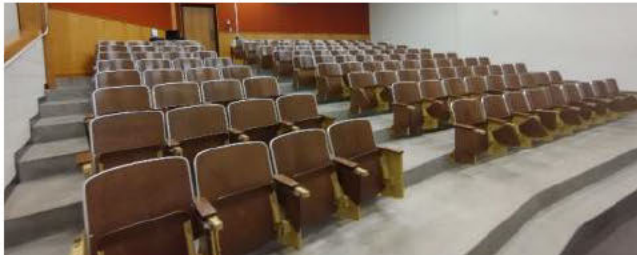
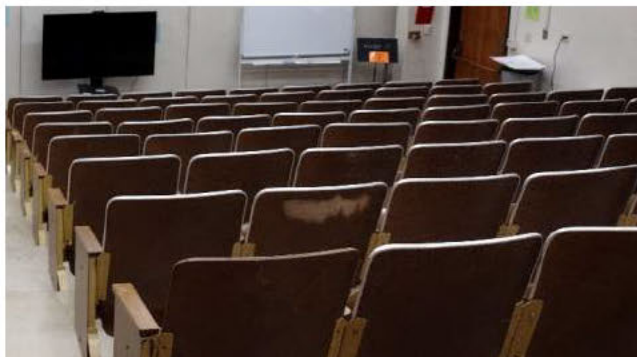
- Auditorium seats poor condition.
- Replace with new auditorium seats.

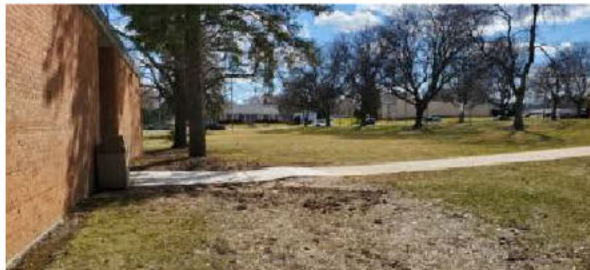
- **Parking Lot(s) Asphalt Pavement**
 - Continue general maintenance (i.e., crack cleaning, filling, and sealcoating).
- **Sidewalk(s)/Concrete Pavement**
 - Remove & replace concrete areas creating a potential trip hazard.
 - Clean & fill expansion joints along adjoining building walls, vertical elements, and building stoops.
 - Add additional concrete pavement to accommodate snow removal equipment and restore turf.
- **Site/Playground Areas**
 - Resecure loose retaining wall caps – fall hazard if climbed on.
- **Site/Grading Areas**
 - Remove sod, regrade to drain away from Door #16, re-sod, fertilize and maintain disturbed turf areas.
 - Correct low grade and drainage along building by removing sod, regrade area to properly drain and

then restore
turf as
above.

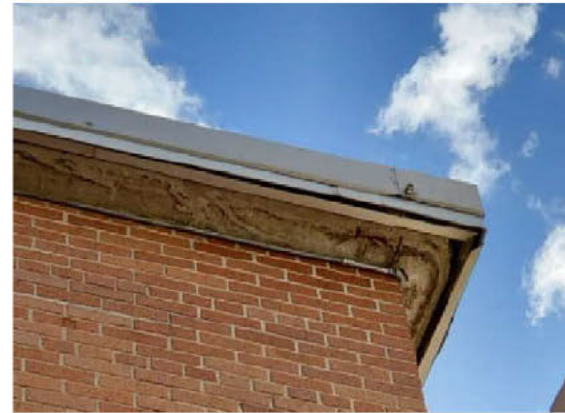
- In the original 1958 classrooms portion of the building, the existing top-of-masonry wall to concrete roof deck intersection, with roof deck projection, relies on only a sealant joint between for watertightness. The underside of the deck, and its joints, are exposed. The sealant joint is failing, likely allowing water to enter into the building by action of wind-driven rain. This detail should be corrected by installing prefinished metal flashing under the projection, extending down onto the face brick with a drip, thus protecting both the underside of the concrete and the intersection.

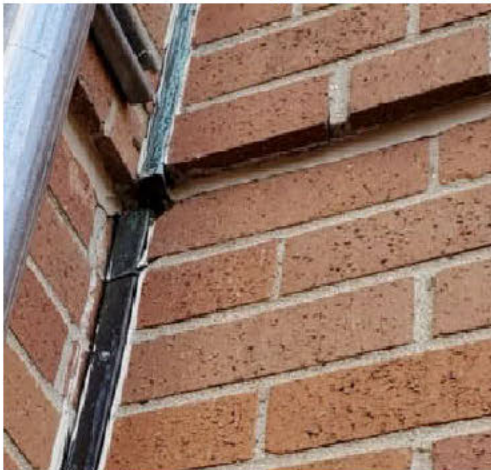
- **Control joints** and original copper expansion joints need to be recaulked throughout the building.

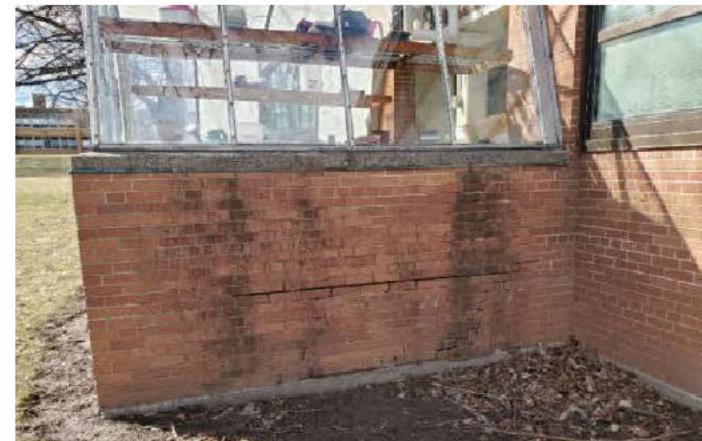
- **Greenhouse:** The greenhouse is original and is in poor condition. The greenhouse structure should be replaced and the walls tuckpointed.

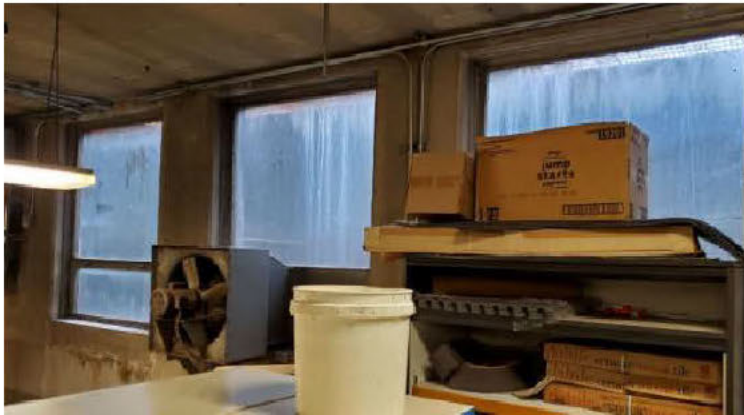
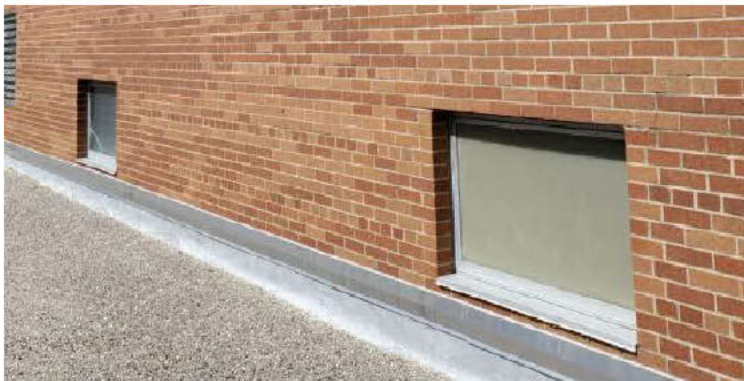
- **Windows:** most are in acceptable condition, but there are some that were not replaced in less visible areas – these should be replaced for envelope integrity. The boiler room windows leak, and the upper window into the boys locker room is cracked.

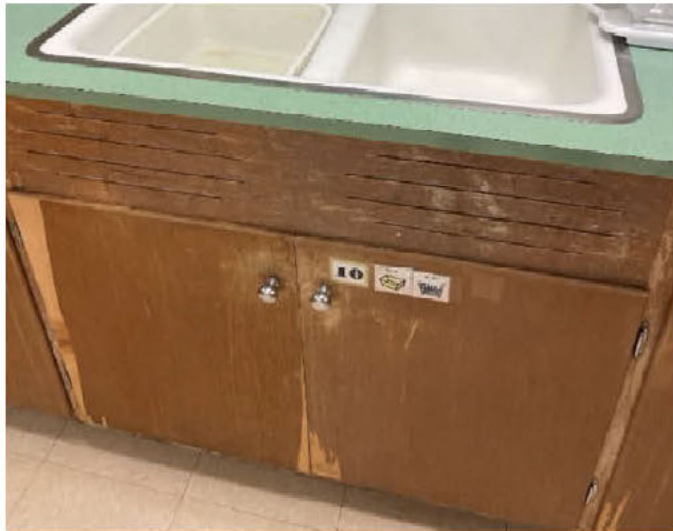
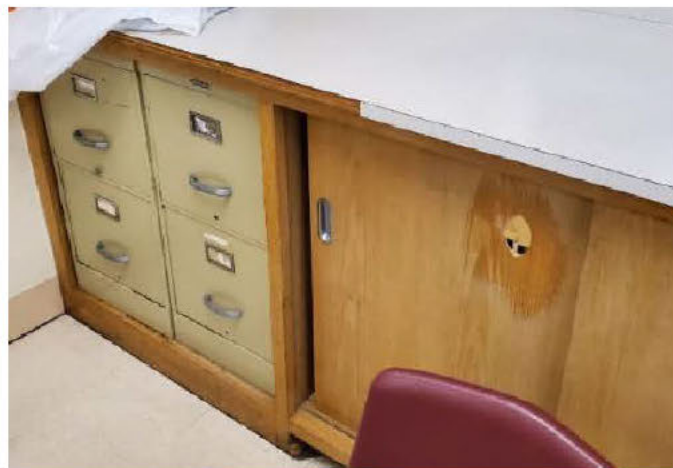
- **Interior doors:** Original 1958 interior wood doors are generally in poor condition and should be replaced (higher use areas are worse). Most doors have knobs instead of lever hardware (required for HC accessibility), and some in assembly spaces are missing panic hardware required by code.
- **Chalkboards** – most rooms still have chalkboards; these should be replaced with markerboards.
- **Casework:** original 1958 wood casework is in generally poor condition. Casework replacement to meet 21st

century educational needs typically triggers flooring, painting, and sometimes board relocation, so these are shown as combination items.

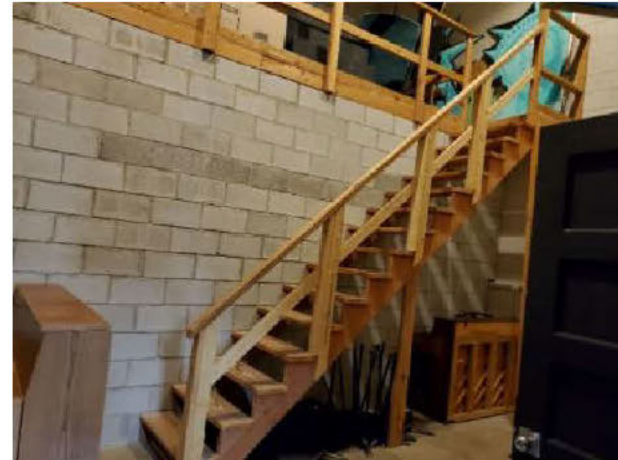
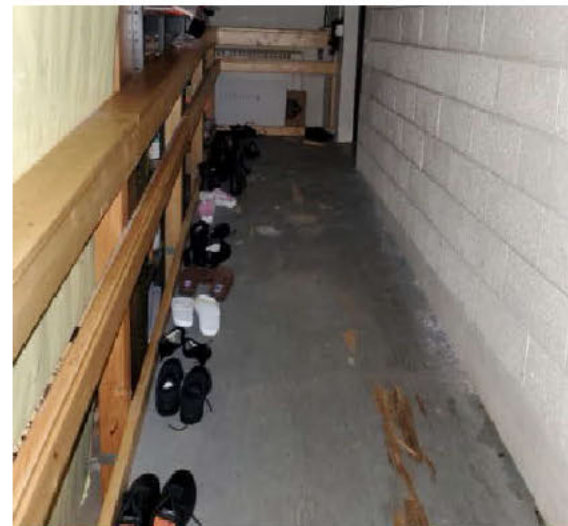
- **Non-code compliant combustible construction:** In the back stage area of the auditorium, a CMU wall with wood floor structure storage mezzanine has been added, as well as a wood stair leading to it and a wood ramp on the other side. Floor structure is not allowed to be combustible in this existing building construction type (non-combustible) and added to a lower standard than the existing building, and the building is not sprinkled to offset this. The storage function makes it more hazardous. The guardrails and no handrail are not code compliant. The ramp surface is also splintering, creating a safety hazard. All this construction should be removed

and replaced with non-combustible construction.

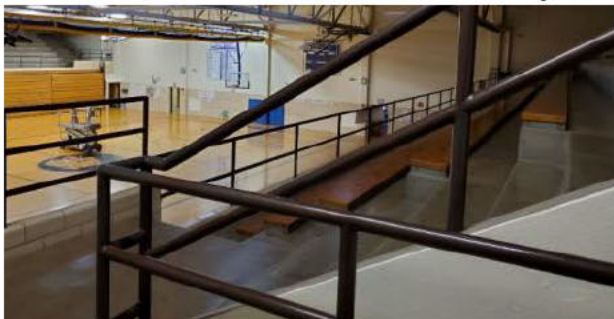
-
- **Railings:** The guardrails in all the stairs on the open side are too short with too large openings, and there are no separate handrails. The guards at the gym mezzanine bleachers front edge have too large spaces in between rails. All these should be modified for safety.

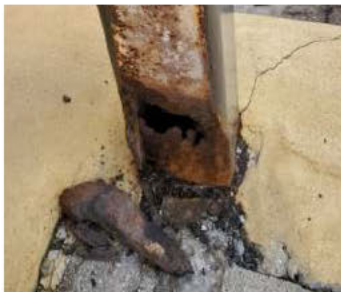
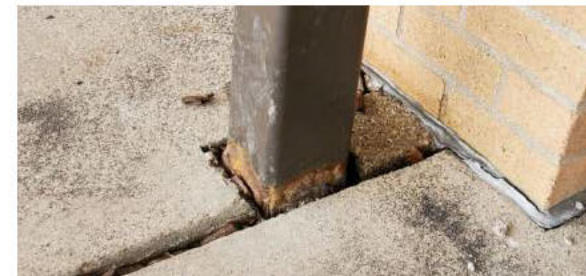
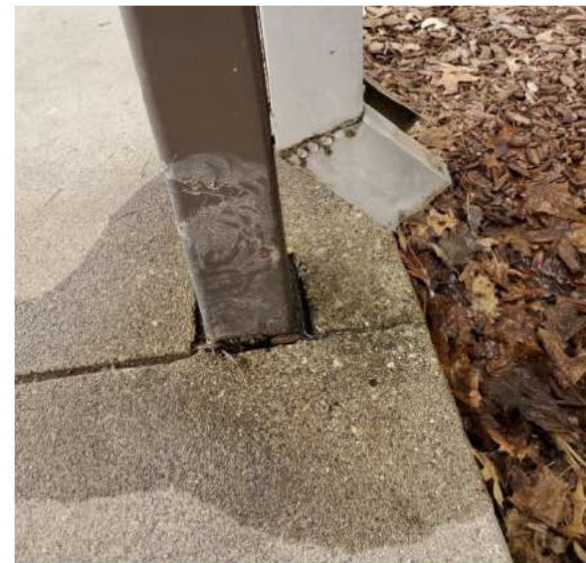
previously removed decorative block walls) are rusted through on the bottom. This is a structural concern and should be a high priority. The bottoms of these columns need to be

cut off and replaced down to the base plate level (below the sidewalk). Other columns are showing rust at the bottom, due to downspouts being too short and pooling water at the base of the columns. Column bases should be repaired, downspouts extended, and the structure repainted.

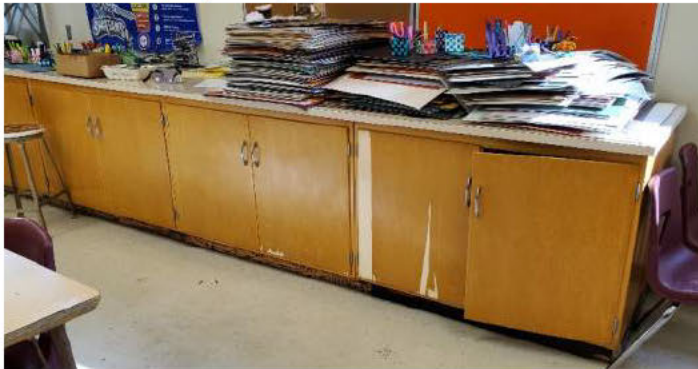
- Some vocational areas such as Art Rm A100-A101, Sewing A102, and some smaller vocational offices/storage spaces – Original casework and flooring (and ceiling) in poor condition; replace finishes and project equipment- cswk/boards.

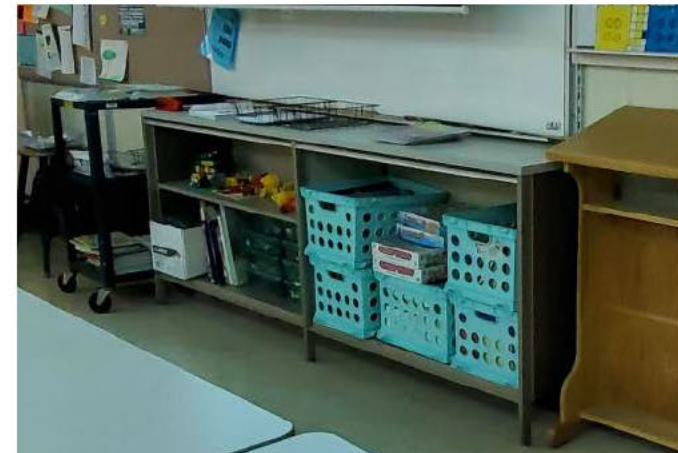
- Former Science Rms in 1964 wing being used as classrooms – clean out poor condition exg cswk, replace finishes and equipment to outfit as typical classrooms.
- Typical 1964 Classrooms: ACT poor condition (see above), have only orig loose cswk on legs, some starting to be less functional/wearing/doors missing, VCT flooring starting to wear, have chalkboards with whiteboard film over that not all are cleaning off well. Recommend in 6-10 years, to replace casework, flooring, chalkboards, associated painting.

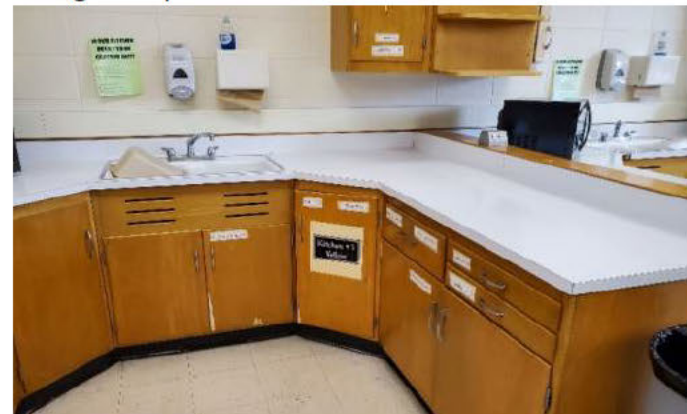
- 1964 bldg FACE room recommended for remodeling – orig cswk poor condition, wearing finishes, layout may change w/ update.

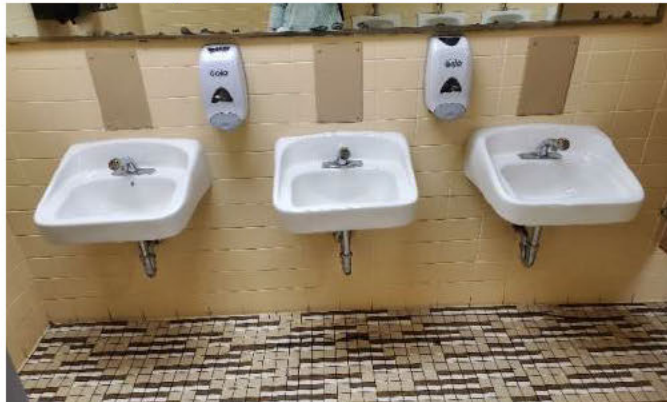
- 1964 building science rooms recommended for remodeling – orig cswk poor condition, wearing finishes, layout may change w/ update.
- 1964 gang toilet across from C162 recommended for remodeling – no ADA toilets in 1964 area, this one has finishes poor condition, and area of cracked/heaved CT floor in boys side.

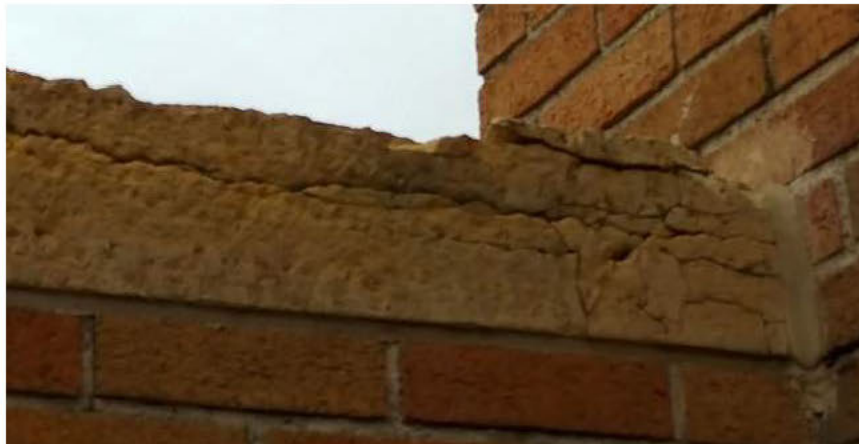
- **Roofs**
 - There are several sections of roof that will need replacing.
- **Wall Systems**
 - There are several locations around the roof where the parapet stone caps are deteriorating and spalling. Replace the stone parapet caps and/or consider covering with prefinished metal flashing.

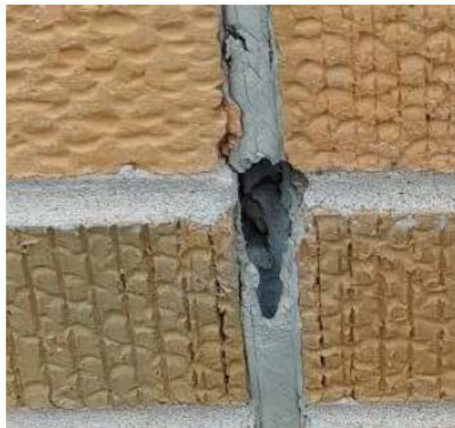
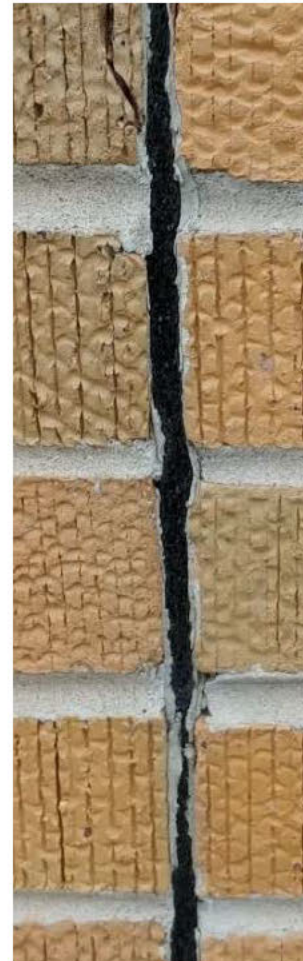
- Control joint sealant in some locations is missing and separated. Replace control joint sealant at these locations.

- Whole building in need of tuckpointing in 6-10 years.

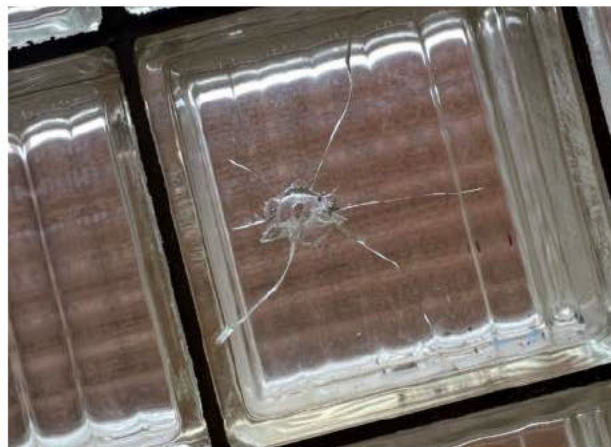
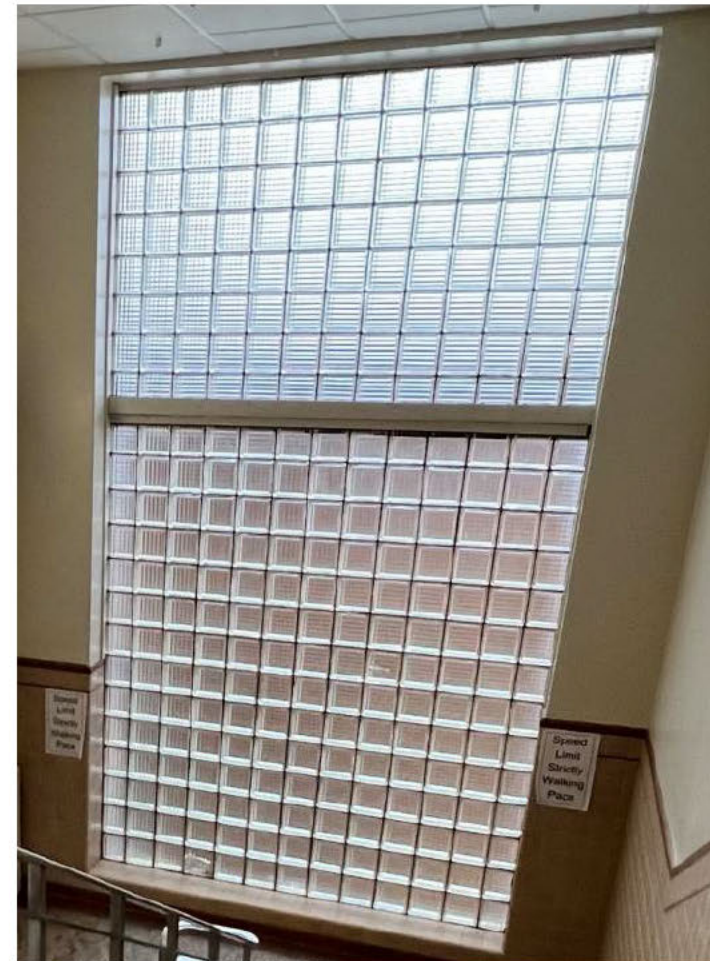
- At the ends of the 3rd corridors and in the 3 stairwells down to 2nd floor there are glass block that have holes on the interior face of block and are not energy efficient. Replace glass

block with aluminum curtainwall framing and insulated glass.

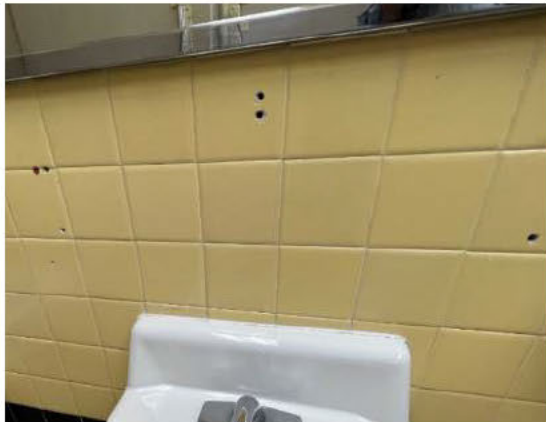
- On the third-floor boys and girls bathrooms the wall tile is cracked, toilet partitions are damaged and equipment missing from bathroom. Replace toilet finishes, equipment and install VACT ceilings.

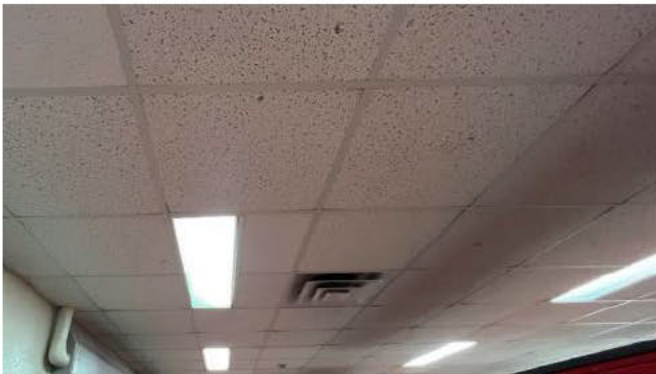
- In various rooms the VCT flooring is worn, damaged and seams are separating. Replace VCT flooring
- **Ceiling**
 - At the boys and girls locker rooms and adjacent corridors the ACT ceiling tile and grid is damaged and stained. Replace the ACT ceilings

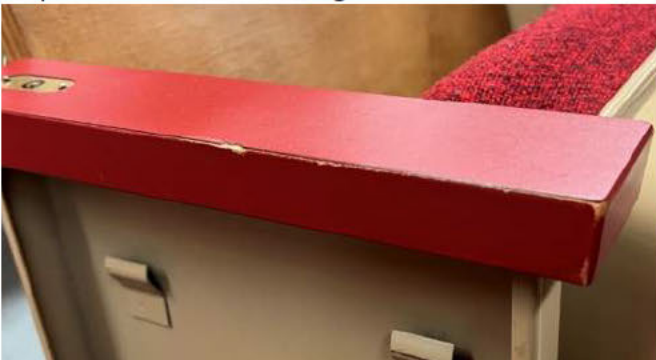
- **Interior Fixed Seating**
 - In the auditorium at all levels, the seat standards are showing signs of rust, chairs are damaged and worn. Replace auditorium seating.

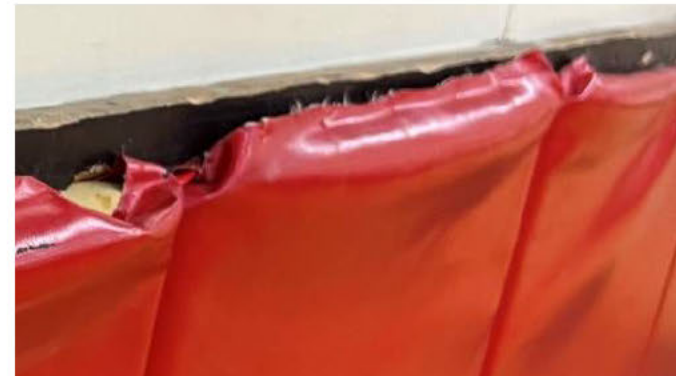
- **Wall Pads**
 - In the Old Gym, the wall protection pads at the perimeter are worn and vinyl fabric at the edges is unfolding. Replace the gym pads.

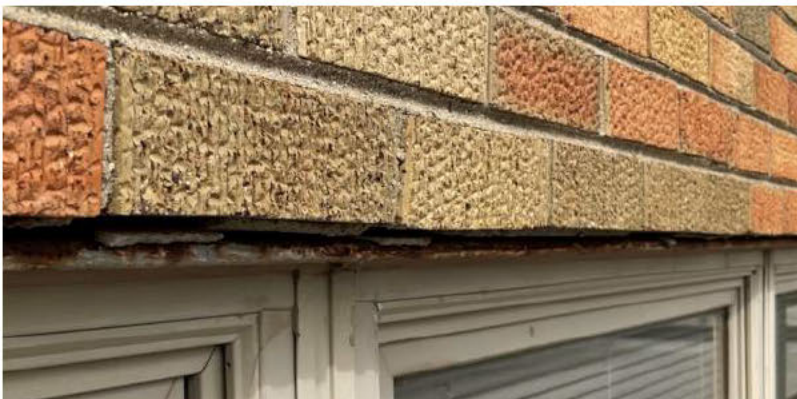
- Lintels are bowing down, rusting and deteriorating (rust jacking) due to water infiltration into walls.

Tuckpoint above windows and investigate parapet flashing above. Replace lintels.

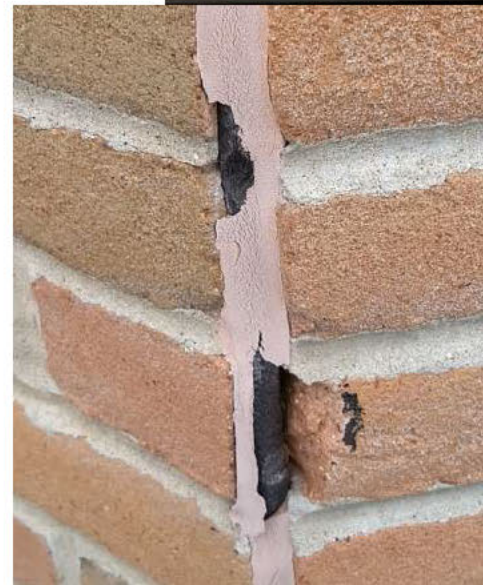
- **Tuckpointing/Sealant**
 - At multiple locations the control joint and vent sealant is cracked, separated, or missing. It is recommended to replace the control joint and vent sealant.

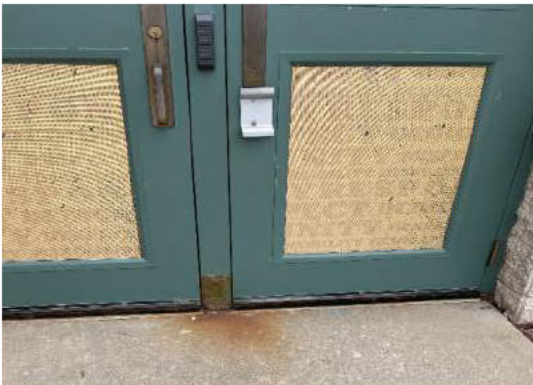
- Several exterior hollow metal doors and frames are rusting. Replace doors and frames with aluminum doors and frames.

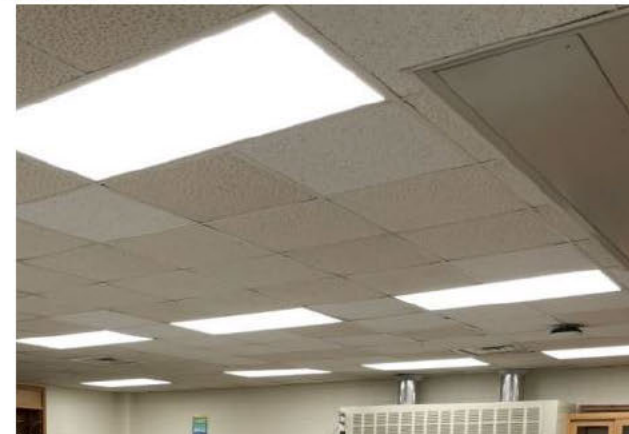
- Multiple rooms have old ceilings, VCT floors that are worn, chalkboards, casework and doors that are sagging and worn. Replace finishes and equipment in the rooms.

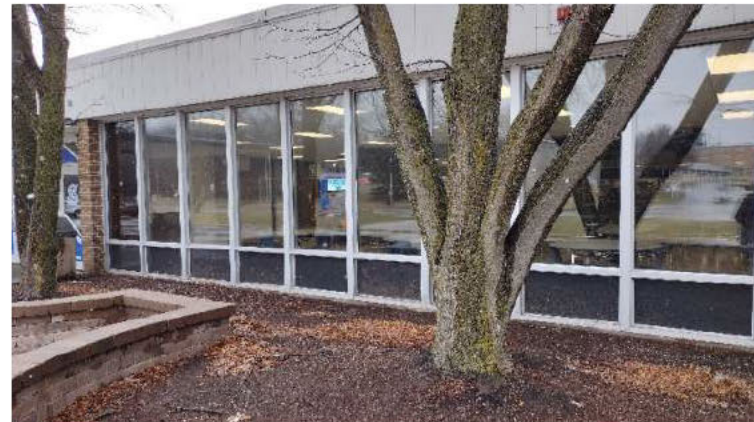
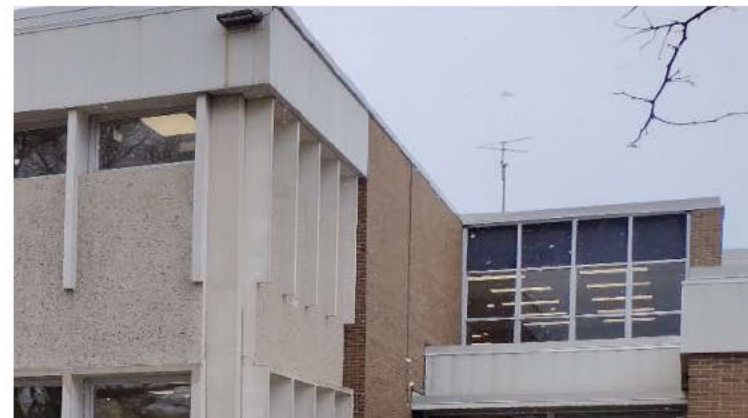
- Aluminum storefronts leaky and worn.
- Replace with new storefronts.

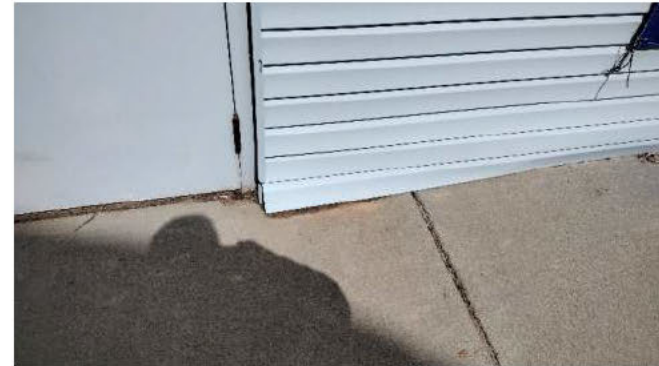
- Vinyl siding poor condition at baseball concession/press box.
- Replace with fiber cement panels or similar.
-

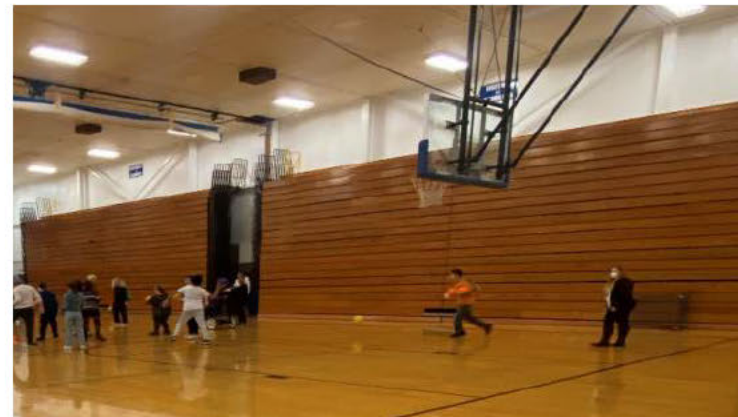
- Wood gym floor and bleachers poor condition.
- Replace resilient wood floor and new retractable plastic seat bleachers.

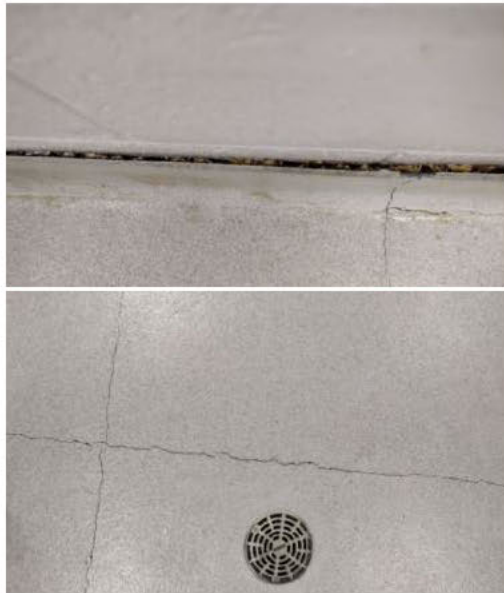
- Epoxy/quartz flooring failing.
- Replace with new ceramic tile flooring address water infiltration issue.

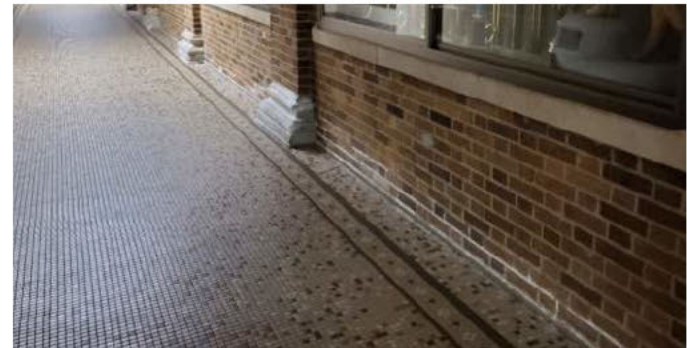
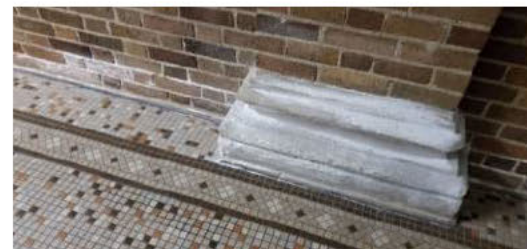
- **Roofing**
 - Efflorescence at bottom of interior wall (former exterior of 1928 building) at 2000 addition. Investigate and repair potential water penetration issue at roof high/low flashing/sealant, especially around column enclosures/pilasters.

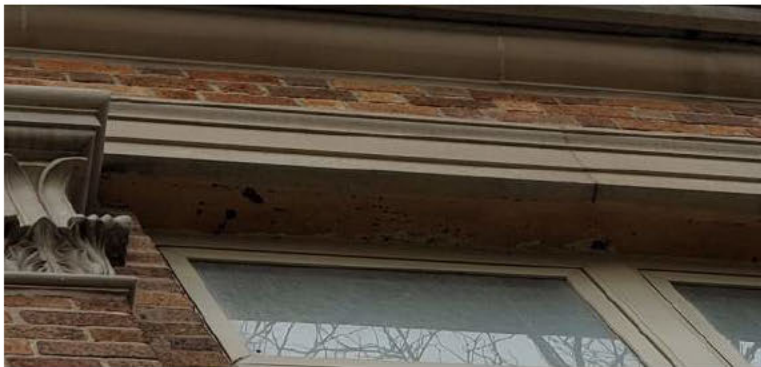
- Roofing Section 25 (BUR-Alum coat) is 36 years old, approx. 6 years past typ life span for built-up roofing, recommend replacement.
- **Tuckpointing and Sealants**
 - Miscellaneous tuckpointing at stone sills, facebrick areas on upper walls of northern side of building, and sealant at control joints.
- **Painting**
 - At 1928 building underside of lintels, remove rust and repaint to protect lintels from further degradation.

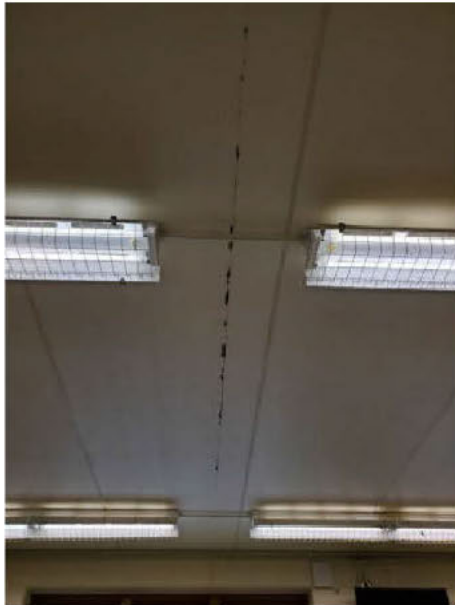
- The precast concrete plank at the floor of the L.2 weight room (ceiling of Fitness room) has developed a crack parallel to the length of one of the planks. According to structural engineers for the plank manufacturer, this is not a structural stability concern. However, the concrete dust/ small debris that are

falling out of the crack are a concern for the room below. Further investigation and coordination with the precast manufacturer is required to recommend a solution.

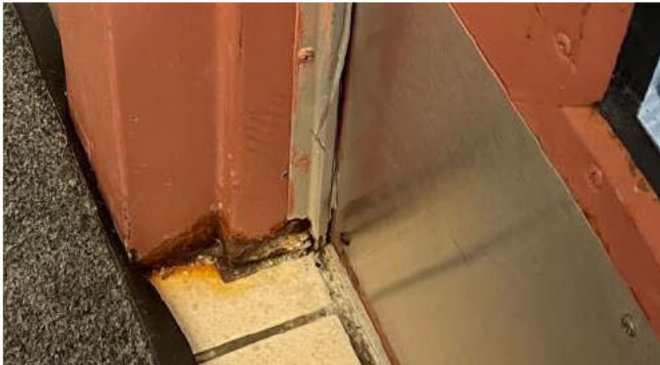
- There are several exterior doors and frames that are rusting. These doors should be replaced with aluminum doors and frames

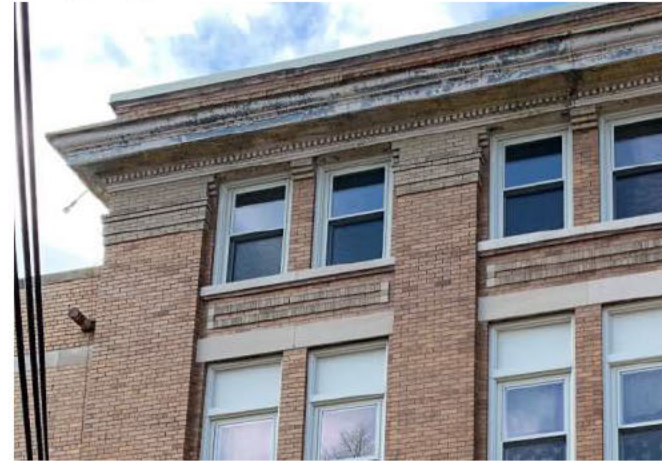
- Peeling and faded paint at exterior wall cornice. Paint cornice

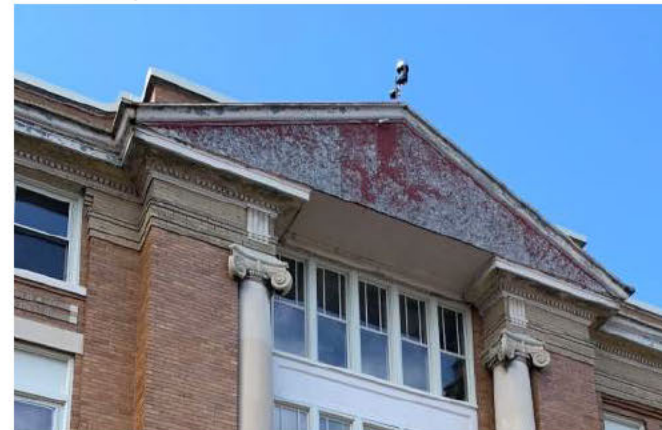
- Peeling and faded paint at pediment above Door 2. Paint pediment

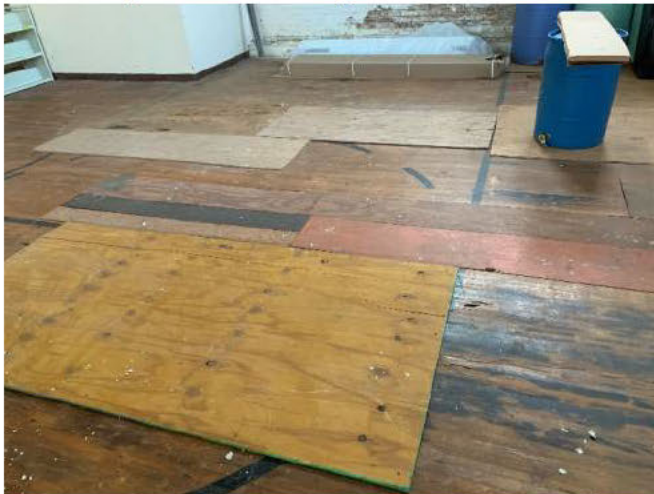
- Existing carpet in poor condition in multiple locations. Replace carpet
- Missing CT base in in Room 222. Provide new CT base
- Damaged wood flooring in Rooms 116, 303

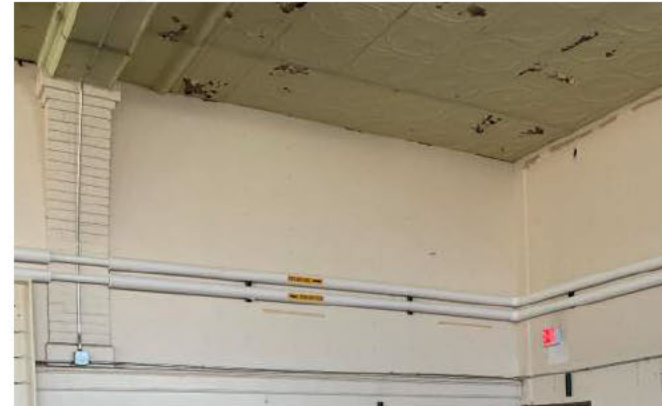
- Damaged plaster ceiling in Room 116. Repair plaster ceiling.

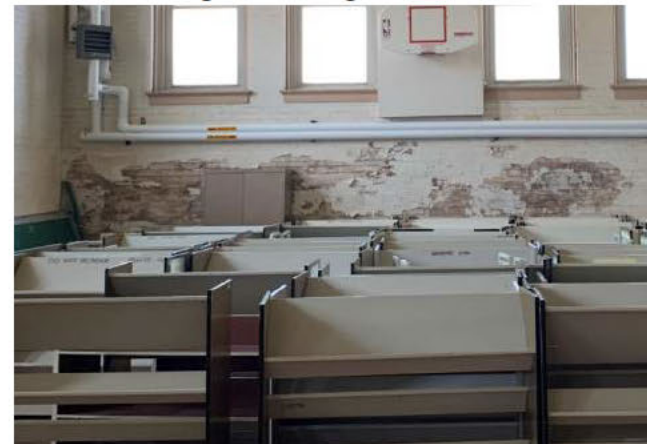
- Paint flaking off existing brick wall. Paint brick wall

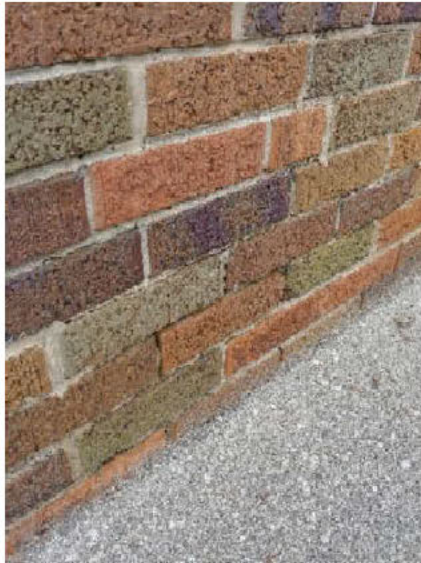
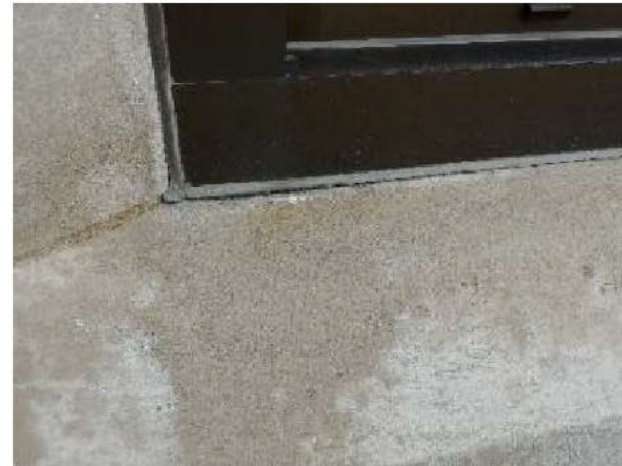
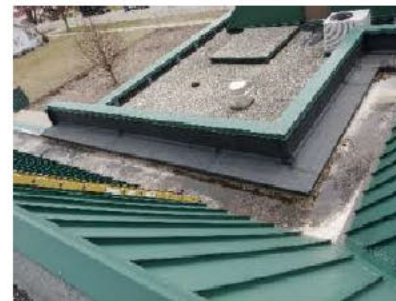
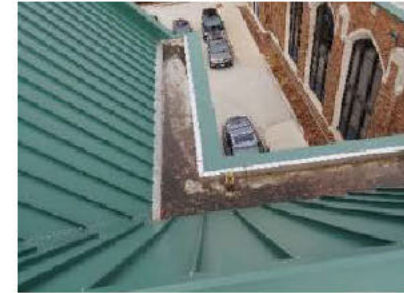
- Tuckpointing needed throughout majority of building.
- Sealant around windows needs replacement in areas
- Roof is not draining adequately as drain piping appears to undersized causing frequent clogging.

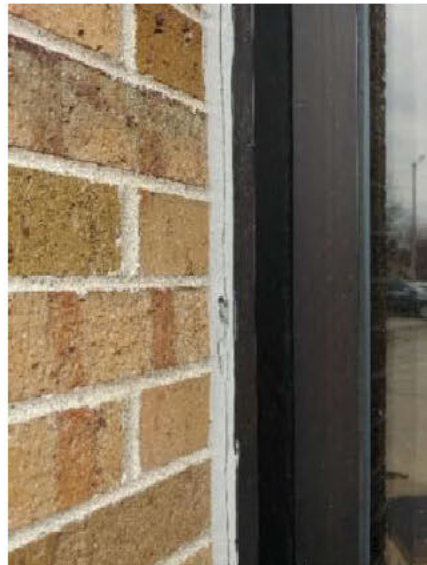
- Sealant in need of replacement on windows.

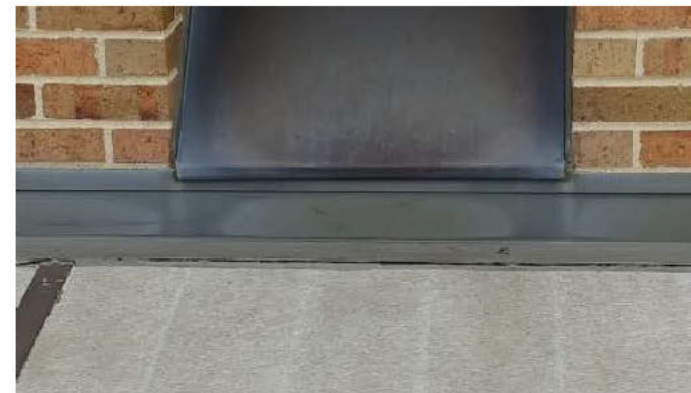
- Repair brick at translucent panel (Kalwal) knee wall

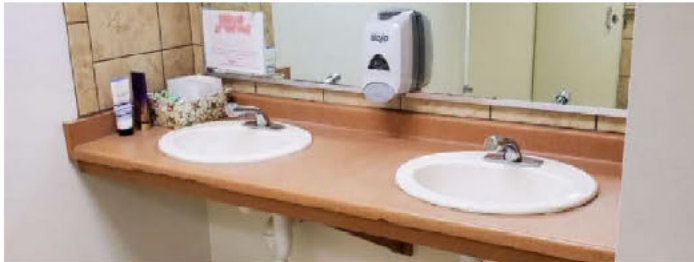
- Bathroom Counter: Plastic laminate sink counter is damaged and should be replaced.

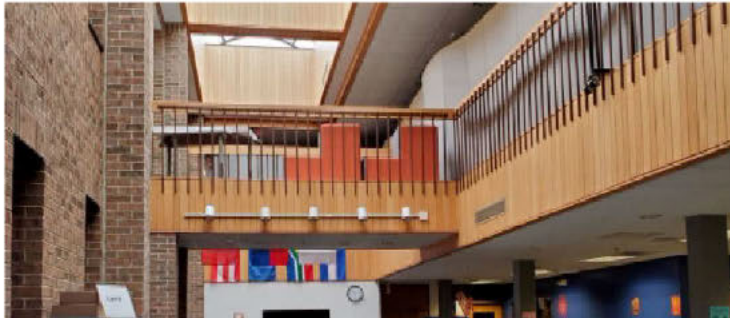
- **Guardrails:** Existing guardrails have 8" spacing instead of code required 4" max; recommended to remedy with additional pickets or acrylic/polycarbonate panels.

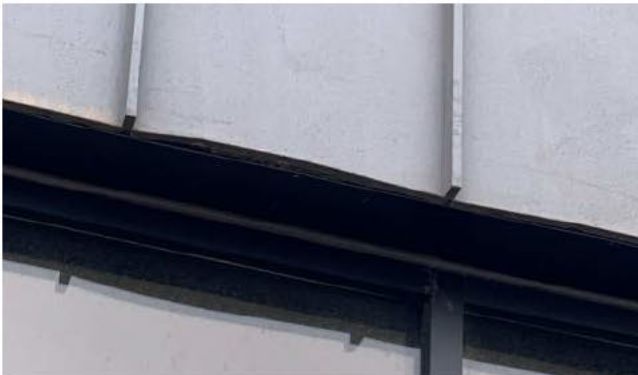
- **Wall Systems**
 - Metal fascia at stairwell is separated at base at one panel. Metal fascia is installed without bottom trim / drip. Not able to correct unless fascia is replaced.

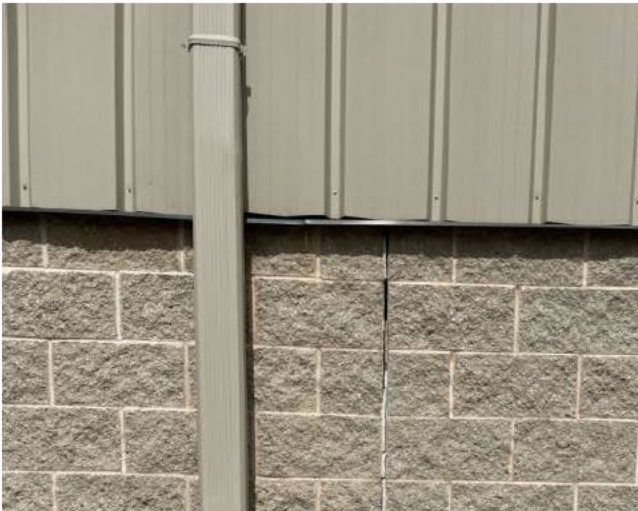
- **Wall Systems**
 - Sealant at building control joints, doors and louvers is cracked and separated. Replace sealant

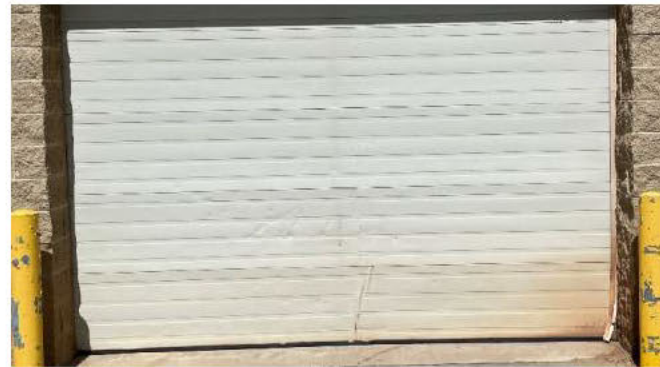
- The weather stripping at doors is damaged or missing. Replace weather stripping at doors
- Overhead door and trim damaged. Replace overhead door

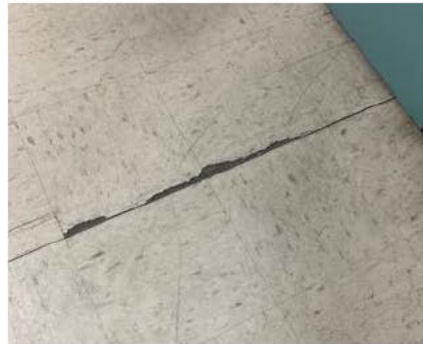
- Cracked and stained VCT in Print Center. Replace VCT

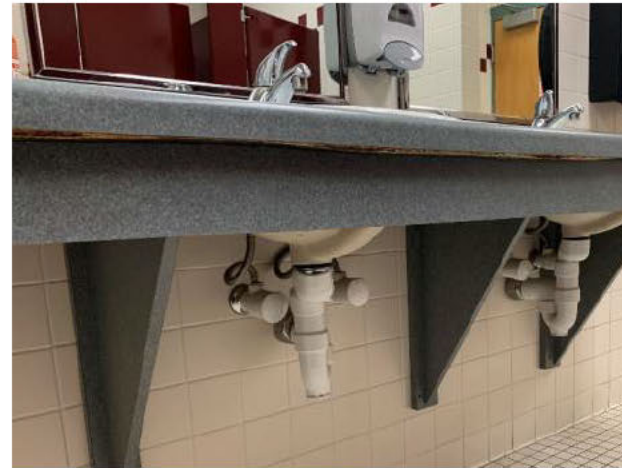
- **Ceiling**
 - Water damage at ACT tiles in Dry Storage, Office Storage. Replace damaged ACT tiles.
- **Cabinetry / Countertops / Stools**
 - Loose edge at Plam countertop in Womens toilet. Replace Plam countertop, remove and reinstall sinks (consider replacement with solid surface).

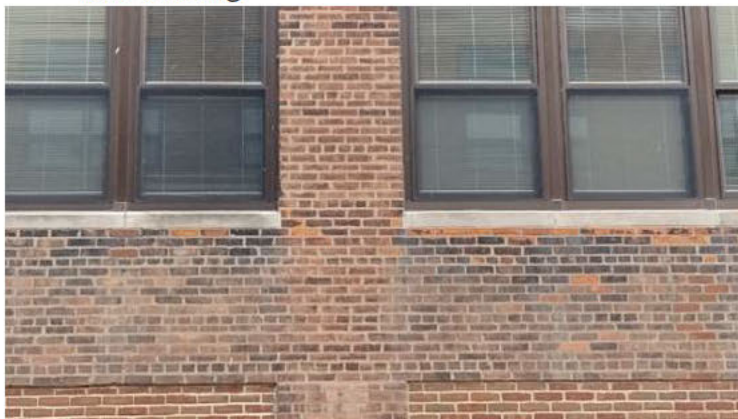
- Failing mortar joints and spalling brick 1928 building
 - Tuck point and brick restoration +-10% of original 1928 building

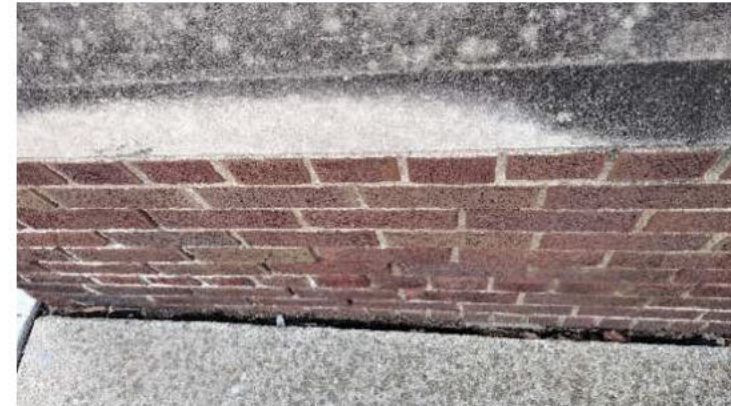
- Base of wall at conc walk no sealant.
 - Install new backer rod and sealant.

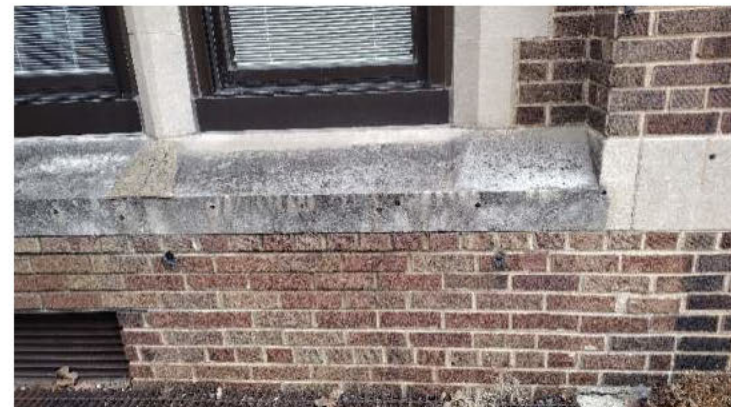
- Mildew soiled Face Brick/Stone multiple locations.
 - Low pressure wash.

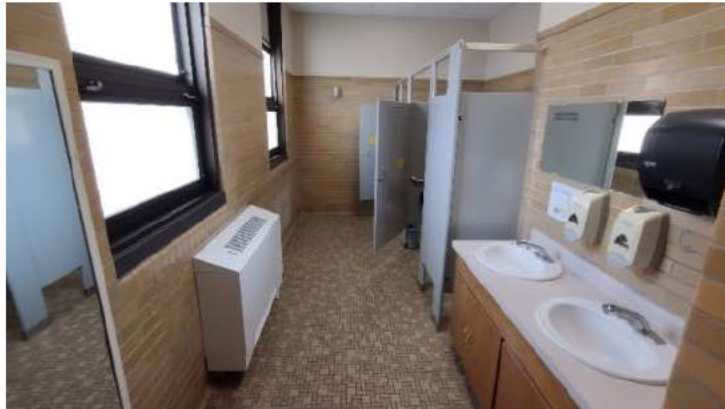
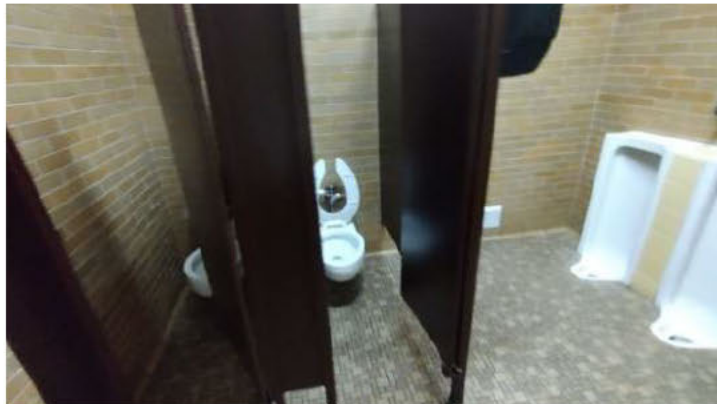
- Numerous ADA up-dates needed.
- Remodel the most central toilet banks each floor.

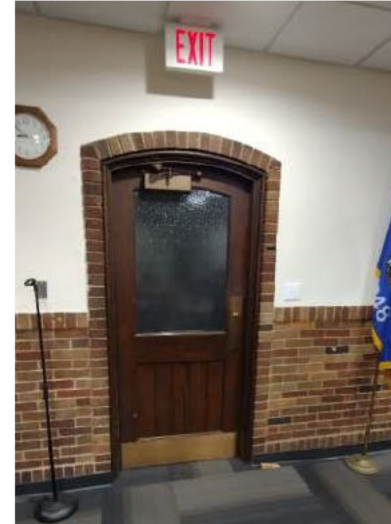
- Boardroom/cafe doors all need panic hardware
- Replace dead bolts with panic hardware

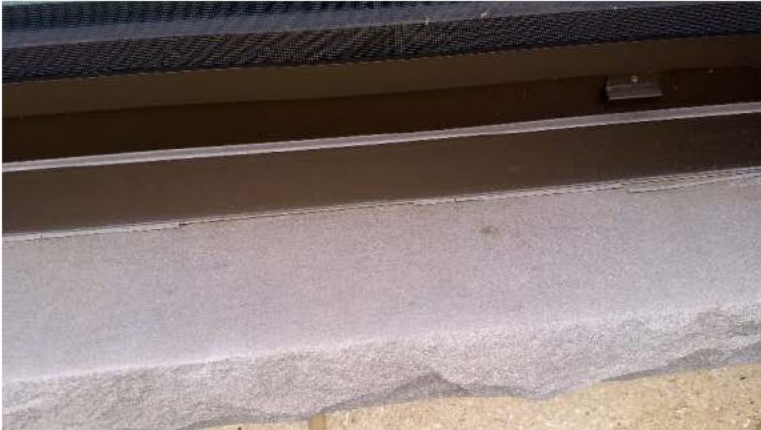
- Caulk between windows and precast concrete sill needs to be replaced, loose / missing – typical.

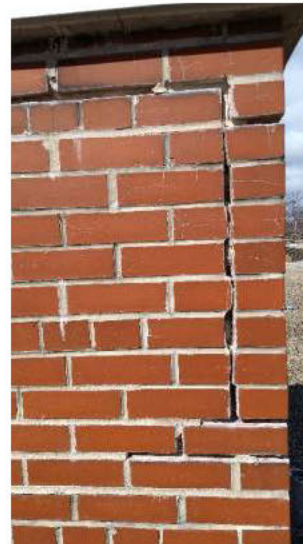
- Repaint hollow metal doors and frames – typical.
- Masonry restoration is needed at the chimney to repair cracked face brick
- Re tucking of the masonry at the chimney is also needed to prevent water migration.
