LONG RANGE FACILITY ASSESSMENT AND EDUCATIONAL ADEQUACY STUDY 2022

VOLUME 2C

FACILITY ASSESSMENT - INDIVIDUAL BUILDING INFORMATION:
MIDDLE SCHOOLS, HIGH SCHOOLS, AND OTHER BUILDINGS

A T S + R

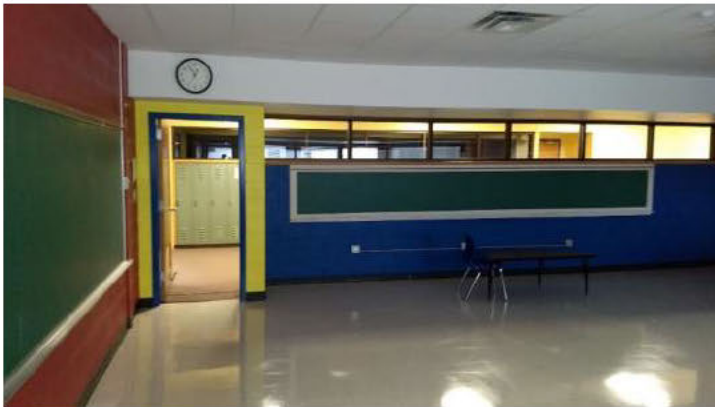
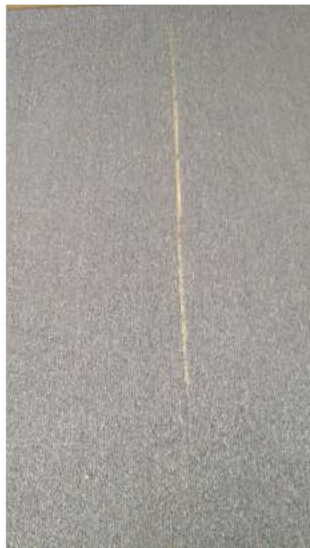
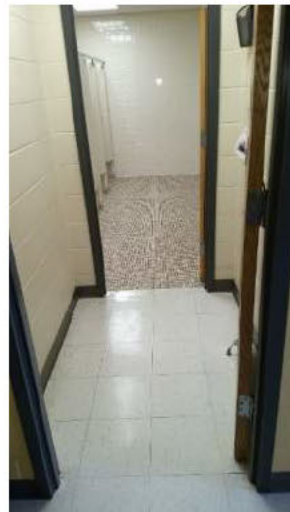
- Recommend updating of classrooms to address fraying broad loom carpet flooring and to replace existing chalk boards with white boards.

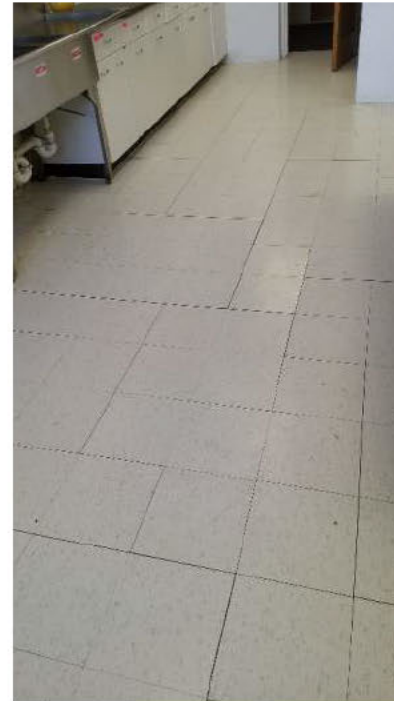
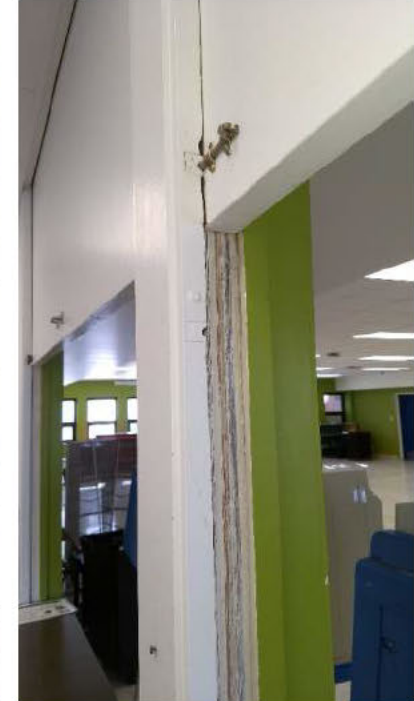
- Recommend remodel of kitchen area to address poor conditions of flooring and casework.

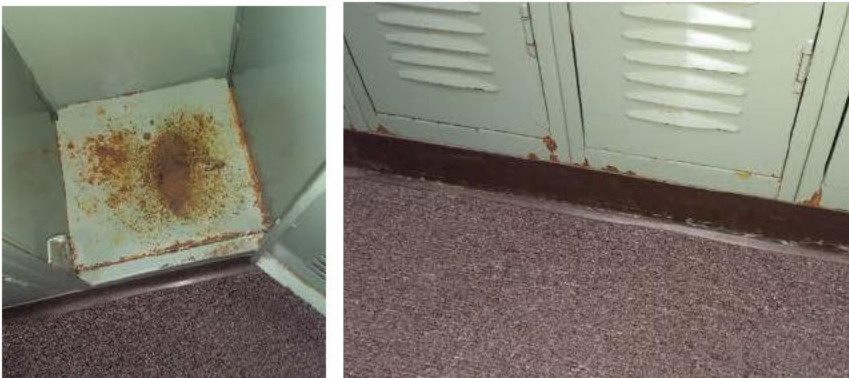
- Metal lockers in the corridor need to be refinished to address signs of rust, or replaced as required for usage.
