PRELIMINARY ASSESSMENT  
RIVER VALLEY LOCAL SCHOOL DISTRICT  
ROOF REPLACEMENT PROJECT  
CALEDONIA, OHIO  
ISSUE DATE: 03-01-2024  
ROH50-001

Prepared by:  
Dan Lawrence, P.E., R.B.E.C.

**River Valley Local School District  
Roof Replacement  
Preliminary Assessment  
Caledonia, Ohio**

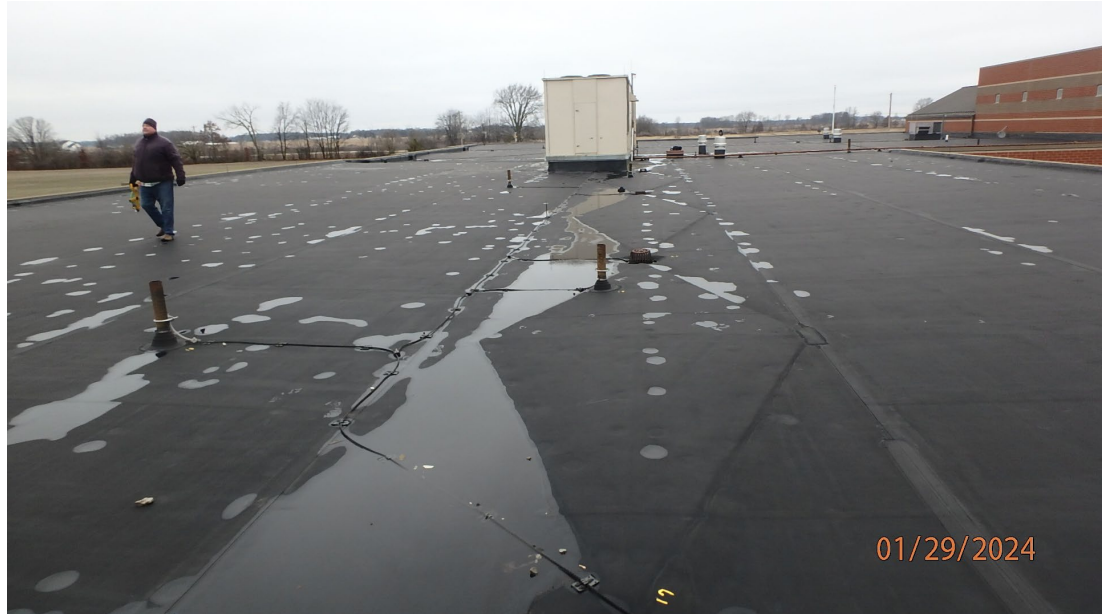
1.1.1.6 Close-up view of the same area from the previous photograph showing that there is some ponding water along this drain line. Tapered insulation around the roof drains and tapered insulation crickets can be installed to improve the drainage at this area.

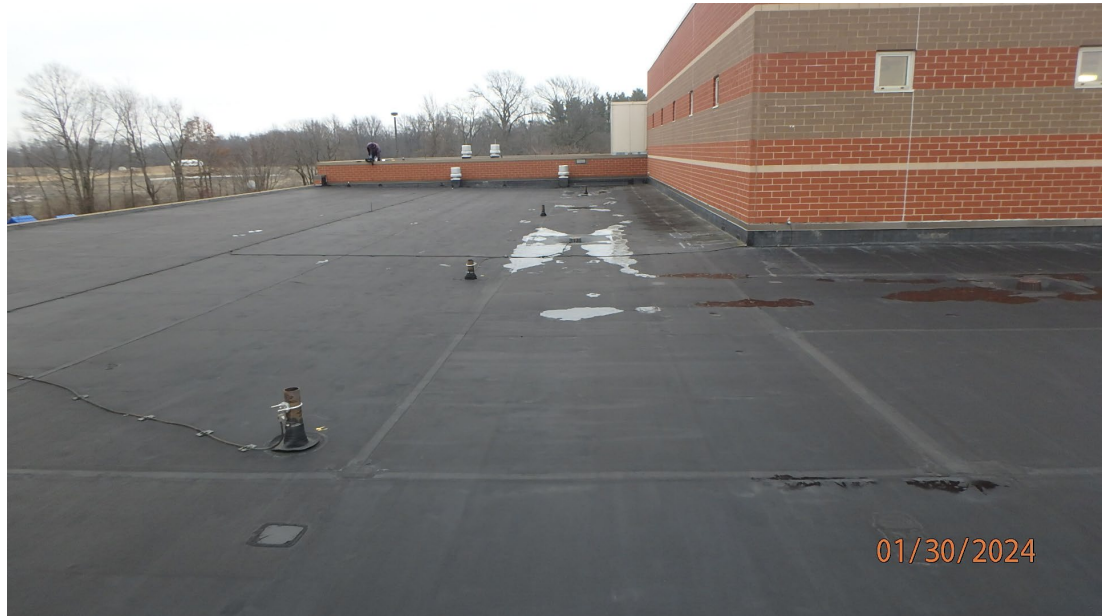
1.1.2.2 View of a line of roof drains on Roof Area B showing there is no significant ponding water. There is some minor ponding water near the roof drains. This can be corrected with addition of tapered insulation around the roof drains.

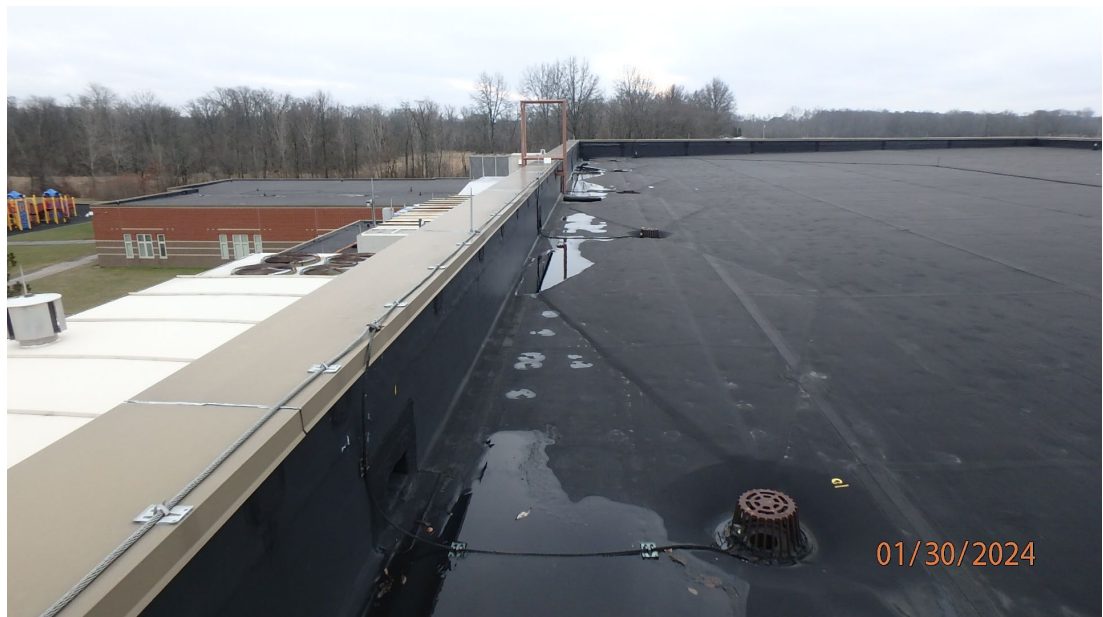
1.1.2.3 View of a line of roof drains on Roof Area C showing there is no significant ponding water. There is some minor ponding water near the roof drains. This can be corrected with addition of tapered insulation to create back slope to the roof drains and tapered insulation around the roof drains.

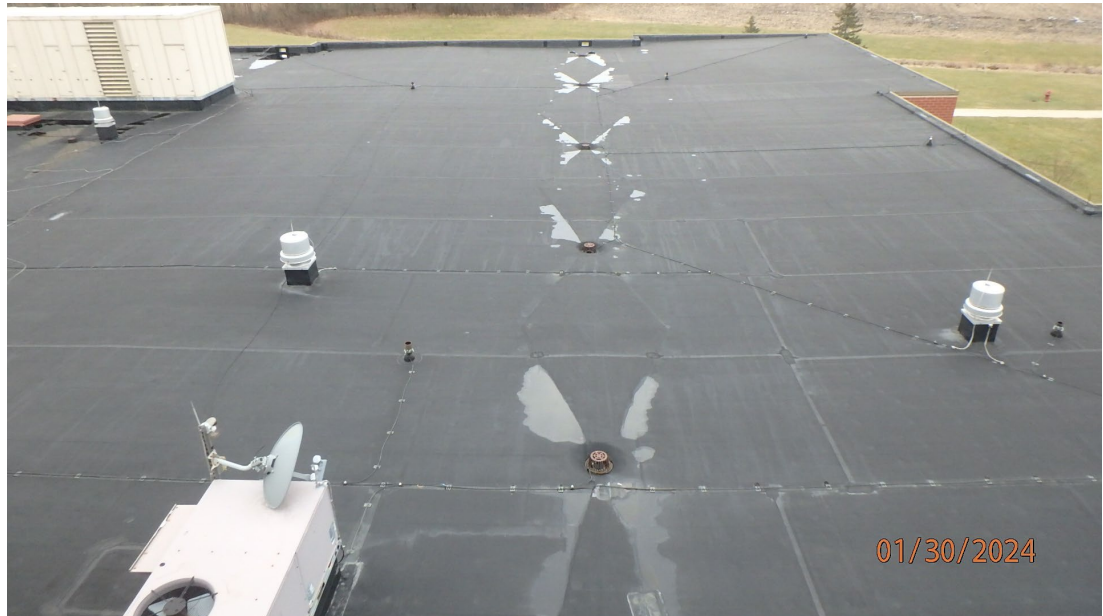
1.1.2.4 View of a line of roof drains on Roof Area D showing there is no significant ponding water. There is some minor ponding water near the roof drains. This can be corrected with addition of tapered insulation around the roof drains.

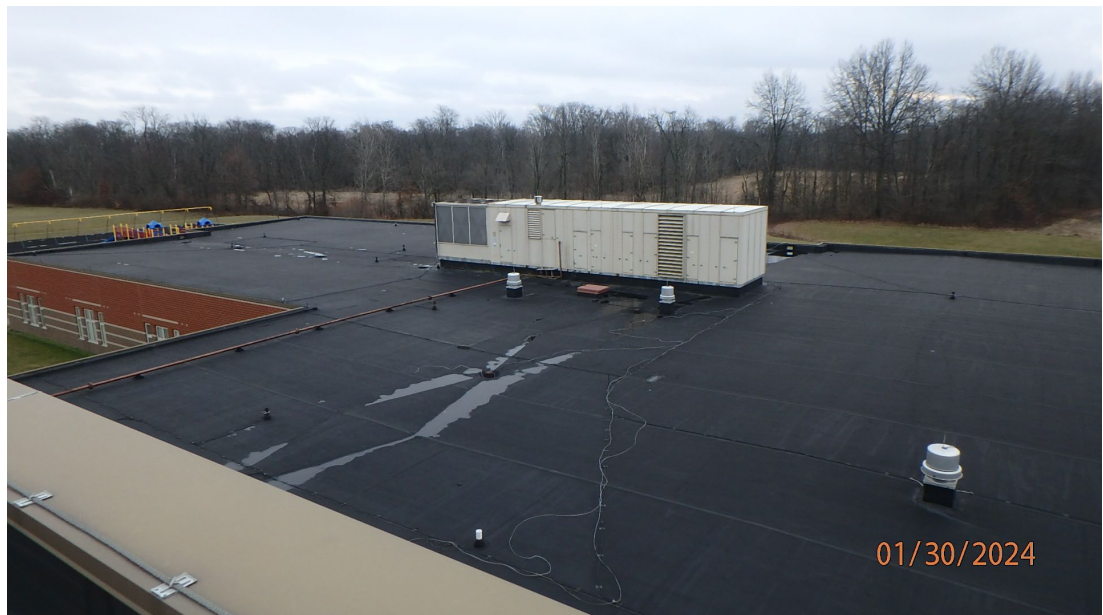
1.1.2.5 View of a line of roof drains on Roof Area D showing there is no significant ponding water. There is some minor ponding water near the roof drains. This can be corrected with addition of tapered insulation around the roof drains.

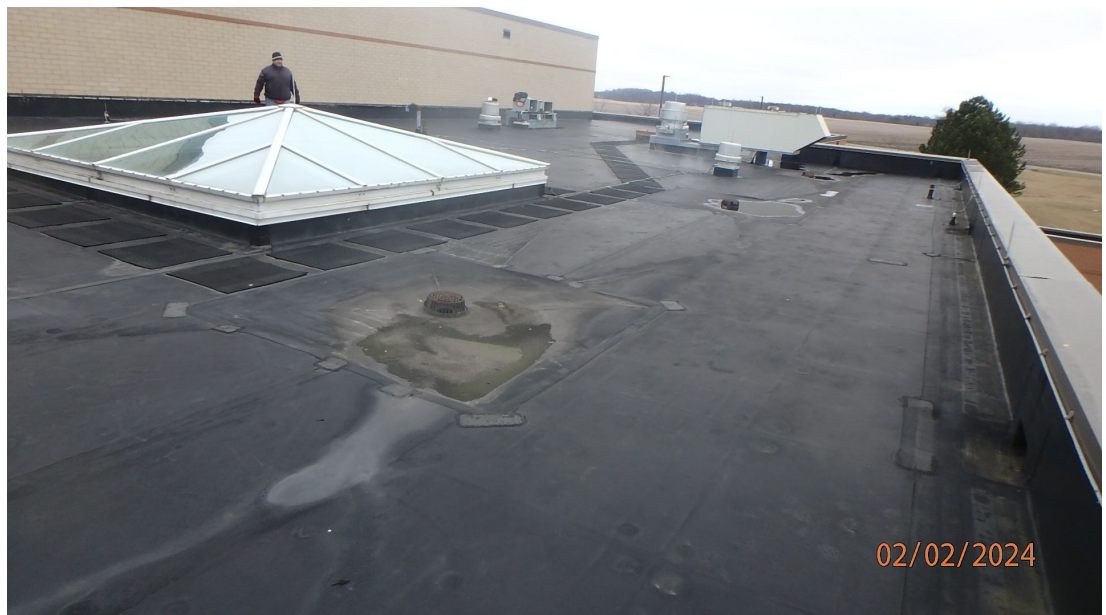
1.1.3.5 Overall view of the drain lines along Roof Area B showing there is some minor ponding around the roof that can be reduced by the addition of tapered insulation around the roof drains.

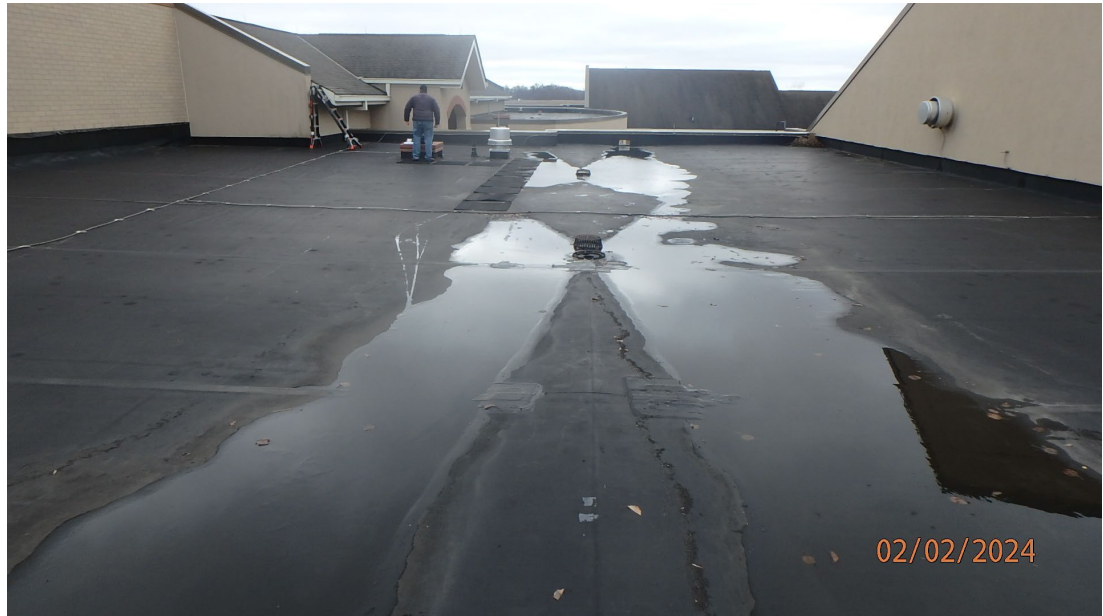
1.1.3.8 Overall view showing there is significant ponding along the drain line on Roof Area C. This will need to be corrected by the addition of tapered insulation around the roof drains and possibly larger tapered insulation crickets.

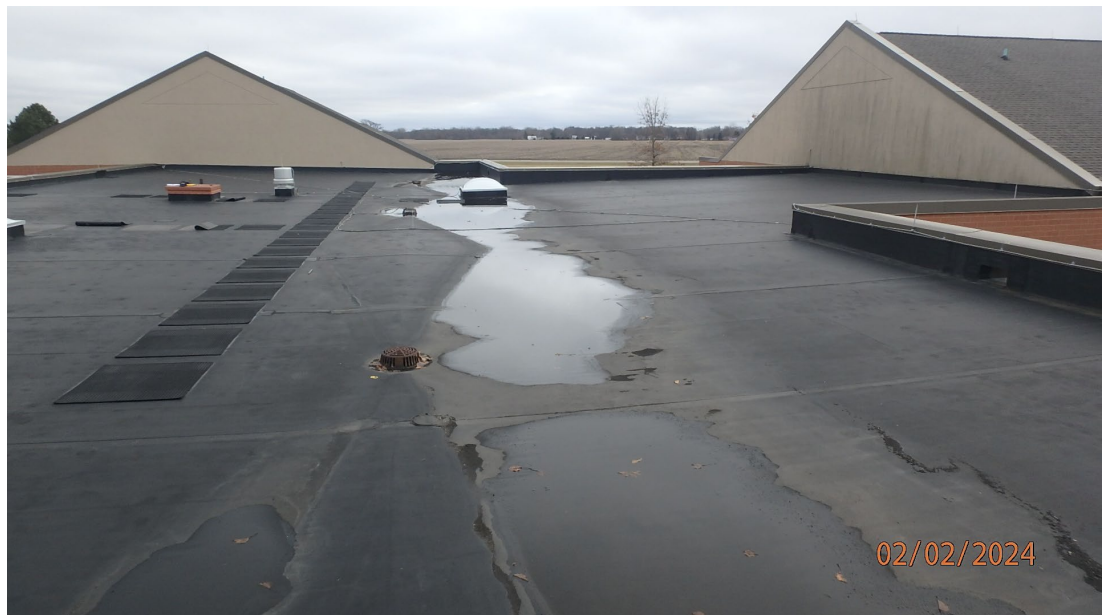
1.1.3.13 Overall view showing there is significant ponding along the drain line on Roof Area I. This will need to be corrected by the addition of tapered insulation around the roof drains, removing the existing crickets, and installing new properly located crickets.

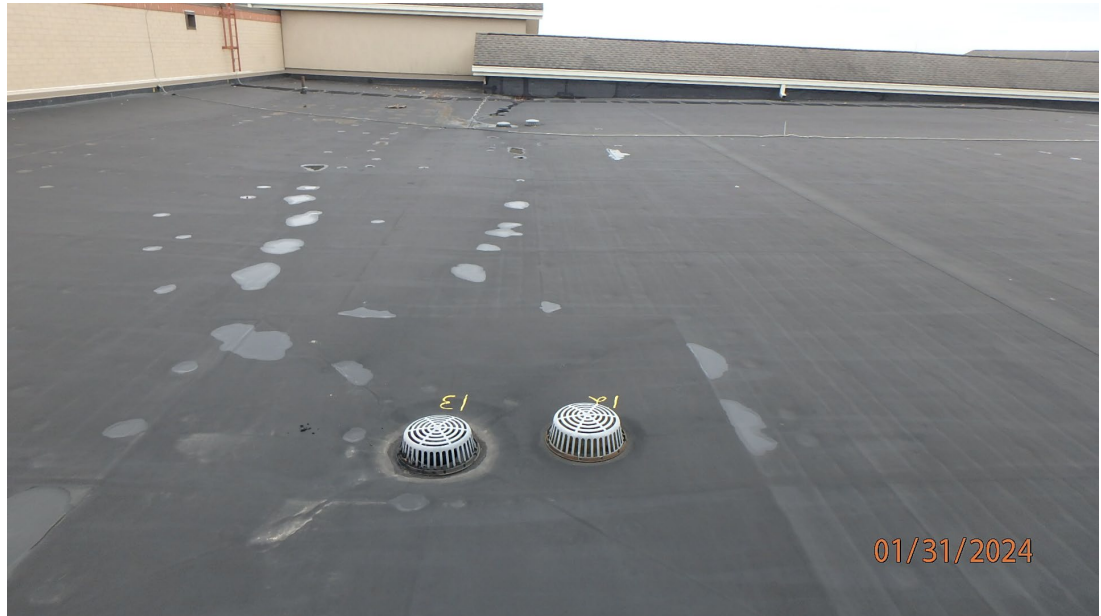
1.1.4.9 View of an area on Roof Area N showing there is no significant ponding on this roof area.

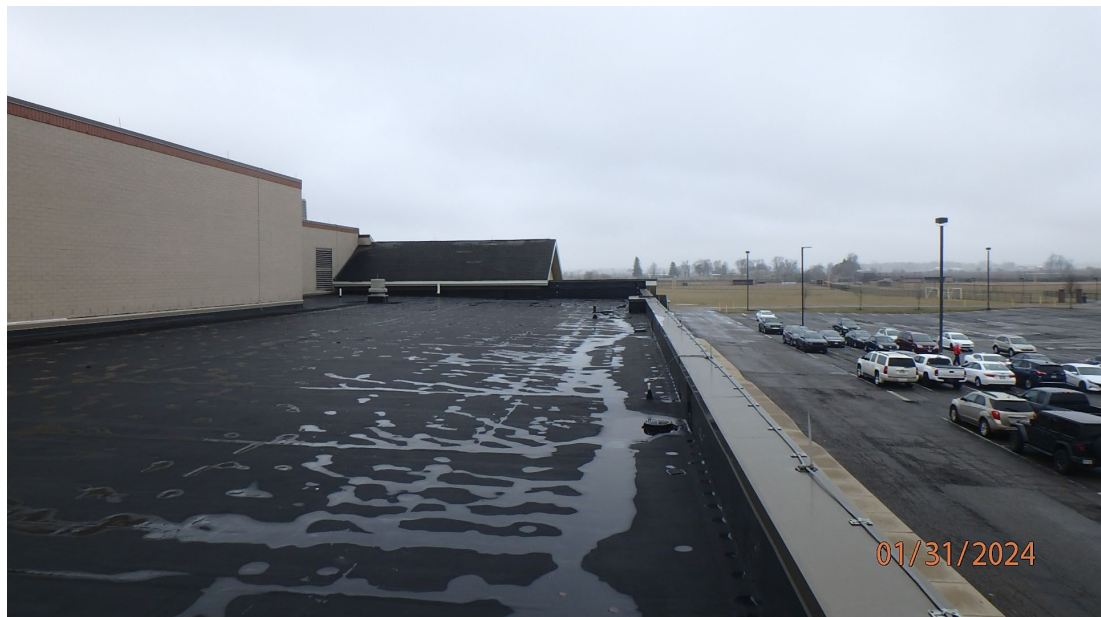
1.1.4.10 View of an area on Roof Area N showing there is no significant ponding on this roof area. Additional tapered insulation would be installed around the drains and larger crickets installed between the roof drains to improve the drainage.

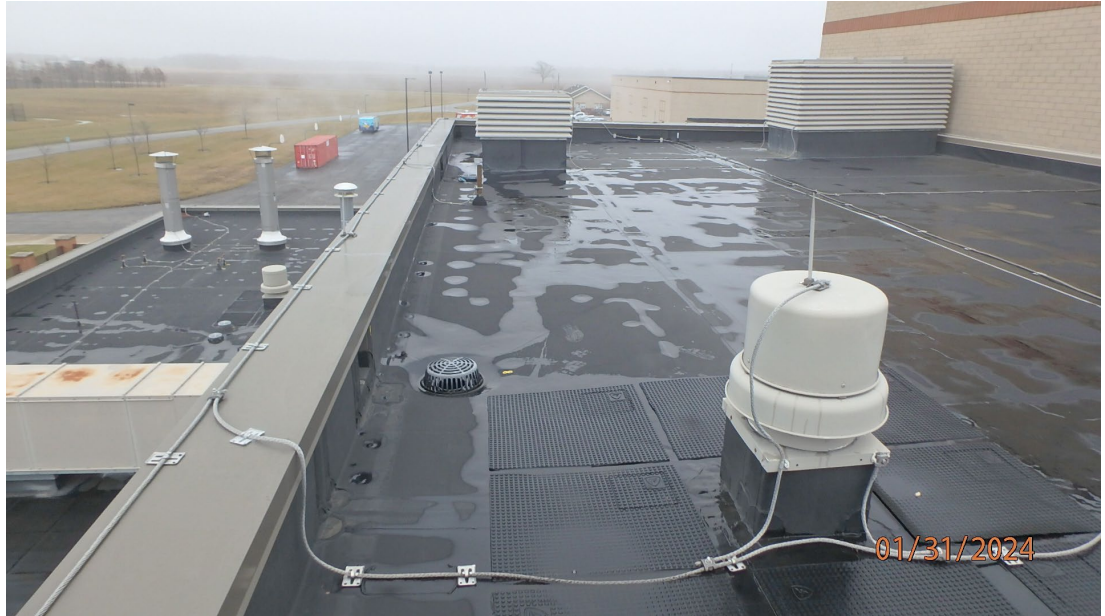
1.1.4.13 View of an area on Roof Area O showing there is no significant ponding on this roof area.

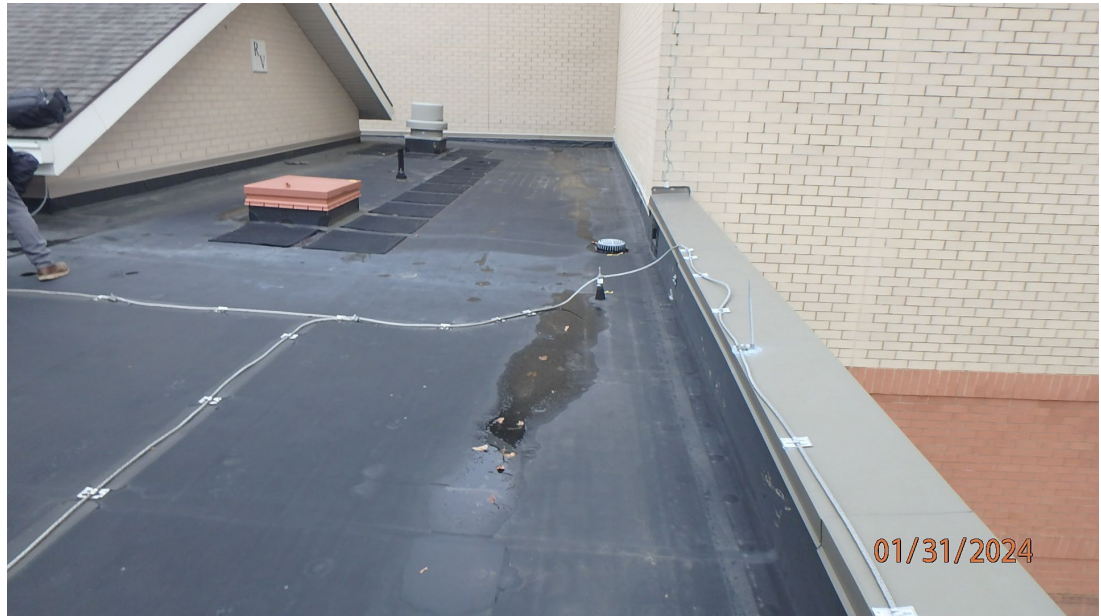
- 1.1.4.15 View of an area on Roof Area Q showing there is no significant ponding on this roof area. Additional tapered insulation would be installed around the drains and larger crickets installed between the roof drains to improve the drainage.

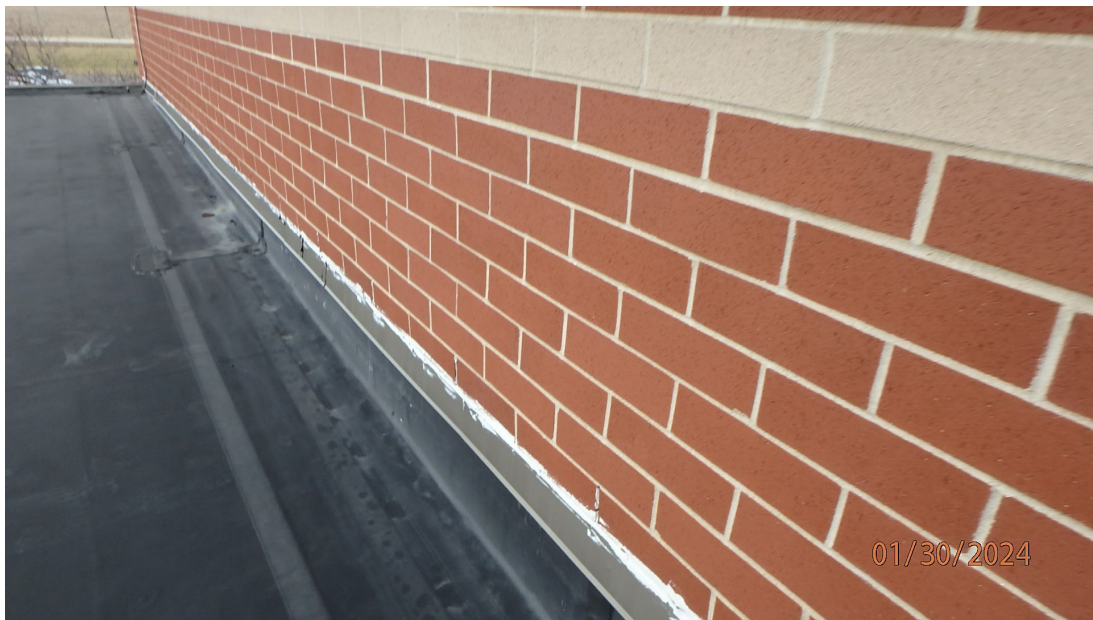
1.3.7 **Liberty Elementary** - View of an area where asphalt can be seen extending out from under the brick veneer at the sheet metal flashing.

Based on the leak damage observed at some areas and that the flashings are not properly installed at many locations, we recommend all masonry through wall flashings be replaced on this building.

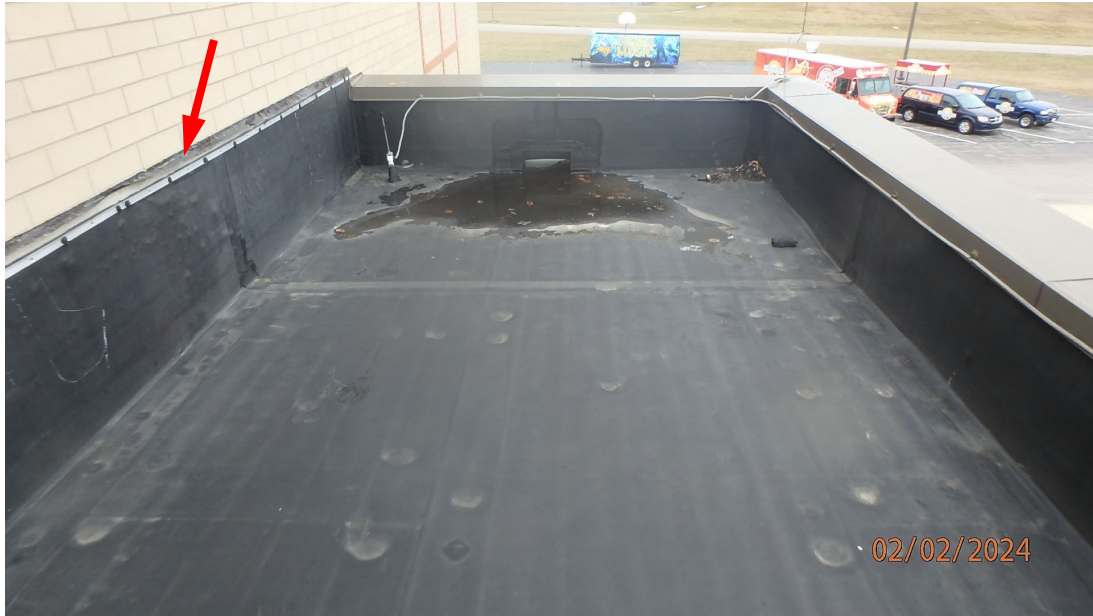
1.3.8 **River Valley Middle School** – View of an area where laminated copper flashing (red arrow) extends out of the wall.

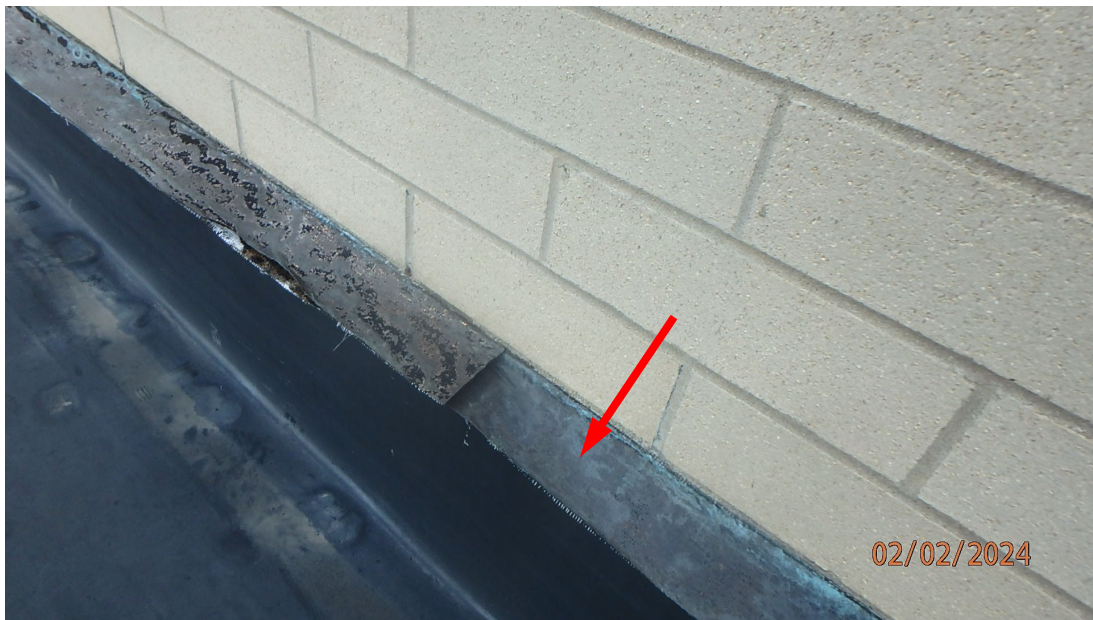
1.3.9 **River Valley Middle School** – Close-up view of the laminated copper masonry through wall flashing material.

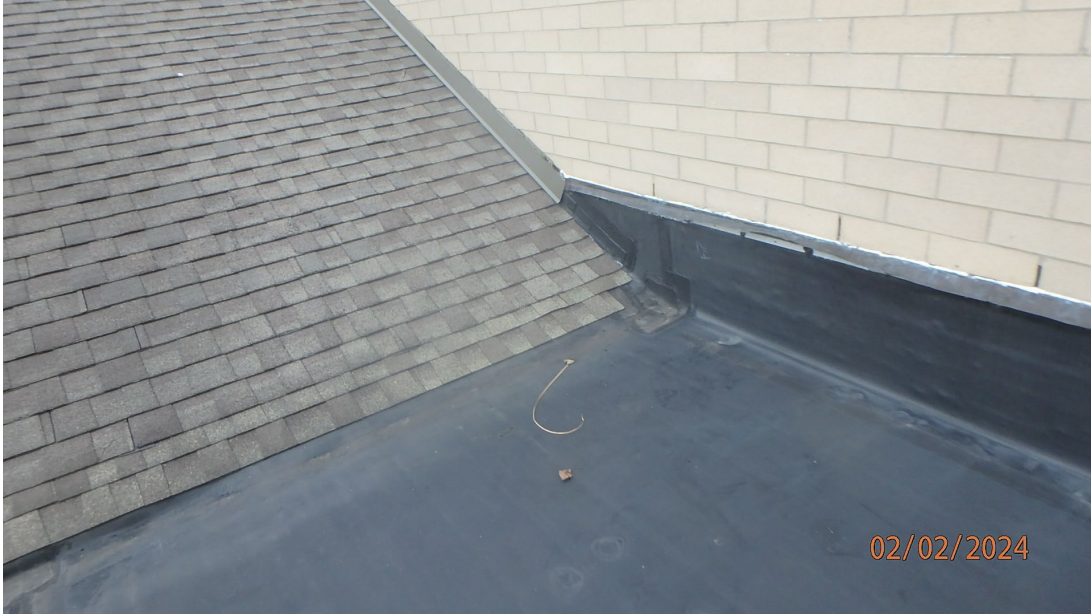
- 1.3.10 **River Valley Middle School** – View of a transition location between a low-sloped roof and a steep sloped roof. It is uncertain if the masonry through wall flashing is terminated. There is also no stepped masonry through wall flashing at the sloped roof area.

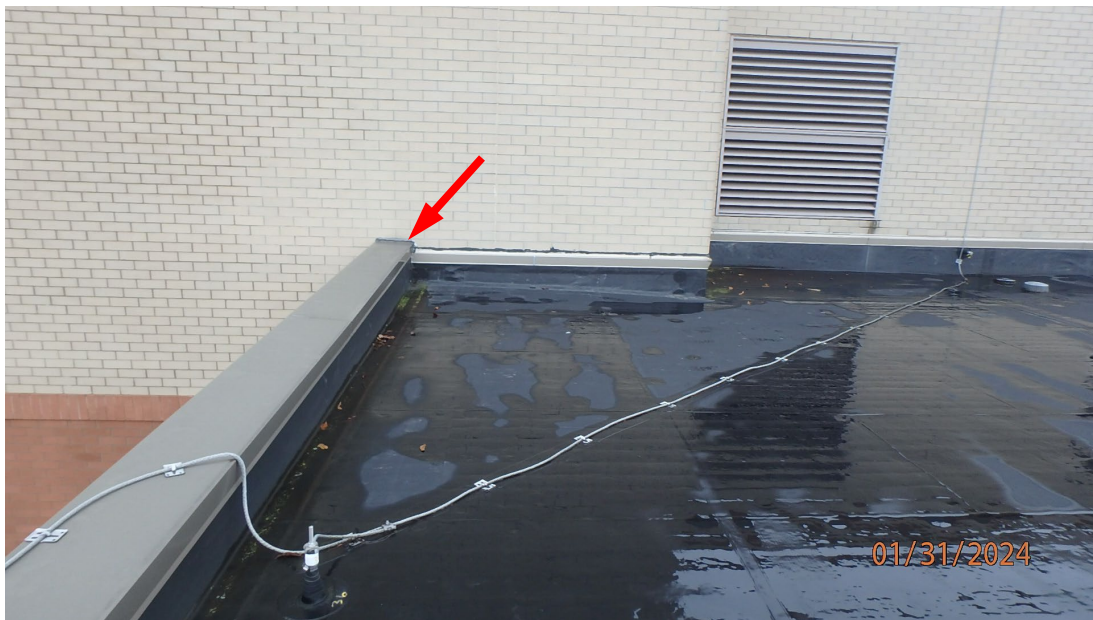
1.3.13 **River Valley High School** – View of an area where the masonry through wall flashing does not step up over the coping cap.

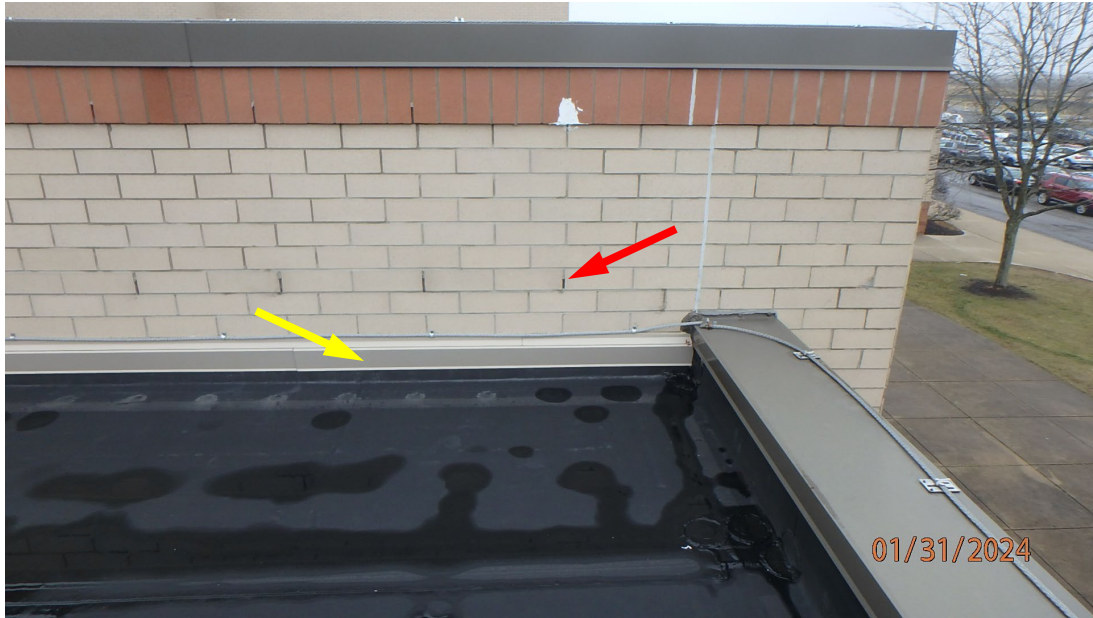
1.3.14 **River Valley High School** – View of an area where the weeps (red arrow) are 2 courses higher than the counterflashing (yellow arrow), leaving 2 courses of masonry that are not flashed.

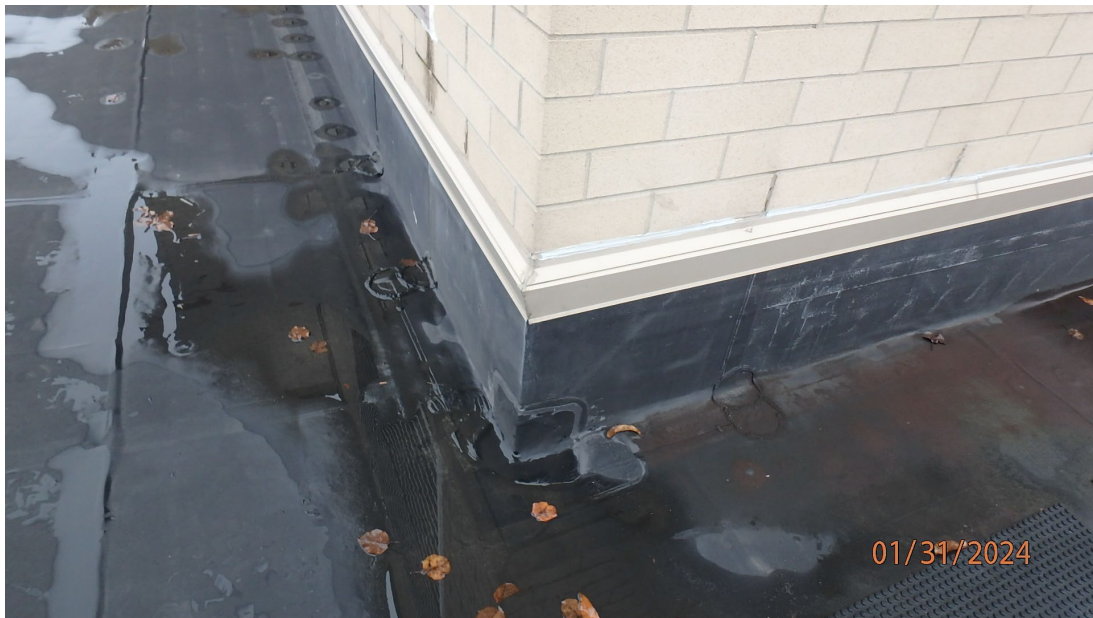
1.3.15 **River Valley High School** – Close-up view showing a 2-piece counterflashing has been installed at the through wall flashing location. Sealant has been installed between the sheet metal receiver and brick masonry.

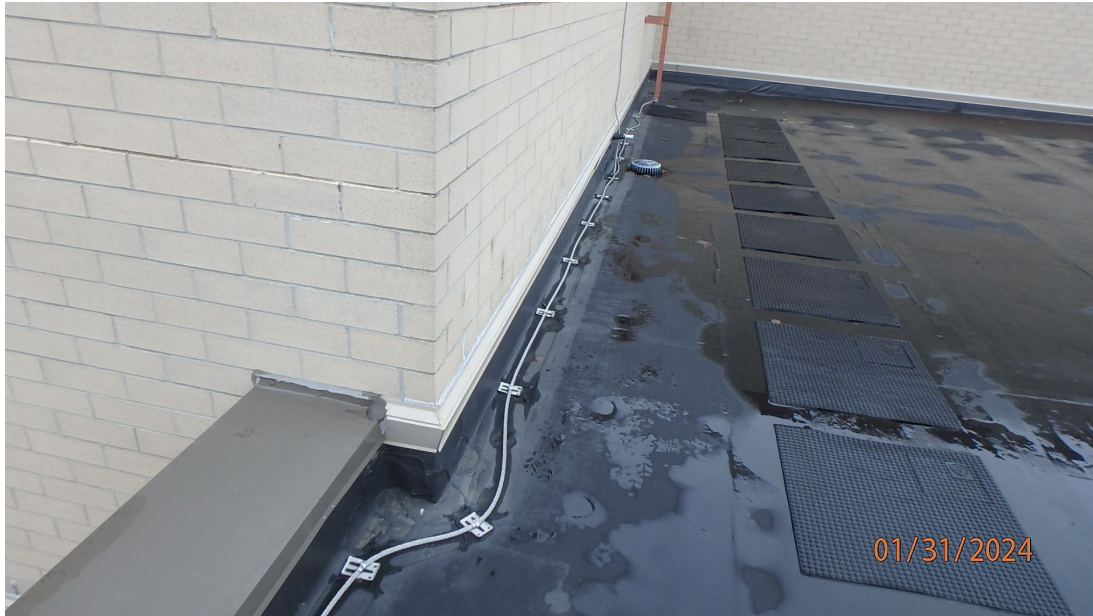
1.3.16 **River Valley High School** – View of another location where the masonry through wall flashing is not stepped up over the coping cap.

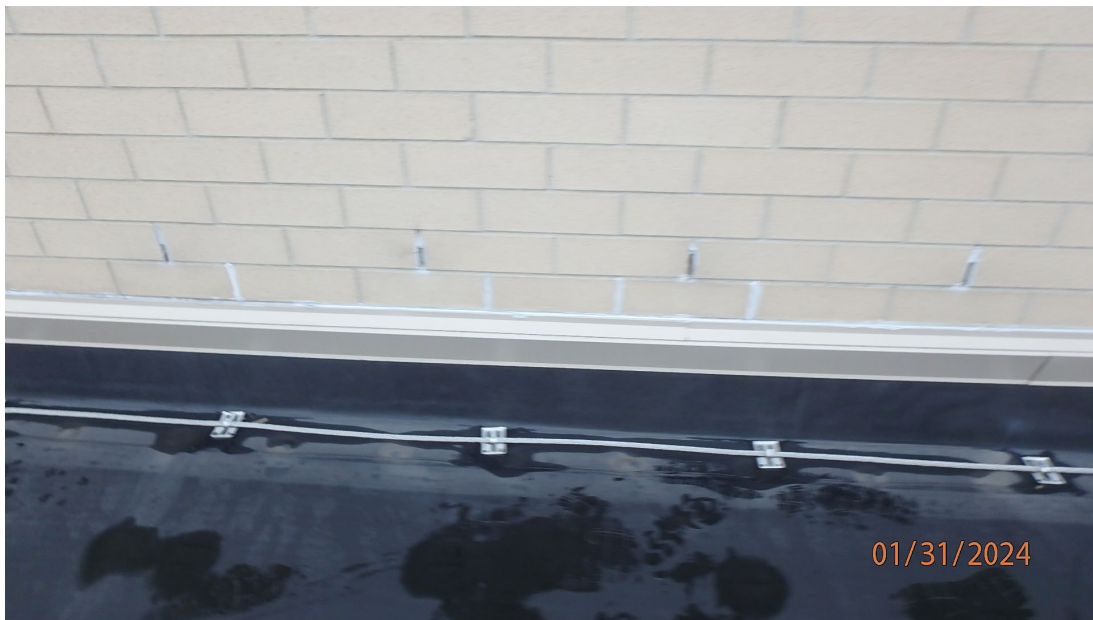
1.3.17 **River Valley High School** – View of an area where the weeps are one (1) course above the receiver.

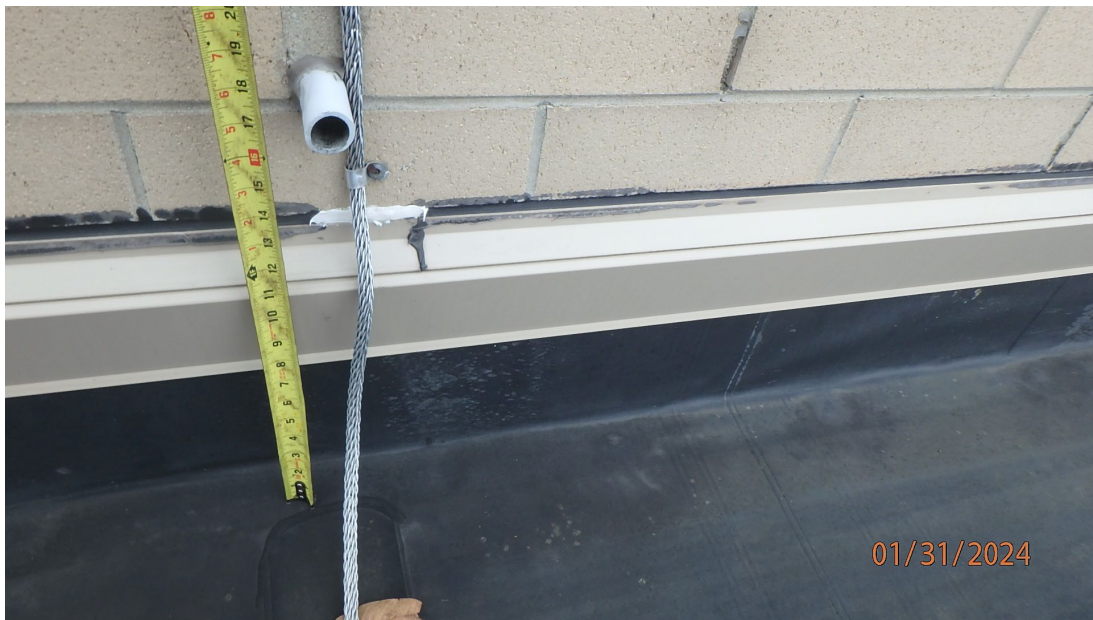
1.3.21 **River Valley High School** – Close-up view of an area where the weeps are installed 1 course above the receiver and sealant has been installed between the receiver and the brick masonry.

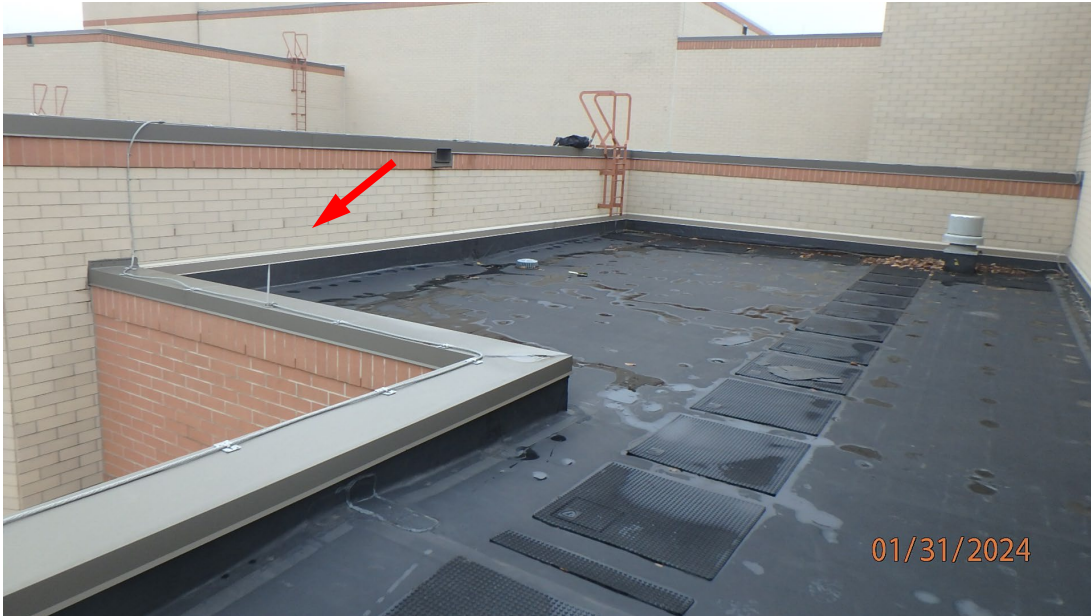
1.3.22 **River Valley High School** – Overall view of an area where the weeps are 3 courses above the receiver.

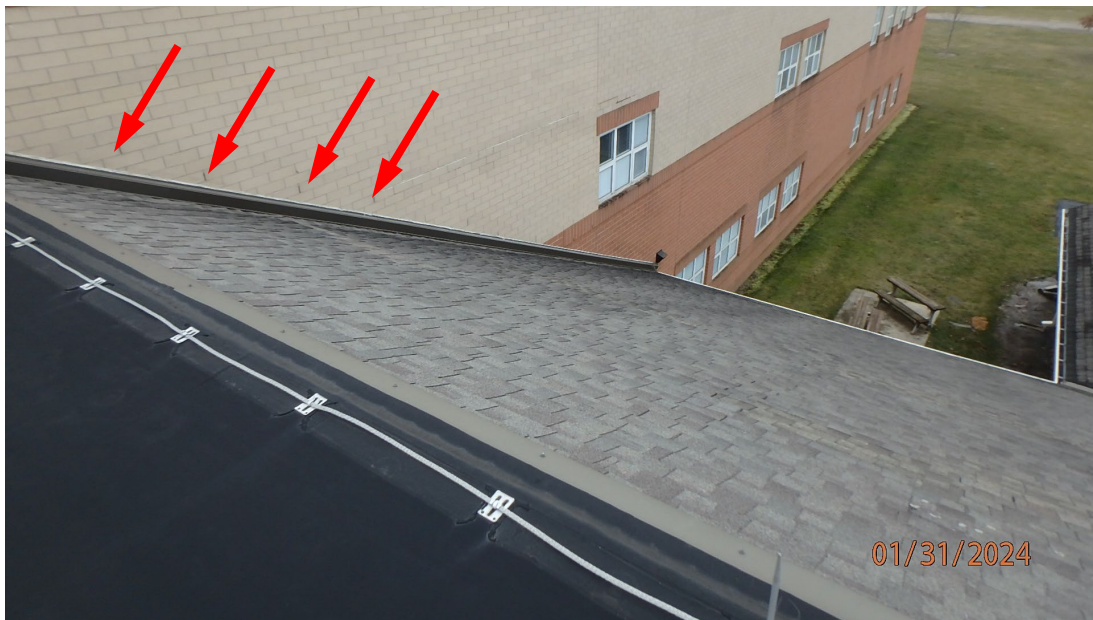
1.3.25 **River Valley High School** – View of a steep sloped roof area where there are weeps above the roof, but there are no stepped counterflashings installed to eliminate unflashed masonry.

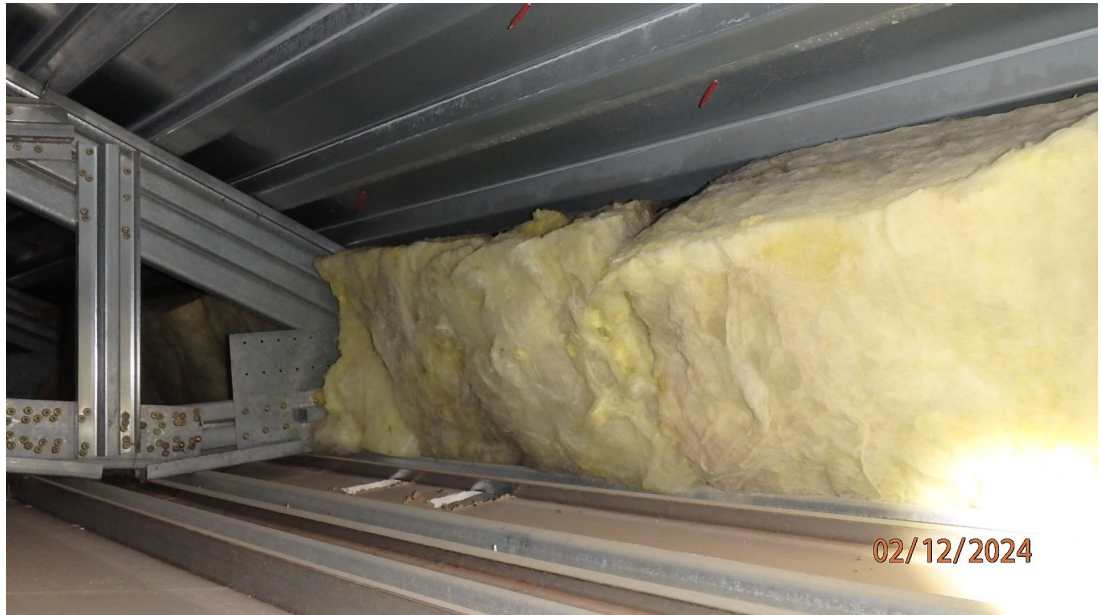
1.4.1.2 View showing batt insulation has been installed between the roof deck and the top of the wall.

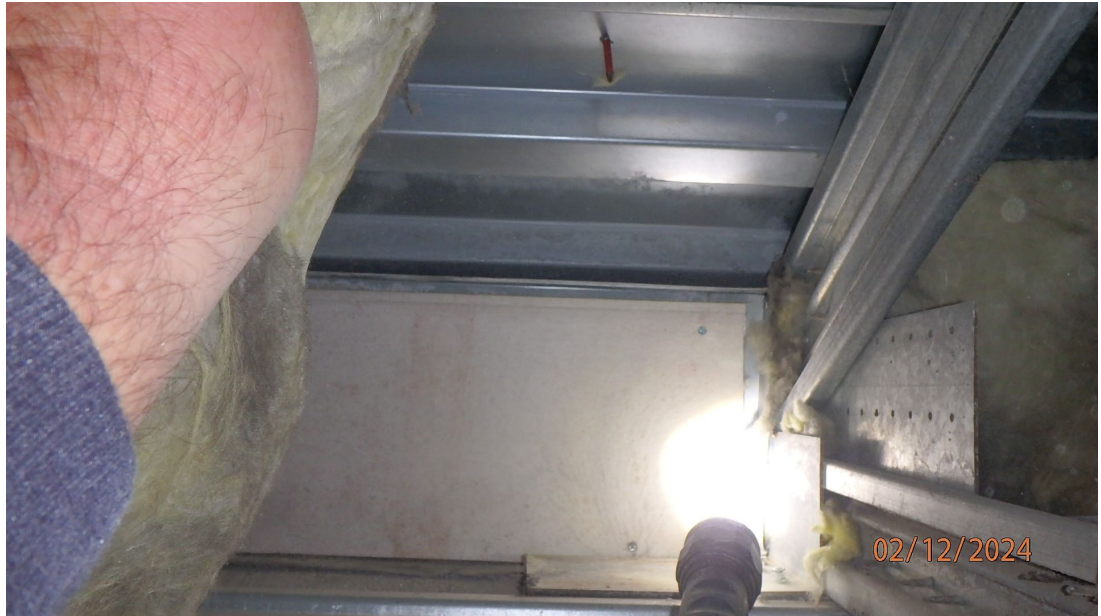
- 1.4.1.3 View of the batt insulation removed showing that the majority of the space between the top of the wall and the bottom of the roof deck has been covered with drywall and supplemental framing. This is likely why no air exfiltration issues were identified at the eaves of the middle school.

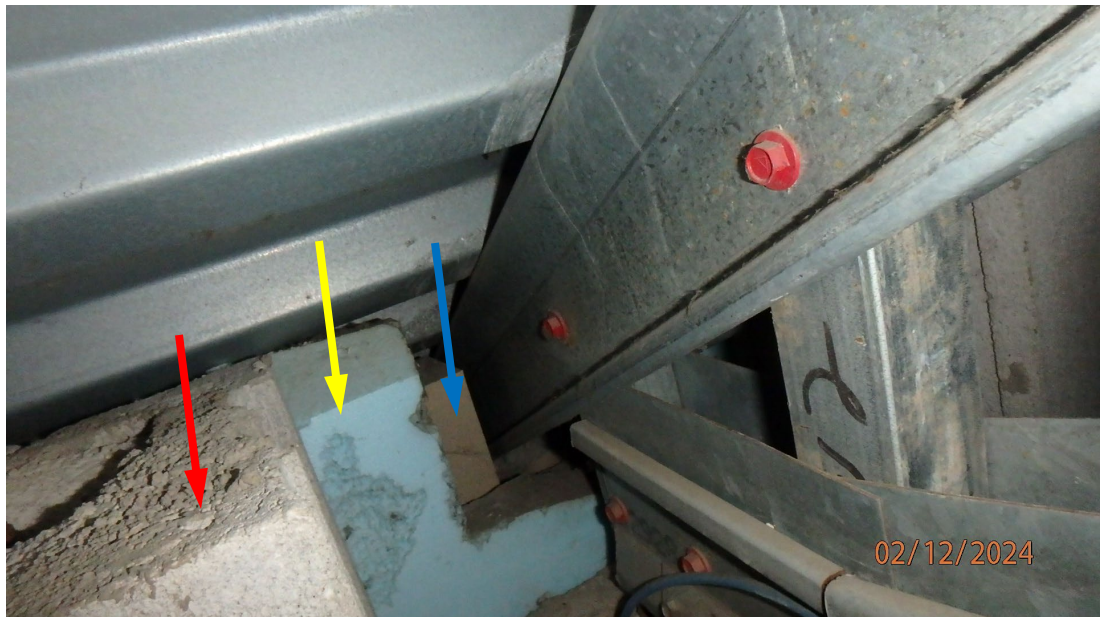
1.4.2.2 View of the existing exterior wall construction through the small opening. The red arrow indicated the CMU back-up wall, the yellow arrow indicates the cavity insulation, and the blue arrow indicates the exterior brick veneer. There is no air barrier installed at this location.

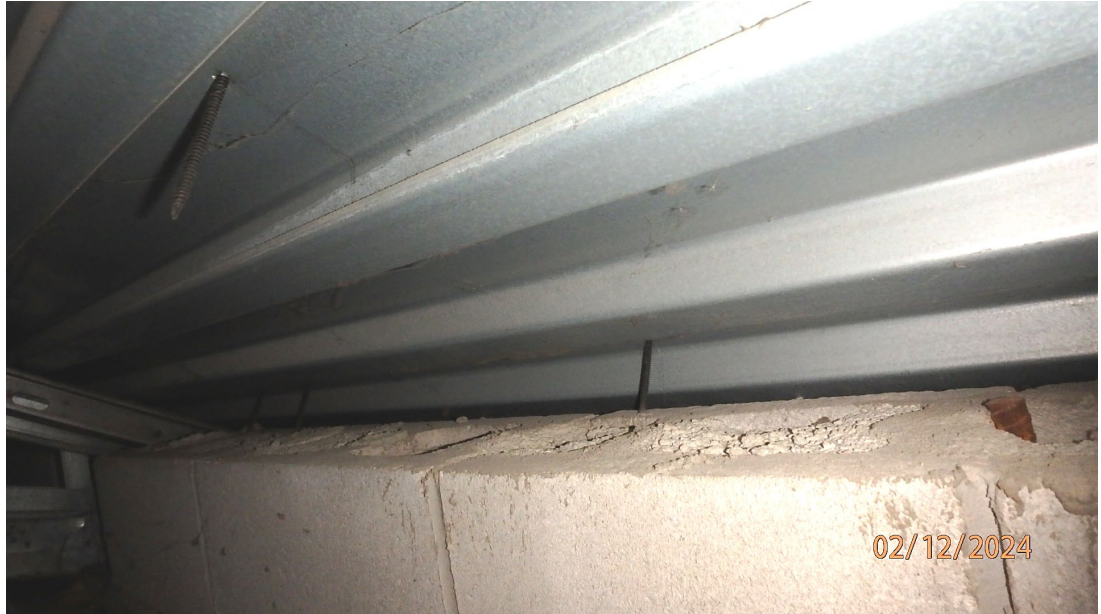
1.4.2.3 View of the same area from a different angle showing there is no air barrier installed at this location.

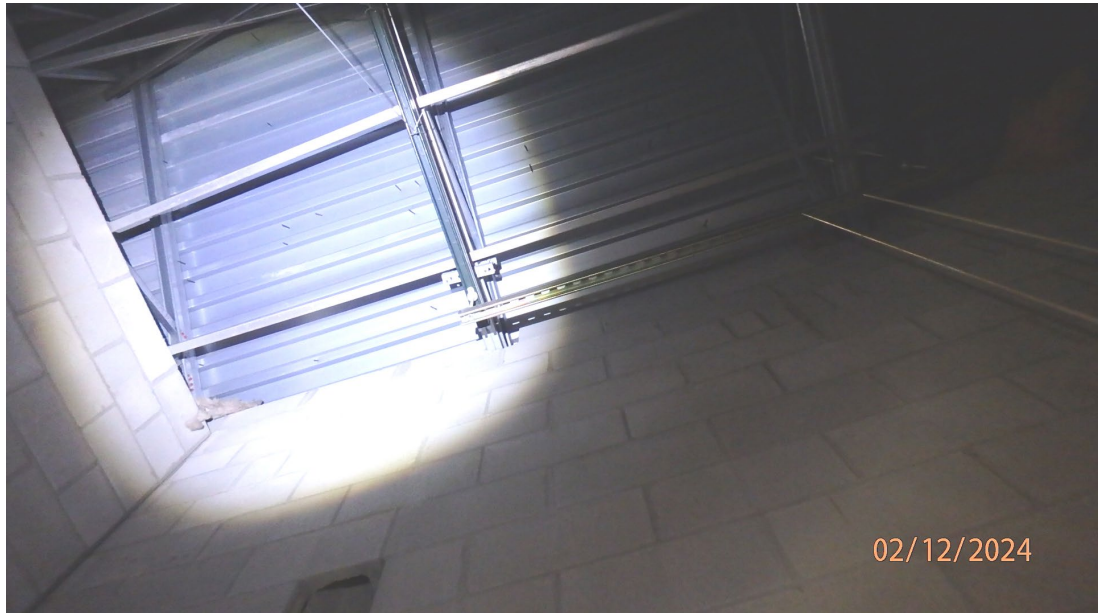
1.4.2.4 View above the drop ceiling at an adjacent hallway area, where a frozen sprinkler line/head was reported. There is no drywall attached to the bottom of the cold-formed metal trusses at these locations and there is no air barrier between the top of the wall and the bottom of the roof deck.

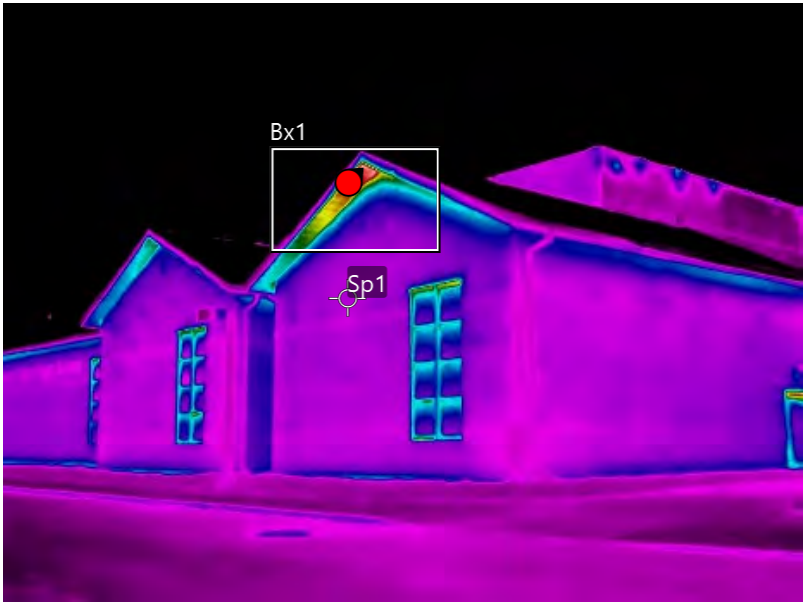
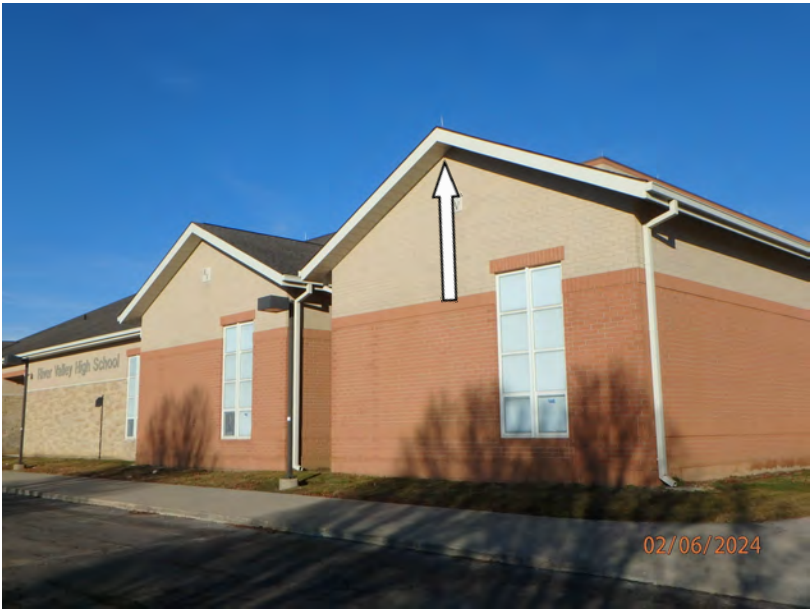
Illustration #1

Parameters	
Atmospheric temp.	30.0 °F
Measurements	
Bx1	
Max	49.1 °F
Sp1	31.0 °F
Dt1	
Bx1.Max -Sp1	18.1 °F

A. Thermal image indicates significant warm interior air exfiltration occurring through soffit detailing at the roof-to-wall transition.

B. Photograph indicates area in which above thermal image was recorded - High School, south elevation. See plan view drawing for location.
