PRELIMINARY ASSESSMENT  
RIVER VALLEY LOCAL SCHOOL DISTRICT  
ROOF REPLACEMENT PROJECT  
CALEDONIA, OHIO  
ISSUE DATE: 03-01-2024  
ROH50-001

Prepared by:  
Dan Lawrence, P.E., R.B.E.C.

**River Valley Local School District  
Roof Replacement  
Preliminary Assessment  
Caledonia, Ohio**

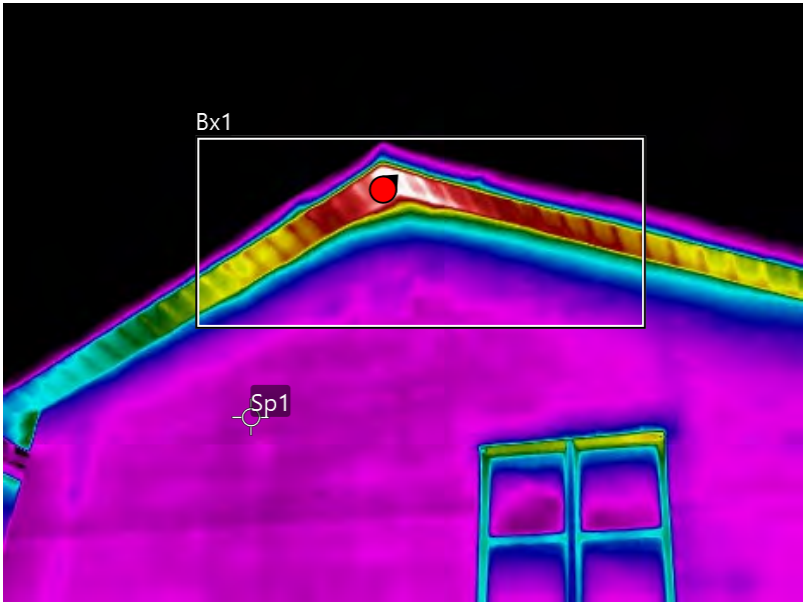
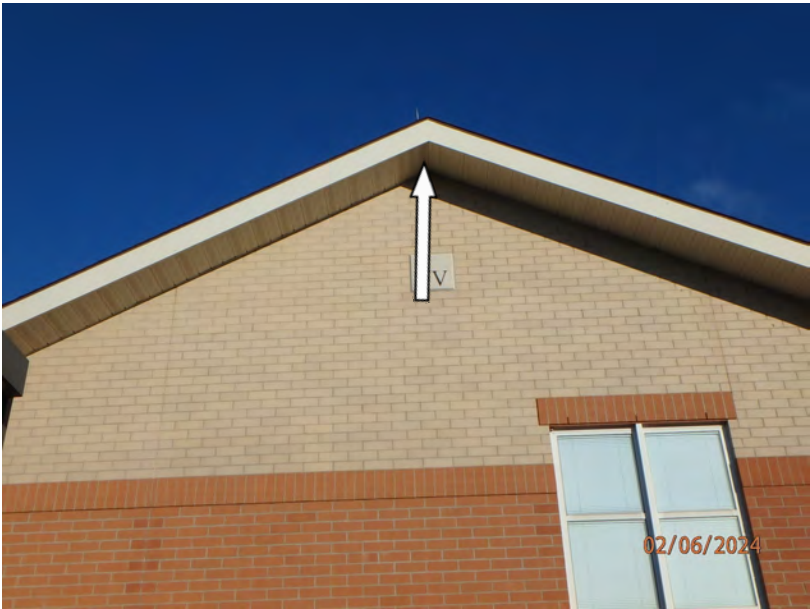
Illustration #2

Parameters	
Atmospheric temp.	30.0 °F
Measurements	
Bx1	
Max	52.6 °F
Sp1	30.9 °F
Dt1	
Bx1.Max -Sp1	21.7 °F

A. Thermal image indicates significant warm interior air exfiltration occurring through soffit detailing at the roof-to-wall transition.

B. Photograph indicates area in which above thermal image was recorded - High School, south elevation. See plan view drawing for location.

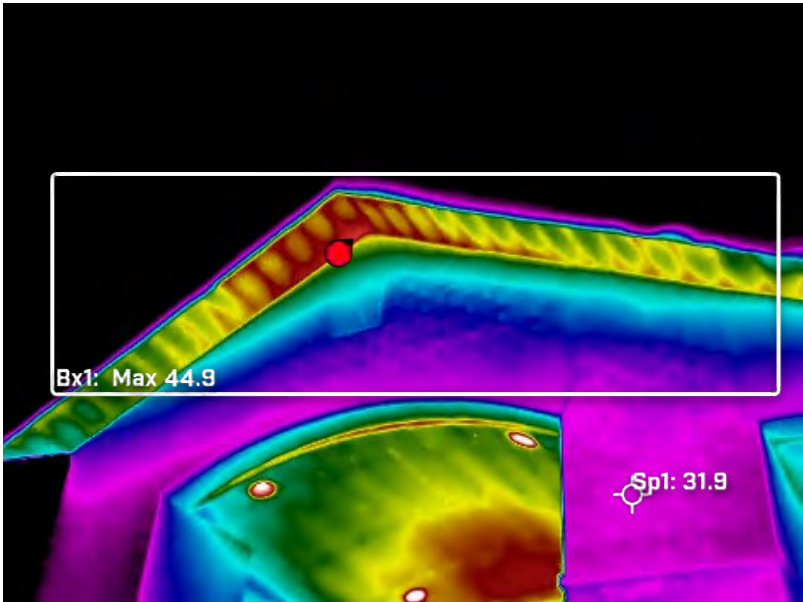
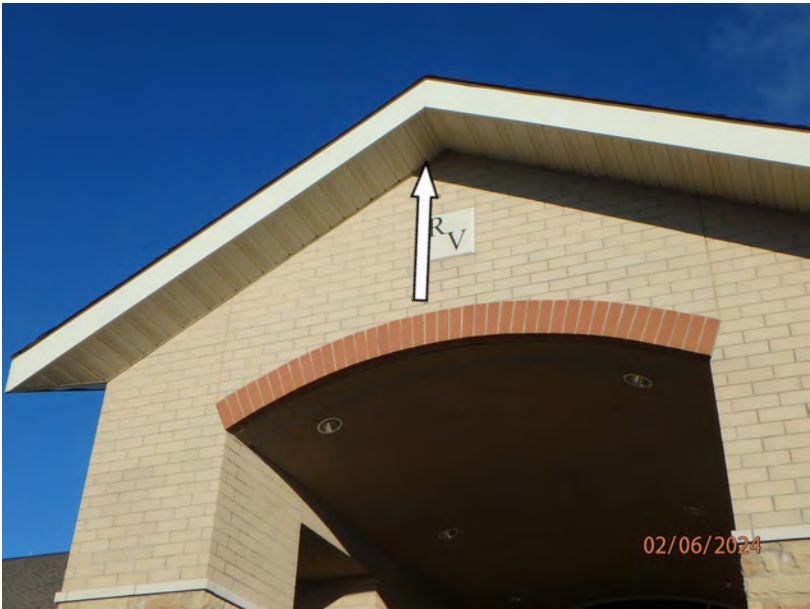
Illustration #3

A. Thermal image indicates significant warm interior air exfiltration occurring through soffit detailing at the roof-to-wall transition.

B. Photograph indicates area in which above thermal image was recorded - High School, south elevation. See plan view drawing for location.

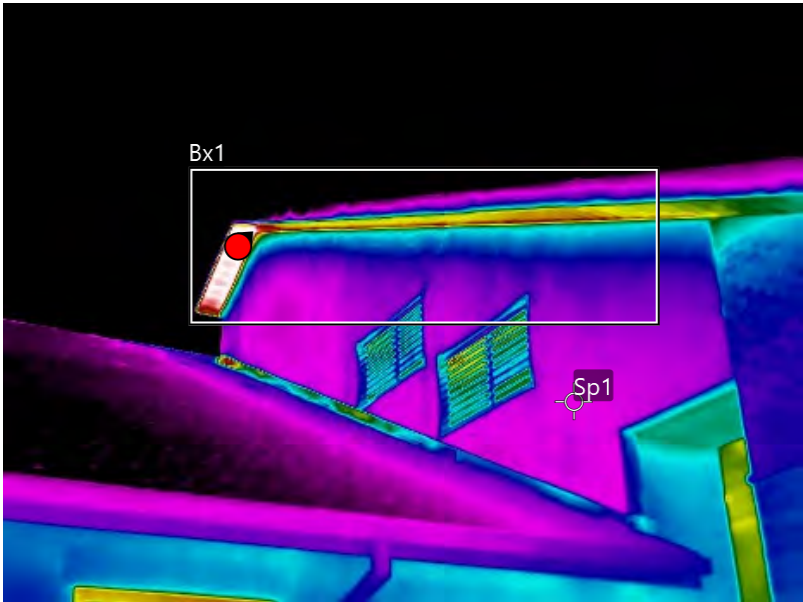
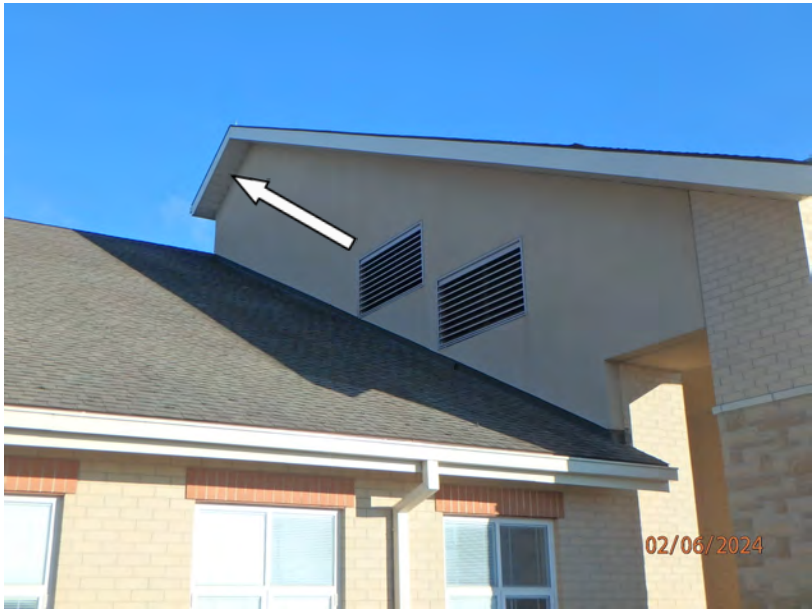
Illustration #4

A. Thermal image indicates significant warm interior air exfiltration occurring through soffit detailing at the roof-to-wall transition.

B. Photograph indicates area in which above thermal image was recorded - High School, west elevation. See plan view drawing for location.

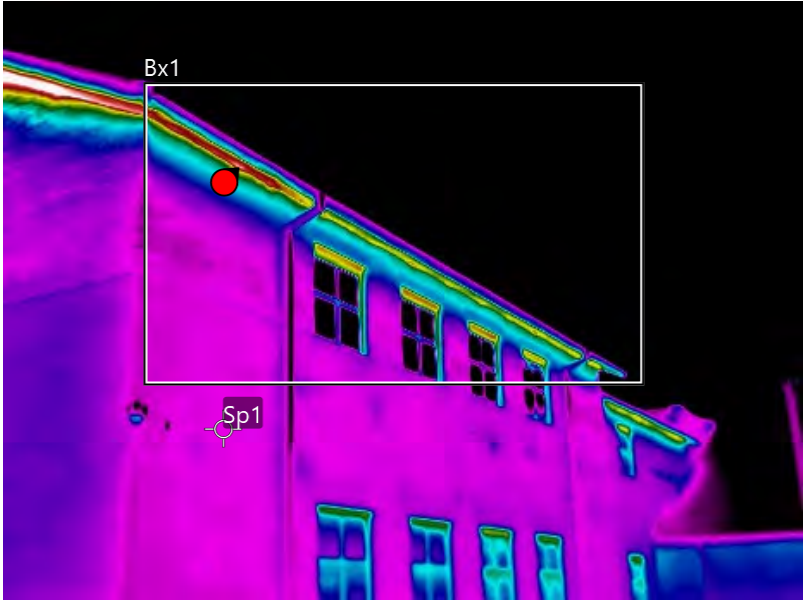
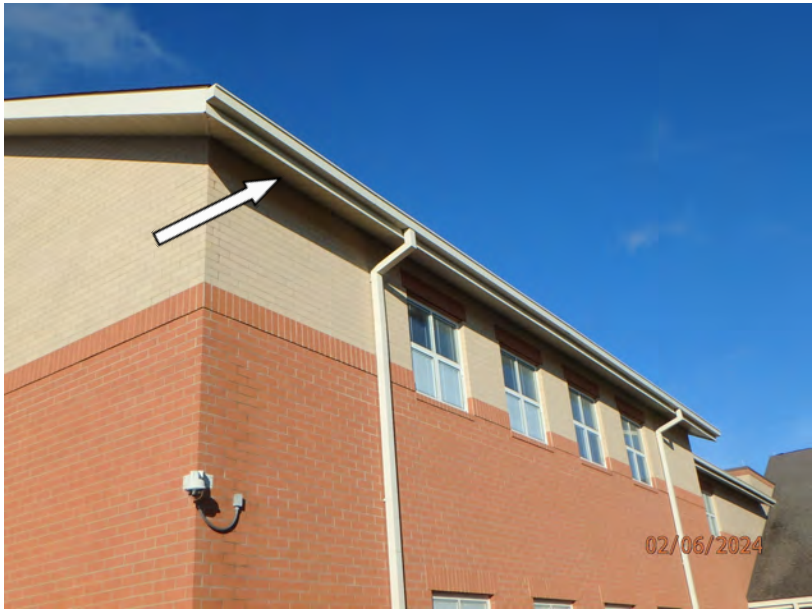
Illustration #5

A. Thermal image indicates significant warm interior air exfiltration occurring through soffit detailing at the roof-to-wall transition.

B. Photograph indicates area in which above thermal image was recorded - High School, east elevation. See plan view drawing for location.

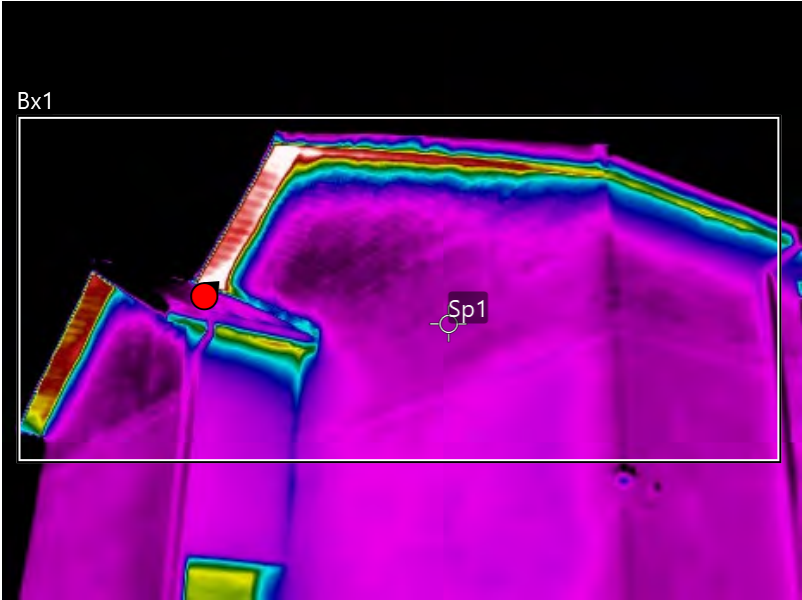
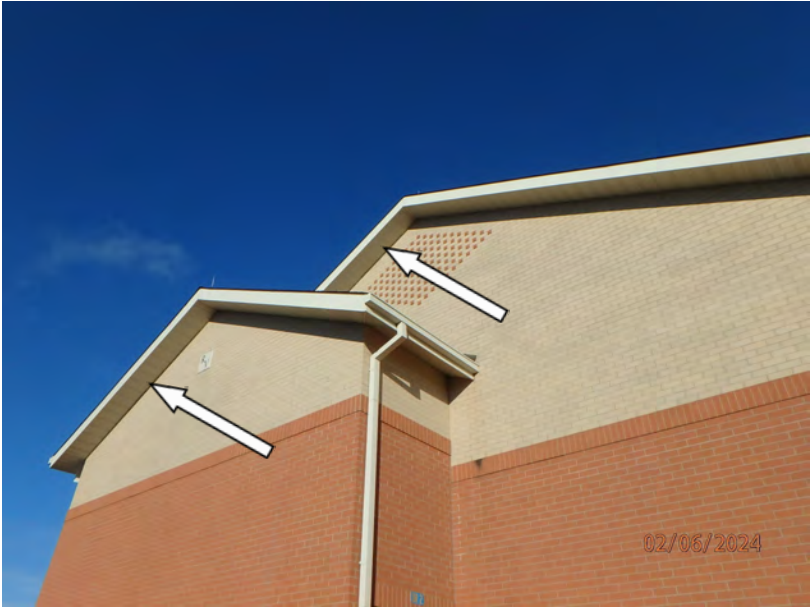
Illustration #6

A. Thermal image indicates significant warm interior air exfiltration occurring through soffit detailing at the roof-to-wall transition.

B. Photograph indicates area in which above thermal image was recorded - High School, south elevation. See plan view drawing for location.

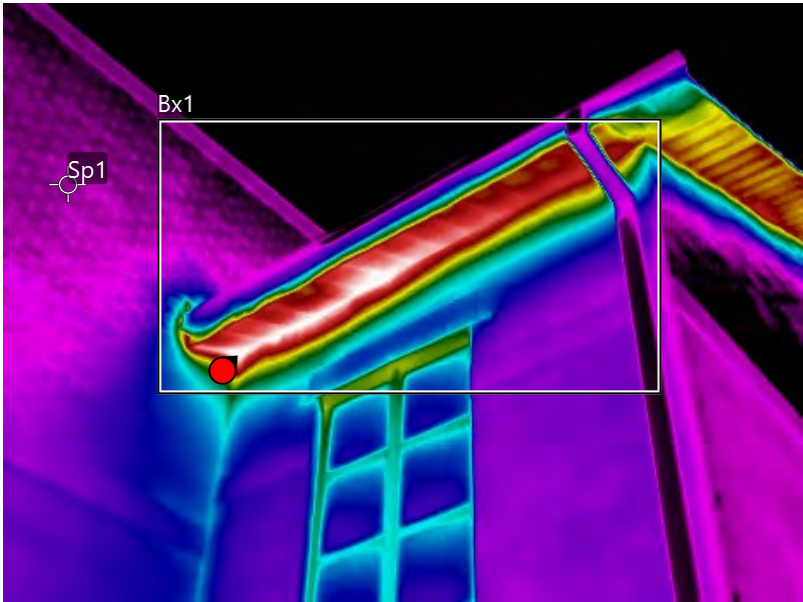
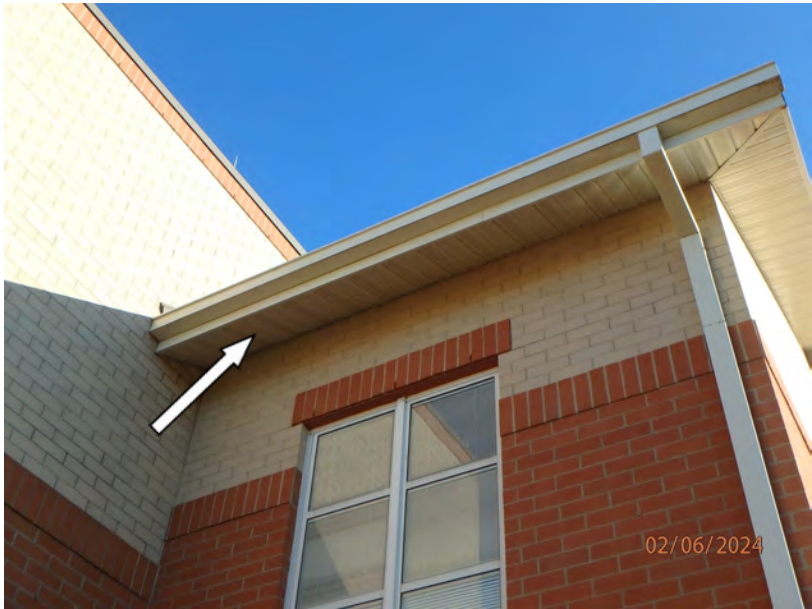
Illustration #7

A. Thermal image indicates significant warm interior air exfiltration occurring through soffit detailing at the roof-to-wall transition.

B. Photograph indicates area in which above thermal image was recorded - High School, west elevation. See plan view drawing for location.

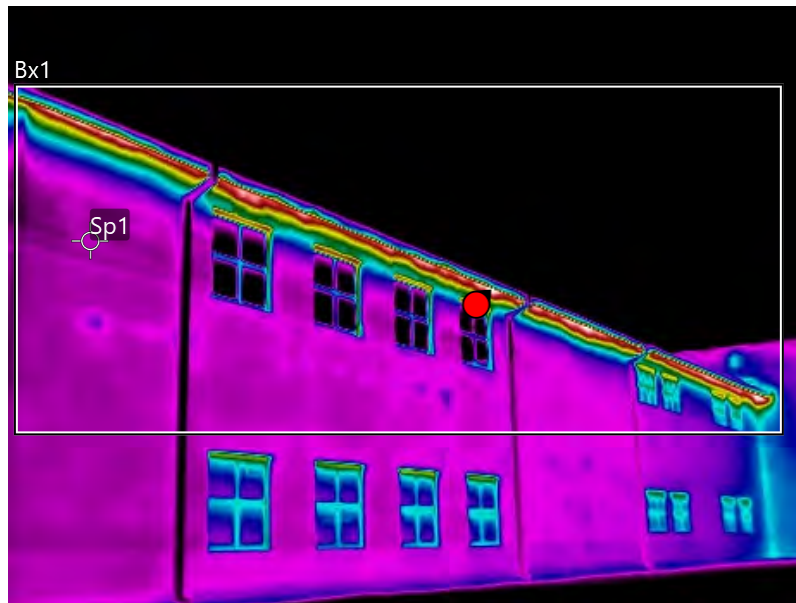
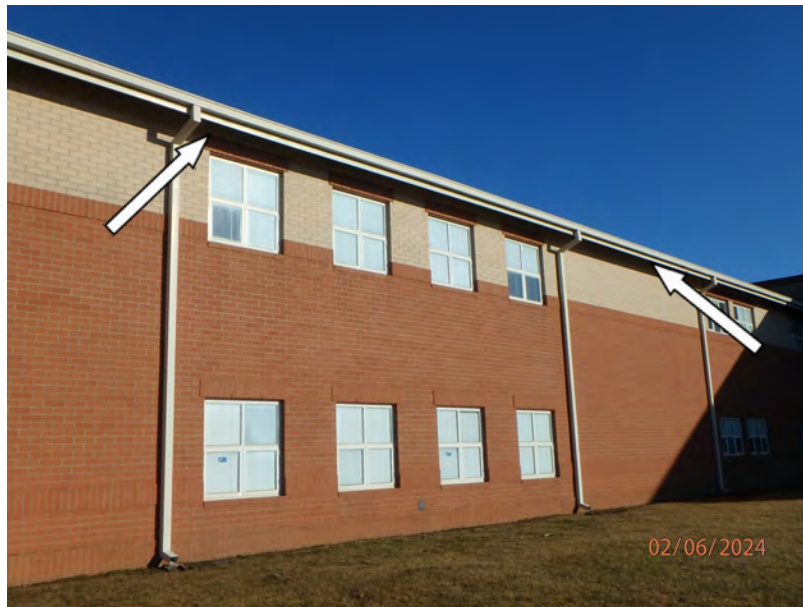
**Illustration #8**

- A. Thermal image indicates significant warm interior air exfiltration occurring through soffit detailing at the roof-to-wall transition.

- B. Photograph indicates area in which above thermal image was recorded - High School, south elevation. See plan view drawing for location.

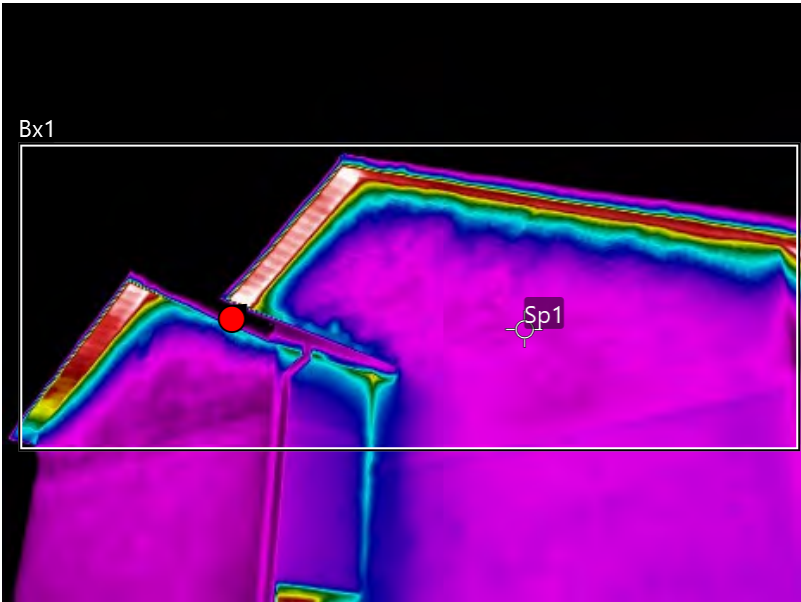
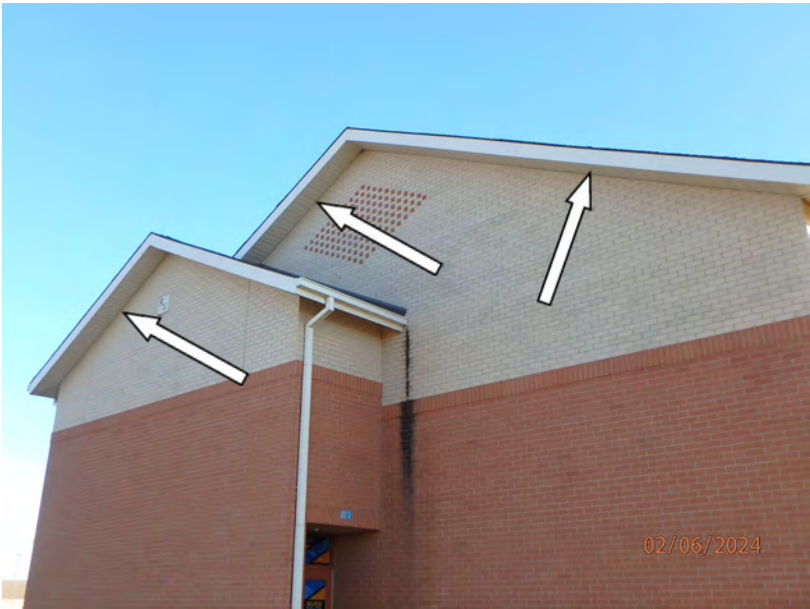
Illustration #9

A. Thermal image indicates significant warm interior air exfiltration occurring through soffit detailing at the roof-to-wall transition.

B. Photograph indicates area in which above thermal image was recorded - High School, west elevation. See plan view drawing for location.

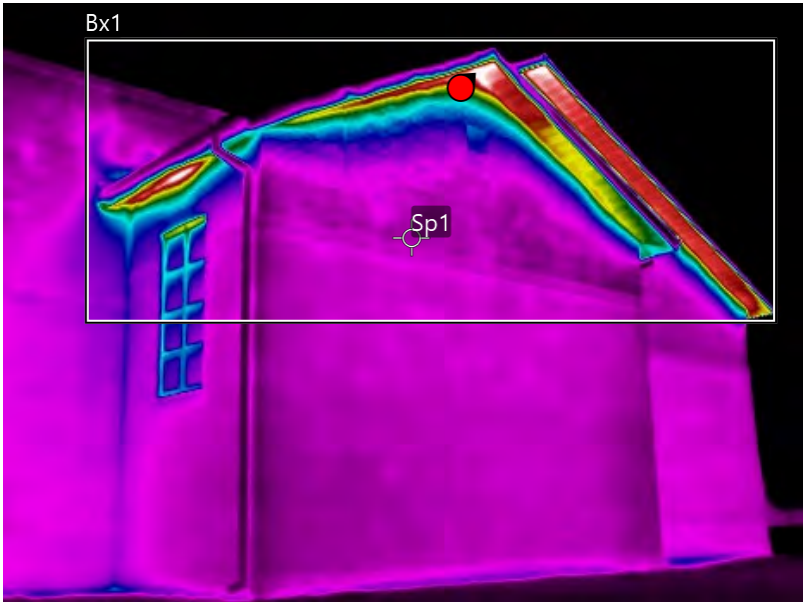
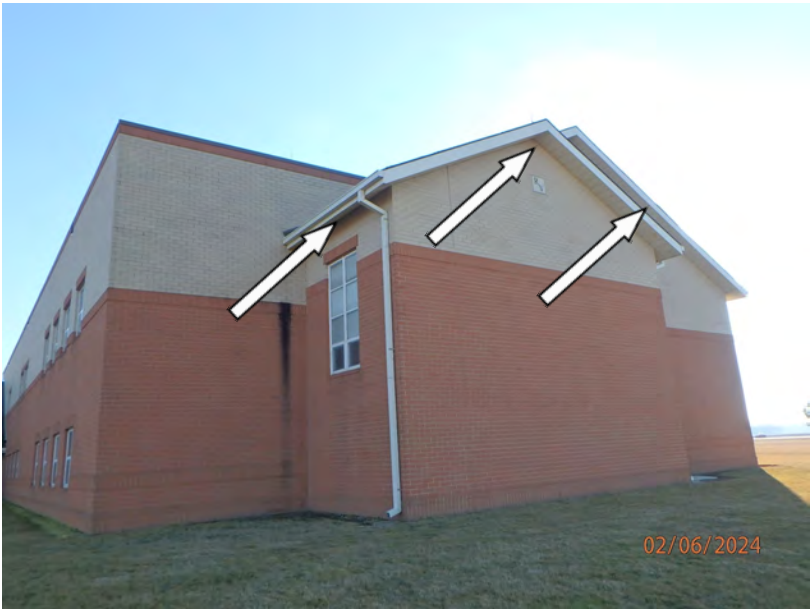
Illustration #10

A. Thermal image indicates significant warm interior air exfiltration occurring through soffit detailing at the roof-to-wall transition.

B. Photograph indicates area in which above thermal image was recorded - High School, west elevation. See plan view drawing for location.

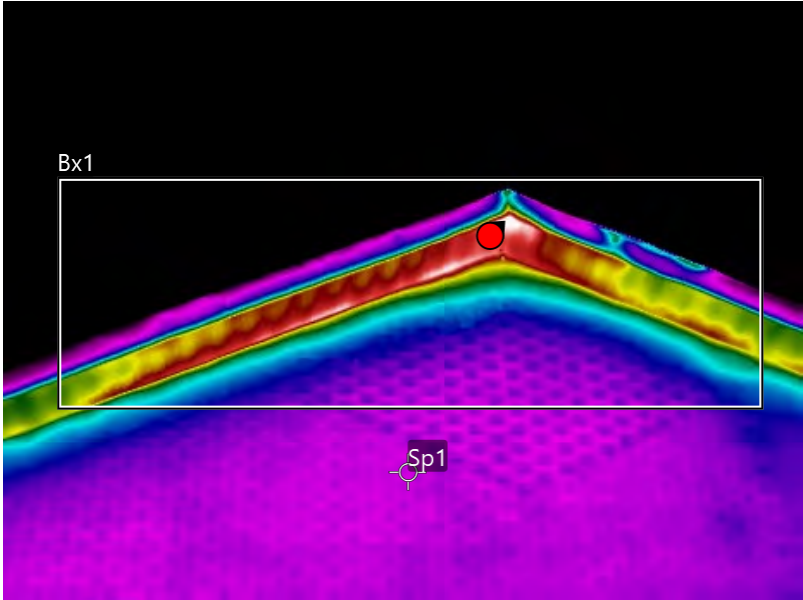
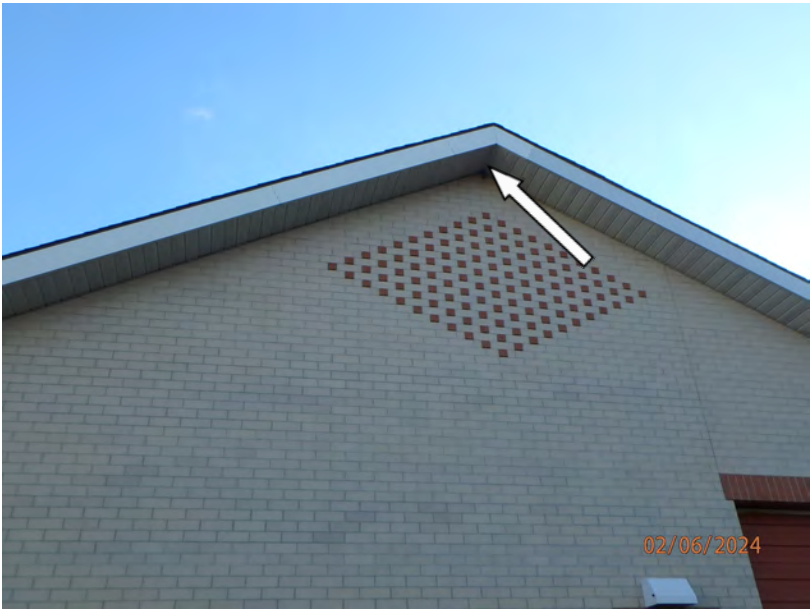
Illustration #11

A. Thermal image indicates significant warm interior air exfiltration occurring through soffit detailing at the roof-to-wall transition.

B. Photograph indicates area in which above thermal image was recorded - High School, west elevation. See plan view drawing for location.

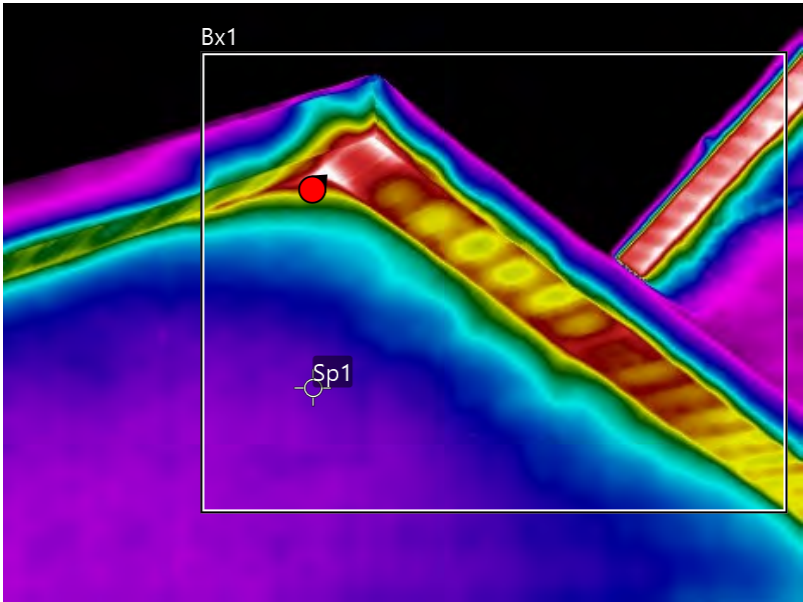
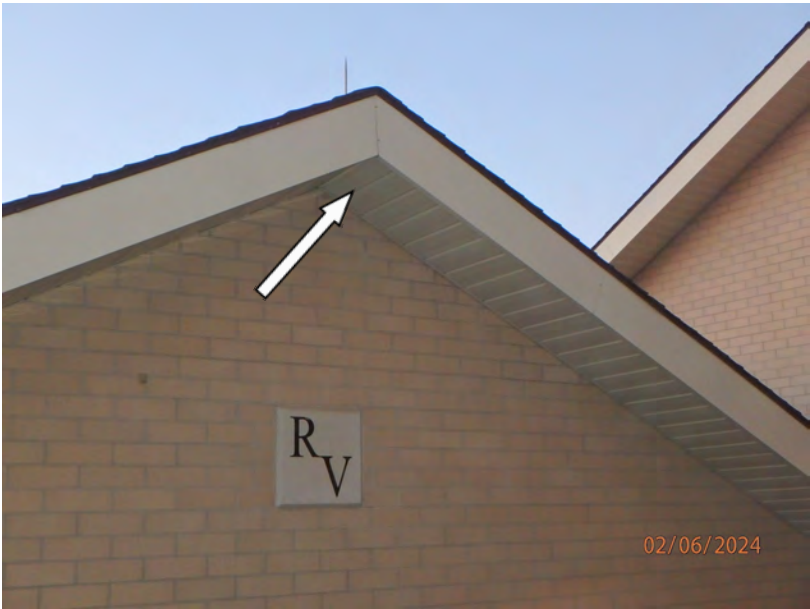
Illustration #12

A. Thermal image indicates significant warm interior air exfiltration occurring through soffit detailing at the roof-to-wall transition.

B. Photograph indicates area in which above thermal image was recorded - High School, north elevation. See plan view drawing for location.

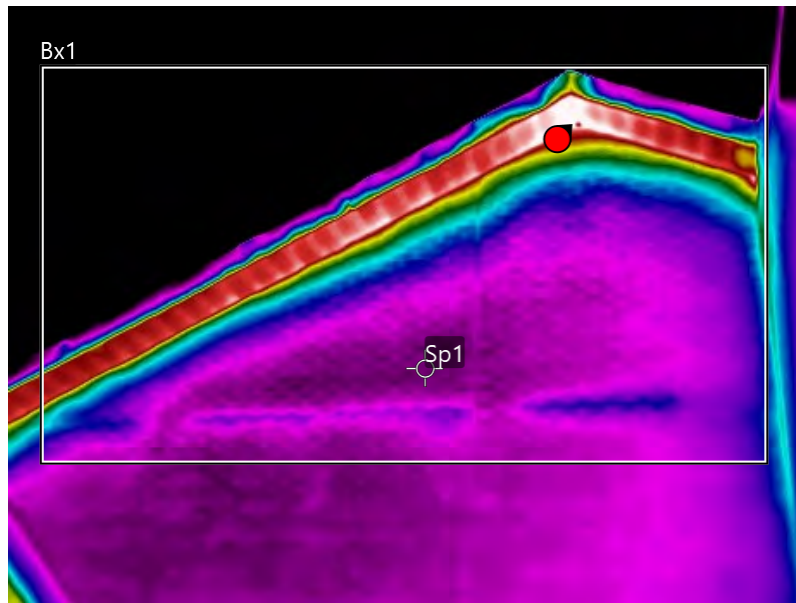
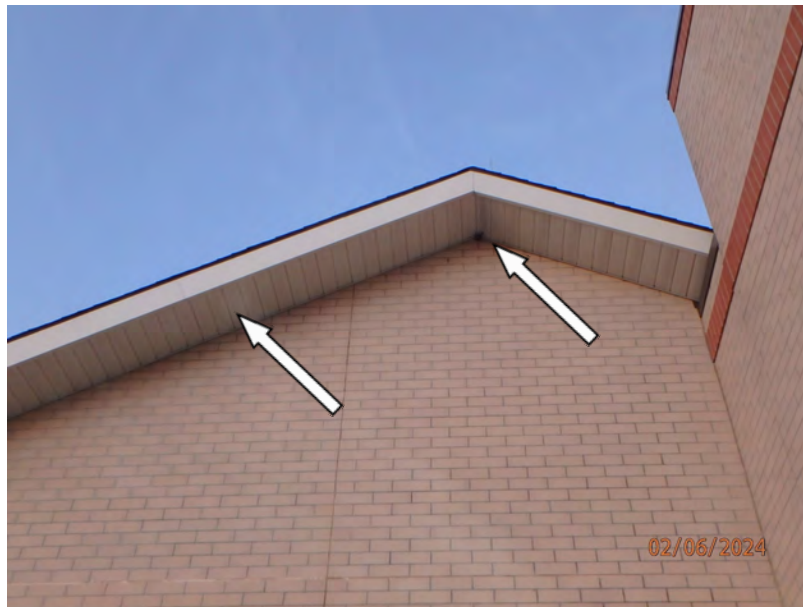
Illustration #13

- A. Thermal image indicates significant warm interior air exfiltration occurring through soffit detailing at the roof-to-wall transition.

- B. Photograph indicates area in which above thermal image was recorded - High School, east elevation. See plan view drawing for location.

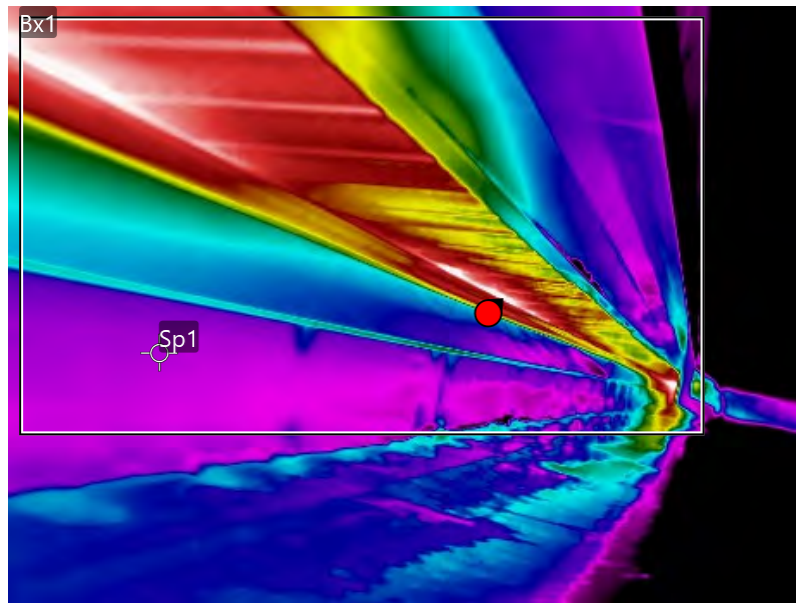
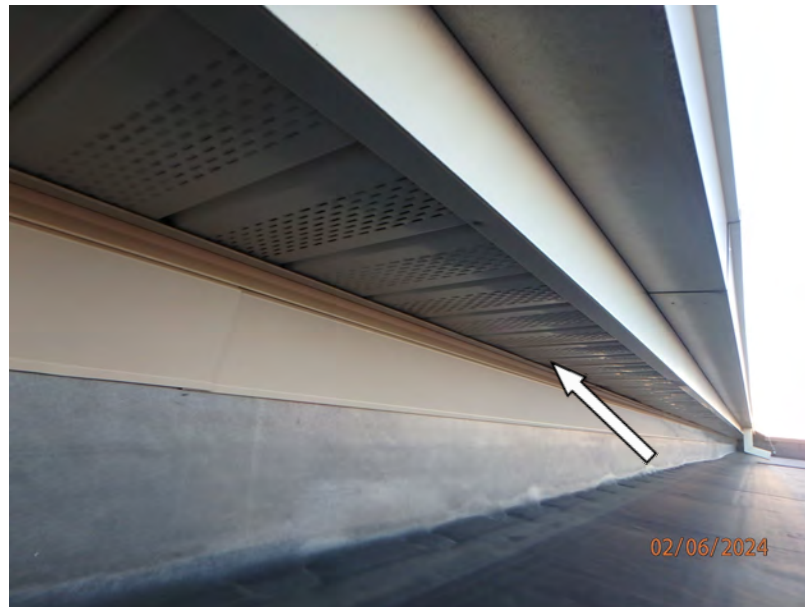
**Illustration #14**

- A. Thermal image indicates significant warm interior air exfiltration occurring through soffit detailing at the roof-to-wall transition.

- B. Photograph indicates area in which above thermal image was recorded - High School, west elevation. See plan view drawing for location.

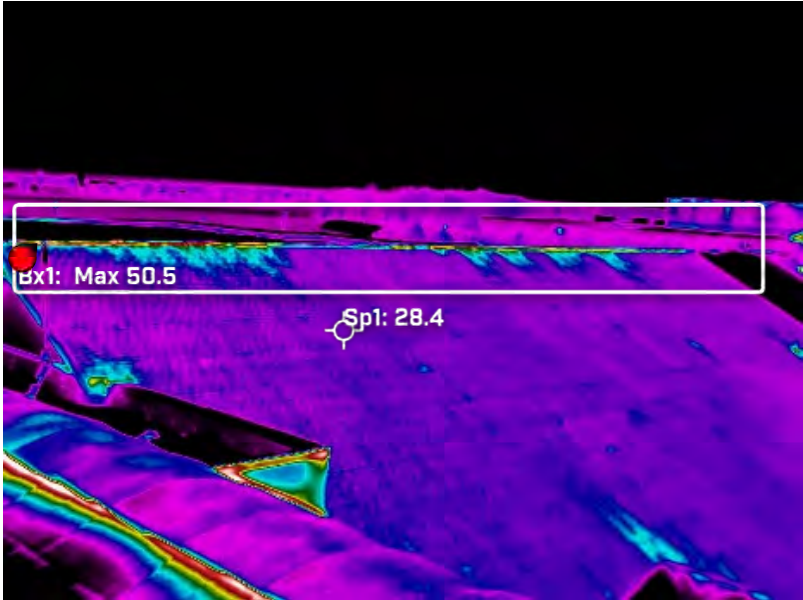
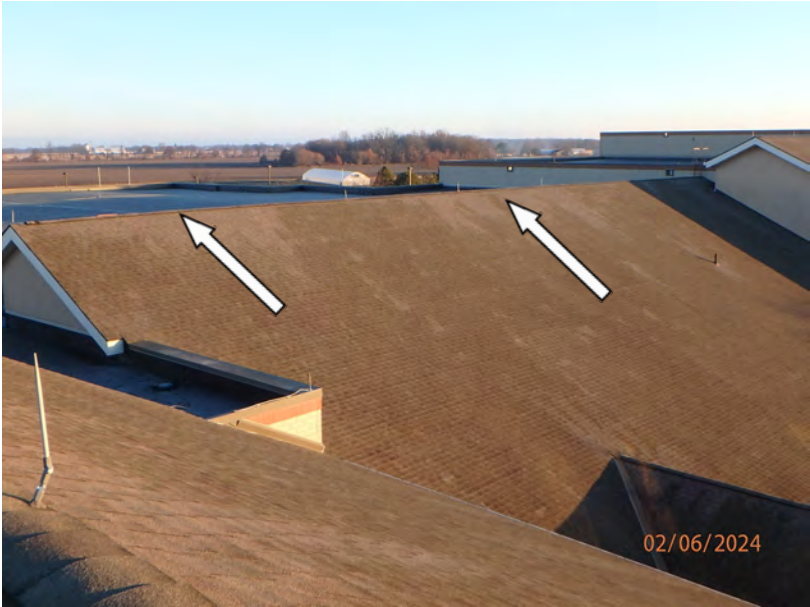
Illustration #15

A. Thermal image indicates significant warm interior air exfiltration occurring through soffit detailing at the roof-to-wall transition.

B. Photograph indicates area in which above thermal image was recorded - High School, south elevation. See plan view drawing for location.

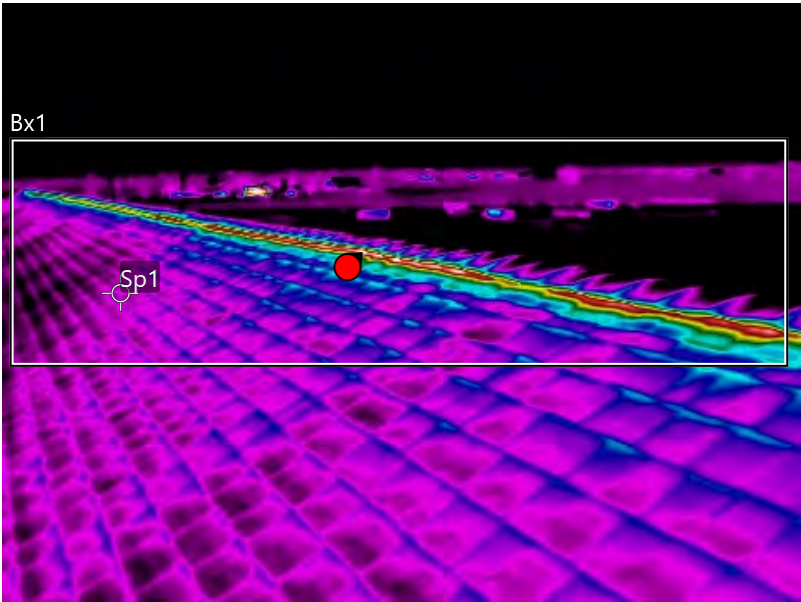
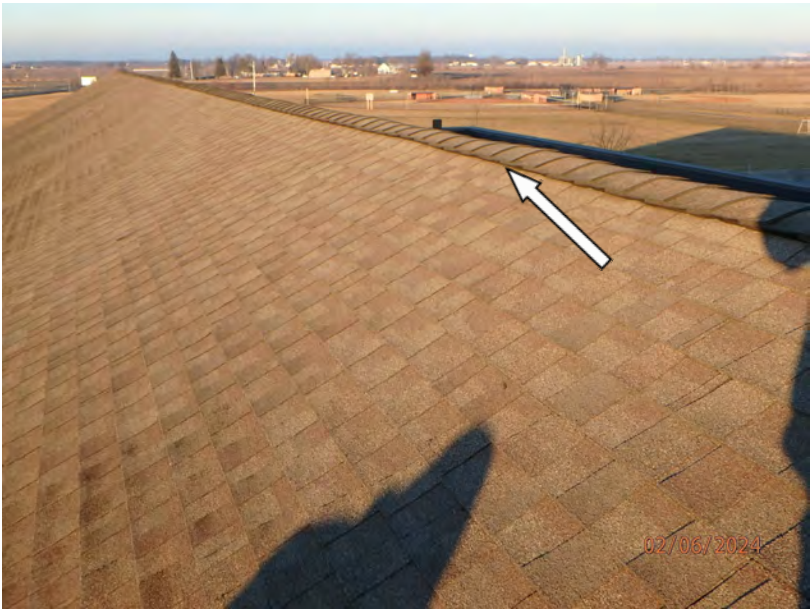
Illustration #16

A. Thermal image indicates significant warm interior air exfiltration occurring through soffit detailing at the roof-to-wall transition.

B. Photograph indicates area in which above thermal image was recorded - High School, south elevation. See plan view drawing for location.

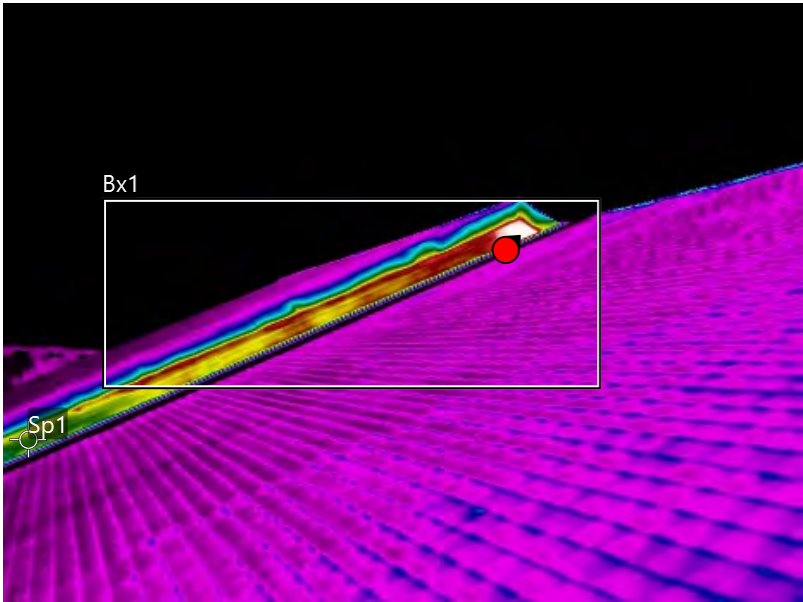
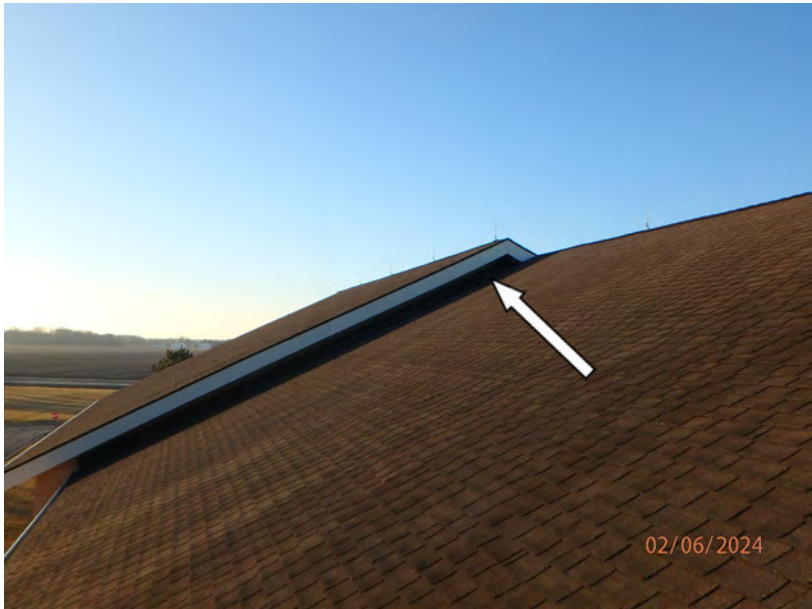
Illustration #17

A. Thermal image indicates significant warm interior air exfiltration occurring through soffit detailing at the roof-to-wall transition.

B. Photograph indicates area in which above thermal image was recorded - High School, north elevation. See plan view drawing for location.

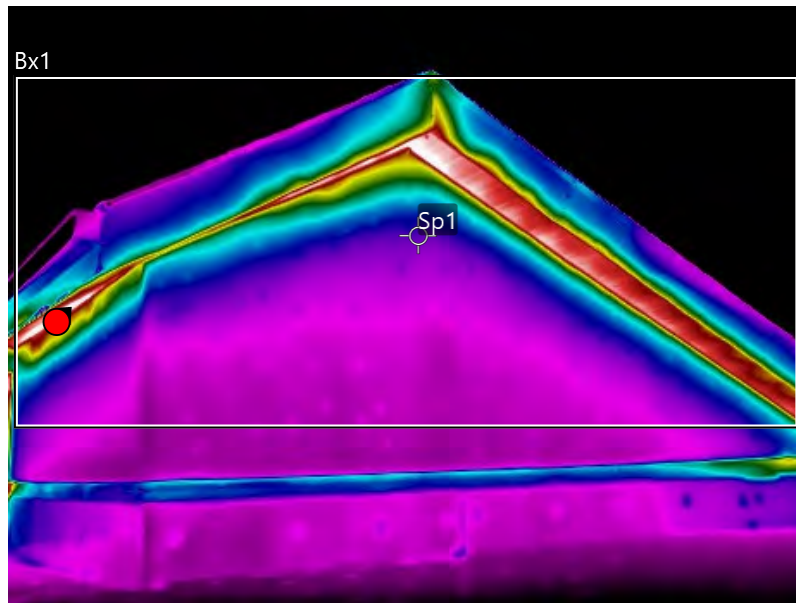
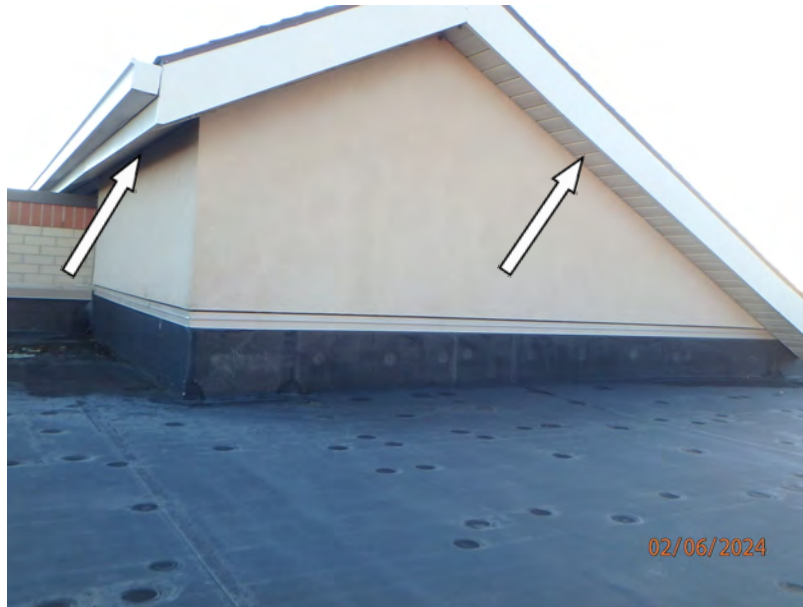
Illustration #18

- A. Thermal image indicates significant warm interior air exfiltration occurring through soffit detailing at the roof-to-wall transition.

- B. Photograph indicates area in which above thermal image was recorded - High School, west elevation. See plan view drawing for location.

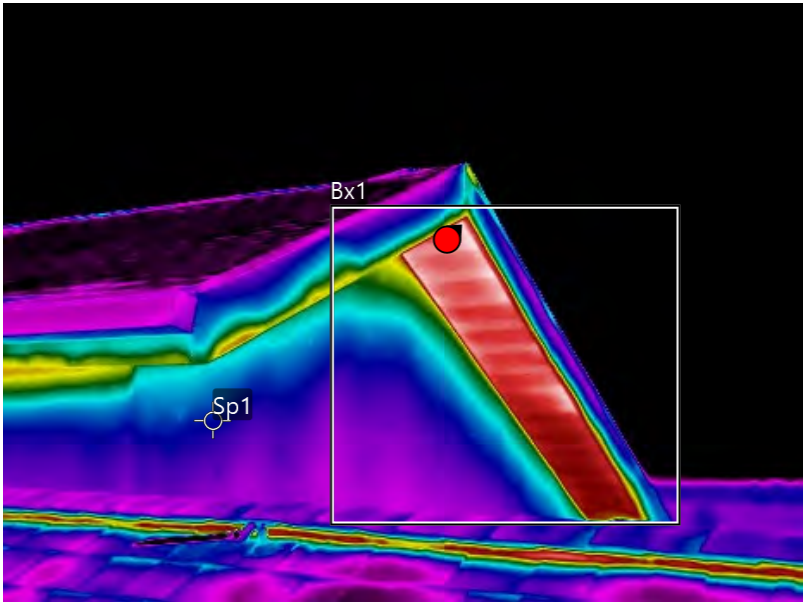
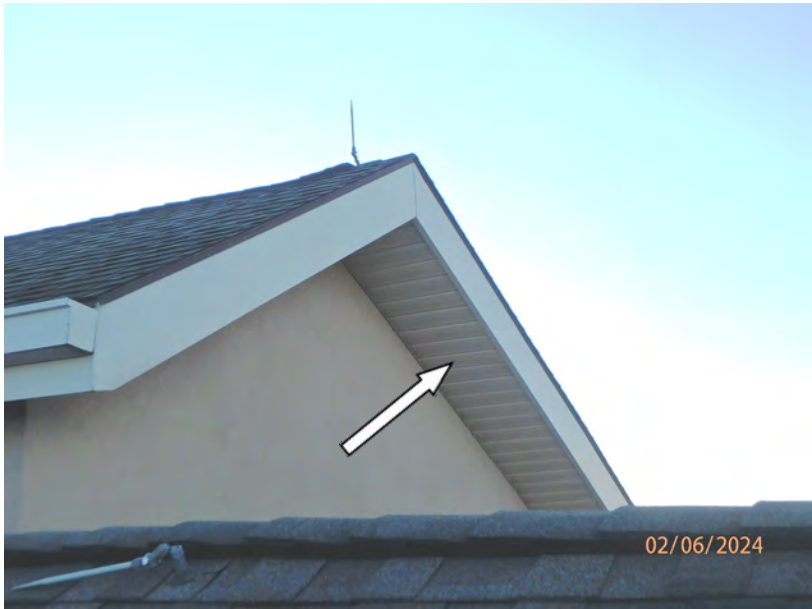
Illustration #19

A. Thermal image indicates significant warm interior air exfiltration occurring through soffit detailing at the roof-to-wall transition.

B. Photograph indicates area in which above thermal image was recorded - High School, west elevation. See plan view drawing for location.

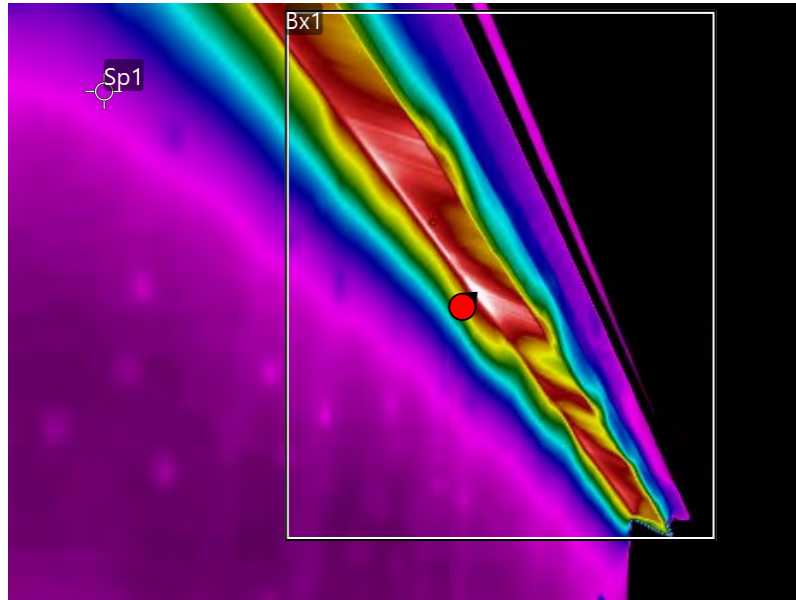
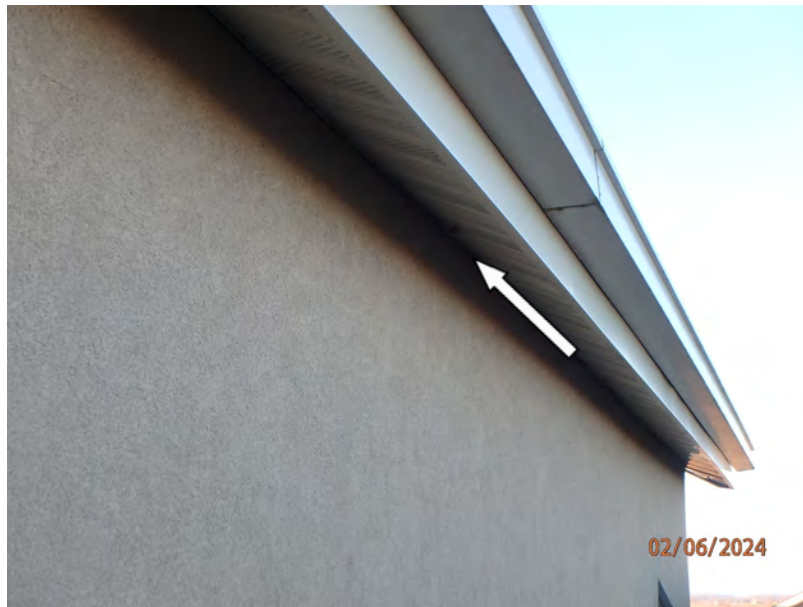
**Illustration #20**

- A. Thermal image indicates significant warm interior air exfiltration occurring through soffit detailing at the roof-to-wall transition.

- B. Photograph indicates area in which above thermal image was recorded - High School, north elevation. See plan view drawing for location.

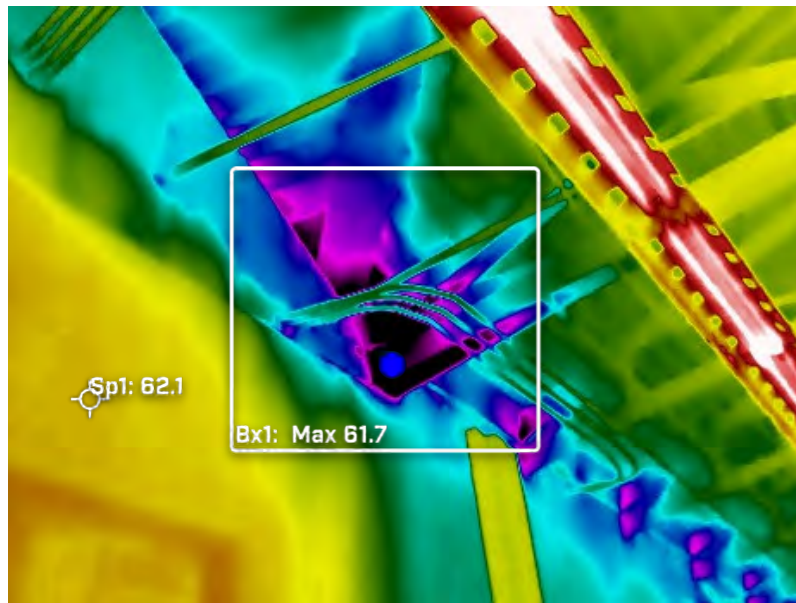
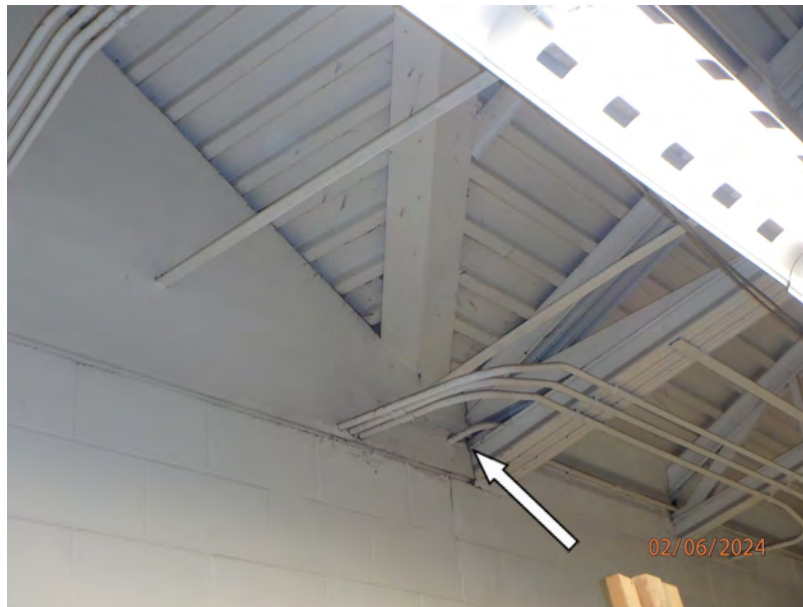
**Illustration #21**

- A. Thermal image indicates significant cold exterior air infiltration occurring at roof-to-wall transition detailing.

- B. Photograph indicates area in which above thermal image was recorded - High School, VO-AG Lab, south elevation wall. See plan view drawing for location.

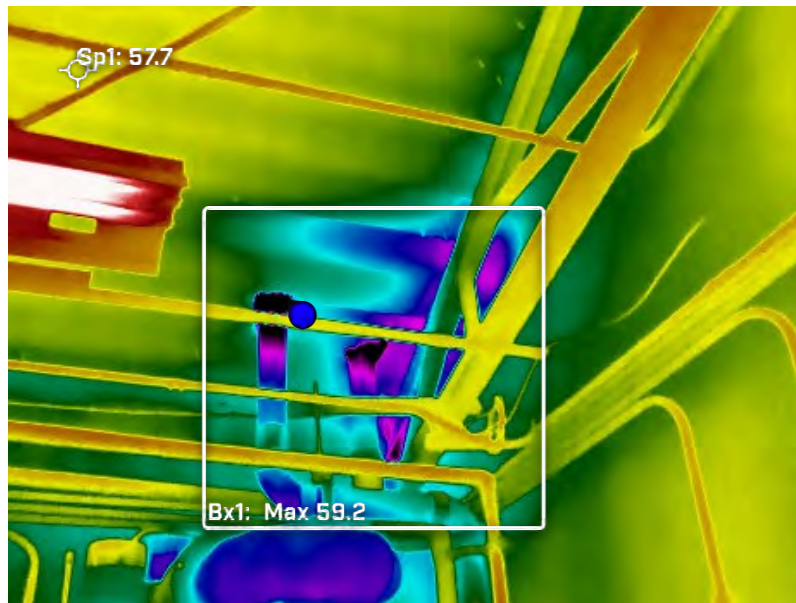
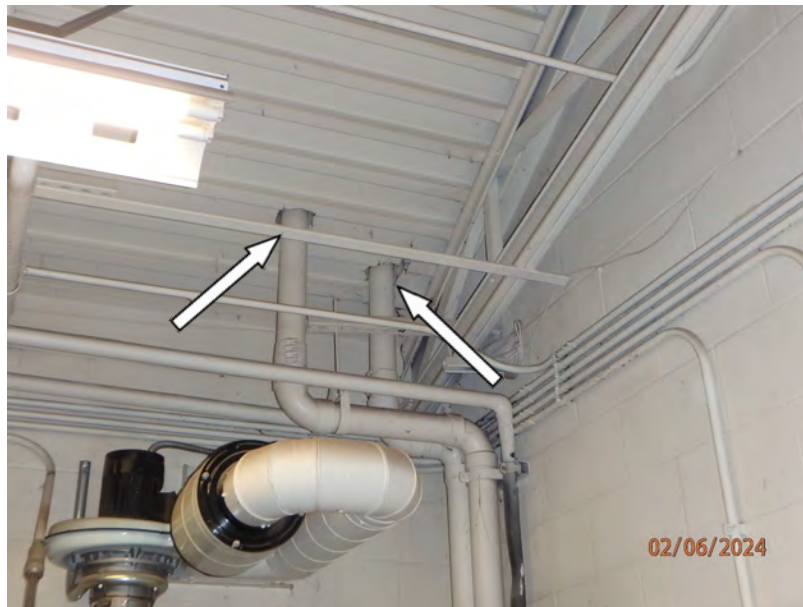
**Illustration #22**

- A. Thermal image indicates significant cold interior air infiltration occurring at through-roof pipe penetrations.

- B. Photograph indicates area in which above thermal image was recorded - High School, VO-AG Lab, southwest corner. See plan view drawing for location.
