PRELIMINARY ASSESSMENT  
RIVER VALLEY LOCAL SCHOOL DISTRICT  
ROOF REPLACEMENT PROJECT  
CALEDONIA, OHIO  
ISSUE DATE: 03-01-2024  
ROH50-001

Prepared by:  
Dan Lawrence, P.E., R.B.E.C.

**River Valley Local School District  
Roof Replacement  
Preliminary Assessment  
Caledonia, Ohio**

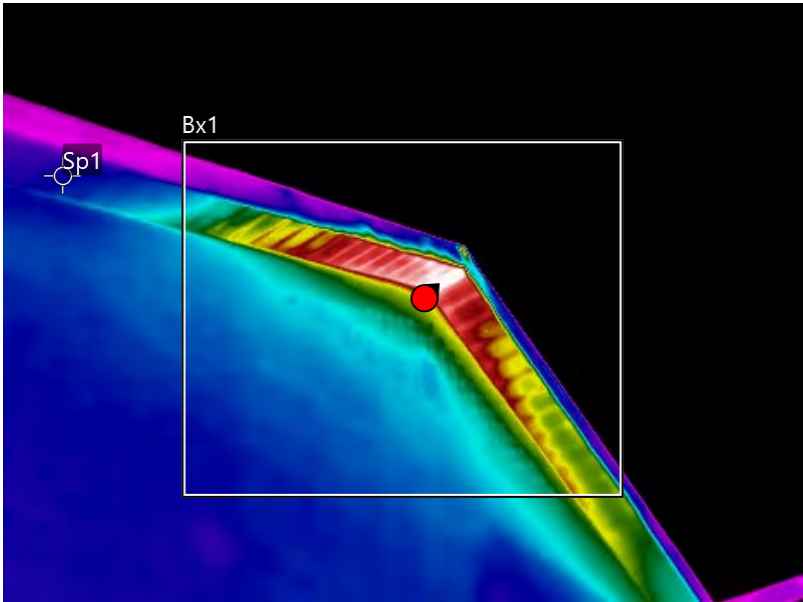
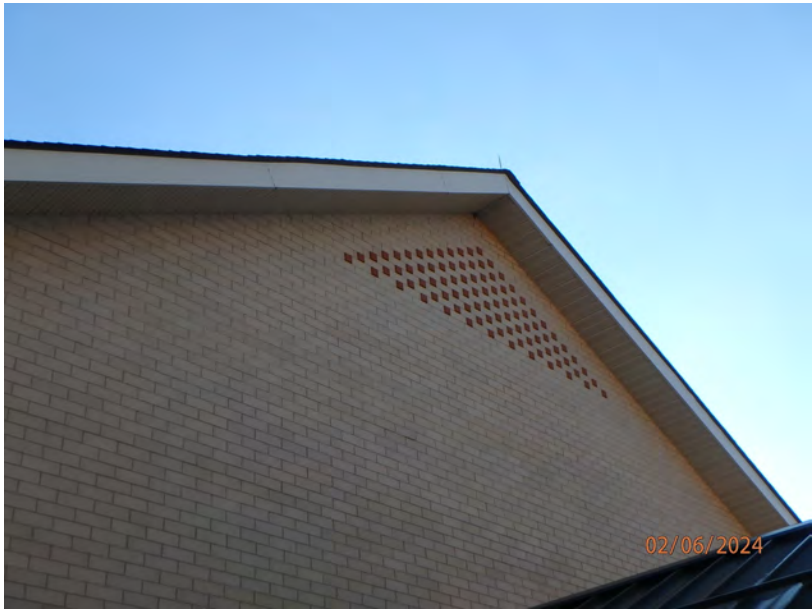
Illustration #1

A. Thermal image indicates significant warm interior air exfiltration occurring through soffit detailing at the roof-to-wall transition.

B. Photograph indicates area in which above thermal image was recorded - Middle School, west elevation. See plan view drawing for location.

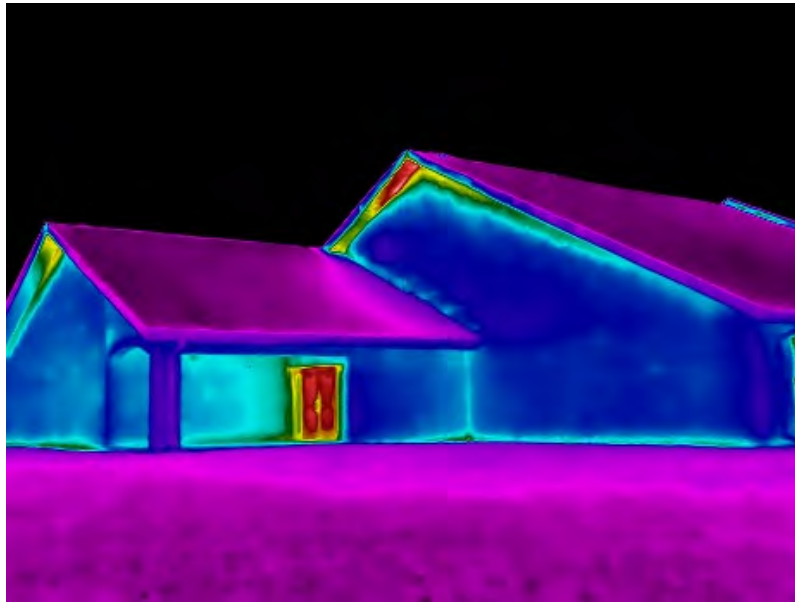
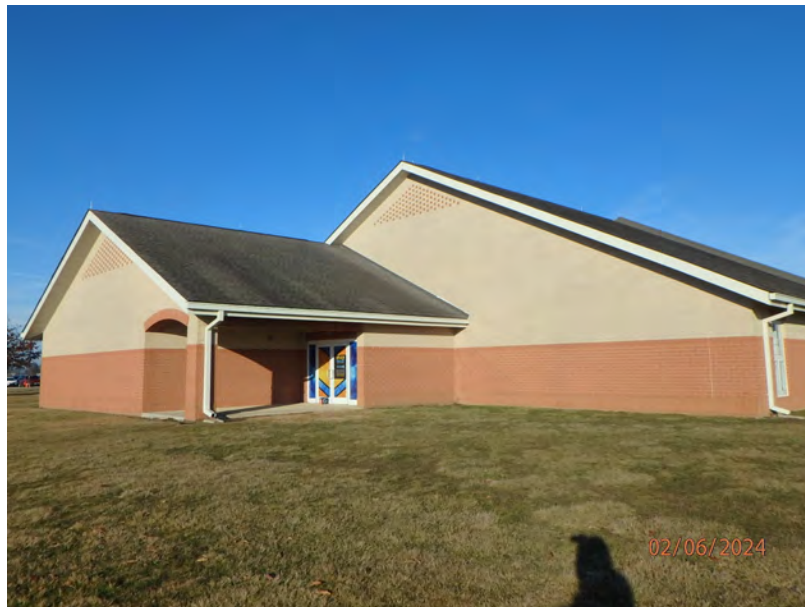
**Illustration #2**

- A. Thermal image indicates significant warm interior air exfiltration occurring through soffit detailing at the roof-to-wall transition.

- B. Photograph indicates area in which above thermal image was recorded - Middle School, south elevation. See plan view drawing for location.

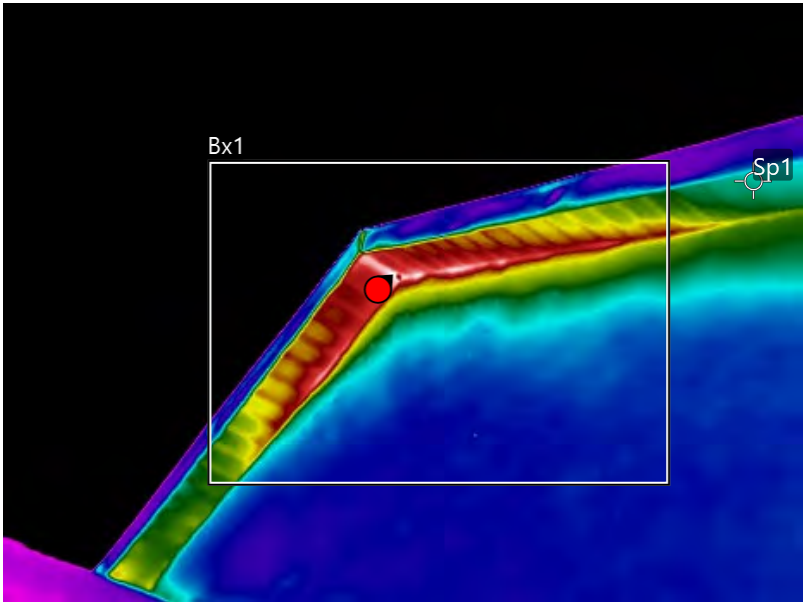
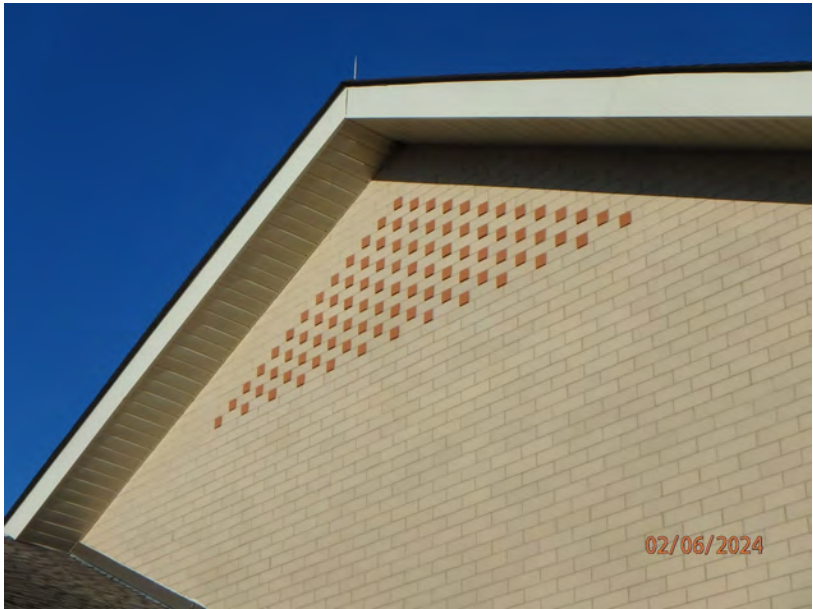
Illustration #3

A. Thermal image indicates significant warm interior air exfiltration occurring through soffit detailing at the roof-to-wall transition.

B. Photograph indicates area in which above thermal image was recorded - Middle School, south elevation. See plan view drawing for location.

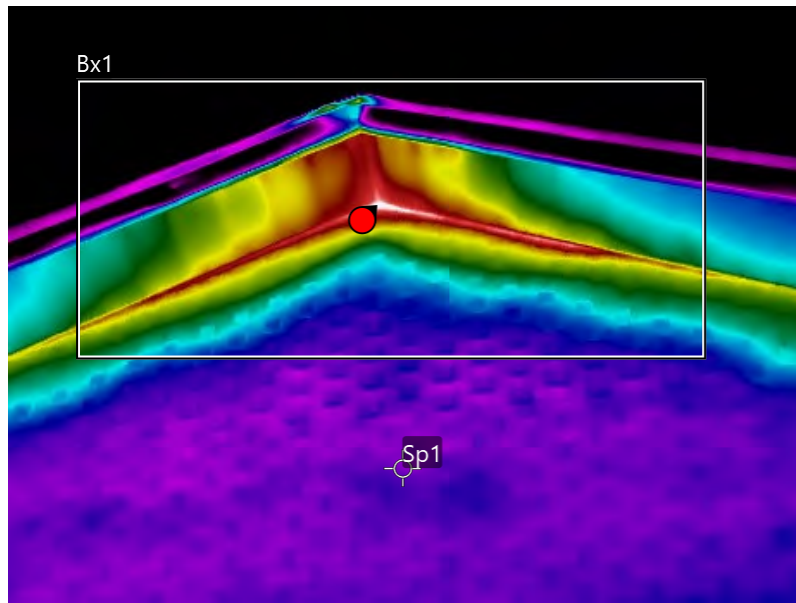
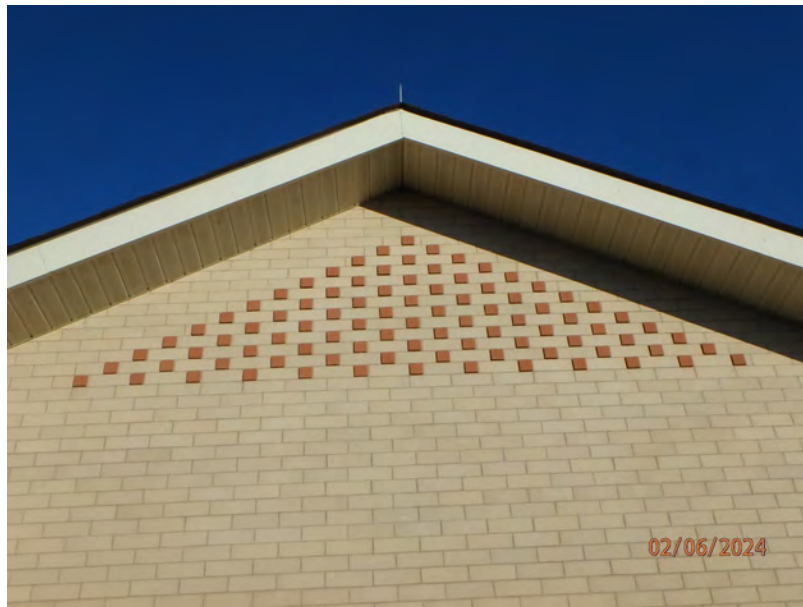
Illustration #4

- A. Thermal image indicates significant warm interior air exfiltration occurring through soffit detailing at the roof-to-wall transition.

- B. Photograph indicates area in which above thermal image was recorded - Middle School, south elevation. See plan view drawing for location.

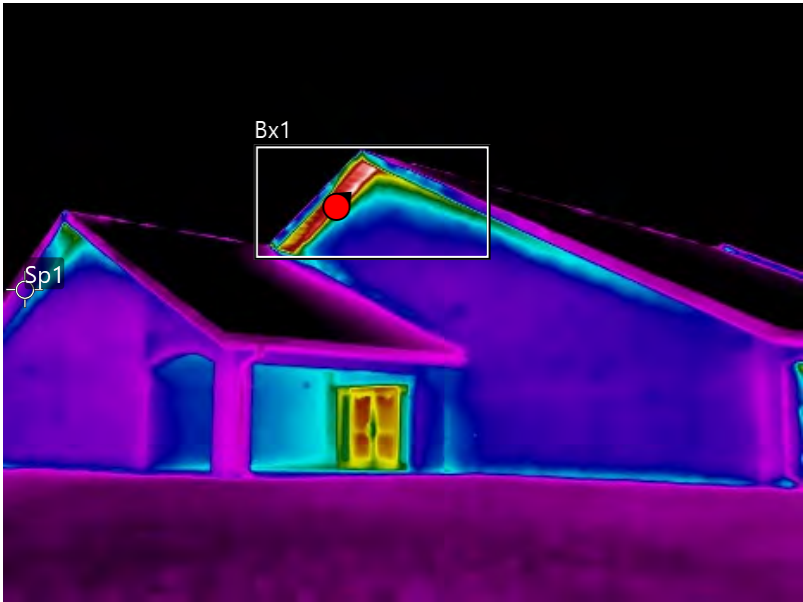
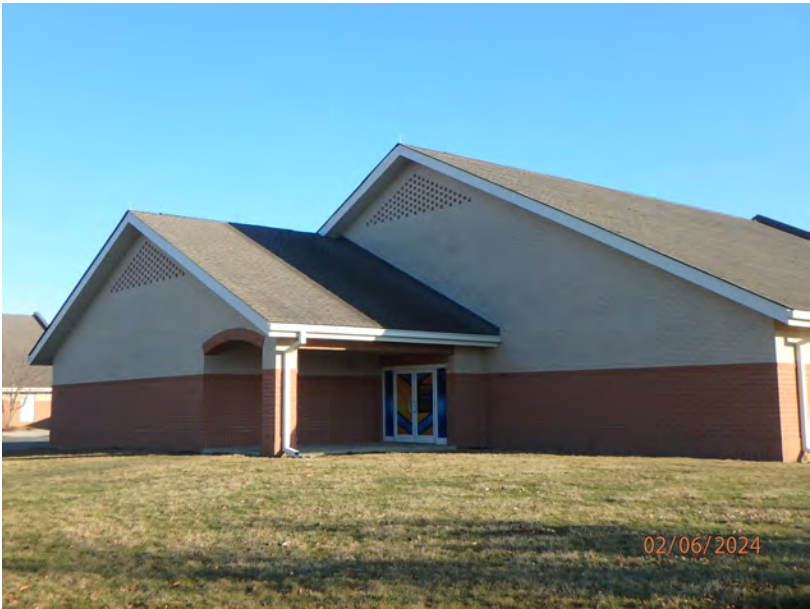
Illustration #5

A. Thermal image indicates significant warm interior air exfiltration occurring through soffit detailing at the roof-to-wall transition.

B. Photograph indicates area in which above thermal image was recorded - Middle School, west elevation. See plan view drawing for location.

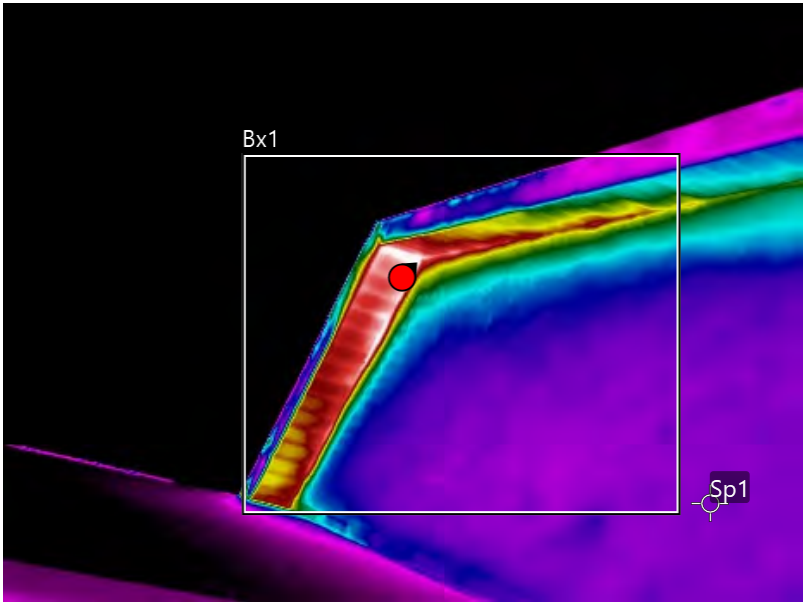
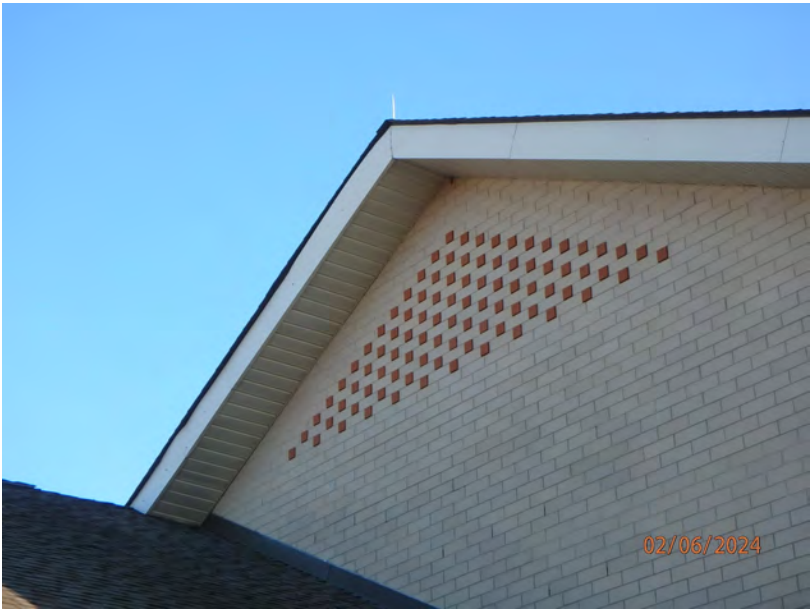
Illustration #6

A. Thermal image indicates significant warm interior air exfiltration occurring through soffit detailing at the roof-to-wall transition.

B. Photograph indicates area in which above thermal image was recorded - Middle School, west elevation. See plan view drawing for location.

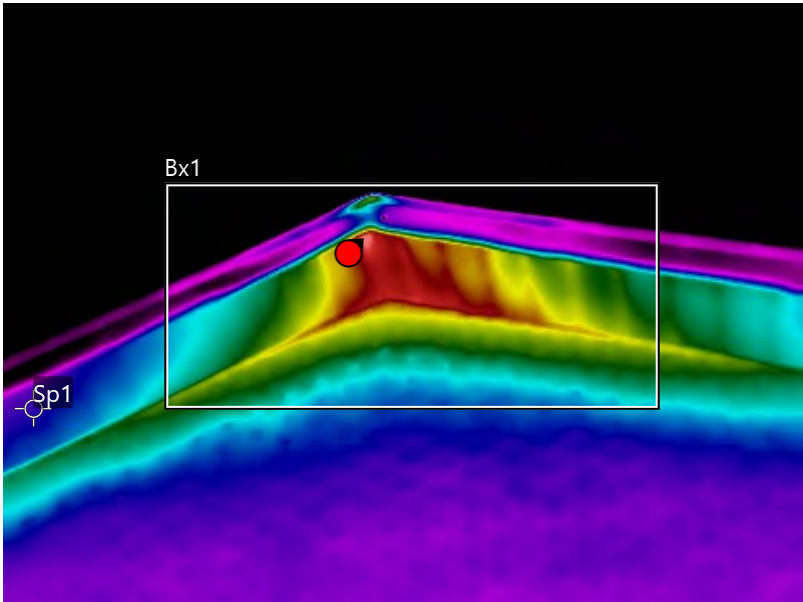
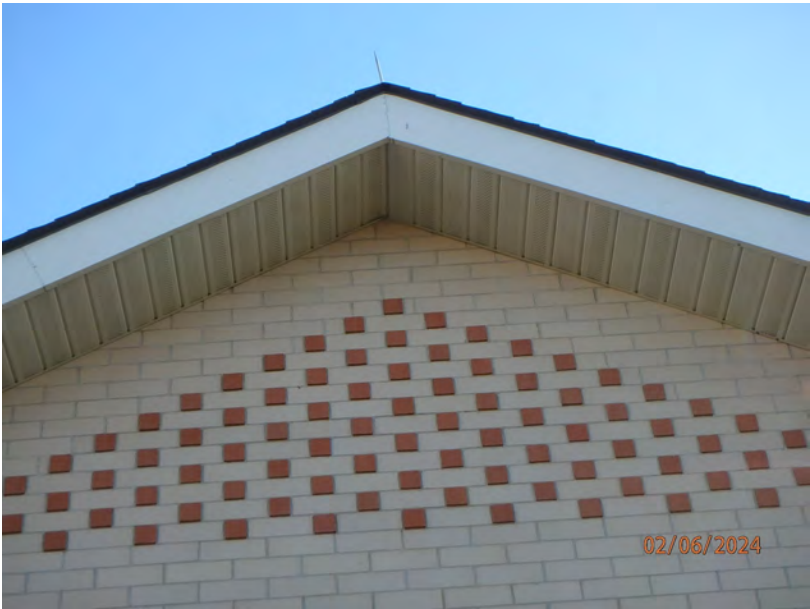
Illustration #7

A. Thermal image indicates significant warm interior air exfiltration occurring through soffit detailing at the roof-to-wall transition.

B. Photograph indicates area in which above thermal image was recorded - Middle School, west elevation. See plan view drawing for location.

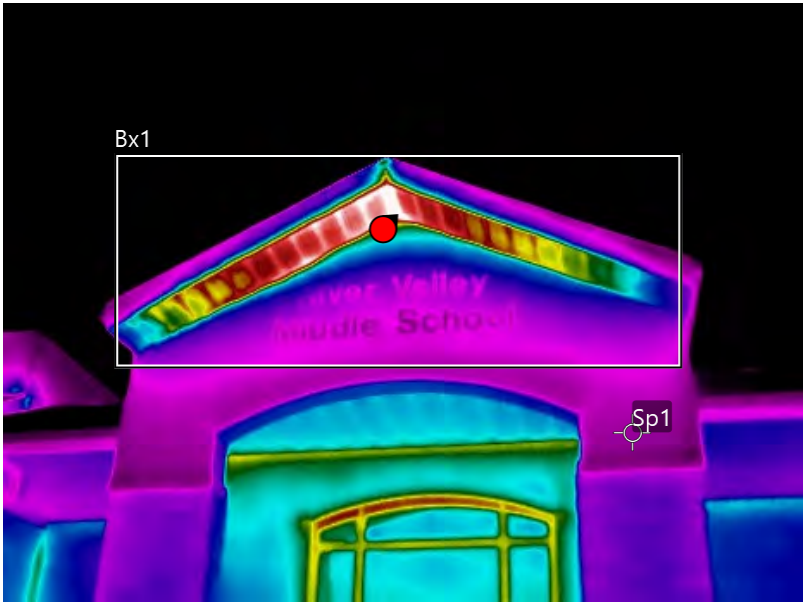
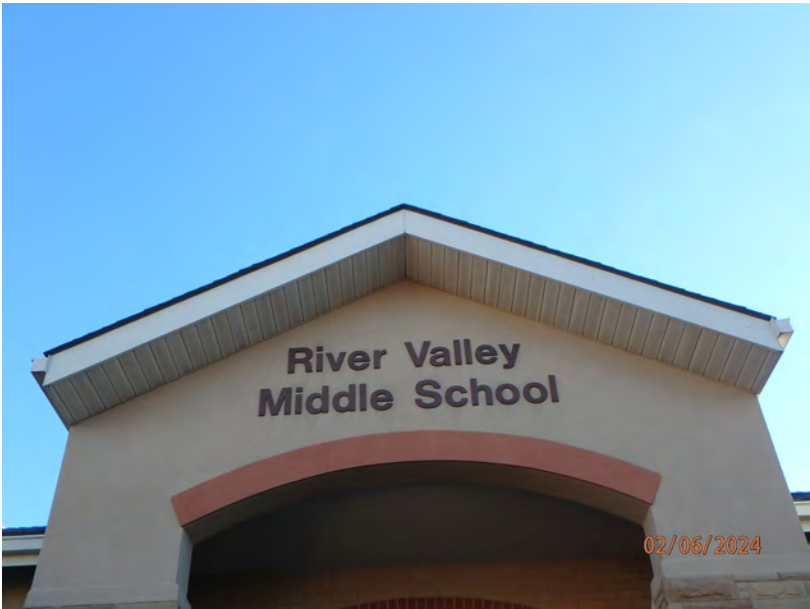
Illustration #8

A. Thermal image indicates significant warm interior air exfiltration occurring through soffit detailing at the roof-to-wall transition.

B. Photograph indicates area in which above thermal image was recorded - Middle School, west elevation. See plan view drawing for location.

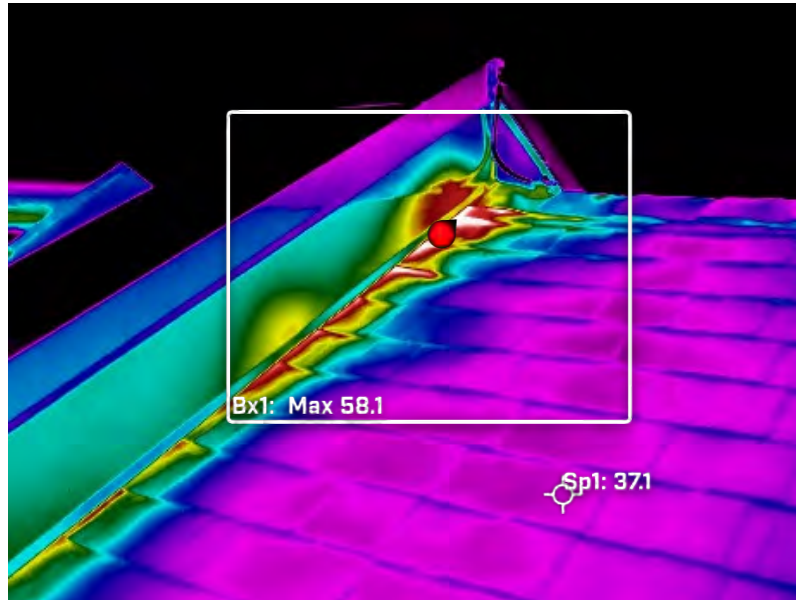
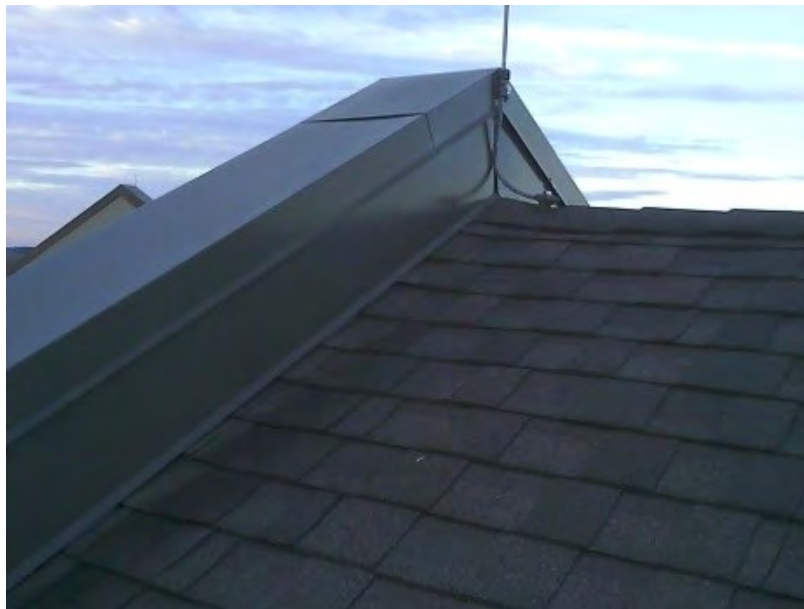
Illustration #9

- A. Thermal image indicates significant warm interior air exfiltration occurring at the roof-to-wall transition.

- B. Photograph indicates area in which above thermal image was recorded - Middle School. See plan view drawing for location.

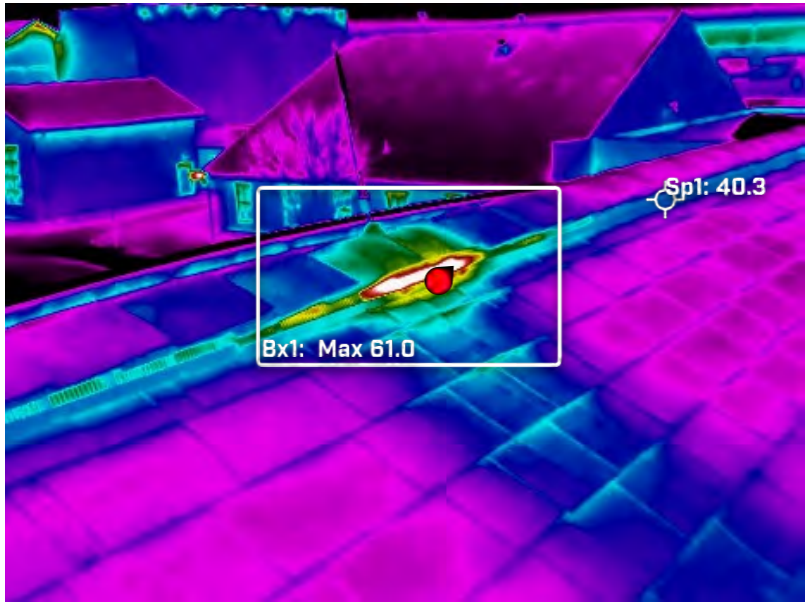
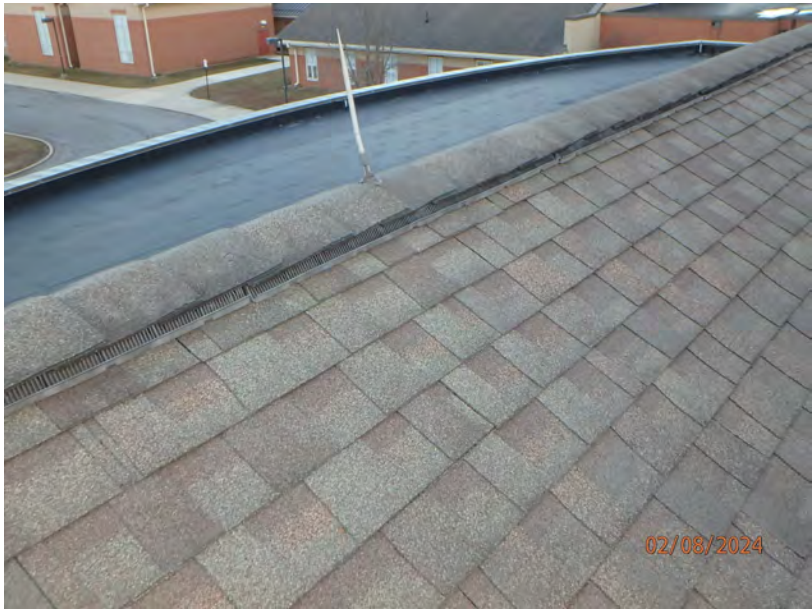
Illustration #10

A. Thermal image indicates significant warm interior air exfiltration occurring through ridge vent detailing.

B. Photograph indicates area in which above thermal image was recorded - Middle School. See plan view drawing for location.

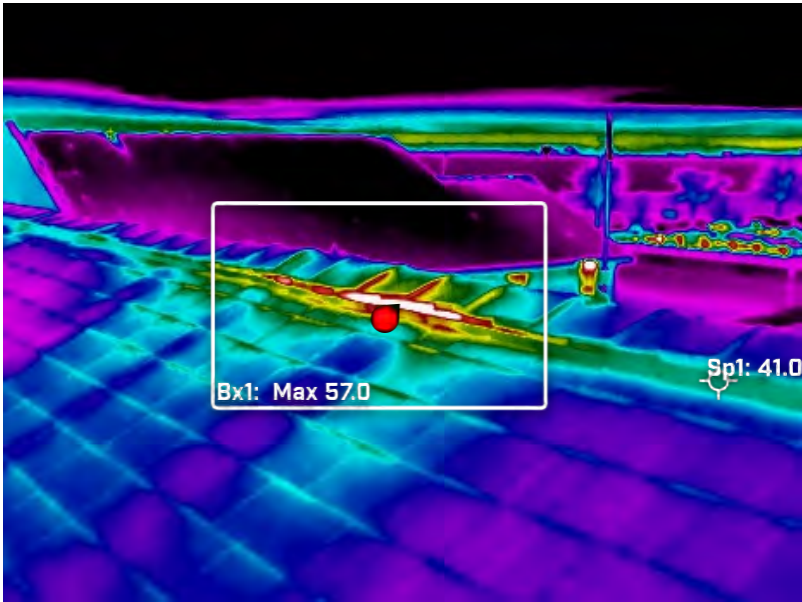
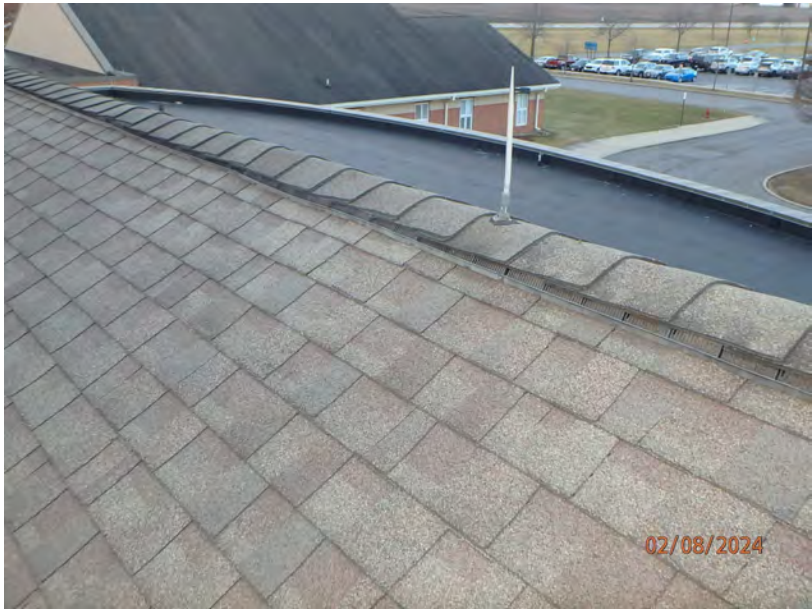
Illustration #11

A. Thermal image indicates significant warm interior air exfiltration occurring through ridge vent detailing.

B. Photograph indicates area in which above thermal image was recorded - Middle School. See plan view drawing for location.

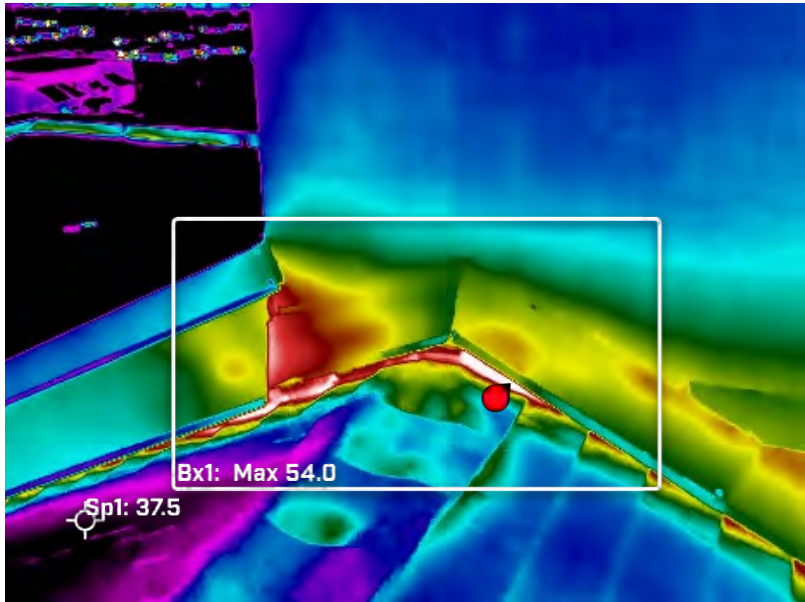
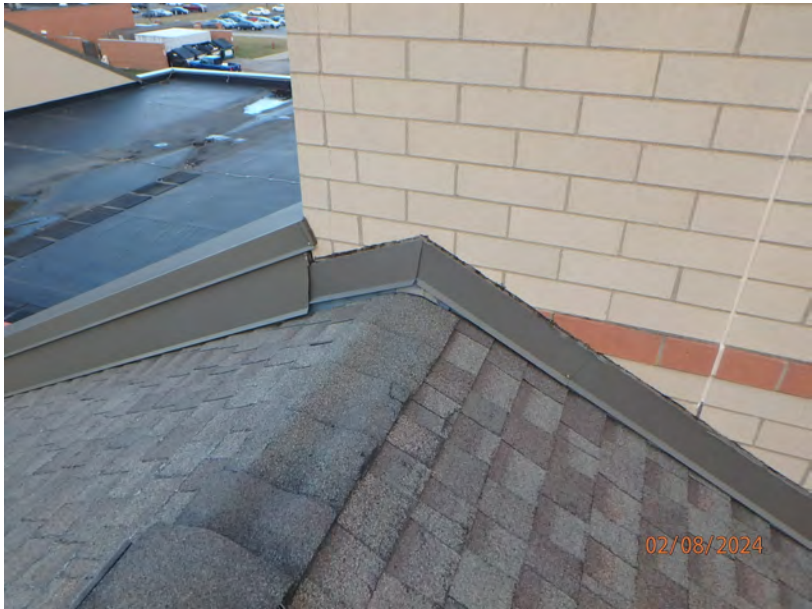
Illustration #12

A. Thermal image indicates significant warm interior air exfiltration occurring at the roof-to-wall transition.

B. Photograph indicates area in which above thermal image was recorded - Middle School. See plan view drawing for location.
