## 6 | Easterly Parkway Elementary School

<b>Address:</b>	234 Easterly Parkway State College, PA 16801
<b>Construction Timeline:</b>	Originally constructed in 1955; renovation/addition in 2002.
<b>Building Square Footage:</b>	55,895 sf
<b>Site Acreage:</b>	11.4 acres

Easterly Parkway Elementary School is a 2-story building located in State College Boro, State College, PA. The school currently houses grades K-5. The property is served by public water, sewer and natural gas.

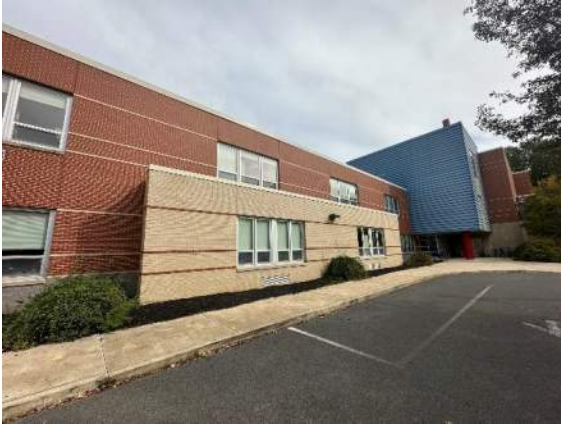
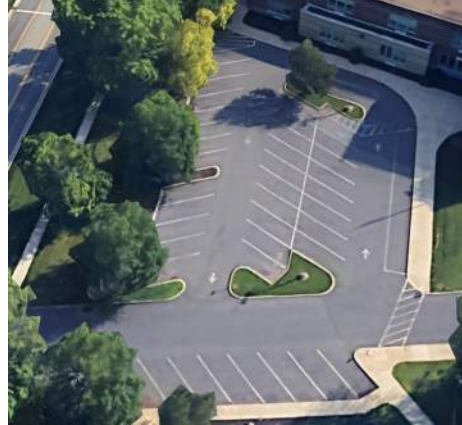
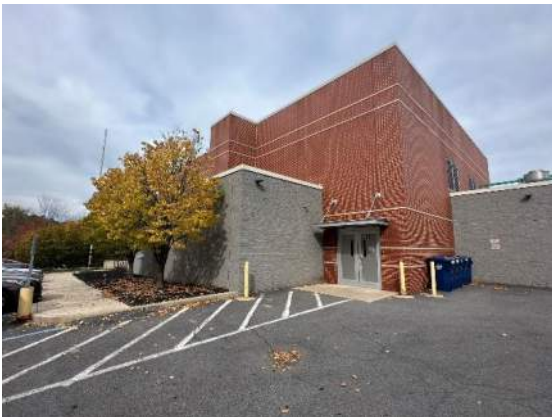
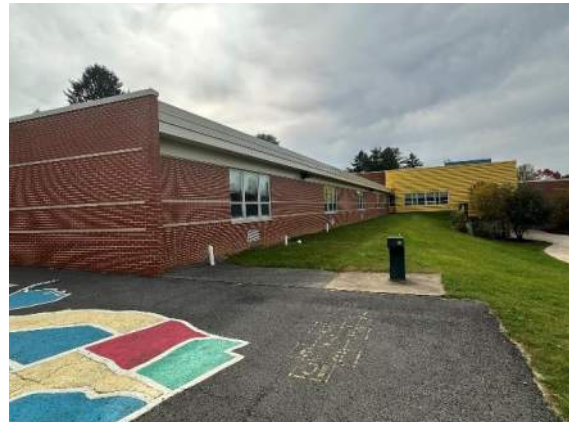
Some of the concrete walks are aging and starting to show signs of wear in that the aggregate (in the concrete) is beginning to show through to the outside surface. The concrete is also stained in many places. Cracking is occurring on some of the paved surfaces. Some of the games painted on the paved surfaces years ago are wearing off and hard to be used for the games they were intended.

- The short-term recommendation for paving is to apply a pourable sealer to the cracks, seal the paving, and repaint lines. The long-term recommendation is to a mill and overlay of existing paved surface and to provide a new wearing course with any new building project. The short-term recommendation for the concrete walks is to clean and remove stains and provide a sealer. The long-term recommendation is to replace the concrete with any new building project.

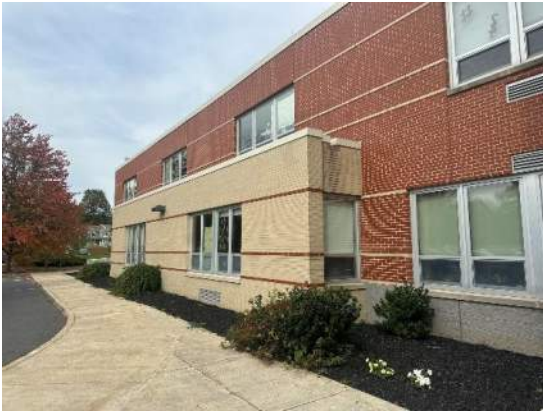
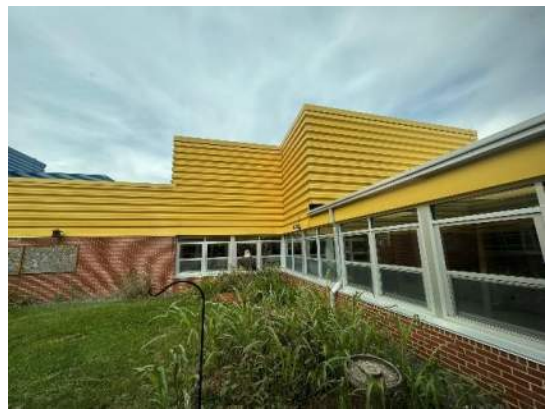
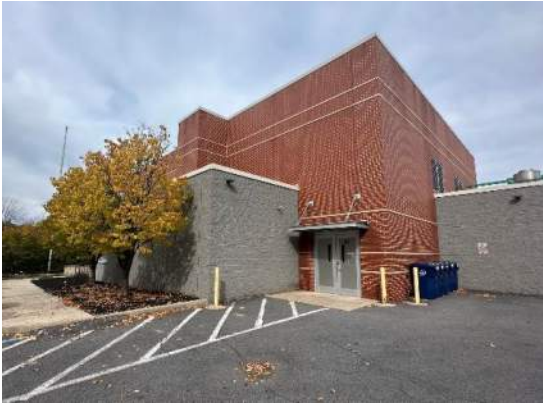
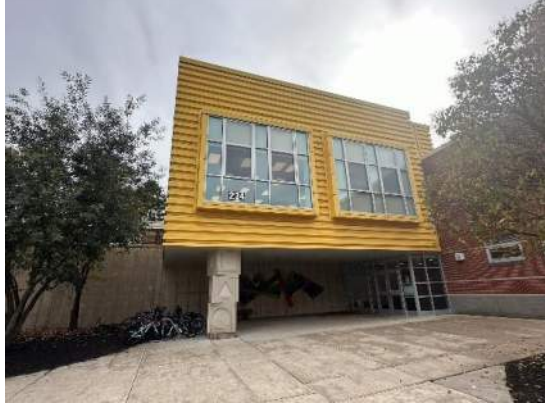
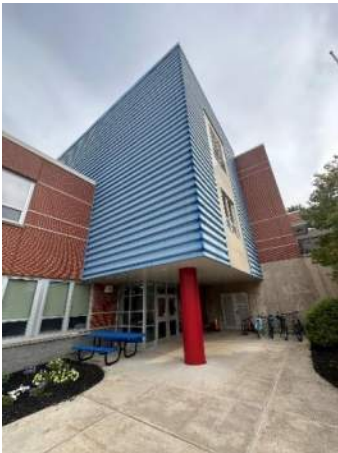
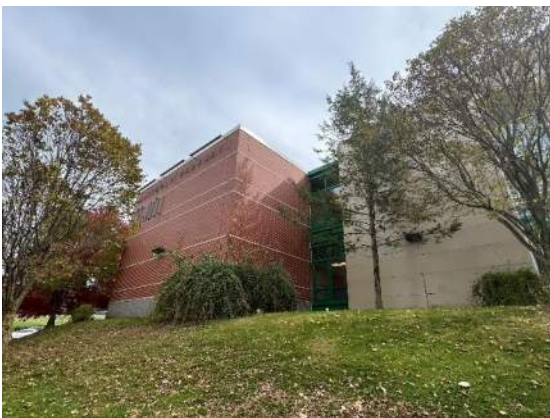
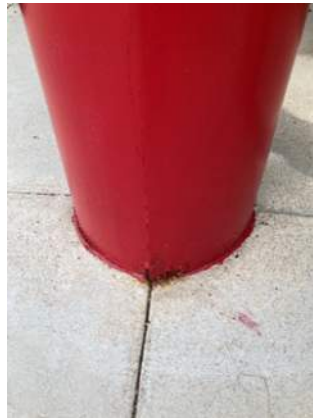
The building exterior consists of insulated masonry cavity walls with various brick and CMU veneers and CMU backup. Masonry walls are in very good condition with plenty of control joints located throughout the building envelope. There is some staining on the face brick below overflow scuppers where downspouts were not provided to collect the water. Windowsills are cast stone and in good condition, however some of the sills are becoming stained. Portions of the building are clad in various colors of corrugated metal wall panels as well as precast wall panels.

- General cleaning of brick veneer, cast stone sills, and precast and metal wall panel systems. May want to consider painting of metal wall panels where colors are beginning to fade or eventual replacement.. At precast wall panels, tuck point joints between panels and caulk.
- Metal column covers are beginning to deteriorate at the base where water tends to settle and wear through the paint finish. Consider patching column bases and re-painting.
- Monitor caulking at control joints and replace with any new building project.

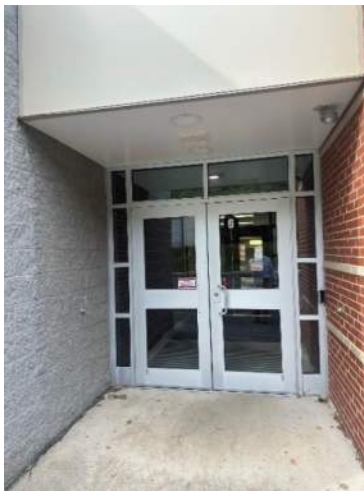
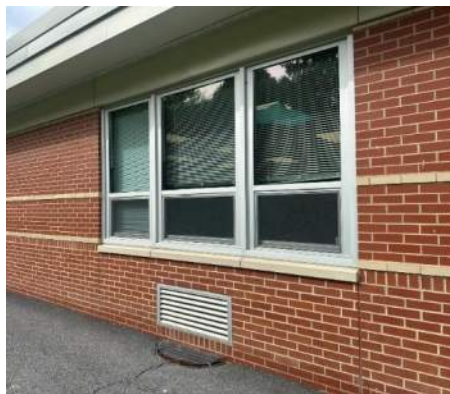
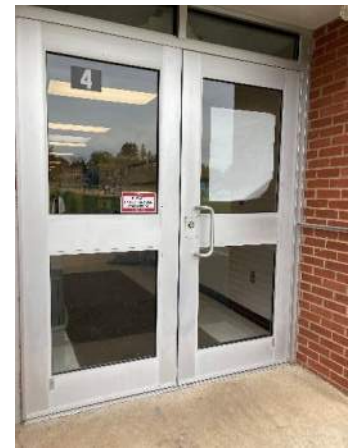
Windows are clear anodized and combination of operable (awning type) and fixed windows with window treatment mounted to the head of the opening. Entrances are also clear anodized aluminum storefront with the wide style door design. Aluminum is beginning to show signs of aging with discoloration.

- None at this time, however should consider replacement with any building renovation project, since they are coming to the end of their life expectancy, however they should easily operate for 10+ years longer if maintained correctly.

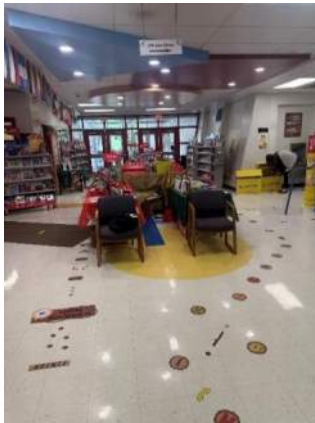
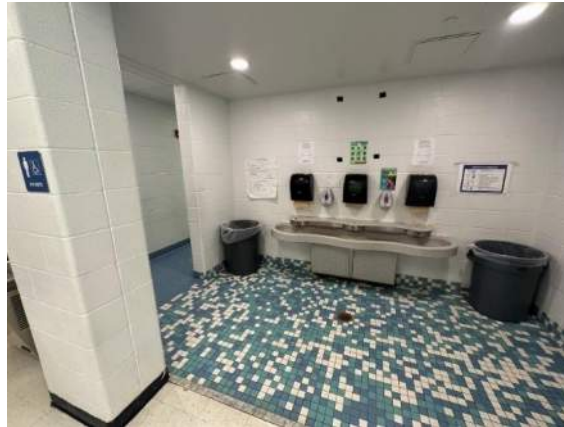
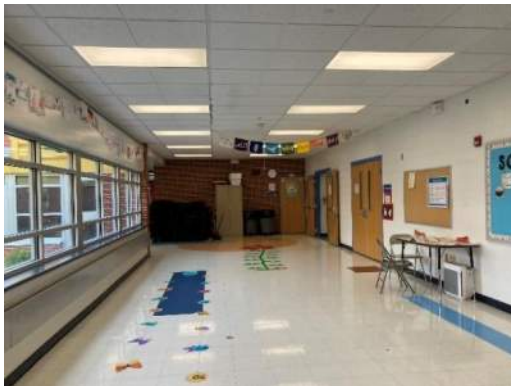
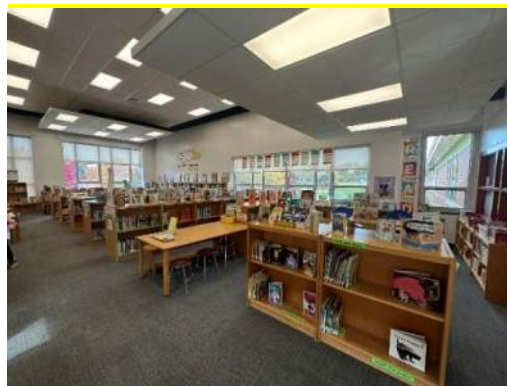
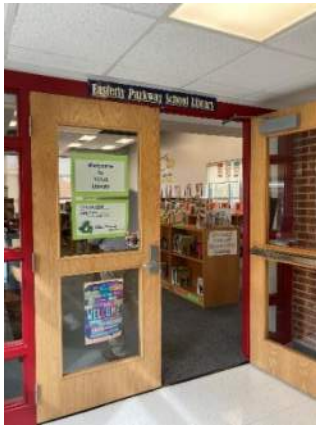
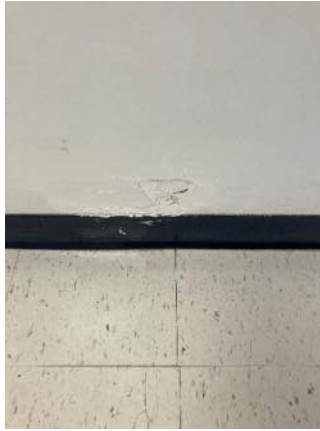
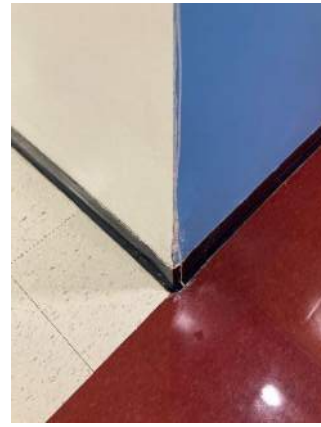
Interior walls are mainly painted CMU and are in good condition. There are areas of exposed brick which is also in good condition. There are also painted GWB partitions in areas where the carpet occurs. Those partitions could use some repair in selected areas and touch-up paint.

Acoustical ceilings throughout the building are in good condition. There are also painted GWB ceilings at the entrance to the group toilet room and other minimal selected areas and are also in good condition. Where GWB ceilings occur, access panels to access plumbing and HVAC items have been provided.

- Patch and repair GWB in-house over the summer or as part of a project.

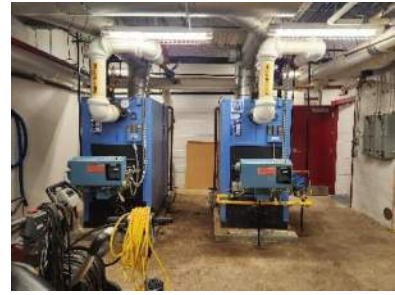
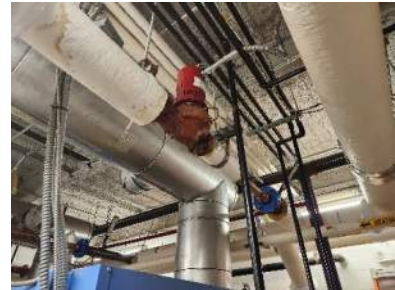
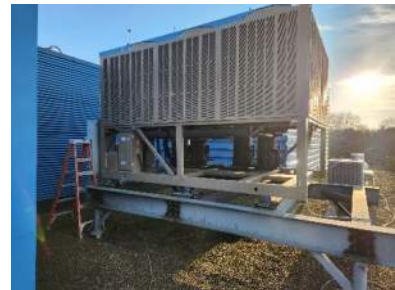
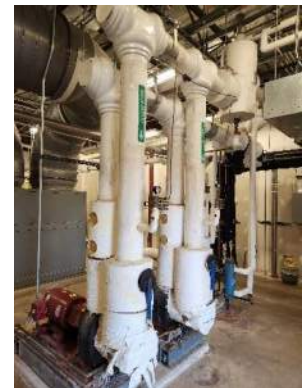
- Two Unilux flex tube boilers (2001) with gas fired burners develop heating hot water for the school. The boilers appear to be in good condition. The tube boilers are very serviceable as the tubes can be replaced in the event of failure.

- The Gordon Piatt burners appear to be in good to fair condition, but it is likely that they will need to be replaced in advance of the boilers. In addition, Gordon Piatt is no longer in business so parts can be difficult to obtain. Consideration should be given to replacing the burners in advance of any major failure to avoid significant downtime.

- Duplex hot water pumps circulate hot water throughout the school. These pumps were installed in 2001 and are in fair condition. They were running rough at the time of our site visit. The pumps do not have VFD's. If a motor were to fail, a replacement motor should be inverter duty for use with a VFD.

- Blend pumps on the boilers are original and in poor condition. While the motors have been replaced, the pump bodies are corroded. They should be replaced in the next few years.

- Duplex chilled water pumps circulate chilled water throughout the school. These pumps were installed in 2001 and are in fair condition. There is some corrosion and deterioration which appears to be a result of condensation from failed insulation. The extent of the corrosion was not able to be verified as the pump is covered with insulation. The pumps do not currently have VFD's. If replacement were to occur, the new pumps shall be inverter duty and include VFD's.

- The chilled water pipe insulation is deteriorating, and moisture related issues were evident in some areas. We recommend that any damaged pipe insulation be replaced.

- HVAC valves throughout are original. It was noted that some of the valves no longer hold, making service and maintenance difficult. We recommend that key valves be replaced when a comprehensive upgrade occurs.

- Repair/seal penetration in the boiler room fire walls.
- Replace the burners.
- Replace the boiler blend pumps.
- Replace the chilled water pumps.
- Replace and damaged pipe insulation.
- Replace strategic HVAC valves for improved maintenance serviceability.

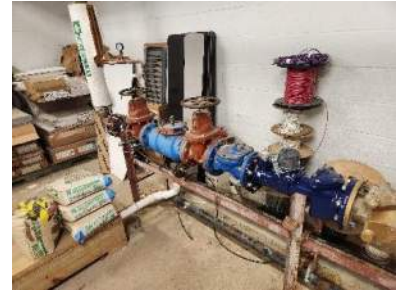
- The school is served off a public water service. The 4" service size is adequate for the school's needs. There were not any observed or noted issues.
- The water service includes a code compliant backflow prevention device that appears to be operational.
- The piping system was reported to be in good condition with no known pipe issues.
- Plumbing valves throughout are original. It was noted that some of the valves no longer hold, making service and maintenance difficult. We recommend that key valves be replaced when a comprehensive upgrade occurs.
- The domestic water system includes a water softening system. The softeners tanks look to be in good condition, but the condition and age of the heads is unknown.

- Replace strategic plumbing valves for improved maintenance serviceability.

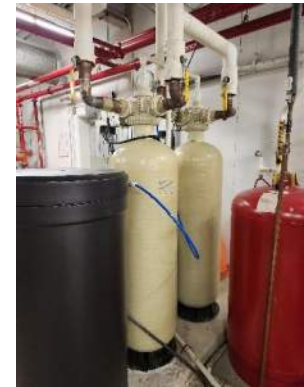
- Domestic hot water is developed by a Bock gas fired water heater that was installed in 2013. The unit is in good condition and should provide several more years of service. It does not, however, have a backup heater. This is highly recommended in case the water heater fails.
- The mixing valve appears to have been replaced and was reported to be in good operating condition. The piping around the water heater and mixing valve is not insulated.

- Install a second water heater for backup.
- Install insulation on the domestic hot water piping.

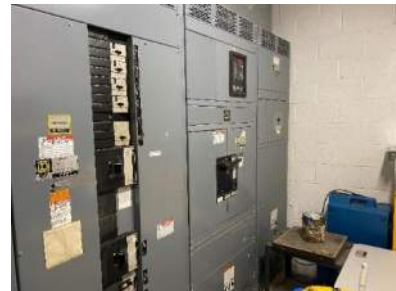
- The existing electrical service is 480/277-volt, 3-phase, 4-wire, and fed from an exterior utility pad mounted transformer. There are two service entrance distribution switchboards that have been installed back-to-back. One of them has a 1200-amp main breaker and the other has a 600-amp main breaker. All the breakers used in the switchboards are obsolete but there are equivalent replacements available. The 1200-amp switchboard does not meet the current NEC requirements. Both main breakers appear to have ground fault protection settings.

- Electrical distribution equipment was manufactured by Schneider/Square D and installed in the 2001/2002 construction project. It appears to be in good condition.

- Obsolete customer meters are located on the switchboards.
- Feeder wiring and raceways appear to be in good condition.

- Upgrade electrical distribution equipment to meet current code requirements with any building wide renovations.
- Inspect electrical equipment connections including thermal imaging, visual inspection and wire connection torque values confirmed with manufactures requirements.
- Follow the manufacturer's recommended maintenance requirements.
- Have a study completed to identify arc flash and PPE requirements for electrical equipment.

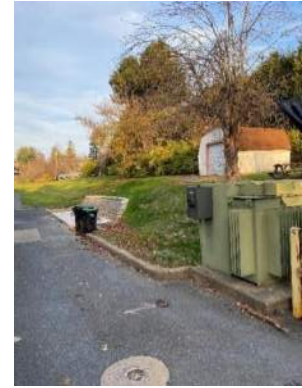
- This building does not have an emergency generator. Plans are in place to install an emergency generator and a concrete pad has been poured outside along the driveway.
- Life-safety egress emergency lighting consists of wall-mounted battery-pack units with integral and remote mounted heads. Also, lamps were used inside fluorescent luminaires that operate on batteries upon a power loss condition.
- Self-contained exit signs with battery back-up are installed in the building and some are in poor condition.
- Newer style battery pack units and integral LED heads and LED remote heads have been installed in this building.

- Complete the installation of the emergency generator and the associated equipment and wiring.
- Replace exit signs that are in poor condition.
- The new generator should be sized to include the building heating equipment branch circuit loads IE: Boilers, blend, and circulator pumps to keep system equipment from damage during a utility power loss.

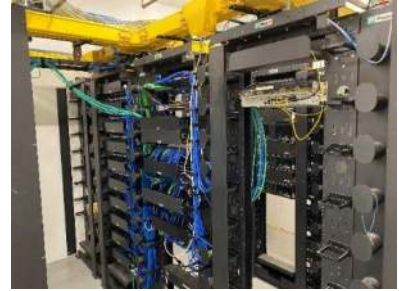
- Category 6 cables/jacks and Wi-Fi wireless access devices are used throughout the building and appear in good condition.
- A VoIP phone system appears to be in use in the building.
- A Rauland Telecenter ICS Intercom system is used in the building and is original to the 2001 renovation. This system is obsolete and service parts may start to be difficult to get.
- Sapling analog clocks are used throughout the building, and they are original to the building 2001 renovation project. The system appears in fair condition.

- The School District is upgrading the data telecommunication systems.
- Remove existing telecommunications systems equipment and cables that are no longer in use. This is a code requirement.
- Upgrade the obsolete Intercom system with a newer IP-based system.
- Plan on replacing the clocks and associated equipment as they are very close to their life expectancy.

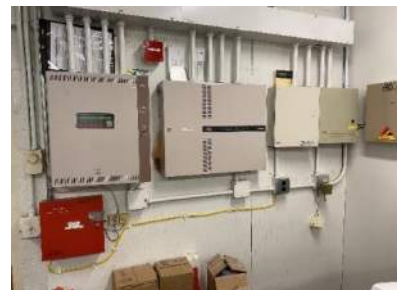
- A Simplex 4010 panel is used in this building. The panel is an addressable system with horn/strobe notification devices and appears to be in good condition but is outdated. The manufacturer's technicians are servicing the system. Simplex is now a part of Johnson Controls (JCI). The system is not compliant with current codes and requirements.
- There are system panels installed that do not appear to be in use.

- There is a piece of Romex wiring used to power the fire alarm communicator. Replace the nonmetallic sheathed cable (Romex) with MC cable or conduit to meet requirements of an educational/commercial installation.
- Remove equipment that is not in use or planned for future use.

- The fire alarm system panels and equipment should be replaced with any major building renovations.
- The new fire alarm system installations will require the use of voice-based speaker notification systems to meet the NFPA requirements.
- Carbon monoxide sensors should be used in areas where fuel combustion occurs inside the building.

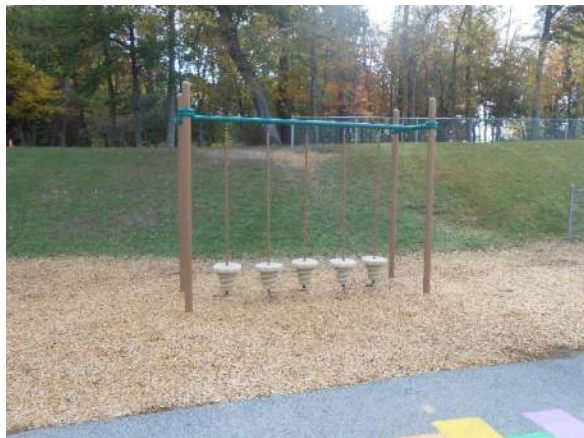
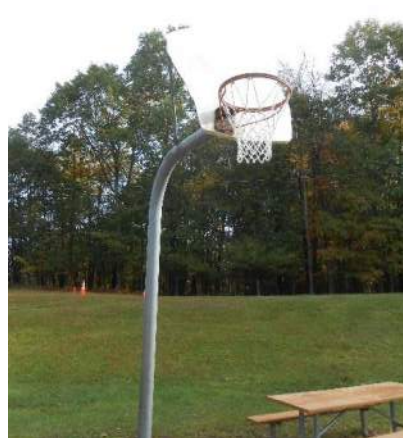
The site has 2 hard-surface play areas with basketball backboards. One backboard is heavily damaged. There are also 2 soft-surface play areas with play equipment. All play areas are in good condition. The 2 soft-surface play areas are surfaced in loose wood chips. All play areas are well separated from vehicular traffic.

- Replace damaged basketball backboard. This is considered routine maintenance.

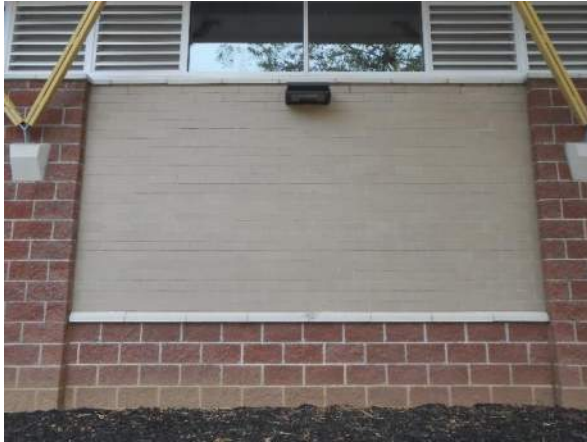
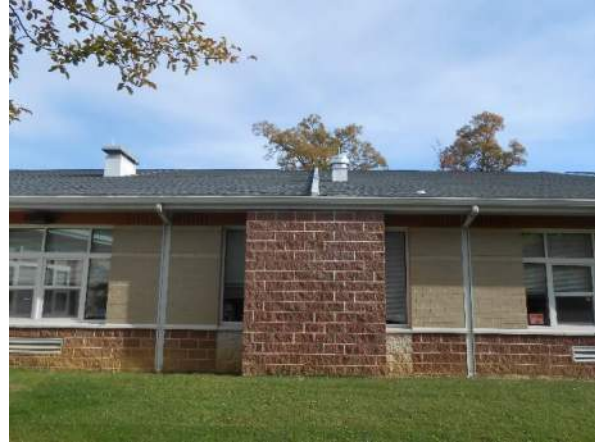
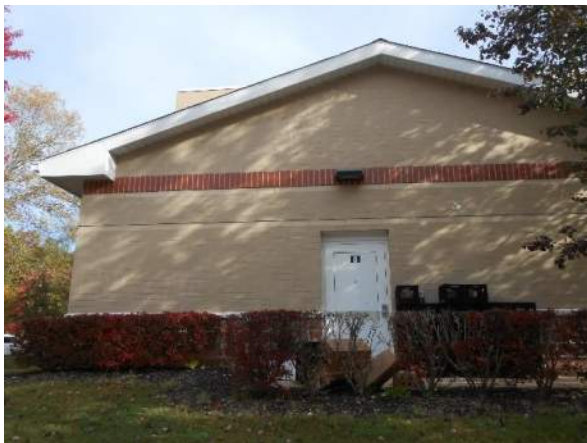
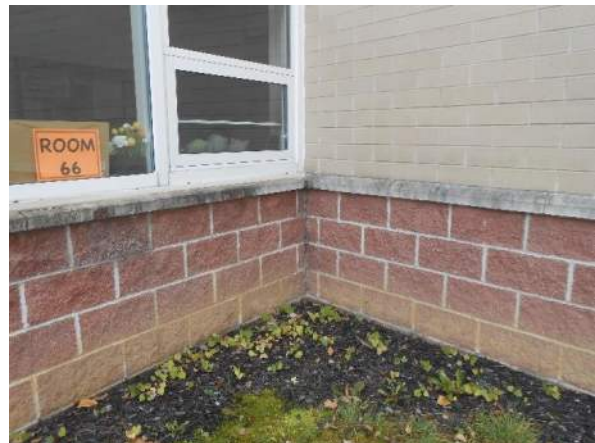
The building exterior consists of insulated masonry cavity walls with modular brick veneer and split face CMU and CMU backup. Window stools are precast concrete and in good condition. Some stools are moderately stained.

- Clean exterior precast concrete stools to remove staining.
- Inspect weep holes at the base of the exterior walls to make sure they are not blocked and trapping moisture within the wall cavity.

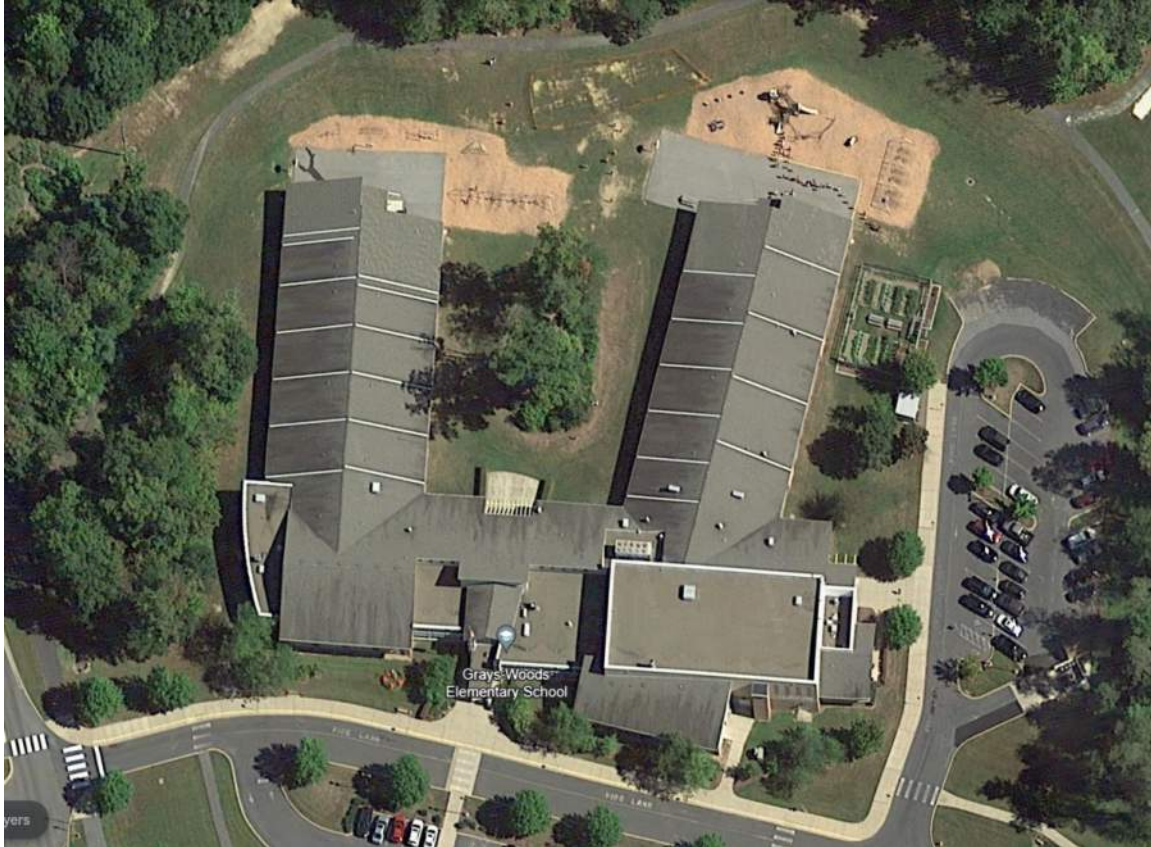
The existing asphalt shingle roofs that were part of the original building constructed in 2002 were replaced in 2023.

The flat roofs associated with the original building constructed in 2002 are a modified bitumen built-up roofing system and are now out of warranty. These roofs are at the end of their life expectancy and should be monitored closely to determine when they should be replaced in the next 5-10 years. If maintained, life expectancy can be extended.

The two small flat roofs at the end of each of the classroom wings that were added in 2011 are fully adhered TPO/EPDM roofs and are in good condition.

For most of the building where the sloped roofs occur, rainwater is collected by gutters and downspouts that ultimately tie into an underground storm system. Roofing and rainwater conveyance appear to be in good condition.

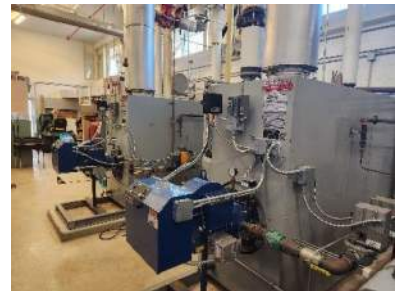
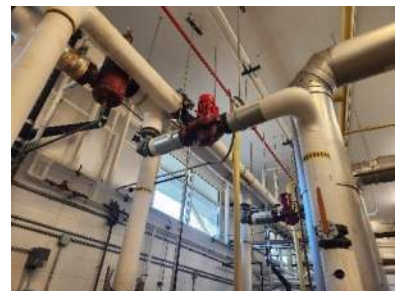
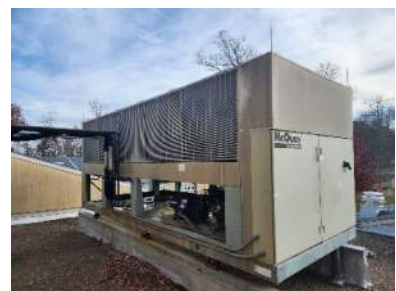
- Two Bryan bent tube boilers (2001) with gas fired burners develop heating hot water for the school. The boilers appear to be in good condition. Bent tube boilers are very serviceable as the tubes can be replaced in the event of failure.

- The Power Flame burners also appear to be in good condition, but it is likely that they will need to be replaced in advance of the boilers.
- Duplex hot water pumps circulate hot water throughout the school. These pumps were replaced in 2022, include VFD's, and are in excellent condition. It was not clear how the VFD's are currently operating. We recommend that control strategies be implemented to allow for variable system flow to reduce pumping power and energy use.

- Blend pumps on the boilers are original and beginning to show signs of aging. They will likely need to be replaced in the next few years.
- The hot water system air separator is in poor condition and should be replaced.

- One of the expansion tanks is original and in need of being replaced.
- The gas fired makeup air unit for the boiler room is operable and in fair condition. We were not able to inspect the heat exchanger, but the normal life cycle of this type of unit is around 20 years.

- Replace the burners.
- Replace the boiler blend pumps.
- Replace the air separator and the old expansion tank.
- Replace the chiller system.

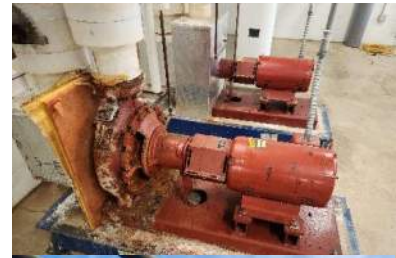
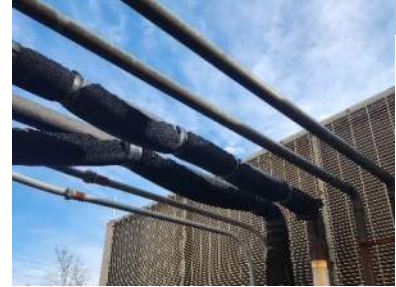
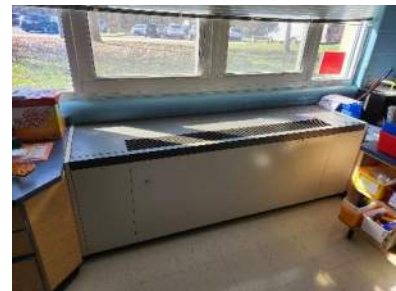
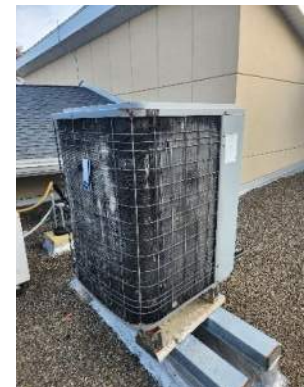
- A McQuay split system chiller is utilized to develop chilled water for cooling. This chiller is original and utilizes R-22 refrigerant. Three of the four compressors are original and have lasted beyond their normal expected lifecycle. R-22 refrigerant has been phased out of production in 2020 due to its ozone depleting characteristics. We highly recommend that the chiller be replaced with a new unit that uses current refrigerants and provides improved energy efficiency.

- The spring isolators on the chiller are in poor and failing condition. These components should be replaced as part of any chiller project.
- The chiller refrigerant piping insulation system has fully deteriorated and needs to be replaced.

- Duplex chilled water pumps circulate chilled water throughout the school. These pumps are original and are starting to show signs of their age. There is some significant deterioration which appears to be a result of condensation from failed insulation. We recommend that the pumps be replaced as part of any chiller replacement project. Consideration should be given to utilizing a primary/secondary pumping arrangement to allow constant flow through the chiller and variable flow to the building. This will result in pump energy savings.

- The pipe insulation is deteriorating in some areas. We recommend that any wet or damaged pipe insulation be replaced.
- HVAC valves throughout are original. It was noted that some of the valves no longer hold, making service and maintenance difficult. We recommend that key valves be replaced when a comprehensive upgrade occurs.

- DX cooling units are installed in several areas including the office, library, and server room. The units are original and utilize R-22 refrigerant. R-22 refrigerant has been phased out of production in 2020 due to its ozone depleting characteristics. We highly recommend that the units be replaced with new units that use current refrigerants and provide improved energy efficiency.

- Note that some of the exterior condensing unit fins are damaged. This can result in poor performance and a reduction in efficiency.
- Exhaust fans throughout are original but appear to be in fair condition.

- Replace the chilled water pumps and specialties.
- Replace and damaged pipe insulation.
- Replace strategic HVAC valves for improved maintenance serviceability.
- Replace R-22 DX cooling systems.
- Repair/comb the damaged fins on the exterior condensing units.

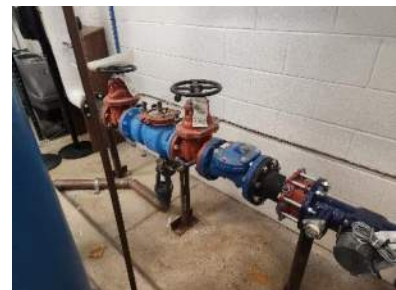
- The school is served off a public water service. The 4" service size is adequate for the school's needs. There were not any observed or noted issues.
- The water service includes a code compliant backflow prevention device that appears to be operational.
- The piping system was reported to be in good condition with no known pipe issues.

- Plumbing valves throughout are original. It was noted that some of the valves no longer hold, making service and maintenance difficult. We recommend that key valves be replaced when a comprehensive upgrade occurs.
- The domestic water system includes a water softening system. The softeners appear to be original to the building construction. It is likely that these units will need to be replaced in the next few years.

- Replace strategic plumbing valves for improved maintenance serviceability.
- Replace the water softening system.

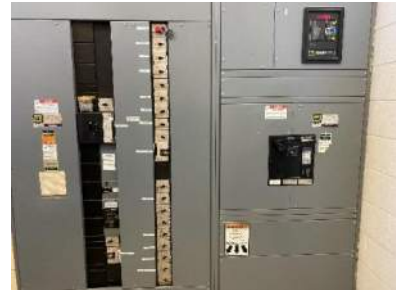
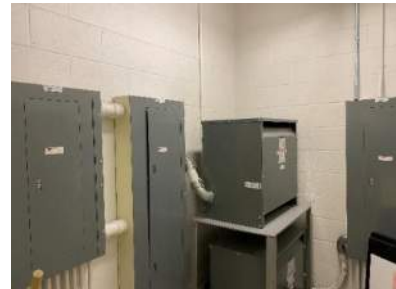
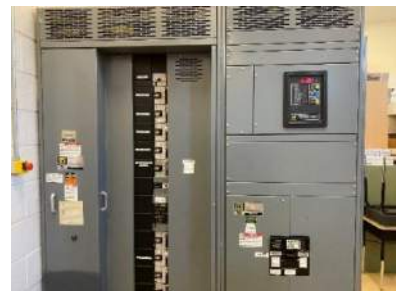
- The existing electrical service is 480/277-volt, 3-phase, 4-wire, and fed from an exterior utility pad mounted transformer. There are two service entrance distribution switchboards that have been installed back-to-back. One of them has a 1200-amp main breaker and the other has an 800-amp main breaker. All the breakers used in the switchboards are obsolete but there are equivalent replacements available. The 1200-amp switchboard does not meet the current NEC requirements. Both main breakers appear to have Ground Fault protection settings.

- Dry-type transformers are used to step down voltage to 208/120-volt.
- 480/277-volt and 208/120-volt branch circuit panelboards provide power throughout the building. The panelboard types used have been replaced with newer equipment versions. Circuit breakers are still available for the existing panelboards.

- Electrical distribution equipment was manufactured by Schneider/Square D and installed in the 2001/2002 construction project. Equipment appears to be in good condition.

- Obsolete Customer meters are located on the switchboards.
- Feeder wiring and raceways appear to be in good condition.

- Upgrade electrical distribution equipment to meet current code requirements with any building wide renovations.
- Inspect electrical equipment connections including thermal imaging, visual inspection and wire connection torque values confirmed with manufactures requirements.
- Follow the manufacturer's recommended maintenance requirements.
- Have a study completed to identify arc flash and PPE requirements for electrical equipment.

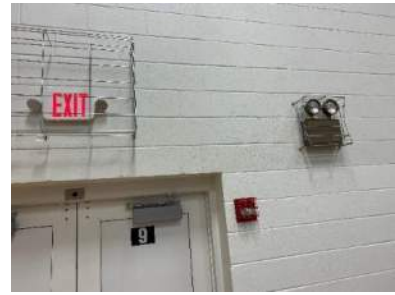
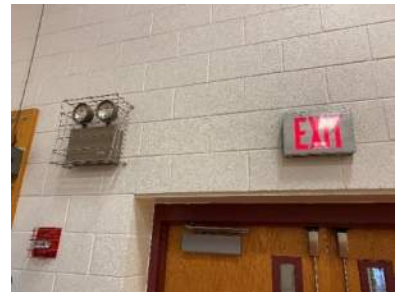
- This building does not have an emergency generator.
- Life-safety egress emergency lighting consists of wall-mounted battery-pack units with integral and remote mounted heads. Also, lamps are used inside fluorescent luminaires that operate on batteries upon a power loss condition.
- Self-contained exit signs with battery back-up are installed in the building.
- Emergency equipment is in poor to fair condition and has had multiple charging board and battery failures requiring replacements. Complete battery-pack replacements have been observed. This type of equipment requires ongoing maintenance and the purchasing of equipment.
- The equipment being replaced is using LED heads.

- Install a generator with automatic transfer switches, normal/emergency panelboards and associated equipment. The generator would be used for life-safety egress emergency lighting and could also be used for optional equipment loads like kitchen walk-in refrigerators, freezers, and mechanical equipment.
- A New generator should be sized to include the building heating equipment branch circuit loads IE: Boilers, blend, and circulator pumps to keep system equipment from damage during a utility power loss.

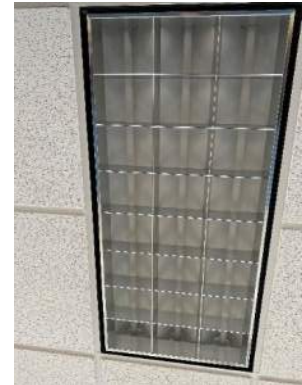
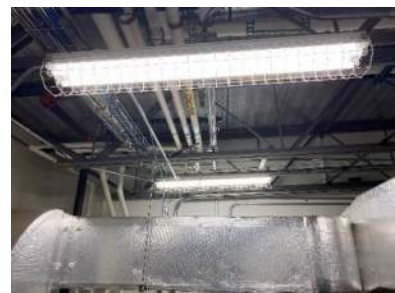
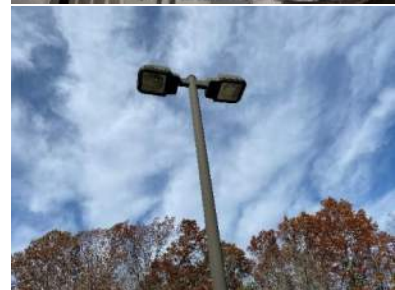
- Corridors are primarily using 2'x 4' recessed luminaires with prismatic lenses and T-8 fluorescent lamps. There are also some recessed high hats using PL fluorescent lamps and some surface wall-mounted linear fluorescent luminaires using T-8 lamps.
- Classrooms have recessed 2' x 4' luminaires with deep cell open parabolic lens and T-8 fluorescent lamps.
- Most areas are controlled by wall switches without energy management devices.
- The (4) newer classrooms are using wall switches and ceiling mounted occupancy sensors.
- Exterior luminaires appear to be using a combination of retrofit LED lamps, HID and PL fluorescent lamps.
- Lighting controls do not meet current energy code requirements for automatic switching, daylight harvesting, and dimming. They are no longer working correctly.

- Luminaires are 22 years old. Fluorescent lamps and ballast will become more difficult and expensive to purchase. The luminaires should be replaced with luminaires using LED lamps and energy code compliant controls should be installed with any planned renovations.
- Upgrade exterior luminaires with LED type.
- Replace lighting controls with new energy code compliant lighting controls.

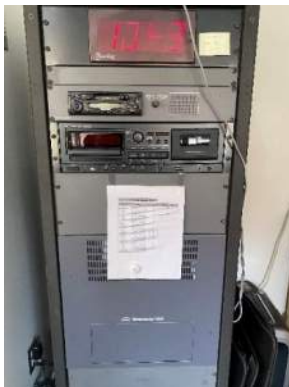
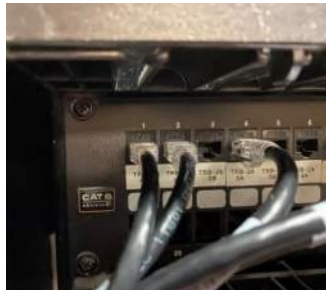
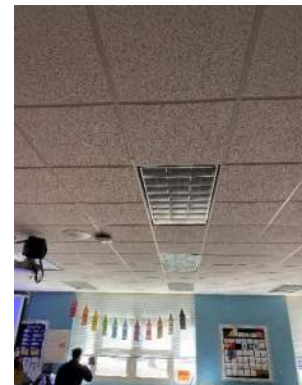
- Category 6 cables/jacks and Wi-Fi wireless access devices are used throughout the building and appear in good condition.
- A VoIP phone system appears to be in use in the building.
- A Rauland Telecenter ICS Intercom system is used in the building and is original to the 2001/2002 construction. This system is obsolete and service parts will be difficult to get.
- Sapling analog clocks are used throughout the building, they are original to the 2001/2002 construction. Digital clock segments are no longer working at the head end location, and the system is in fair condition.

- The School District is currently upgrading data telecommunication systems.
- Remove existing telecommunications systems equipment and cables that are no longer in use.
- Upgrade/Replace the obsolete Intercom system with a newer IP-based system.
- Upgrade/Replace the clocks and associated equipment as they are very close to their life expectancy.

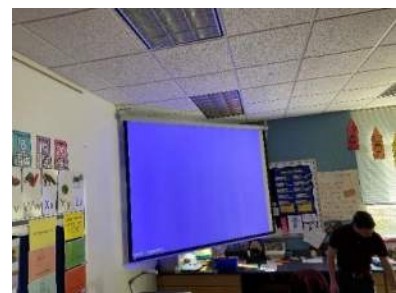
- Ceiling-mounted projectors with an audio speaker and pull-down projection screens are used in the classrooms. Teachers have input stations at their desks. Equipment is dated with older connection types.
- Audio systems with older technologies are used in the building and appear to be original to the building construction.
- There appears to be abandoned cables and equipment that are no longer in use in this building.

- Upgrade the existing learning areas and Classrooms with newer A/V technology system equipment and wiring systems.
- Remove existing low-voltage cables and associated equipment when no longer needed or in use.

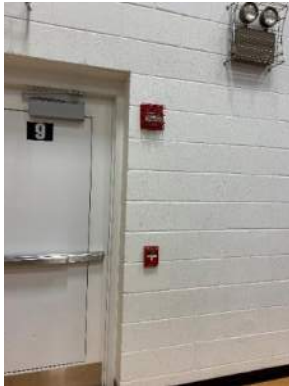
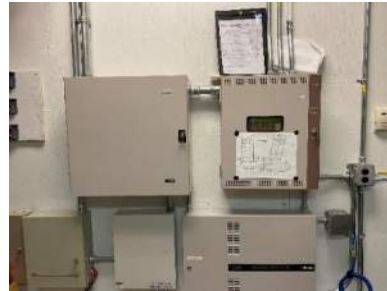
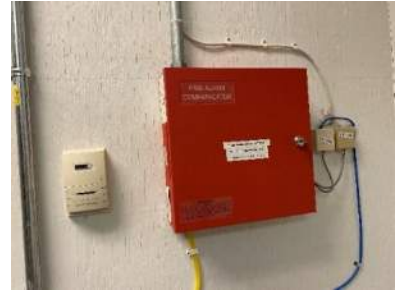
- A Simplex 4010 panel is used in this building. The panel is an addressable system with horn/strobe notification devices and appears to be in good condition but outdated. The manufacturer's technicians are servicing the system. Simplex is now part of Johnson Controls (JCI). The system is not compliant with current codes and requirements.
- Strobe devices appear to be installed lower than they are required to be.
- There are system panels installed that do not appear to be in use.
- Any new systems installed will be required to have voice/speaker notification devices.

- Review strobe notification device installations and confirm required heights are correct. Correct as needed.
- There is a short piece of Romex wiring used to power the fire alarm communicator. Replace the nonmetallic sheathed cable (Romex) with MC cable or conduit to meet requirements of an educational/commercial installation.
- Remove equipment that is not in use or planned for future use.
- The fire alarm system panels and equipment should be replaced with any major building renovations.
- The new fire alarm system installation will require the use of voice-based speaker systems to meet the NFPA requirements.
- Carbon monoxide sensors should be used in areas where fuel combustion occurs inside the building.

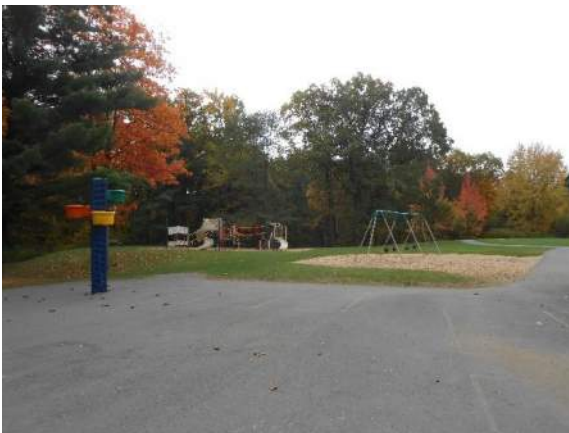
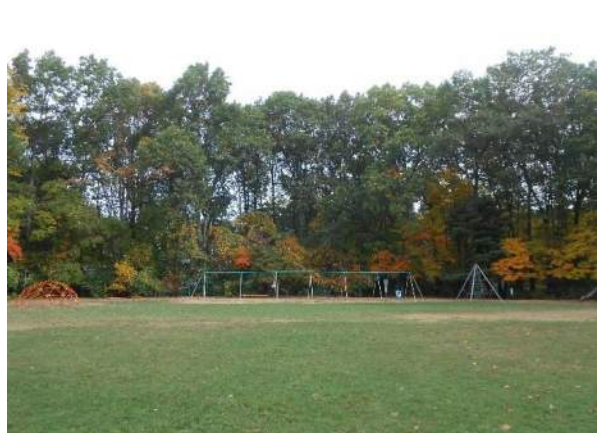
The site has one hard-surface play area, which includes a basketball backboard. There are multiple soft-surface play areas with play equipment, which are surfaced in loose wood chips. The site also features two grass fields. All are in good condition and all play areas are well separated from vehicular traffic.

- None at this time.

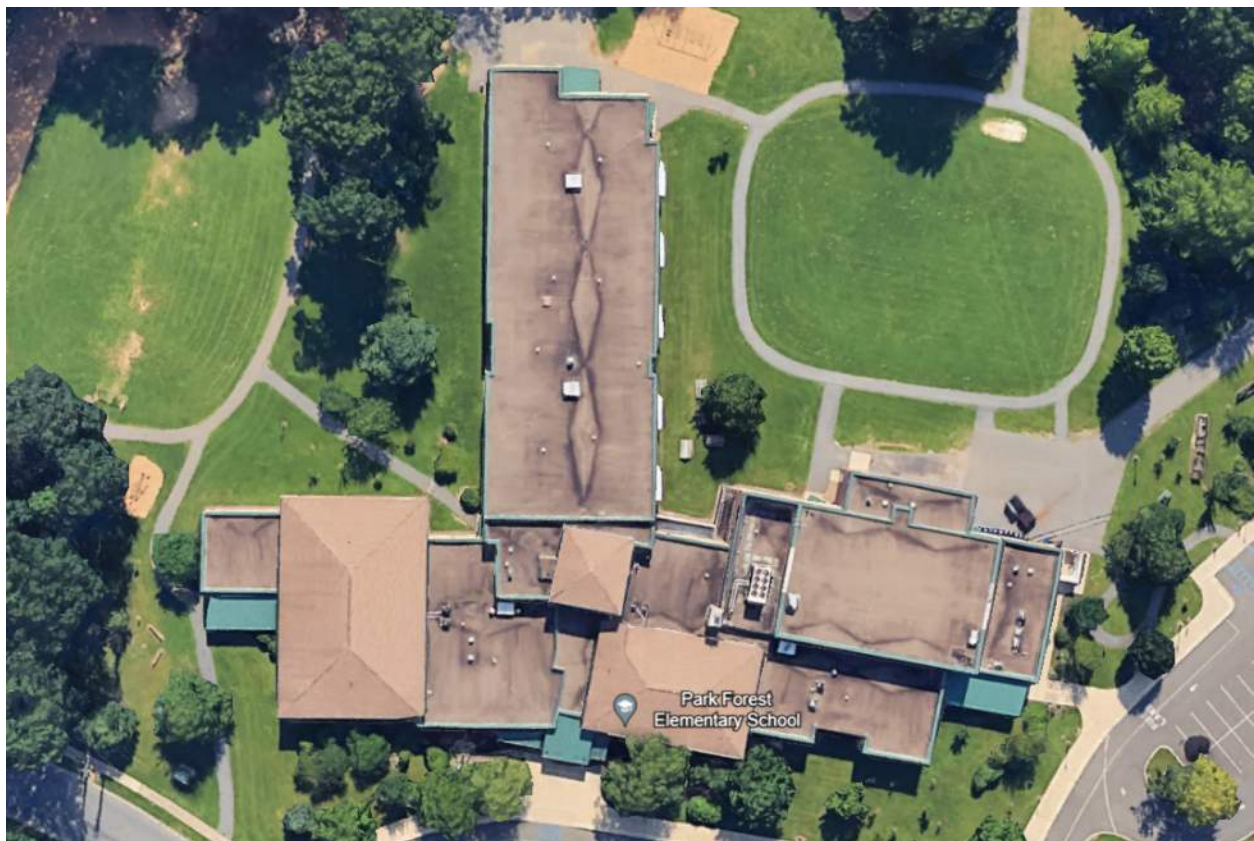
All three types of roofs (asphalt shingles at sloped roofs, built-up roofing system at flat roofs and metal roofing at sloped roof canopies at entrances) are original and are at the end of their life expectancy and should be monitored closely to determine when they should be replaced in the near future. This should be a capital project in the coming 5-10 years.

Where the sloped roofs occur, rainwater is collected by gutters and downspouts that ultimately tie into an underground storm system. Roofing and rainwater conveyance appear to be in good condition.

- Monitor to determine replacement.

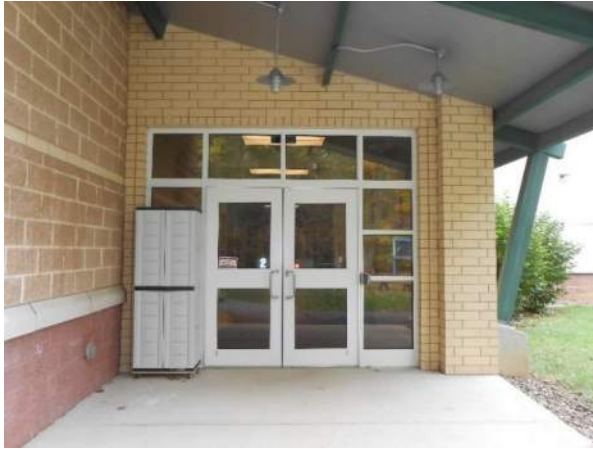
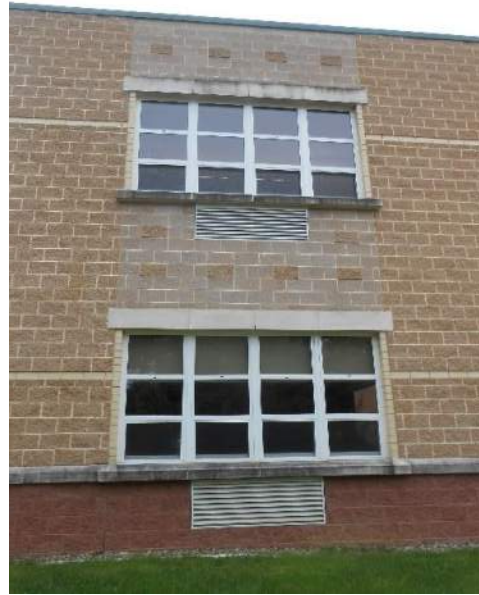
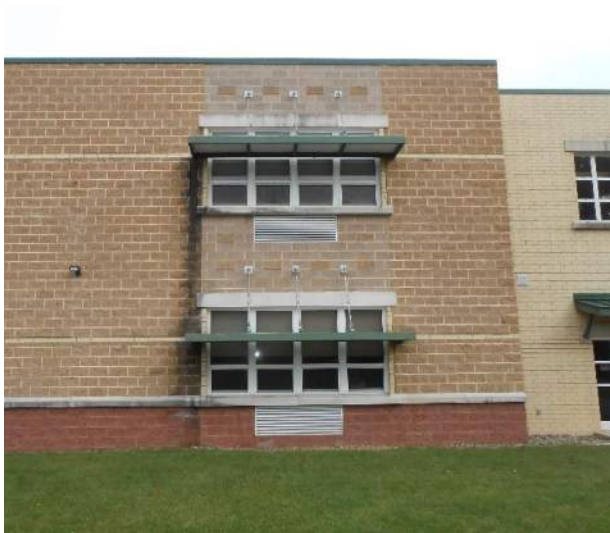
Windows are combination of operable and fixed window units with window treatment mounted at the head of the window. The blinds and shades appear to be in good condition. Entrances are clear anodized aluminum storefront with the wide style door design.

Upper and lower-level windows on the south sides of the building have integral shading devices with the aluminum storefront system.

- Windows and doors are original to when the building was built in 2005 and are in good condition, they will be at the end of their life expectancy in the coming 10 years, but if recaulked regularly and maintained life expectancy can be extended for another 10-20 years.

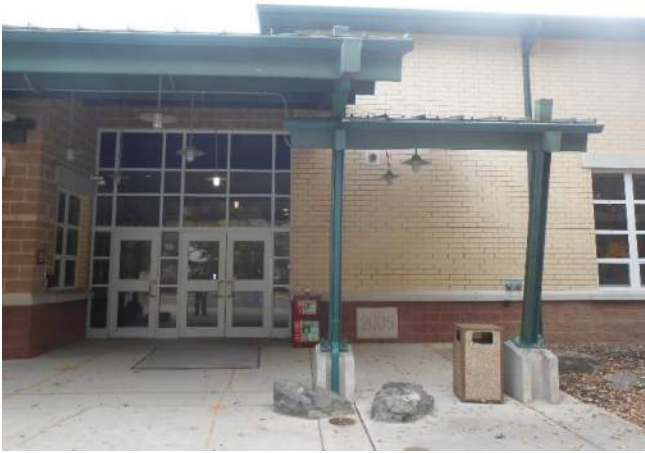
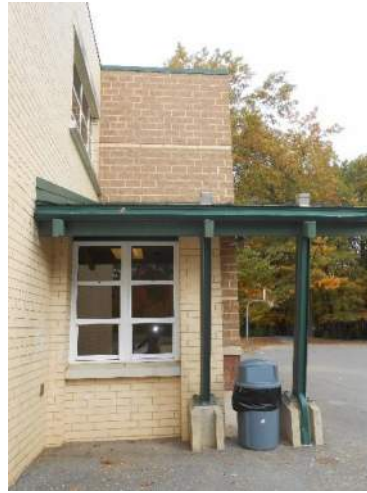
The building is a 2-story masonry load bearing structure. Exterior canopies are supported with steel beams and columns. Overall, the building structure does not have any major cracks and appears to be in good condition.

- None at this time.

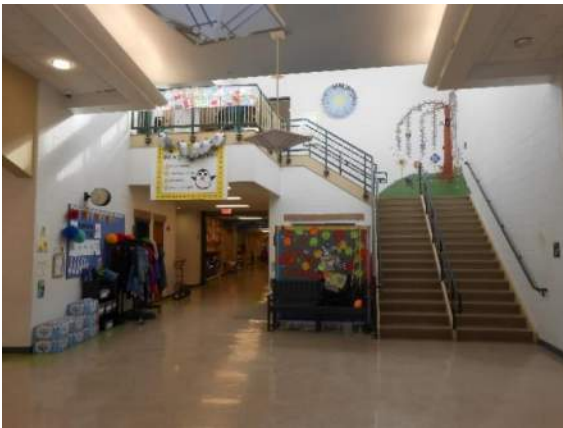
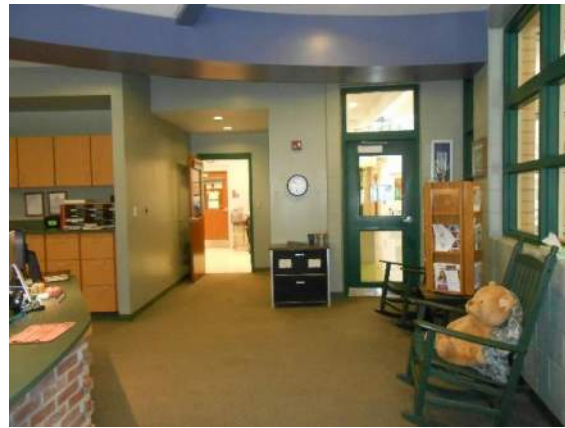
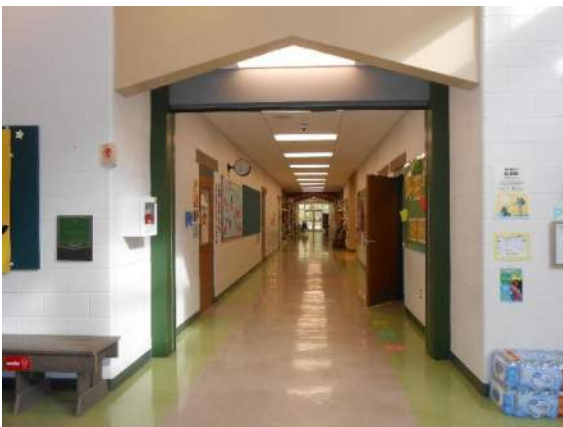
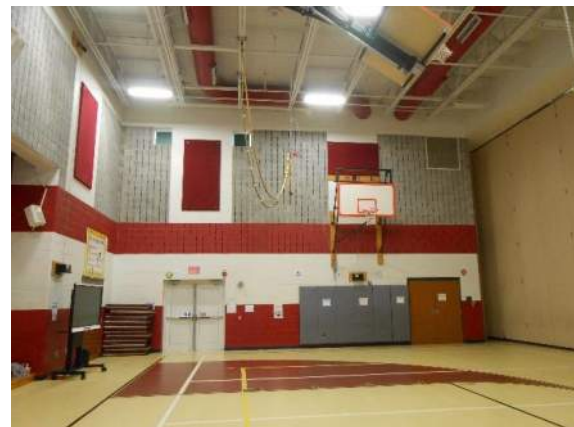
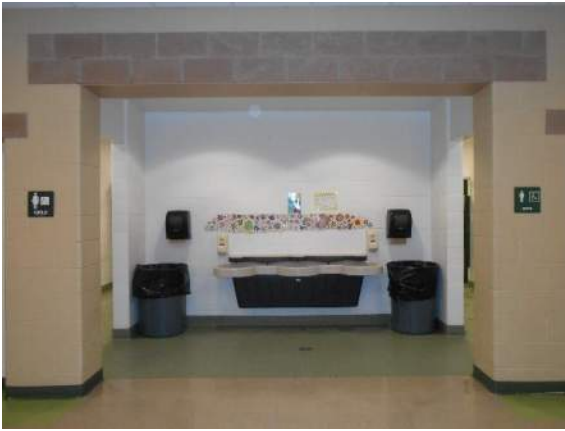
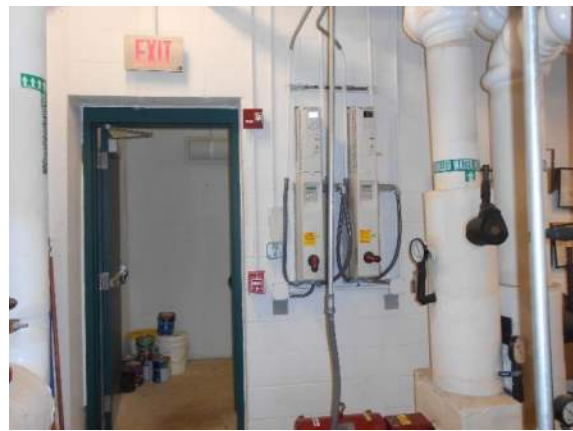
Most of the flooring throughout the school is VCT and is in good condition. Carpet exists in the main office and is well maintained. The flooring in toilet rooms is porcelain tile. Mechanical areas have painted concrete. The gymnasium has sheet vinyl flooring which is in good condition.

Interior walls are predominantly painted CMU and are in good condition. Acoustical and gypsum board ceilings and bulkheads throughout the building are in good condition.

- Due to the building being 19 years old, while VCT is in good condition, it would be recommended to plan for VCT replacement in the next 10 years as a capital project.
