## 6 | Easterly Parkway Elementary School

<b>Address:</b>	234 Easterly Parkway State College, PA 16801
<b>Construction Timeline:</b>	Originally constructed in 1955; renovation/addition in 2002.
<b>Building Square Footage:</b>	55,895 sf
<b>Site Acreage:</b>	11.4 acres

Easterly Parkway Elementary School is a 2-story building located in State College Boro, State College, PA. The school currently houses grades K-5. The property is served by public water, sewer and natural gas.

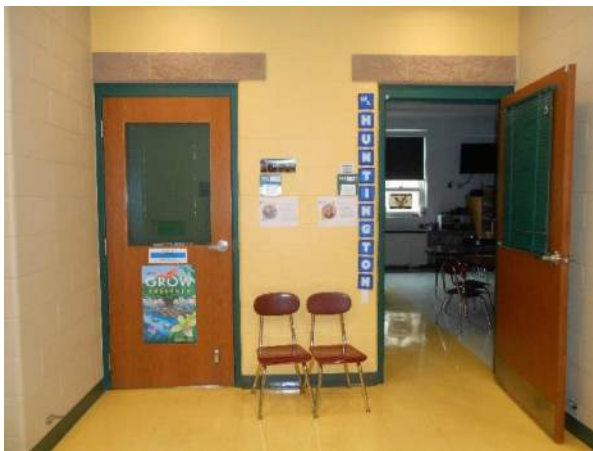
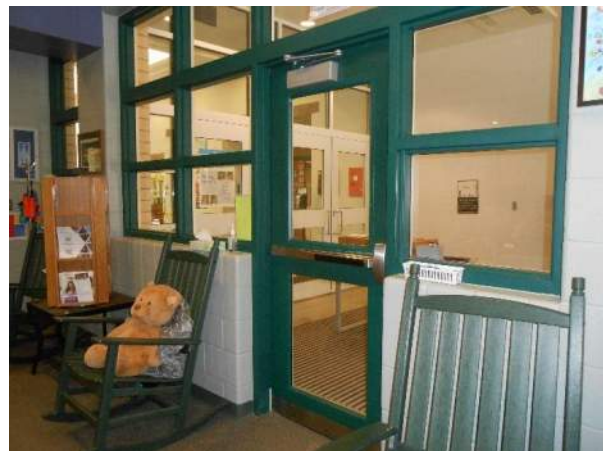
Interior doors are solid core wood and painted hollow metal in painted hollow metal frames and are in good condition. Interior aluminum doors are also in good condition.

- None at this time.

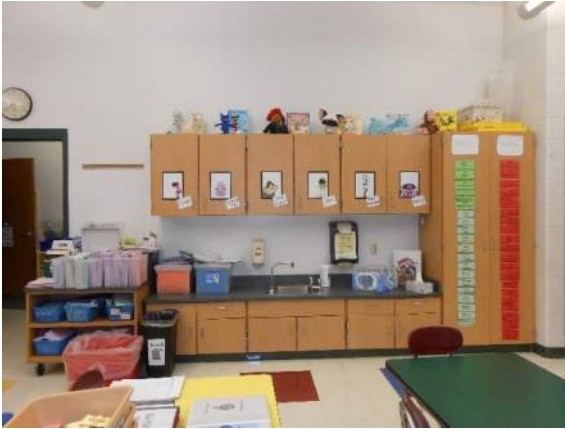
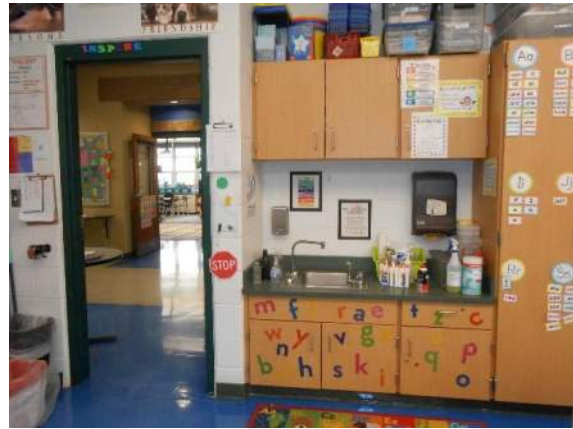
Interior casework is in good condition. Casework underneath the sinks throughout the building do not allow for a forward approach for accessibility.

- Provide casework that includes sinks that meet ADA accessibility guidelines. This should only occur if a future casework replacement would occur. Casework met code requirements when installed and does not require replacement at this time.

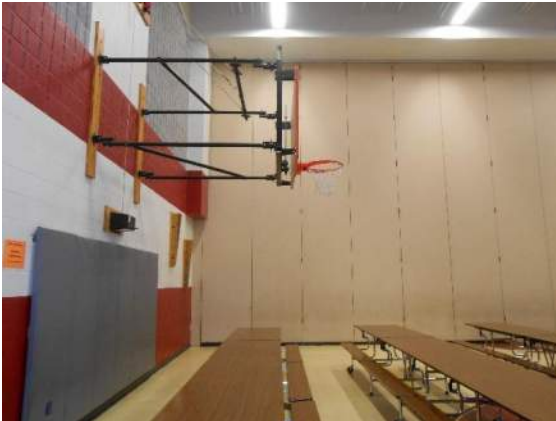
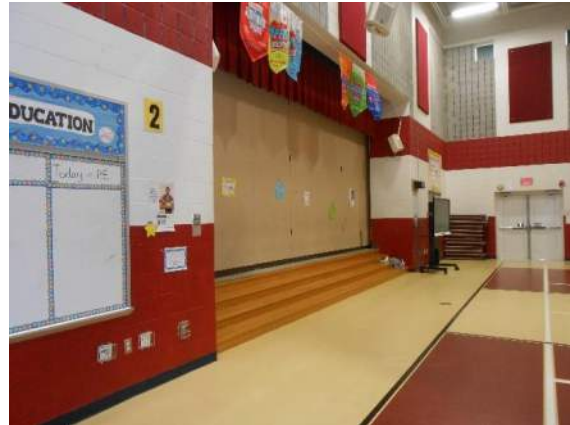
The multi-purpose room equipment consists of retractable, ceiling-hung and wall-hung basketball backstops. There is a folding wall partition for the multi-purpose room and the stage. All are in good condition. The stage curtain/ folding partition and lighting are original to the building but are also in good condition.

- None at this time.

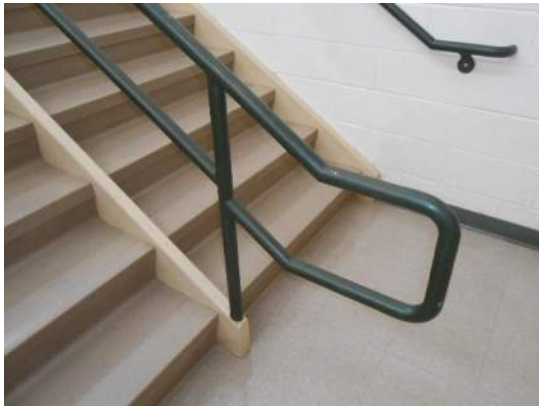
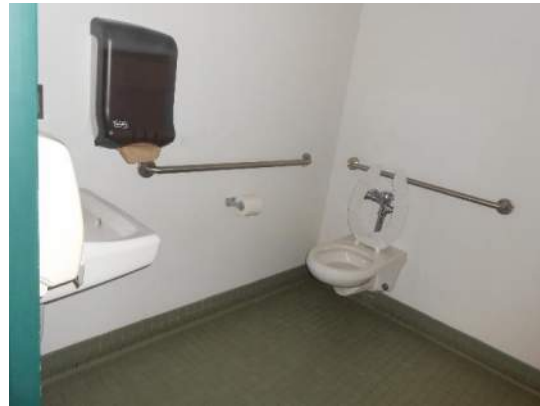
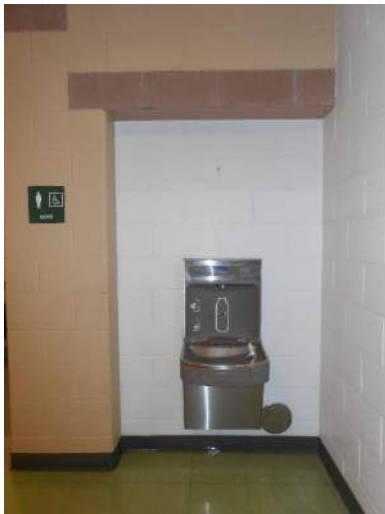
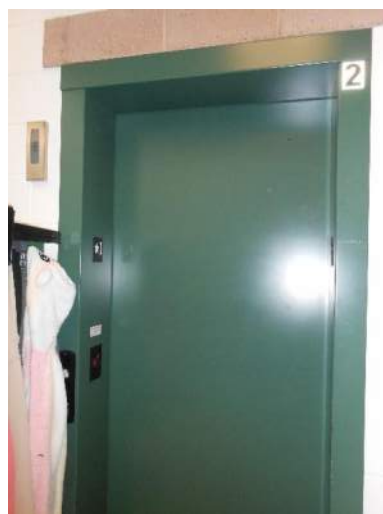
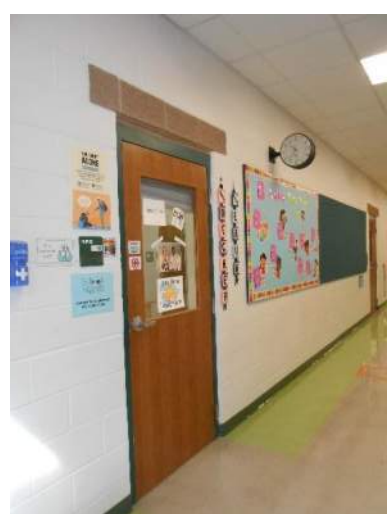
Water coolers are the new ones where bottles can be refilled.

There is an elevator that serves both floors and appears to be ADA compliant.

- Provide ADA compliant grab bars in group toilet rooms.
- Provide new room signage with the braille tactile writing system with any comprehensive renovation project.

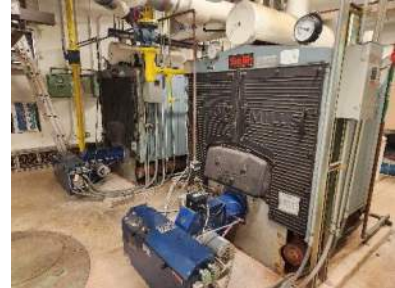
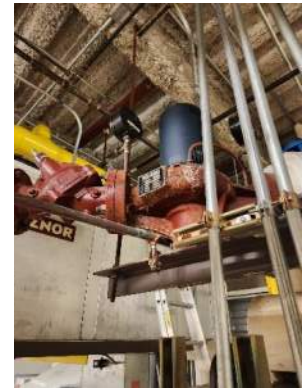
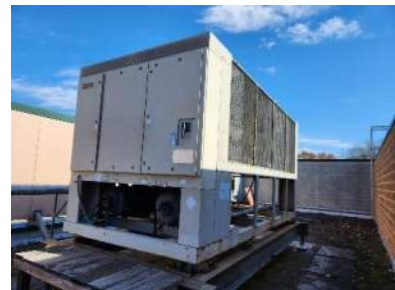
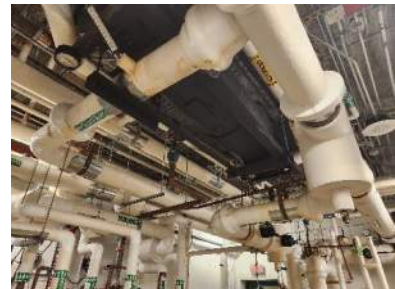
- A roof mounted McQuay split system chiller is utilized to develop chilled water for cooling. This chiller is original and utilizes R-134a refrigerant. Based on its age, the chiller will likely need significant maintenance or replacement in the next few years.

- The unit frame and spring isolators on the chiller are rusting and in poor condition.
- The internal bundle is in the ceiling of the mechanical room and is difficult to access.

- The pipe insulation is deteriorating in some areas. We recommend that any wet or damaged pipe insulation be replaced.

- Consider boiler and burner replacement. Replace them with high efficiency gas boilers.
- Replace the hot water pumps and the boiler blend pumps as part of any boiler project.
- Replace the chiller.
- Replace the chilled water pumps as part of any chiller replacement project.
- Replace/repair and damaged HVAC pipe insulation.
- Replace strategic HVAC valves for improved maintenance serviceability.
- Replace R-22 DX cooling systems.

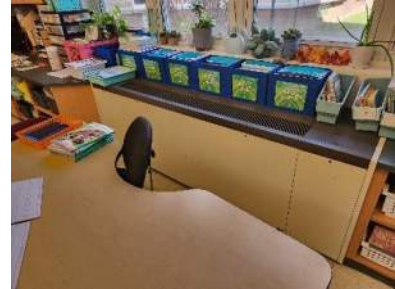
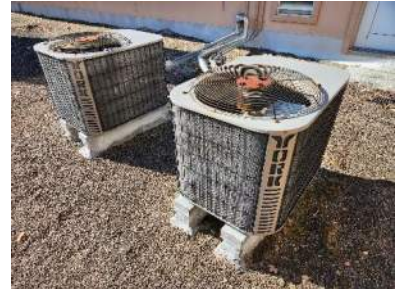
- HVAC valves throughout are original. It was noted that some of the valves no longer hold, making service and maintenance difficult. We recommend that key valves be replaced when a comprehensive upgrade occurs.

- Classrooms are served by vertical 4-pipe unit ventilators on the exterior walls. Some of the larger spaces are served by McQuay 4-pipe air handlers. These units are original but appear to be in good condition.

- DX cooling units are installed in several areas including the office, library, and server room. Some units have new compressors. The units are original and utilize R-22 refrigerant. R-22 refrigerant has been phased out of production in 2020 due to its ozone depleting characteristics. We highly recommend that the units be replaced with new units that use current refrigerants and provide improved energy efficiency.

- Exhaust fans throughout are original but appear to be in fair condition.

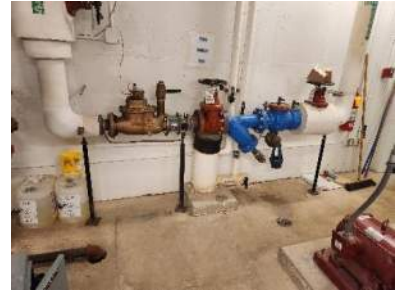
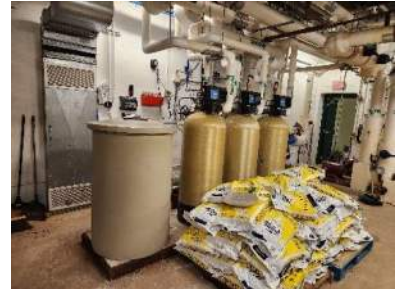
- The school is served off a public water service. The 4" service size is adequate for the school's needs. There were not any observed or noted issues.
- The water service includes a code compliant backflow prevention device that appears to be operational.
- The piping system was reported to be in good condition, but we noted that some copper piping was replaced with PEX. We recommend that further inspection be carried out to determine if the pipe systems have internal or pin hole issues.
- Plumbing valves throughout are original. It was noted that some of the valves no longer hold, making service and maintenance difficult. We recommend that key valves be replaced when a comprehensive upgrade occurs.
- The domestic water system includes a water softening system. The softeners appear to be in good condition.

- Inspect the internal condition of the domestic water piping.
- Replace strategic plumbing valves for improved maintenance serviceability.

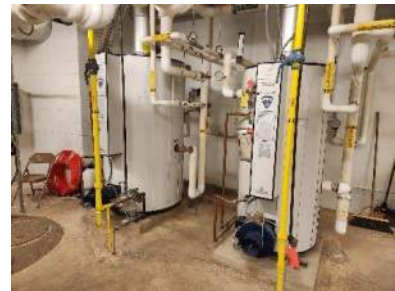
- Domestic hot water is developed from two PVI gas fired water heaters that were installed in 2005. They are in fair condition. Based on age, it is likely that they will soon need to be replaced.
- Note that the water heaters are not currently interconnected. We recommend that the new system be piped together to provide redundancy/backup capabilities.
- The hot water recirculation pumps appear to be in aged and poor condition and should be replaced as part of any water heating system upgrade.
- The domestic hot water mixing valve appears to be in aged and poor condition and should be replaced as part of any water heating system upgrade.

- Replace/upgrade the domestic water heating system.

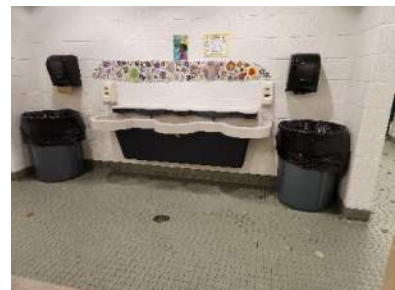
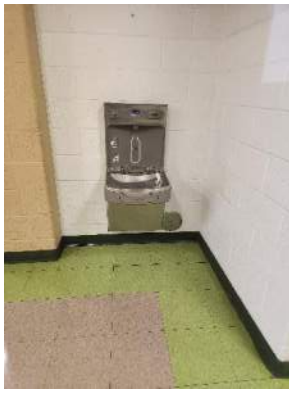
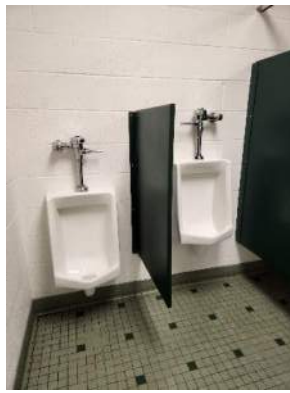
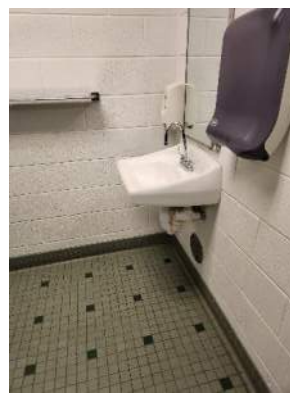
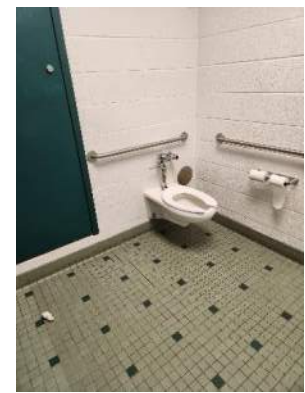
- Plumbing fixtures throughout appear to be in good condition.
- Water closets and urinals utilize manual flush valves.
- Multi-station lavatories are utilized at group toilet rooms. These units include hands free faucets. There were not any reported issues with these units.
- Classroom sinks include bubblers and faucets with blade handles.
- Water coolers include bottle fillers. They do not appear to all be ADA compliant.

- Address ADA issues with fixtures.

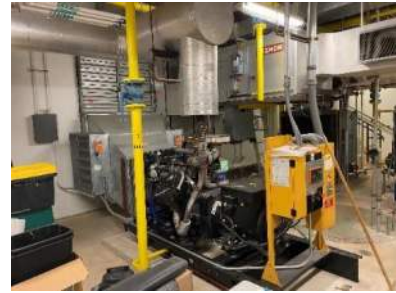
- A 150kW natural gas generator provides emergency power.
- The generator is manufactured by Olympian and the automatic transfer switches are manufactured by ASCO.
- Both life-safety and optional-standby building loads each have a separate automatic transfer switch for emergency power distribution.
- The generator, transfer switches and area protection panel are in good condition.
- The life safety equipment is in the same room as the service entrance and building electrical distribution systems. This does not meet the code requirements.
- Generator has one distribution breaker that is used for both Life safety and Optional standby distribution systems.
- Boilers, blend pumps and circulator pumps appear to be backed up by the generator.

- The emergency power distribution system is in fair to good condition.
- Relocate life-safety equipment as needed to meet code requirements.
- Anchor/fasten generator to foundation per manufactures requirements.
- Maintain generator per manufacturer's requirements.
- Review building equipment systems that are to be powered by the generator upon a utility power loss with owner and address as needed.
- Confirm the heating systems are backed up by the emergency generator.
- Review adding a dedicated breaker on gen set and feeder for life safety systems.

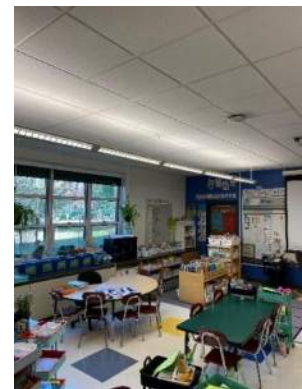
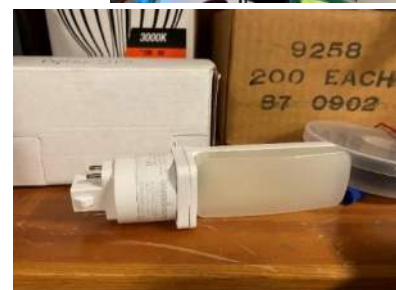
- It appears that standard 4' fluorescent lamps are still being utilized but the compact fluorescent lamps are being replaced with LED type lamps.
- The multi-purpose room has linear fluorescent high-bay lighting fixtures.

- Exterior post-top lantern luminaires are used at the driveway with canopy and wall mount luminaires. Lamps in use appear to be LED, HID and PL fluorescent types. Luminaires appear to be in good condition.

- Emergency lighting is integrated into the standard lighting fixtures.
- Corridor and exterior Lighting is controlled through a central relay panel. Controls include occupancy sensors.

- Exit signs are LED type with battery back-up.
- Lighting controls do not meet current energy code requirements for automatic switching, daylight harvesting, and dimming.

- Luminaires and controls are in good condition and will operate adequately for a few years to come; however, fluorescent lamps will become more scarce and costly to replace.

- Interior lighting and lighting controls should be replaced throughout with LED type luminaires and energy code compliant controls. It is our understanding that lighting upgrades are scheduled for this year..
- Exterior LED lighting is in good condition and no further action is required.

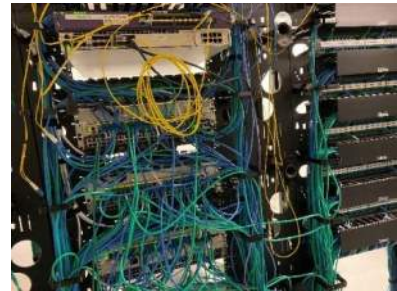
- Category 6 cables/jacks and wireless access devices are used throughout the building and appear to be in good condition. This appears to have been an upgrade from the system installed in 2005.
- Hardwired data drops and Wi-Fi coverage are provided throughout the building, and in good condition.
- A VoIP phone system is used in the building.
- A Rauland Telecenter intercom system with a digital master clock is installed in the building and it is original to the 2005 construction. The intercom system is obsolete.
- Sapling analog clocks are used throughout the building, and they are also original to the 2005 construction.

- The School District is upgrading data telecommunication systems.
- Remove existing telecommunications systems equipment and cables when no longer in use.
- Plan on upgrading the clocks and associated equipment.
- Plan on upgrading the intercom system to an IP based system.
- Monitor maintenance activities as the equipment is 19-years old and is at or near life expectancy. Plan upgrades as needed.

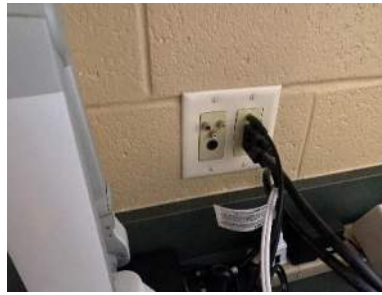
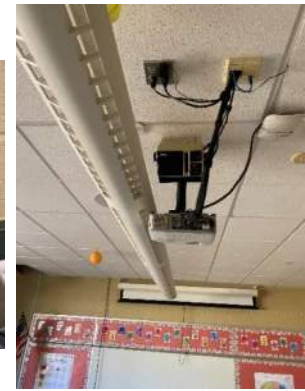
- Ceiling-mounted projectors with an audio speaker and pull-down projection screens are used in the classrooms. Teachers have input stations at their desks. Equipment is dated with older connection types.
- The multi-purpose room has an AV system that is most likely from 2005.

- Upgrade the existing learning areas and classrooms with newer A/V technology systems.
- Upgrade components in multi-purpose room system. Items such as cassette players are out of date.

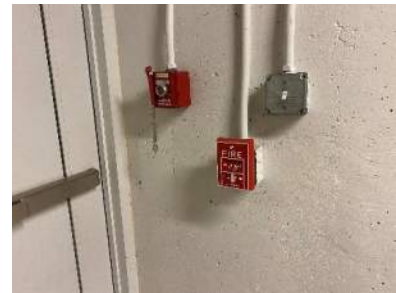
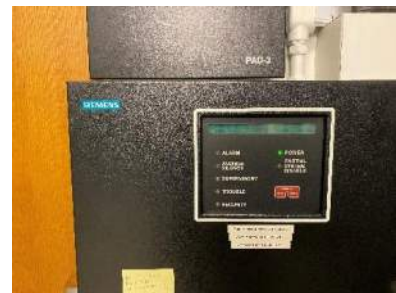
- A Siemens MXL-IQ addressable fire alarm system panel and horn/strobe notification devices are used in this building. This panel and some of the associated devices that are used with it are obsolete. The system is not compliant with current codes and requirements.

- System testing appears to be completed by JCI.
- The system does not provide notification in classrooms and public spaces per code requirements.
- The existing building horn-based notification system is grandfathered, but current NFPA codes require voice-based (speaker) annunciation in education buildings. Voice fire alarm communication capabilities and speaker-type notification devices will need to be installed for any future renovations that require changes to the fire alarm system.

- There is a sprinkler flow and tamper switch located in an open ceiling area that is not being monitored by the fire alarm system. This should be reviewed and corrected if in use.

- Future renovations will necessitate installation of voice communication capabilities for the fire alarm system. Audio Horn devices will need to be replaced with speaker type notification devices.
- The fire alarm system should be considered for full replacement with any major building renovations.
- Add a fire alarm monitoring device and associated wiring to the sprinkler system unmonitored valve and flow switch if it is in use.

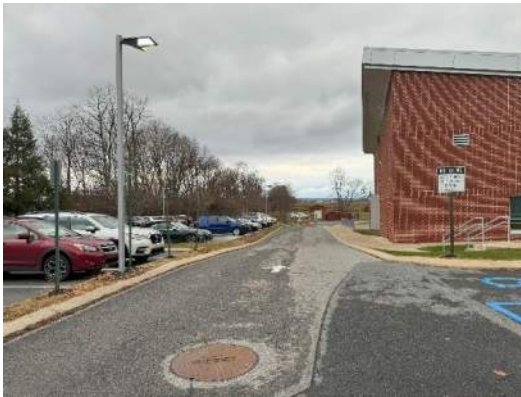
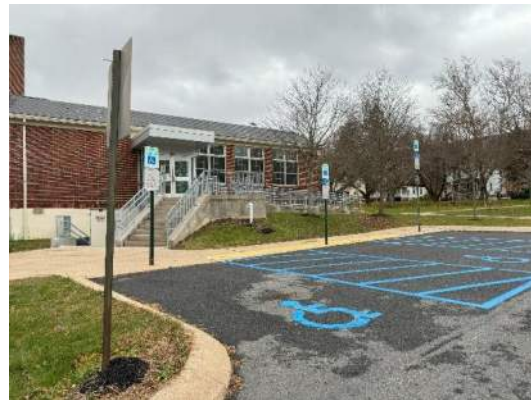
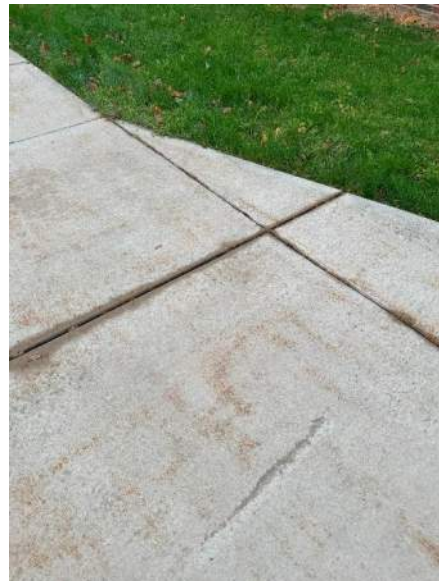
Some of the concrete walks are aging and starting to show signs of wear and tear, in that the aggregate (in the concrete) is beginning to show through to the outside surface. The concrete is also stained in many places. Cracking is occurring on some of the paved surfaces.

- The short-term recommendation for paving is to apply a pourable sealer to the cracks, seal the paving, and repaint lines. The long-term recommendation is to remove 1" to 1-1/2" of existing surface and to provide a new wearing course with any new building project. The short-term recommendation for the

concrete walks is to clean and remove stains and provide a sealer. The long-term recommendation is to replace the concrete with any new building project.

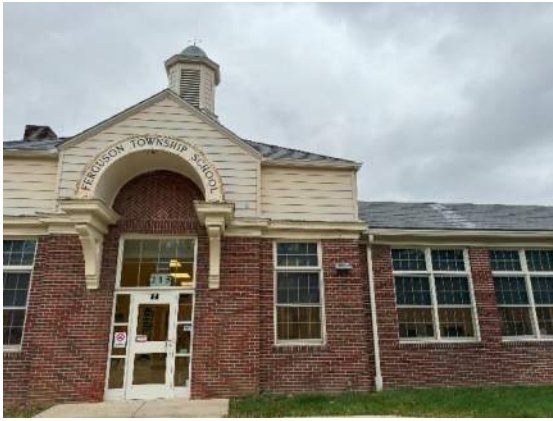
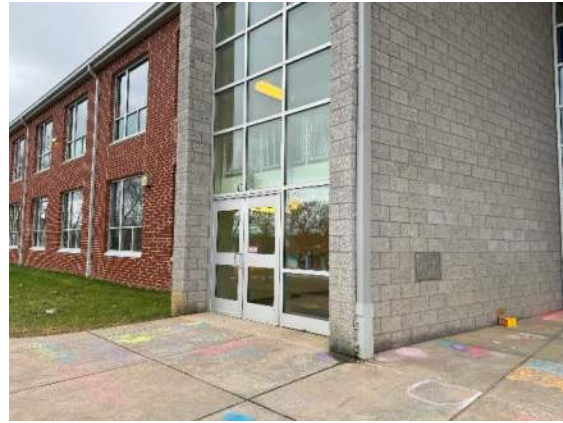
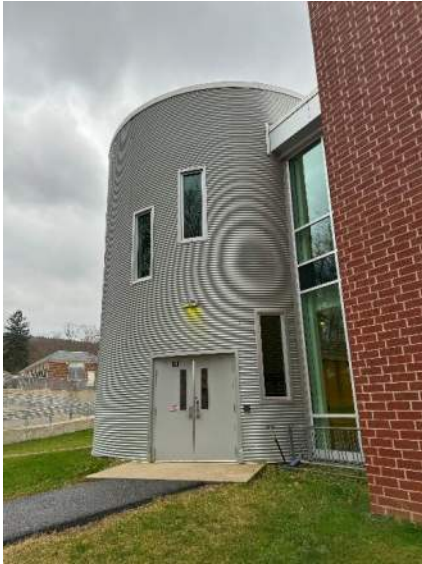
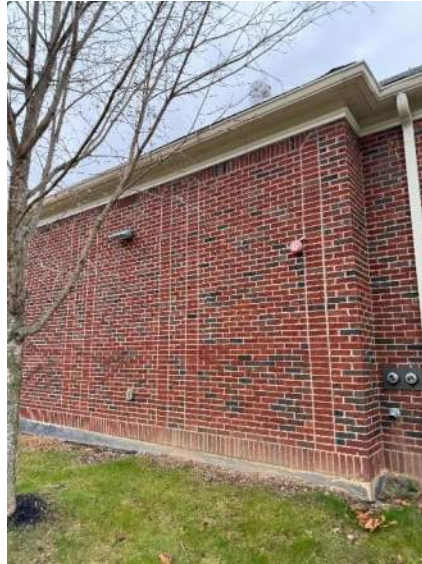
At the base of some of the masonry walls there is a moisture build-up and is creating staining on the masonry. Weep holes should be checked to make sure they are not plugged up or covered. Window stools are metal drip edges and are in good condition.

- Clean stained masonry and clean out weep holes in the masonry.

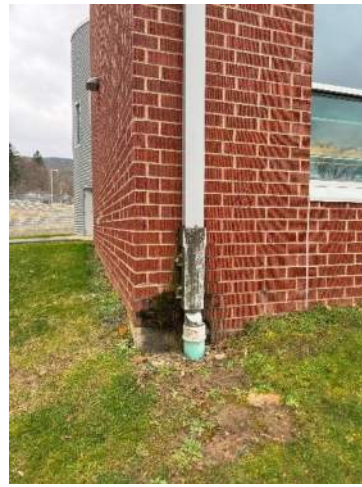
Rainwater for the most part is collected in metal gutters and taken down metal downspouts that tie into an underground storm system. Roofing and rainwater conveyance appear to be in good condition except for the one downspout/underground stormwater piping (shown below) that may be clogged and is staining the face brick.

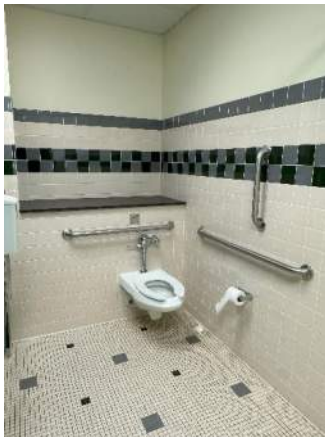
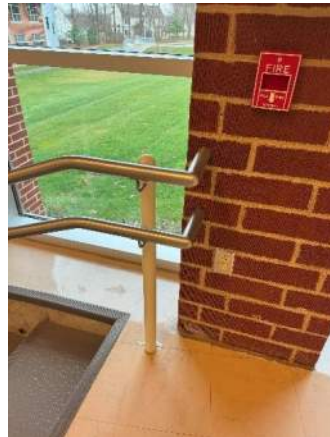
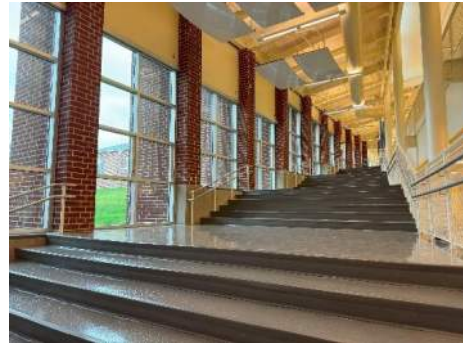
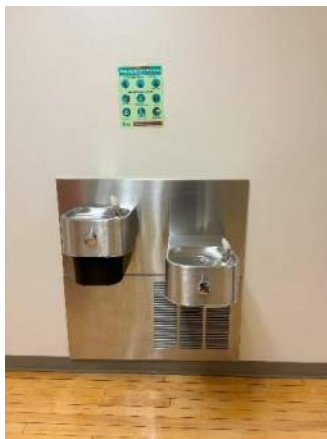
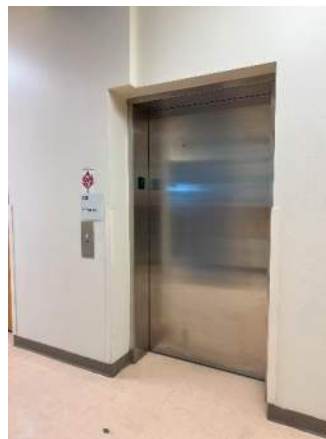
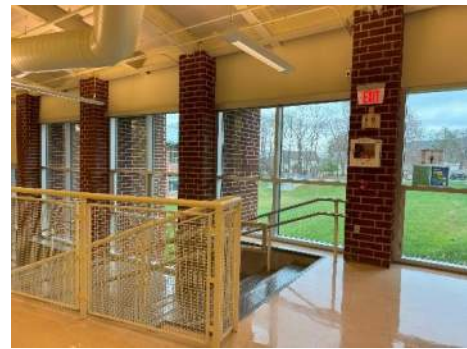
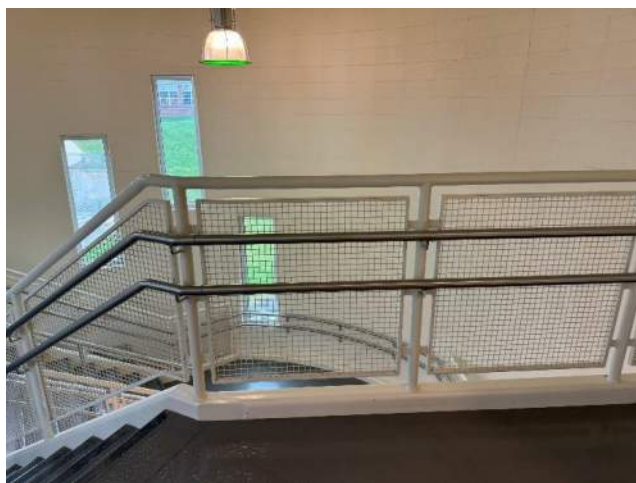
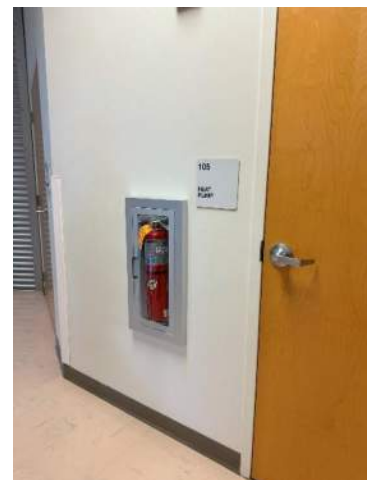
The guard rails and handrails in the building are code compliant and are in good condition. Two handrails are provided, one for adult mounting height and one for children mounting height. Exit stairs are enclosed.

There is an elevator that serves both floors and appears to be code compliant.

Fire extinguisher cabinets are semi-recessed with clear plastic bubbled front and mounted at the correct height.

- None at this time.

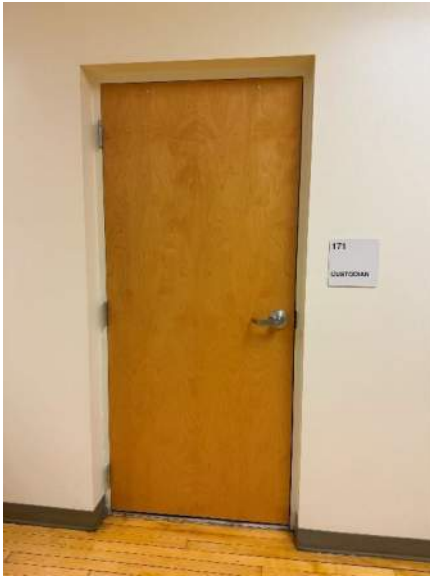
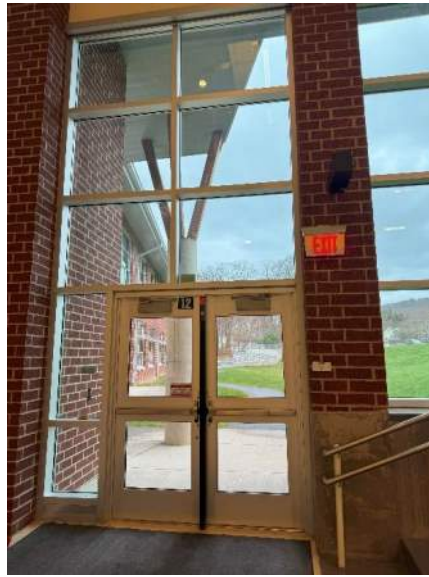
Interior doors are solid core wood and painted hollow metal in painted hollow metal frames and are in good condition. Interior aluminum doors are also in good condition.

- None at this time.

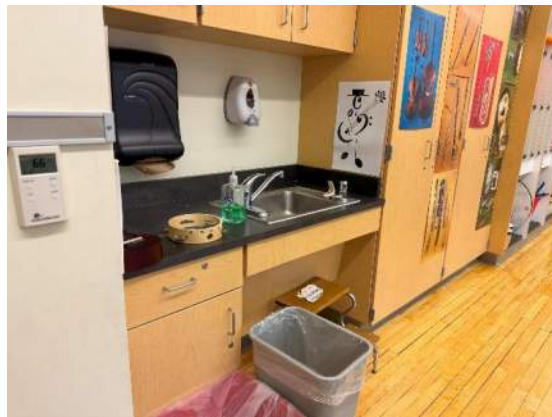
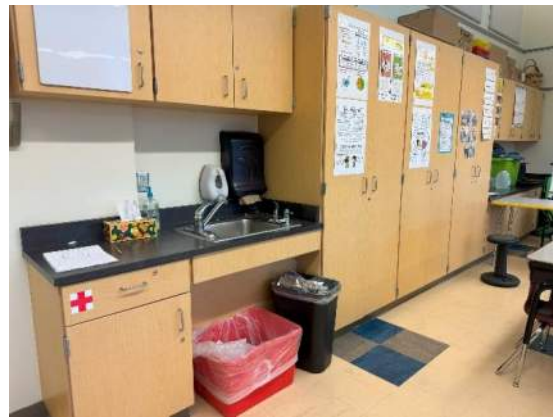
Interior casework is in good condition. Casework underneath the sinks throughout the building allows for a forward approach for accessibility.

- None at this time.

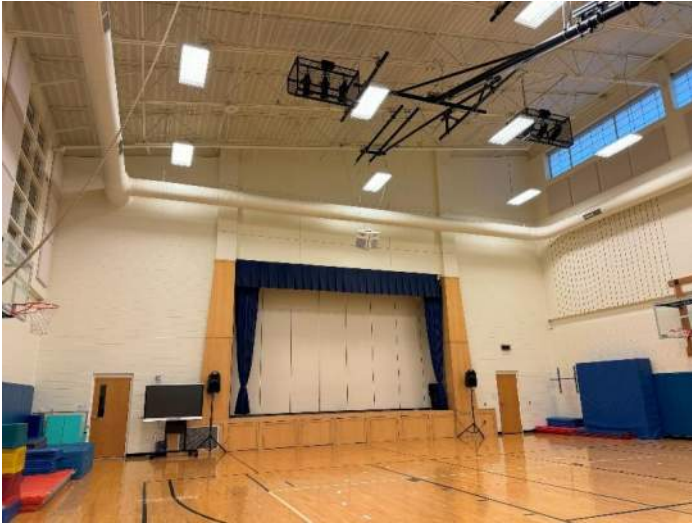
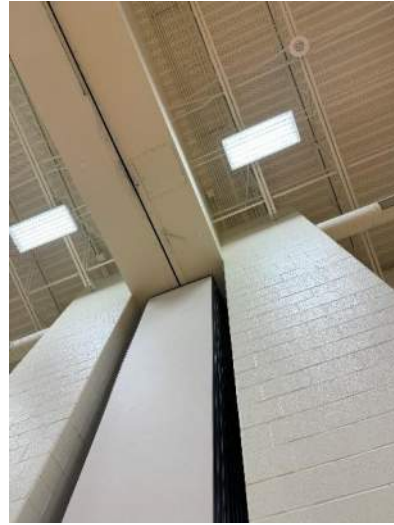
The multi-purpose room equipment consists of retractable basketball backstops. There is a folding wall partition for the multi-purpose room. All are in good condition. The stage curtain and lighting are also in good condition.

- None at this time.

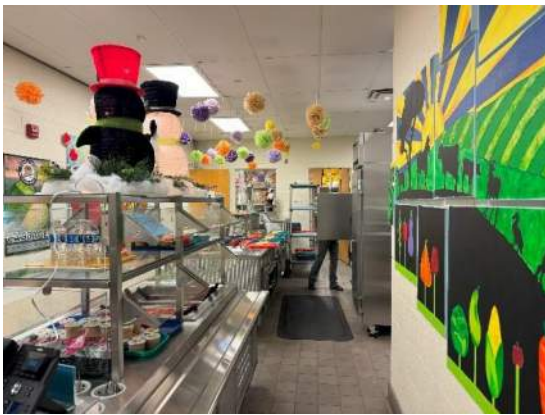
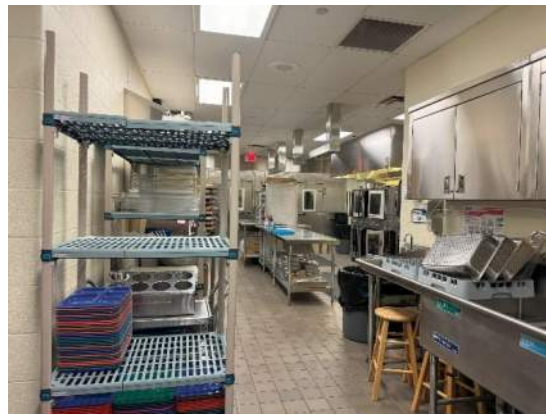
The food service equipment was installed in the 2011 addition and renovation project. Recently one of the ovens and steamer were replaced and the dishwash was replaced approximately 5-6 years ago.

- None at this time. Kitchen is being maintained within current food service budget with routine updated equipment.

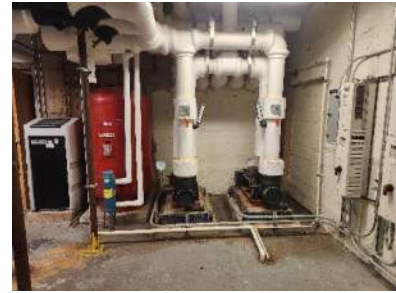
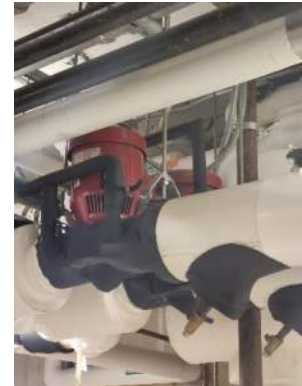
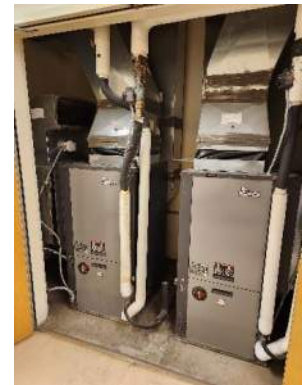
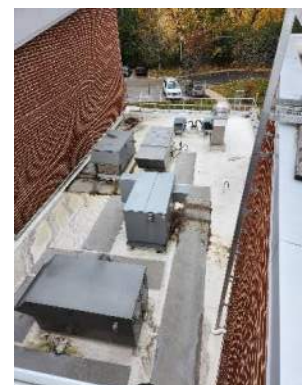
- Classrooms are mainly served by ducted vertical geothermal Climate Master heat pumps located in closets. The units utilize R-410a, are serviceable, and were found to be in good condition. These units typically have a 20-year lifecycle if properly serviced and maintained.

- Some of the loop water pipe insulation is failing and in need of repair or replacement. Condensation was evident because of the failed or inadequate pipe insulation.

- Outdoor air ventilation is provided by five roof mounted energy recovery ventilators with wheels. Pre-conditioned air is delivered to the closets and circulated through the plenum returns. These units were found to be in good operating condition.

- Large zones utilize roof mounted units with compressors to provide HVAC to the related space. These units were found to be in good operating condition.

- Mini split units are provided for several IT areas. All were noted to be in good operating condition.
- Electric unit heaters and cabinet heaters are utilized for specific space heating only needs.

- Test and verify water chemistry and glycol concentration.
- Clean classroom heat pump closet plenums.
- Replace/repair damaged pipe insulation.

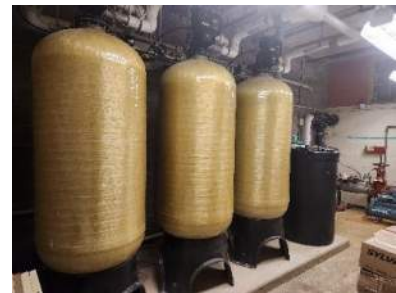
- The school is served off a public water service. The 4" service size is adequate for the school's needs. There were not any observed or noted issues.
- The water service includes a code compliant backflow prevention device that appears to be operational.
- The piping system was reported to be in good condition with no known pipe issues.
- The domestic water system includes a triplex water softening system. The softeners are in good condition.

- None.

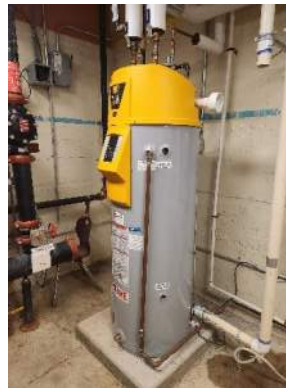
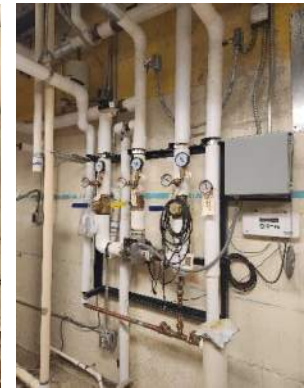
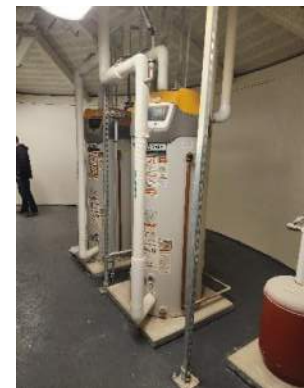
- The single water heater in the lower mechanical room was installed in 2016. The unit appears to be in good condition. It does not, however, have a backup heater. This is highly recommended in case the water heater fails.

- The mixing valve in the lower mechanical room is valved off and bypassed. It was not evident as to the issue. We recommend that this be repaired or replaced so it can be put back into service.

- Duplex water heaters are installed in the upper mechanical room above the stairs. These units were installed in 2011. They appear to be in good condition, but their typical lifecycle is 12-15 years. Replacement may be necessary in the next few years.

- The mixing valve in the upper mechanical room appears to have been replaced and was reported to be in good operating condition. The piping around the mixing valve is not insulated.

- Install a second water heater for backup in the lower mechanical space.
- Repair or replace the lower mechanical room mixing valve.
- Install insulation on the domestic hot water piping at the mixing valve.
- Replace the water heaters in the upper mechanical room in the next few years.

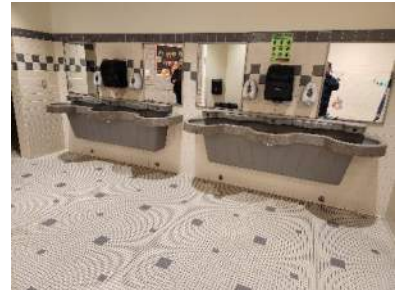
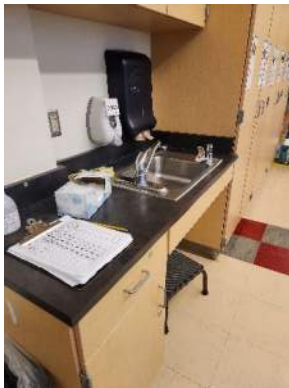
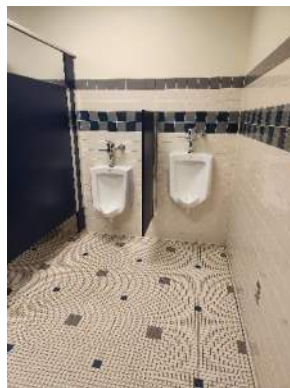
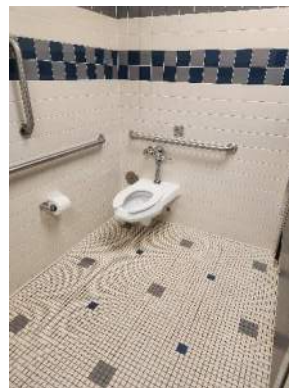
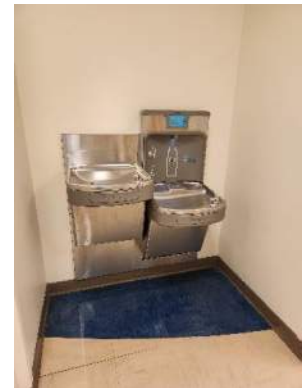
- Plumbing fixtures throughout appear to be in good condition.
- Water closets and urinals utilize manual flush valves.
- Multi-station lavatories are utilized in group toilet rooms. These units include hands free faucets. There were not any reported issues with these units.
- Classroom sinks include bubblers and faucets with blade handles.
- Dual level water coolers appear to meet ADA and include bottle fillers.

- None.

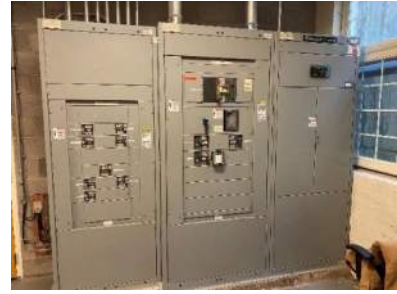
- A GE Spectra Series 1200-amp 480/277-volt 3-phase, 4-wire switchboard is installed and is fed from an exterior utility pad-mount transformer. The service and distribution equipment were installed during the 2011 construction project. It does not meet current code requirements.
- The switchboard includes ground-fault protection, customer metering and surge protection.
- 208/120-volt is provided in the building via dry-type step-down transformers.
- 480/277-volt and 208/120-volt panelboards provide branch circuit power throughout the building.
- Electrical distribution equipment appears to be in good condition.
- Feeder wiring and raceway are in good condition.

- The distribution system is in good condition. Upgrade to meet current codes as needed with any renovations.
- Inspect electrical equipment connections including thermal imaging, visual inspection and wire connection torque values confirmed with manufactures requirements.
- Have a study completed to identify arc flash and PPE requirements for electrical equipment.

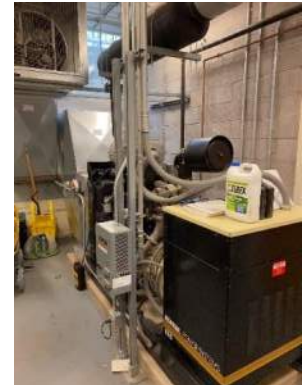
- A 125kW natural gas generator provides emergency power.
- The generator is manufactured by Kohler and was manufactured in 2010.
- Both life-safety and optional-standby building loads each have a separate automatic transfer switch for emergency power distribution.
- The generator, transfer switches and area protection panel are in good condition.

- The emergency power distribution system is in good condition.
- Panelboard NELEQGA used for normal emergency power of optional loads has a damaged Transient Voltage Surge Suppressor and appears to have a line 1 failure and is in an alarm condition. The Unit should be serviced and replaced if needed.

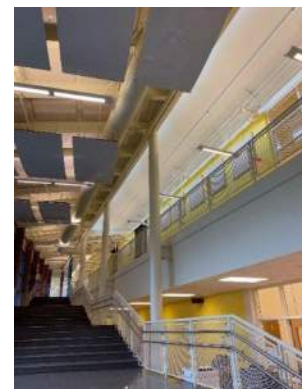
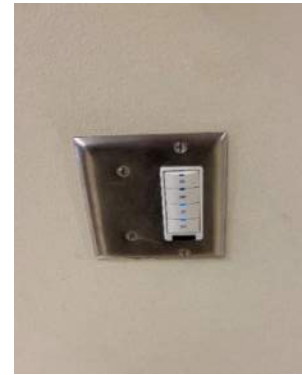
- Interior lighting is primarily comprised of 2' x 4'recessed fluorescent luminaires with prismatic lens. (in corridors), direct/indirect pendants (in classrooms and special areas), and compact fluorescent downlights.
- It does not appear that LED retrofit lamps have been utilized.
- The multi-purpose room is lighted with linear fluorescent high-bay lighting fixtures.
- Exterior building mounted and pole mounted lighting has been upgraded to LED type fixtures and is in good condition.
- Emergency lighting is integrated into the standard lighting fixtures.
- Lighting controls include low-voltage multi-button preset switches, occupancy sensors and daylight harvesting.
- Exit signs are LED type.

- LED retrofit lamps should replace fluorescent lamps throughout the building until a renovation occurs.
- The lighting and controls are in good condition and will operate adequately for a few years to come; however, fluorescent lamps will become more scarce and costly to replace.
- Interior lighting should be replaced throughout with LED type luminaires and energy code compliant controls with any major building renovation.
- Exterior LED lighting is in good condition and no further action is required.
- Lighting controls are not working properly and could need to be replaced/updated.

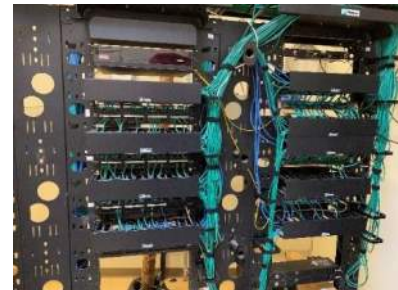
- Telecommunications systems were updated during the 2011 renovations.
- Hardwired data drops and Wi-Fi coverage are provided throughout the building, and in good condition.
- Data cabling is Cat-6 and in good condition.
- A VoIP phone system is used.
- A Rauland Telecenter intercom system with Sapling master clock system was installed during the 2011 renovations. The intercom system is obsolete.
- Digital clocks are in educational spaces, corridors, and offices. A couple of clocks have digital segments missing and are starting to dim. Clock replacements should be planned.

- Upgrade/Replace the existing obsolete intercom system.
- Replace/Repair failing digital clocks.
- Upgrade Data Telecommunications system as needed to meet the School Districts requirements with any planned building renovation.

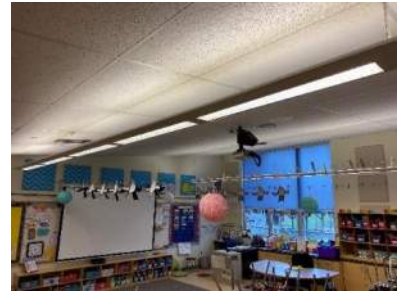
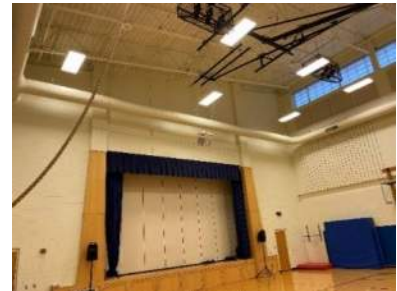
- Ceiling-mounted projectors with an audio speaker and pull-down projection screens are used in classrooms. Teachers have input stations at their desks. Equipment is dated with older equipment types.
- The Multi-purpose Room has the AV system from 2011. It appears to be used and in fair condition, but a portable sound system was also set up at the time of the survey.
- A cart with multiple projectors was at the Audio Closet in the Multi-purpose Room.

- The multi-purpose room sound system should be further investigated to determine the use of the portable system.
- Upgrade the building with new A/V Technology equipment and wiring systems.

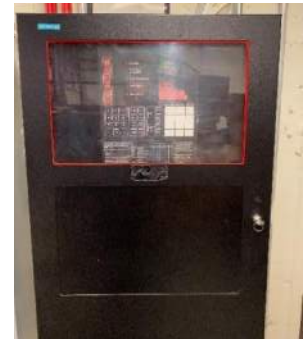
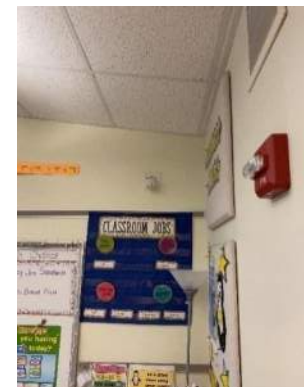
- The main fire alarm panel was replaced during the 2011 renovations and appears to be in fair condition. It is our understanding that there have been issues with maintaining this system.

- The fire alarm system is having maintenance and servicing issues and should be considered for full replacement with a new code compliant system.

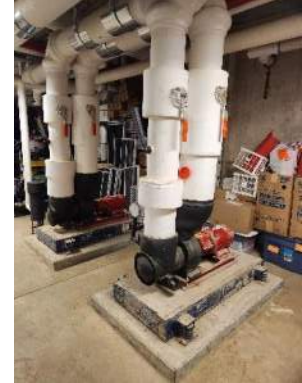
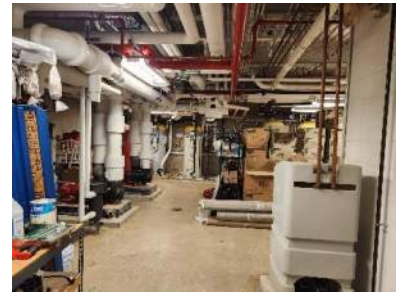
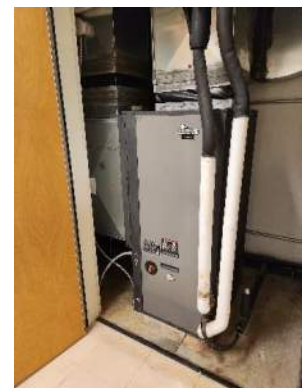
- Some of the loop water pipe insulation is failing and in need of repair or replacement. Condensation was evident because of the failed or inadequate pipe insulation.

- Test and verify water chemistry and glycol concentration.
- Clean classroom heat pump closet plenums.
- Replace/repair damaged pipe insulation.

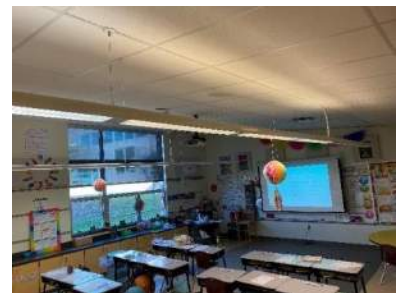
- Interior lighting is primarily comprised of 2' x 4' recessed fluorescent luminaires with prismatic lens. (in corridors), direct/indirect pendants (in classrooms and special areas), and compact fluorescent downlights.
- It does not appear that LED retrofit lamps have been utilized.
- The multi-purpose room is lighted with linear fluorescent high-bay lighting fixtures.
- Exterior building mounted and pole mounted lighting have been upgraded to LED type fixtures and are in good condition.
- Emergency lighting is integrated into the standard lighting fixtures.
- Lighting controls include low-voltage multi-button preset switches, occupancy sensors and daylight harvesting and are not working correctly.
- Exit signs are LED type.

- LED retrofit lamps should replace fluorescent lamps throughout the building until a renovation occurs.
- Luminaires and controls are in good condition and will operate adequately for a few years to come; however, fluorescent lamps will become more scarce and costly to replace. Interior lighting should be replaced throughout with LED type luminaires and energy code compliant controls with any major building renovation.
- Exterior LED lighting is in good condition and no further action is required.
- Replace/upgrade lighting controls and associated equipment that are no longer working correctly.

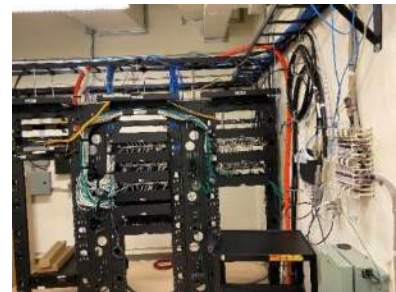
- Telecommunications systems were installed during the 2011 building construction.
- Hardwired data drops and Wi-Fi coverage are provided throughout the building and in good condition.
- Data cabling is Cat-6 and in good condition.
- A VoIP phone system is used.
- The Rauland Telecenter intercom and Sapling master clock systems were installed during the 2011 building construction. The Rauland Telecenter intercom system is obsolete and service parts will be difficult to get.
- Digital clocks are in classrooms and other educational spaces and offices throughout the building. The digital clocks are starting to have failed digital segments and reduced lumen levels.

- The School District is currently upgrading data telecommunication systems.
- Remove existing telecommunications systems equipment and cables that are no longer in use.
- Upgrade/Replace the obsolete Intercom system with a newer IP-based system.
- Upgrade/Replace the clocks and associated equipment as they are very close to their life expectancy.

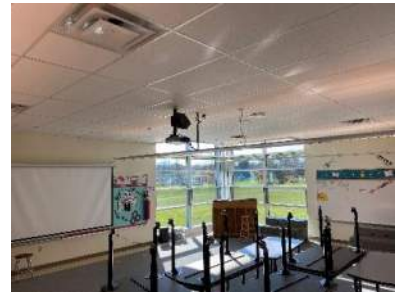
- The multi-purpose room has the AV system from 2010. It appears to be in fair condition.
- A portable projector is used in the multi-purpose room.

- Upgrade the building with new A/V Technology equipment and wiring systems.

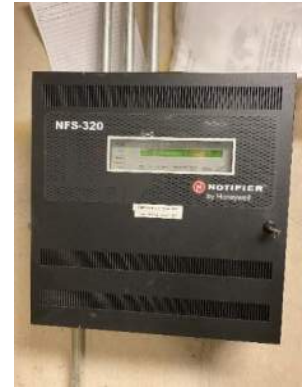
- The existing fire alarm system is a Notifier and manufactured by Honeywell. It is a zone addressable system with horn/strobe alarm notification.
- It was installed as part of the 2010 renovations and is in good condition.
- Smoke detector coverage and pull stations appear to be provided where required.
- The existing fire alarm system is grandfathered, but current NFPA codes require voice-based (speaker) notification in educational buildings. Voice fire alarm communication capabilities and speaker notification devices will need to be introduced for any future renovations that require changes to the fire alarm system.
- A rescue assistance system exists at stairs where egress is restricted.

- Future renovations will necessitate installation of voice communication capabilities for the fire alarm system. Horn based notification devices will need to be replaced with speaker type devices, and additional modules/components will be required at the head-end fire alarm control panel.
- The fire alarm system should be considered for full replacement with any major building renovations.

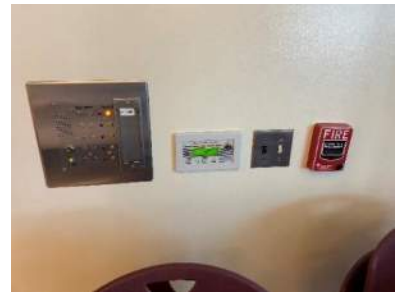
- Card access readers are in use at selected exterior doors.
- An audio-visual intercom system is being used at the main entrance.
- CCTV cameras are in use at the interior and exterior locations of the building.
- Panic buttons are installed in receptionist areas.

- Systems appear to be in good condition. Upgrade systems as needed to meet the School District and any future renovation requirements.
- Maintain systems per manufactures requirements.

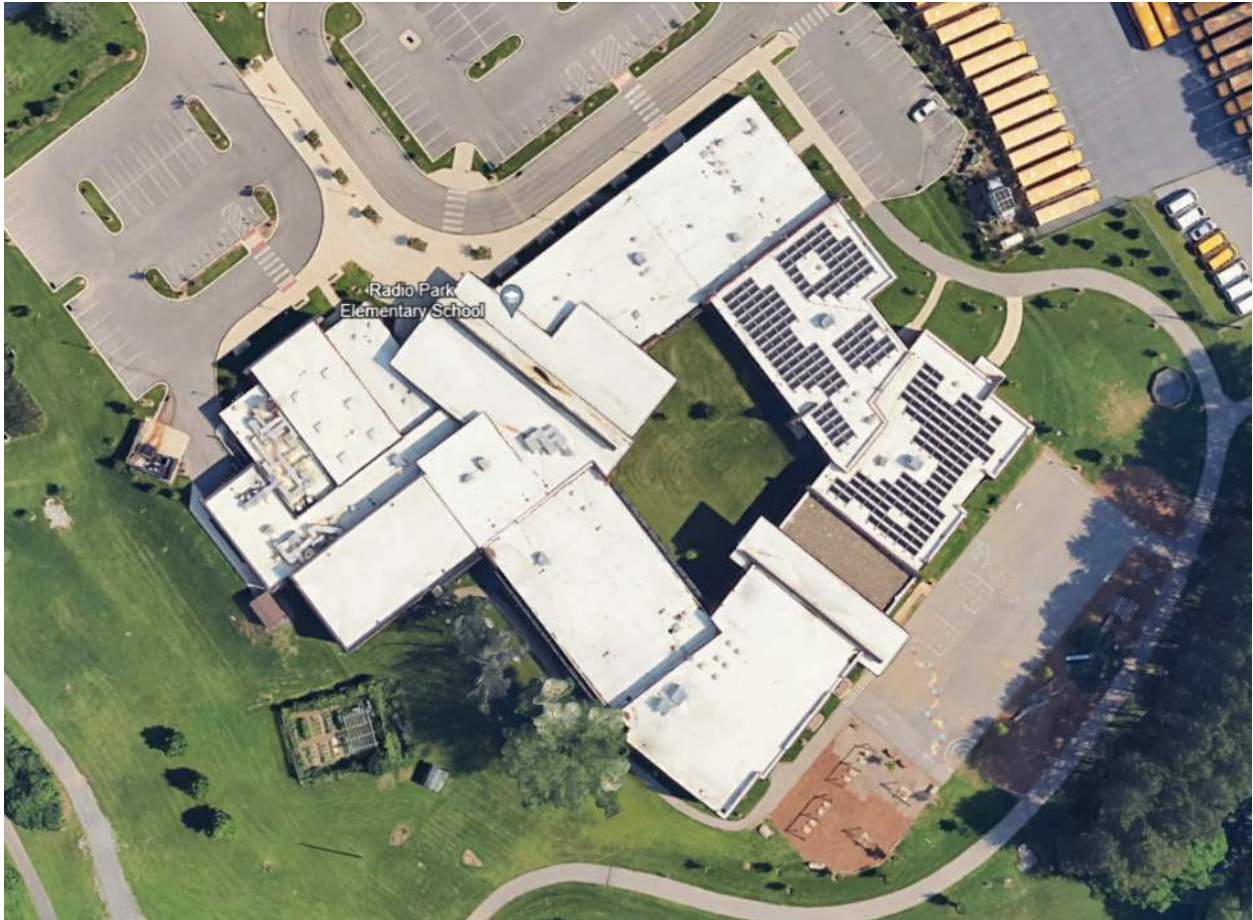
The existing roof was replaced in 2019 as part of the construction project for both the new construction and existing and is currently under warranty. Rainwater is conveyed away from the building by roof drains, gutters and downspouts that tie into an underground storm system. Roofing and rainwater conveyance are in good in good condition.
