## 6 | Easterly Parkway Elementary School

<b>Address:</b>	234 Easterly Parkway State College, PA 16801
<b>Construction Timeline:</b>	Originally constructed in 1955; renovation/addition in 2002.
<b>Building Square Footage:</b>	55,895 sf
<b>Site Acreage:</b>	11.4 acres

Easterly Parkway Elementary School is a 2-story building located in State College Boro, State College, PA. The school currently houses grades K-5. The property is served by public water, sewer and natural gas.

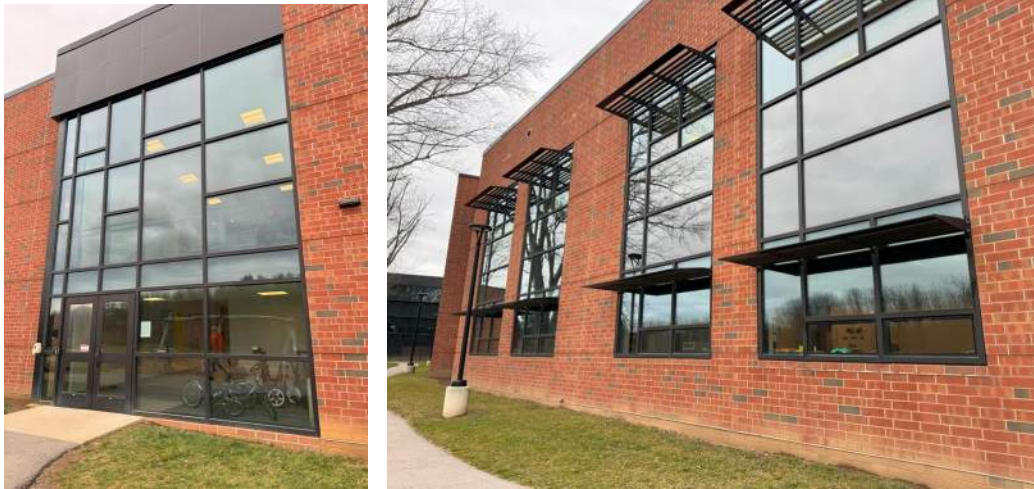
Windows are operable, awning windows with blinds mounted to the window head opening. Entrances are anodized black aluminum storefront. Windows and doors are in good condition.

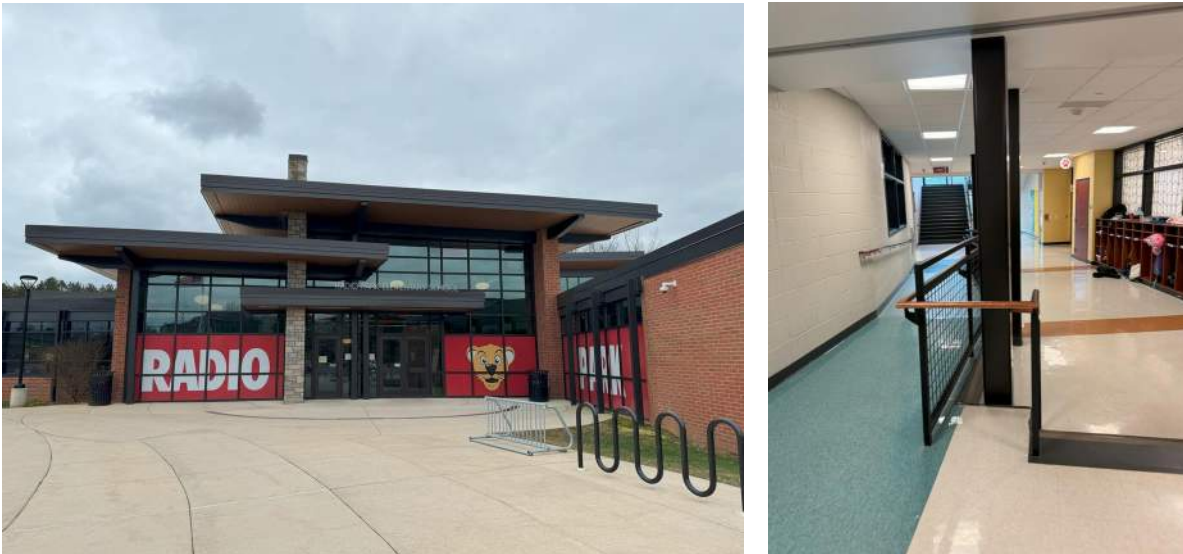
The building is a 2-story masonry load bearing for recent additions and steel frame for the original 1963 structure. The multi-purpose room has an exposed steel structure. Exterior canopies are supported with exposed steel columns that are wrapped. Overall, the building structure appears to be in good condition.

- None at this time, structure is in good condition.

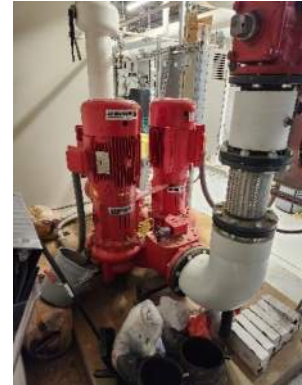
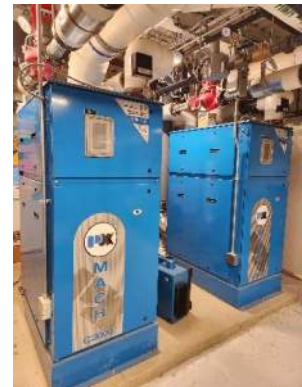
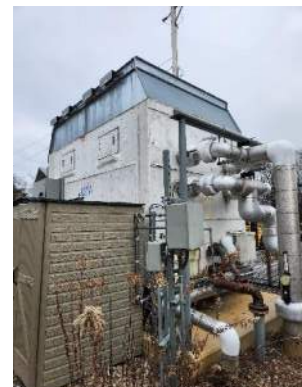
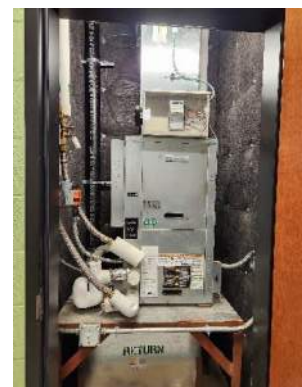
- The tower was found to be in fair condition. It was reported that there have been coil freeze issues with the tower. We suggest that a control strategy be implemented to circulate water through the tower to prevent freezing in the future. A flow meter should be added and monitored through the DDC system to verify that adequate flow is being circulated.

- The tower is showing general signs of corrosion. Cleaning and refinishing the surfaces will help to extend the unit life.
- Patterson Kelly high efficiency gas boilers are utilized to heat the loop during the heating season. The boilers were found to be in good condition.

- Implement freeze protection flow strategies on the existing tower system.
- Clean and refinish the tower surfaces that are showing signs of corrosion.
- Test and verify water chemistry and glycol concentration.
- Clean classroom heat pump closet plenums.

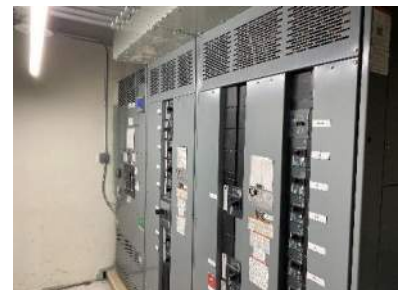
- The electric service entrance comes into the building from a 300 KVA pad-mounted Utility transformer to a three section 4000-amp, 208/120-volt, 3-phase, 4-wire switchboard with a 4000-amp main breaker with 2500a trip setting in one section and two sections for distribution circuit breakers.
- Utility CT's and meter are located at the pad mounted utility transformer.
- The Switchboard has a surge suppression device and a customer meter.
- Distribution and branch circuit panelboards are located throughout the building.
- All electrical distribution equipment was manufactured by Schneider/Square D and installed during the 2018-2019 project. The equipment appears to be in very good condition.

- The Switchboard does not appear to meet the current code requirements to have Arc Energy Reduction which became an adopted code requirement after this project was completed.
- There is a Solar Photovoltaic System located on the roof of this building and its service disconnect is located on the rear exterior wall across from the utility transformer.

- Maintain equipment per manufactures requirements.
- Replace surge suppression devices. It is our understanding that the Surge Suppression Devices have been recalled by the manufacturer and that the Owner is working with Farfield Electrical contractor and Schneider/Square D to replace them.
- Review ways to address new Arc Energy Reduction code requirement.

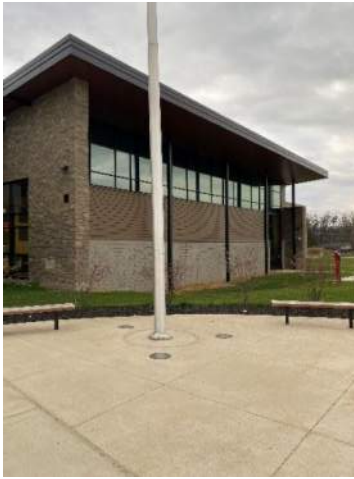
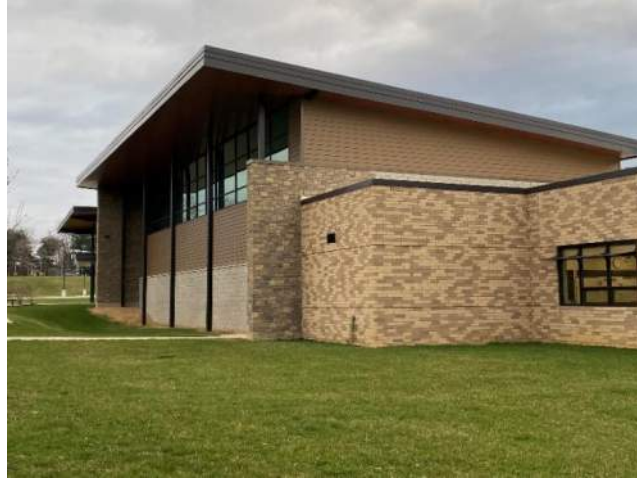
The building exterior consists of insulated masonry cavity walls with combination of brick, ground face CMU, and manufactured stone veneer, with CMU backup. Cavity insulation is spray foam insulation. There is minor staining on the face brick where rainwater conductors for overflow drains empty out onto grade.

- Minor cleaning of face brick where stains have occurred. This is localized to only 2 or 3 locations building wide and is a routine cleaning item.

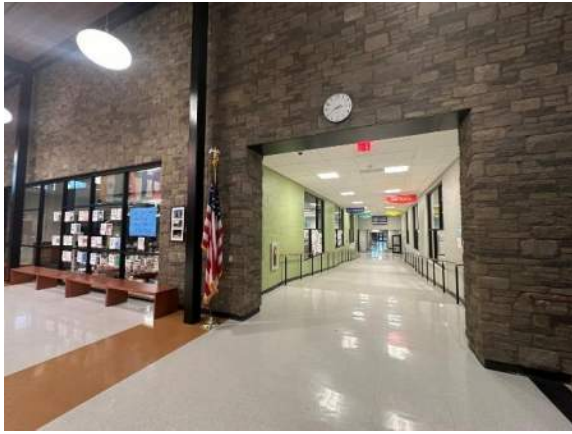
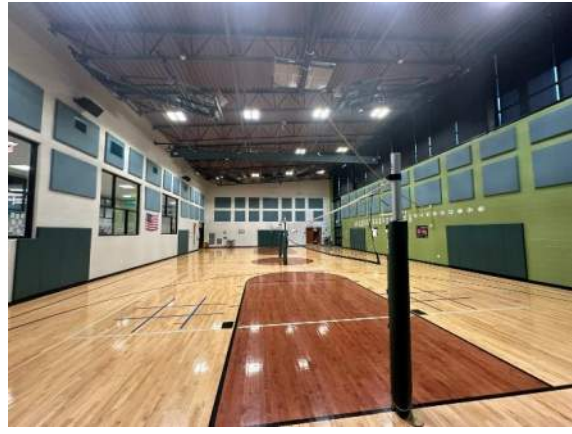
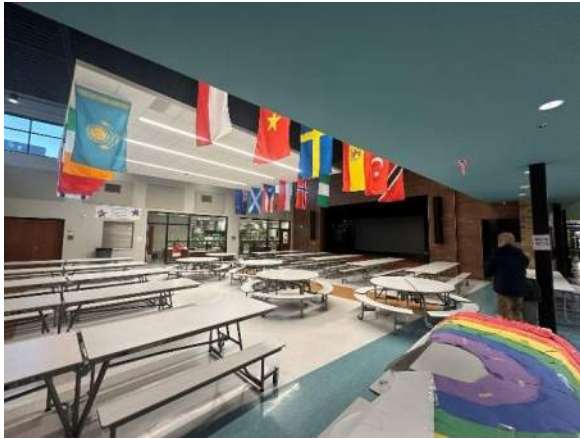
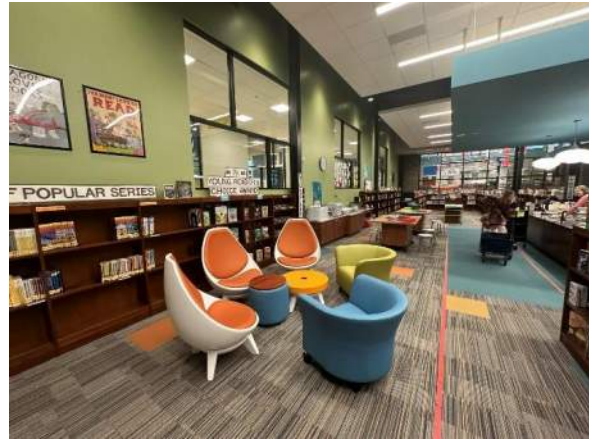
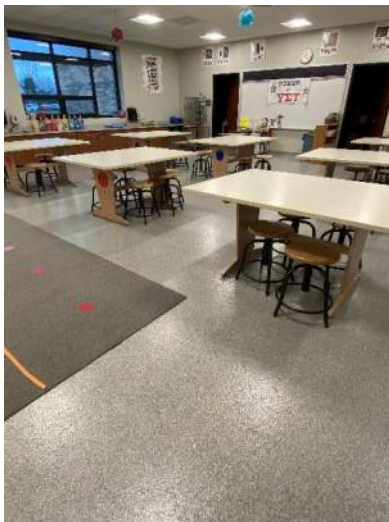
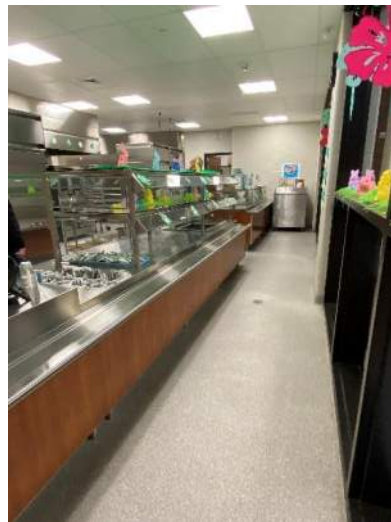
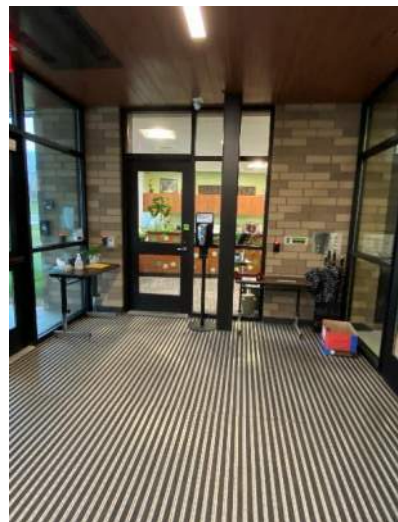
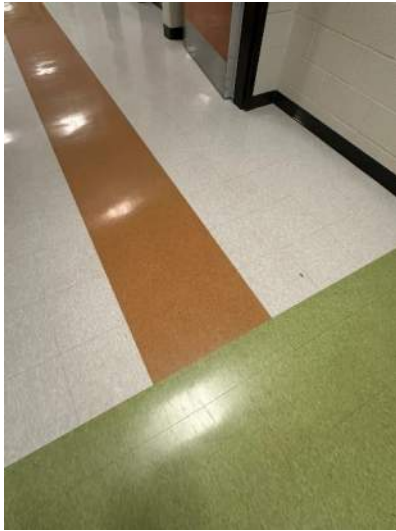
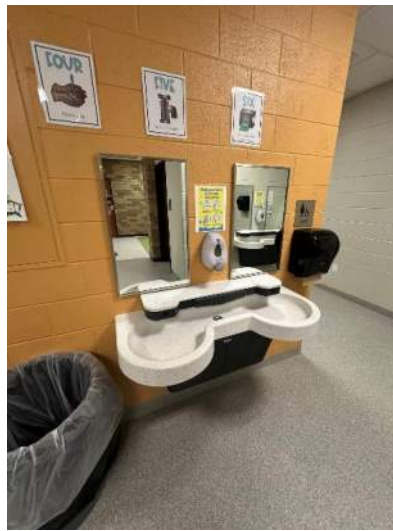
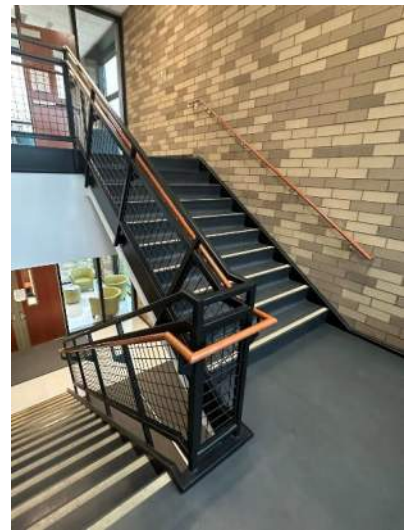
VCT exist throughout most of the school. The VCT floor tile is located in the corridors and the VCT continues in the classrooms. All are in good condition.

Carpet tiles are found in the main office, miscellaneous offices throughout, and in the Media Center and is in good condition. A recessed entrance mat is included in the secure vestibule at the main entrance.

Flooring in the group and single compartment toilet rooms, Art Room and Kitchen area is poured resinous flooring and base and is in very good condition.

The Gymnasium has a competition wood floor that is in very good condition.

Mechanical areas have sealed concrete. The cafeteria has VCT which is in good condition.

Interior walls are combination of exposed brick, manufactured stone, painted CMU and gypsum wallboard.

Acoustical ceilings throughout the building are in good condition.

Recommendations:

- None at this time.

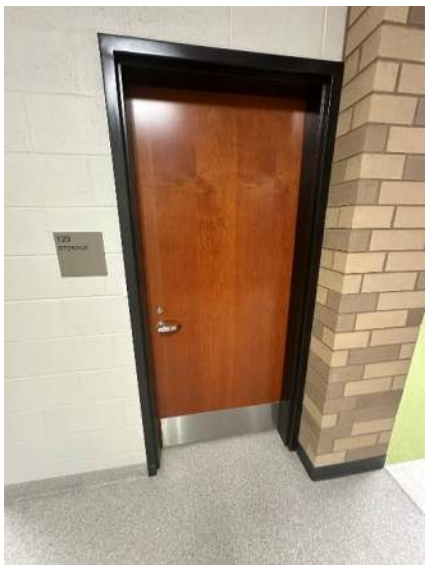
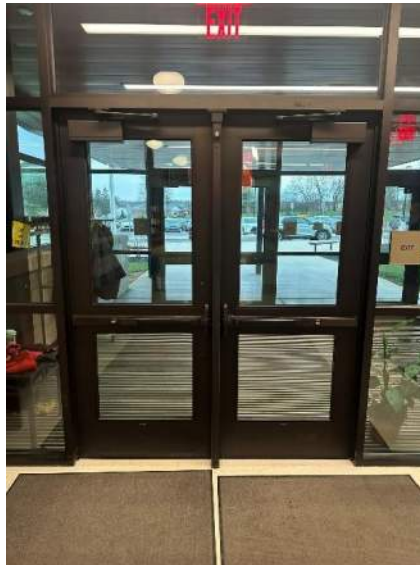
Interior doors are solid core wood or painted hollow metal in painted hollow metal frames, and are in very good condition.

Interior aluminum doors and frames match the color of the exterior frames and are also in very good condition.

Recommendations:

- None at this time.

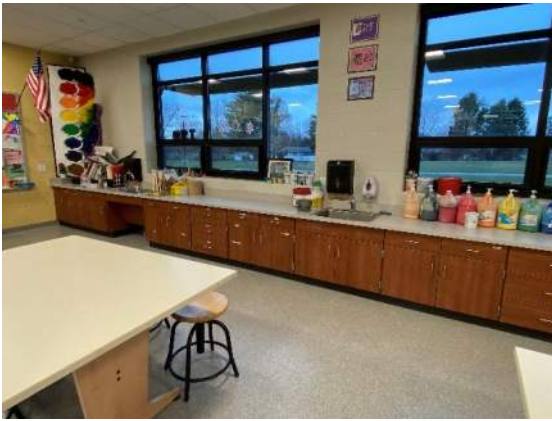
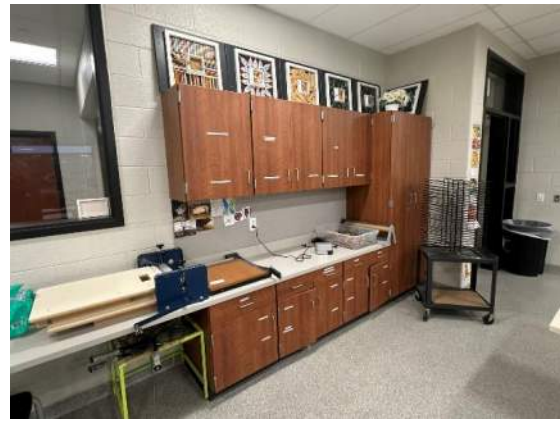
Interior casework is plastic laminate and in very good condition. Casework allows for forward approach to sinks for accessibility.

Recommendations:

- None at this time.

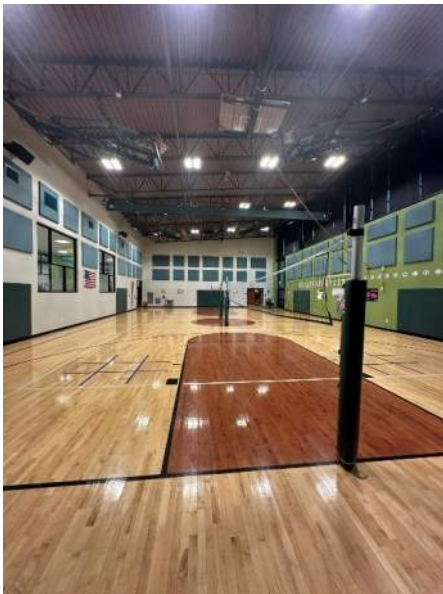
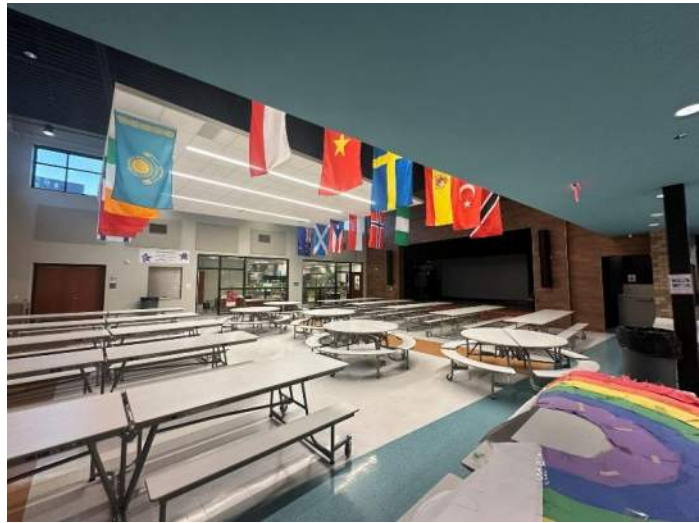
Gymnasium equipment consists of retractable, ceiling-hung basketball backstops, ceiling mounted retractable curtain, badminton and volleyball nets. All are in working order and in good condition.

The stage curtain and lighting and sound systems in the Cafeteria are also in good condition.

Acoustical wall panels are in both the Gymnasium and Cafeteria to control noise.

Recommendations:

- Not at this time.

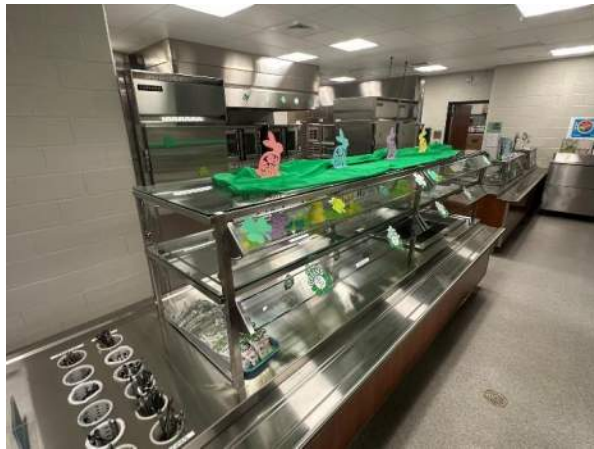
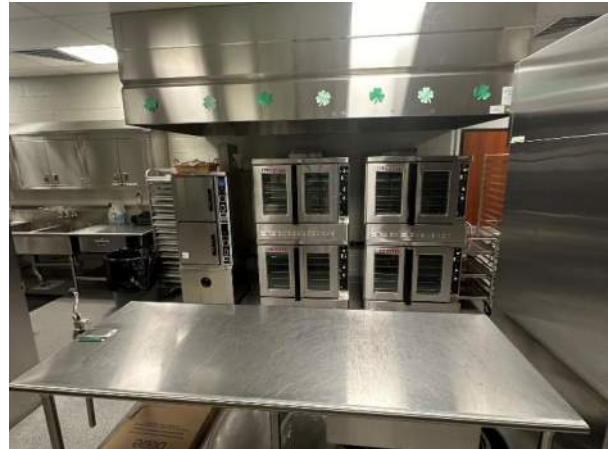
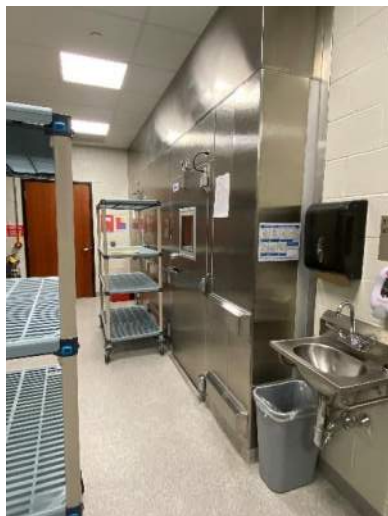
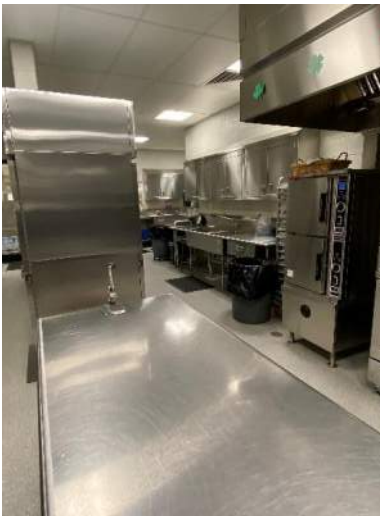
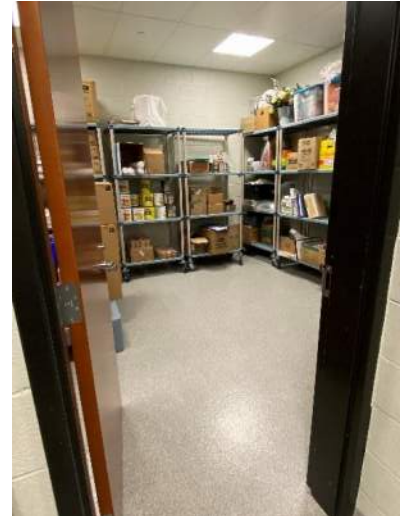
The food service equipment is original to the building's construction in 2019 and is in very good condition.

### Recommendations:

- None at this time.

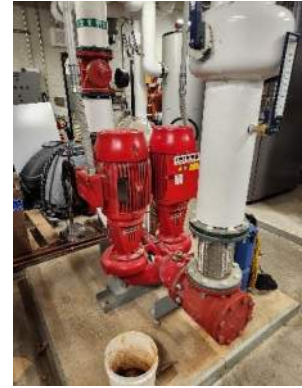
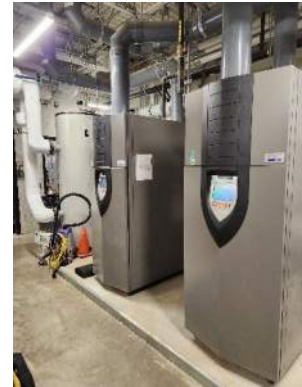
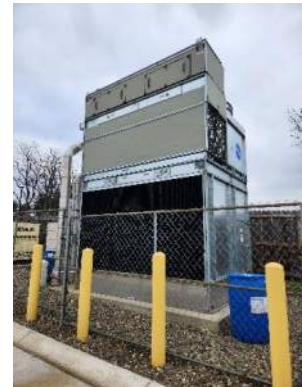
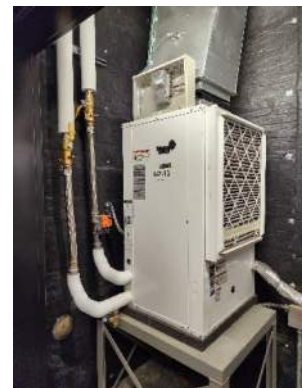
- The building is served by a water source heat pump system. Most of the system and components date back to the 2019 additions and renovation project.
- Duplex loop water pumps circulate water through the building systems. These pumps include VFD's to vary system flow based on demand. The pumps are in good condition.

- Loop water temperature is maintained using a closed-circuit cooling tower in the cooling season and boilers in the heating season.
- The Baltimore Aircoil closed-circuit cooling tower is installed remote from the building. There are 6" underground loops connecting the tower to the building system. Loop water is circulated through the tower to reject heat from the heat pump loop to the outside. The tower was found to be in good condition. It was reported that there have been coil freeze issues with the tower. We suggest that a control strategy be implemented to circulate water through the tower to prevent freezing in the future. A flow meter should be added and monitored through the DDC system to verify that adequate flow is being circulated.

- Lochinvar high efficiency gas boilers are utilized to heat the loop during the heating season. The boilers were found to be in good condition.
- Classrooms are mainly served by vertical heat pumps located in closets. The units utilize R-410a, are serviceable, and were found to be in good condition. These units typically have a 20-year lifecycle if properly serviced and maintained.

- Classroom outdoor air ventilation is provided by York roof mounted energy recovery wheels. Pre-conditioned air is delivered to the closets and circulated through the plenum returns. These units were found to be in good operating condition.

- Large zones utilize roof mounted units with compressors to provide HVAC to the related space. These units were found to be in good operating condition.

- Mini split units are provided for several IT areas. All were noted to be in good operating condition.
- Electric unit heaters and cabinet heaters are utilized for specific space heating only needs.

- Exhaust fans throughout are up to current standards and in good condition.

Recommendations:

- Implement freeze protection flow strategies on the existing tower system.
- Test and verify water chemistry and glycol concentration.
- Clean classroom heat pump closet plenums.

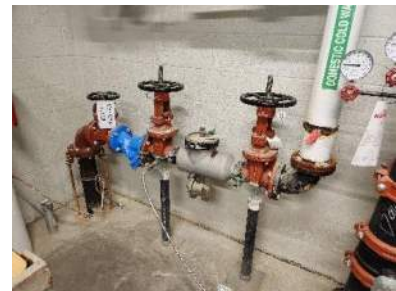
- The school is served off a public water service. The 4" service size is adequate for the school's needs. There were not any observed or noted issues.
- The water service includes a code compliant backflow prevention device that appears to be operational.
- The piping system was reported to be in good condition with no known pipe issues.
- The domestic water system includes a Marlo duplex water softening system with an exterior brine tank system. The softener system is in good condition.

Recommendations:

- None.

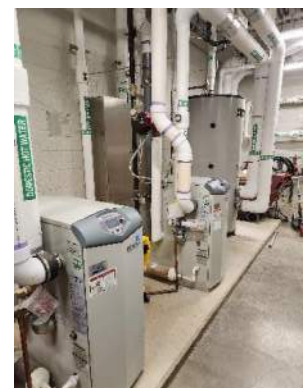
- Domestic hot water is developed by two Lochinvar Armor high efficiency gas fired boilers tied to a 318-gallon storage tank. The tank was found to be in good condition.
- A Leonard high/low mixing valve is used for temperature control. The valve is in good condition.
- The hot water recirculation pumps are in good working condition with no reported issues.

Recommendations:

- None.

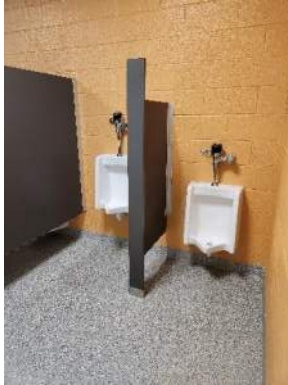
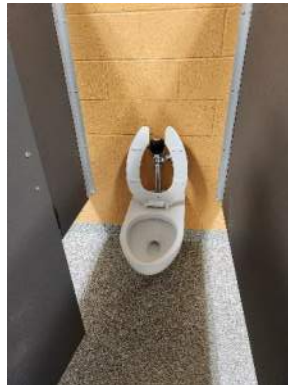
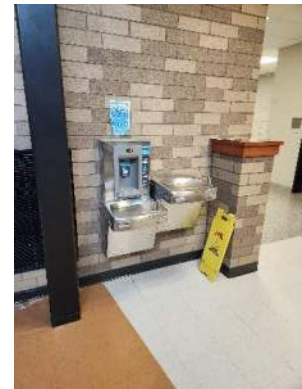
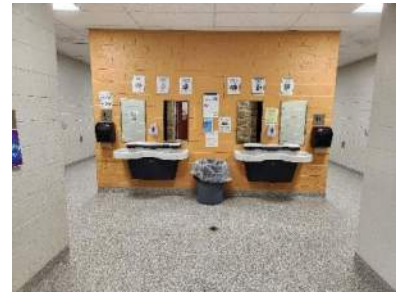
- Plumbing fixtures throughout appear to be in good condition. Fixtures and fittings are low flow for water savings.
- Water closets and urinals utilize automatic hands-free flush valves.
- Multi-station lavatories are utilized in group toilet rooms. These units include hands free faucets.
- Classroom sinks include bubblers and faucets with blade handles.
- Dual level water coolers appear to meet ADA and include bottle fillers.

Recommendations:

- None.

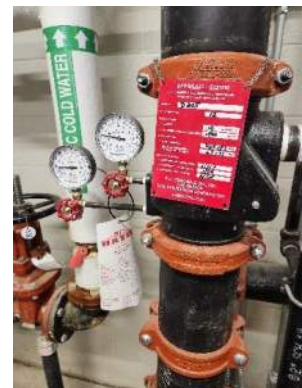
- The building is fully protected by a fire sprinkler system. This system is served off a 6" public water service. There are multiple feeds to separate sections of the building based on fire areas.
- The system is a wet pipe system.

Recommendations:

- None.

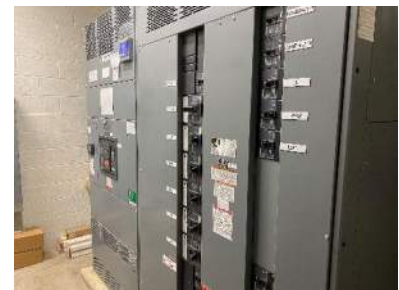
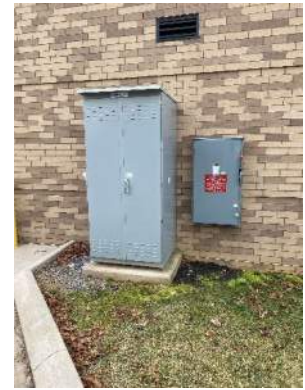
- The electric service entrance comes into the building from a 300 KVA pad-mounted Utility transformer to a two section 4000-amp, 208/120-volt, 3-phase, 4-wire switchboard with one section containing the 4000A main frame breaker with 2500a trip setting and one section for distribution circuit breakers.
- Utility CT's and meter are located at the exterior pad mounted CT cabinet located next to the building across from the utility transformer.
- The Switchboard has a surge suppression device and a customer meter.
- Branch circuit panelboards are located throughout the building.

- All electrical distribution equipment was manufactured by Schneider/Square D and installed during the 2018-2019 building construction. The equipment appears to be in very good condition.
- The Switchboard does not appear to meet the current code requirements to have Arc Energy Reduction which became an adopted code requirement after this project was completed.
- There is a Solar Photovoltaic System located on the roof of this building and its service disconnect is located on the exterior wall beside the pad mounted CT cabinet across from the utility transformer.

- Maintain equipment per manufactures requirements.
- Replace surge suppression devices. It is our understanding that the Surge Suppression Devices have been recalled by the manufacturer and that the Owner is working with Farfield Electrical contractor and Schneider/Square D to replace them.
- Review ways to address new Arc Energy Reduction code requirement.

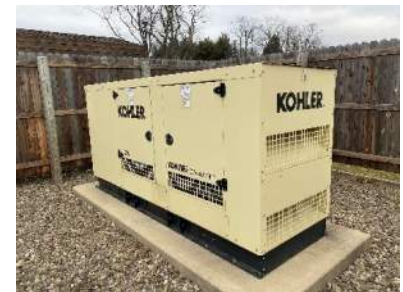
- An exterior pad mounted 125 KW, 208/120v, 3 Ph, 4 W, Natural Gas generator is used for both life safety loads and optional equipment loads in this building.
- There are three separate automatic transfer switches and panelboards used for life safety loads and optional standby equipment loads. They are in their own dedicated room away from the normal distribution equipment.
- There are separate life safety and optional standby branch circuit panelboards located at multiple locations in the building.
- Generator and Automatic Transfer Switches are manufactured by Kohler and all equipment appears to be in good condition.
- Emergency generator and associated equipment were installed in 2018-2019 during the building construction project.
- A wall mounted generator remote annunciator is in the receptionist office area.

- Maintain Generator per manufactures requirements.

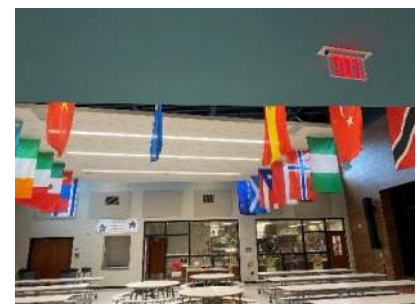
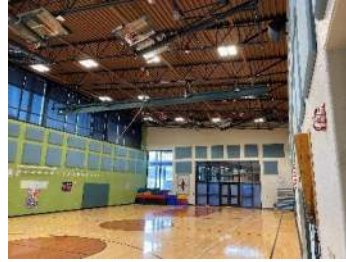
- Site lighting consists of LED type luminaires.
- 2'x 2' recessed LED luminaires with prismatic lens are used in corridor areas.
- 2'x 2' recessed LED luminaires with opal diffuser are used in classrooms.
- The library has recessed linear LED luminaires, pendant mounted LED luminaires with white diffuser, pendant mounted and recessed downlight LED luminaires.
- The cafeteria has pendant mounted LED downlight luminaires and recessed LED linear luminaires.
- LED strip luminaires with diffusers are in the mechanical/electrical, and storage rooms areas.
- Luminaires are controlled by Energy Management Devices.

- All LED luminaires and energy management devices were installed during the 2018-2019 building construction project. They appear to be in good condition.

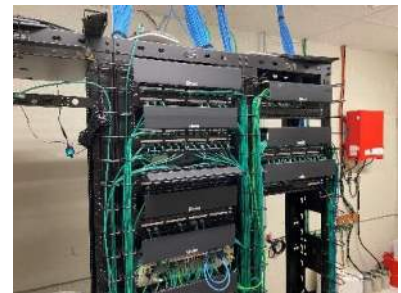
- Data cable is Category 6 and in good condition.
- WiFi coverage is provided in classrooms and learning areas throughout the building.
- A VoIP phone is used.
- A Rauland Telecenter IP intercom system with call stations is in use in this building.
- Analog IP Clocks manufactured by Sapling are used throughout the building in classrooms, corridors, office areas, Multi-Purpose, Library, and other learning areas.
- A small nurse call system is in use in the nurse suite area.
- New systems were installed during the 2018-2019 building construction project. They appear to be in good condition.

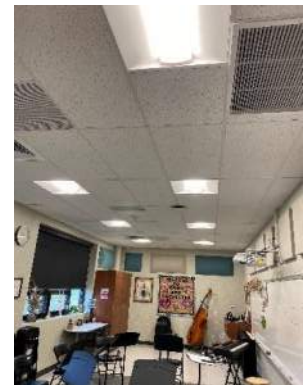
- Wall mounted projectors with white boards are used in every classroom.
- Wall mounted projector is used in learning stair area.
- A rear mount projector is used with a projection screen on the stage area.
- Crestron A/V systems are used in classrooms and other learning spaces.
- All installations were completed during the 2018-2019 building construction project. They appear to be in good condition.

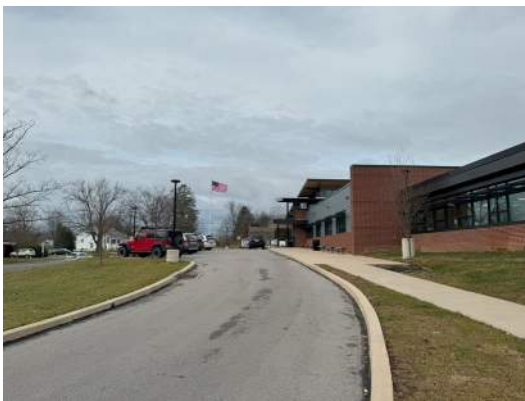
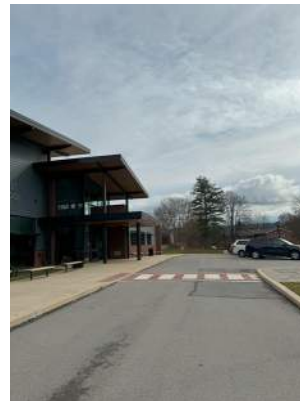
Vehicular access to the site is from South Corl Street. There is a drive running parallel with the front of the school on which parents pick up and drop off students and also from S. Corl Street. There is another drive along W. Highland Alley that connects from the front drive that runs parallel to the north side of the school which is used by buses to pick up and drop off.

Deliveries are made along West Highland Alley. Staff park is located in the paved lot located at the back of the school in the northeast corner. Visitors park in the paved spaces across from the main entrance of the school. There are ADA accessible parking spaces in both parking areas, and an accessible route from the parking spaces to the front entrance and rear entrance of the building exist at both locations.

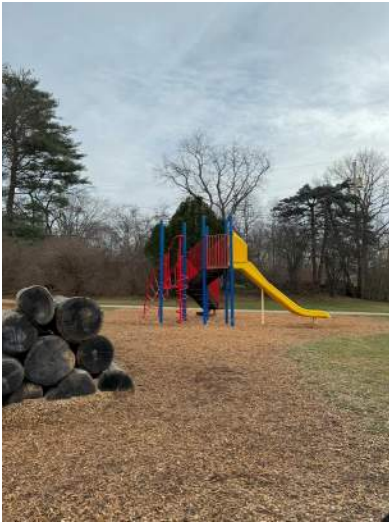
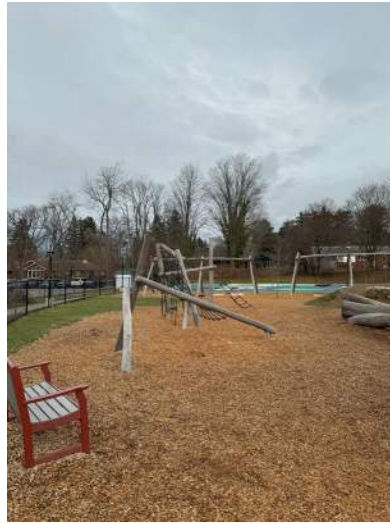
The site has one hard-surface play area in the northeast corner of the site, which includes a basketball court with backboards. There is a large soft-surface play area with naturally designed play equipment, and is surfaced in loose wood chips that does require routine maintenance. The site also features a small grass play area. All are in good condition and all play areas are well separated from vehicular traffic.

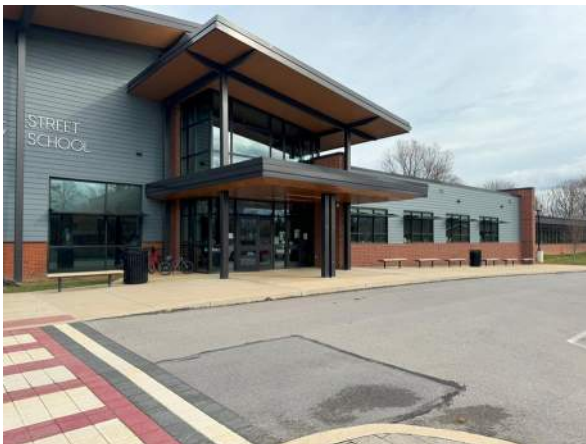
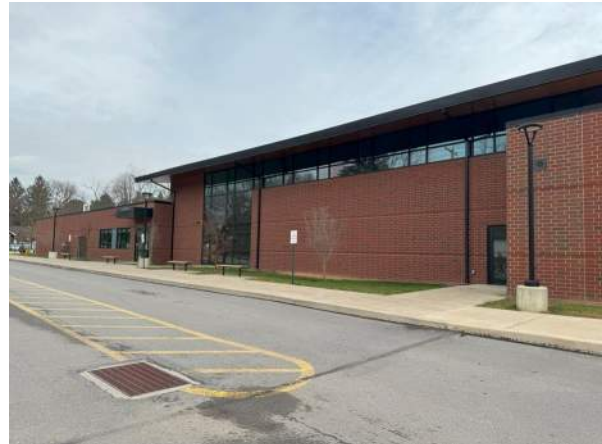
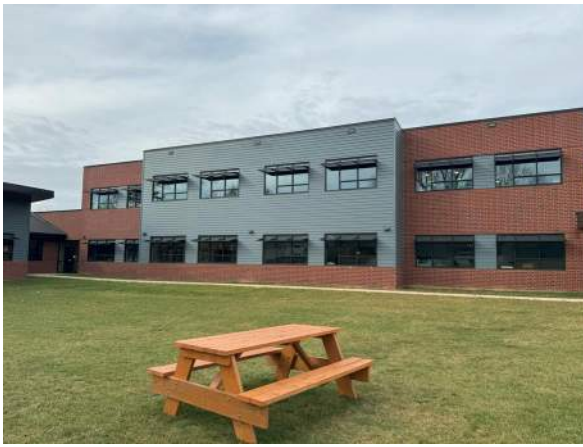
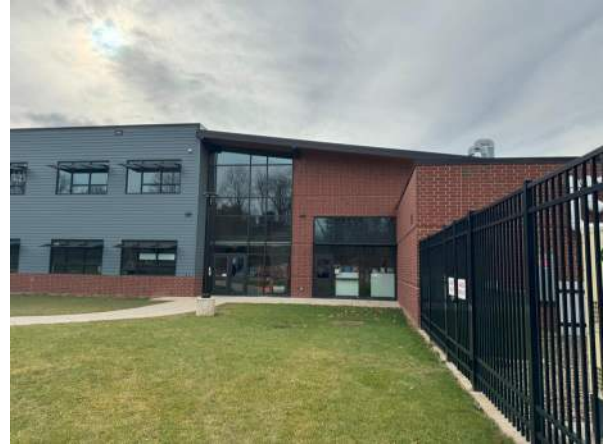
The building exterior consists of insulated masonry cavity walls with brick veneer and concrete plank over CMU backup. Window stools are brick and in good condition.

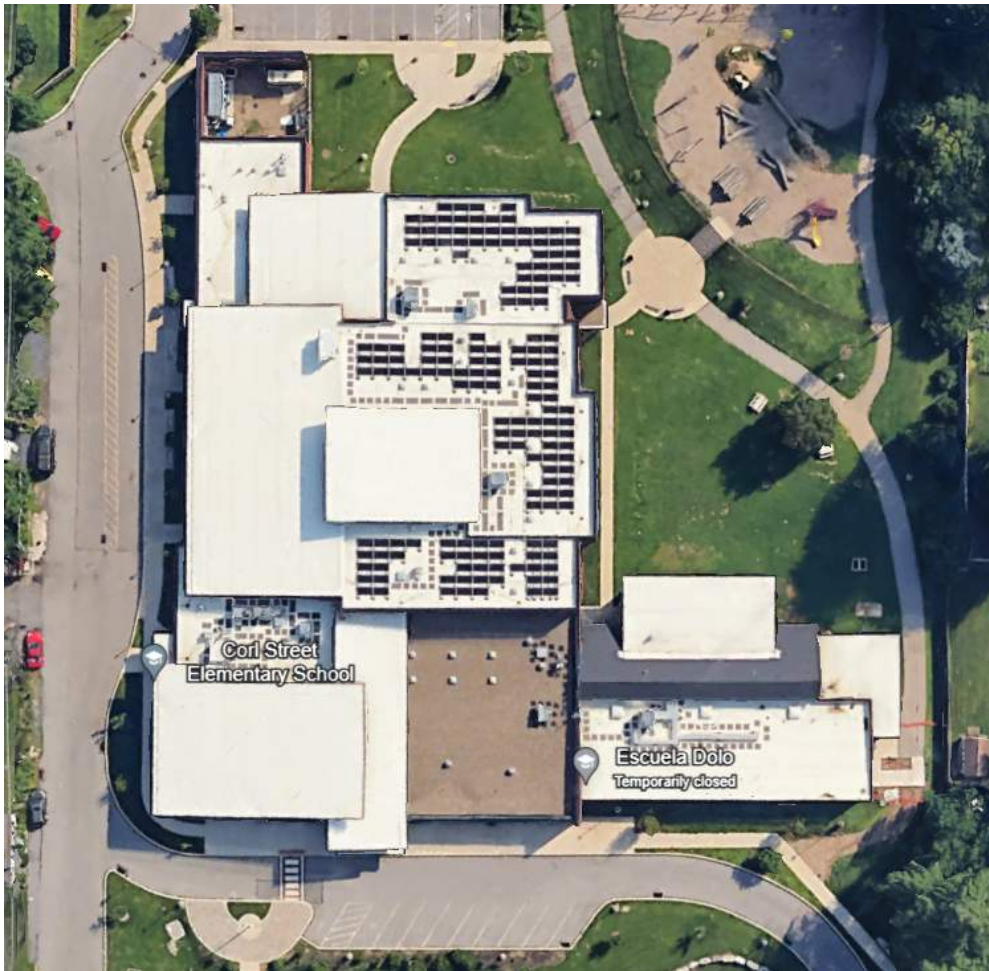
The existing roof was replaced in 2019 and is under warranty. Rainwater is conveyed away from the building by roof drains, gutters and downspouts that tie into an underground storm system. Roofing and rainwater conveyance are in good condition.

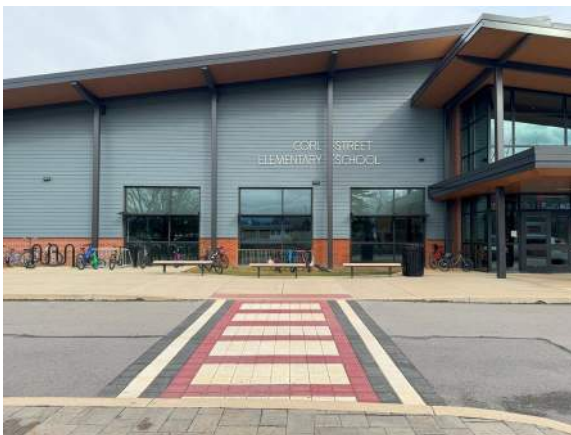
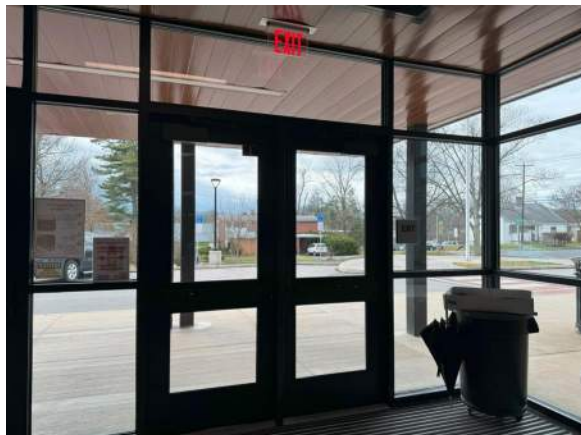
Windows are operable, awning windows with blinds mounted to the window head opening. Entrances are anodized aluminum storefront. Windows and doors are in good condition.

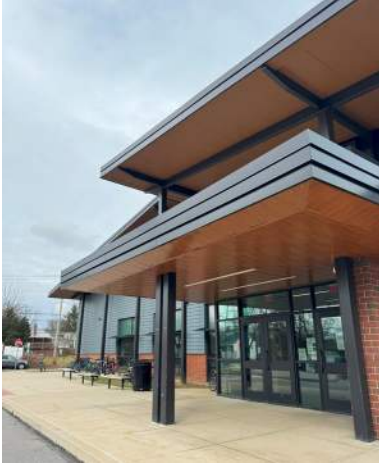
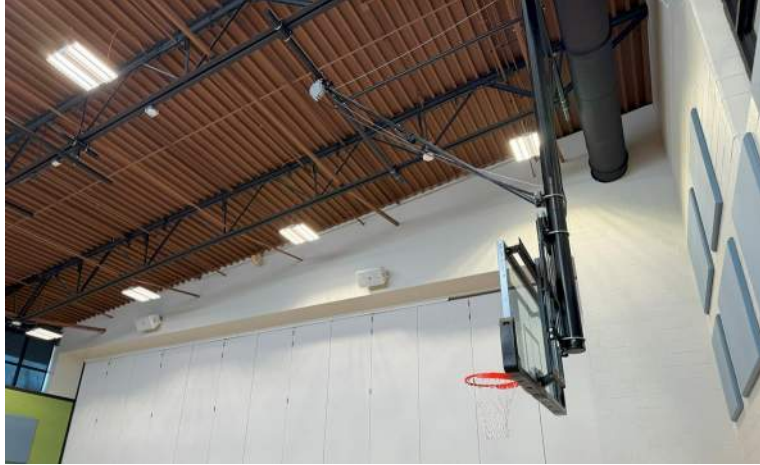
The building is a 2-story masonry load bearing & central steel frame structure along the main street of the school and central public program functions. The multi-purpose room has an exposed steel structure. Exterior canopies are supported with steel beams and columns. Overall, the building structure is in good condition.

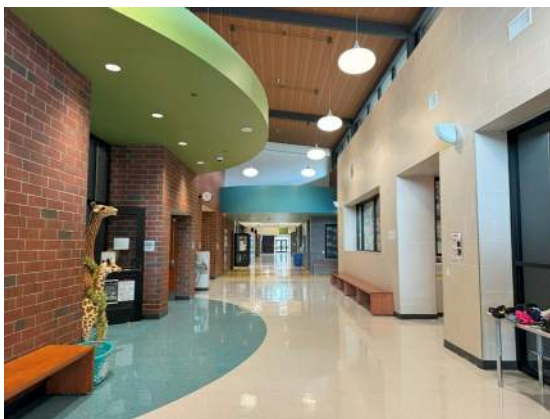
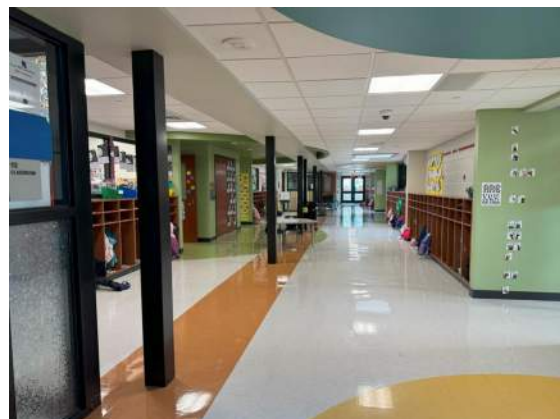
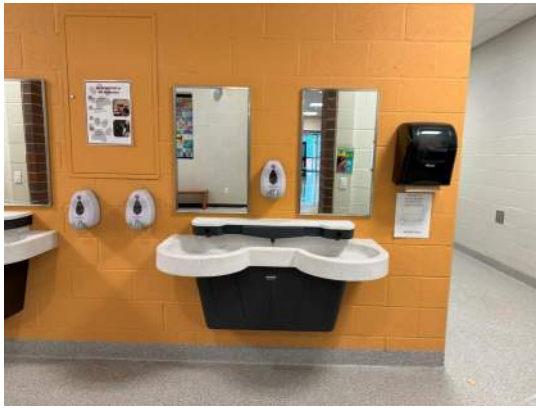
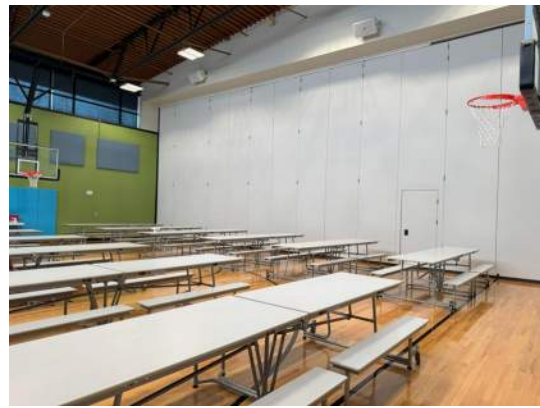
Most of the flooring throughout the school is VCT and is in good condition. Carpet exists in the main office and is well maintained. The toilet rooms and kitchen have a resinous floor. Mechanical areas are sealed concrete. The multi-purpose room is wood flooring which is in good condition.

Interior walls vary between exposed brick, tile, and CMU and are in good condition. Acoustical and gypsum board ceilings and bulkheads throughout the building are in good condition.

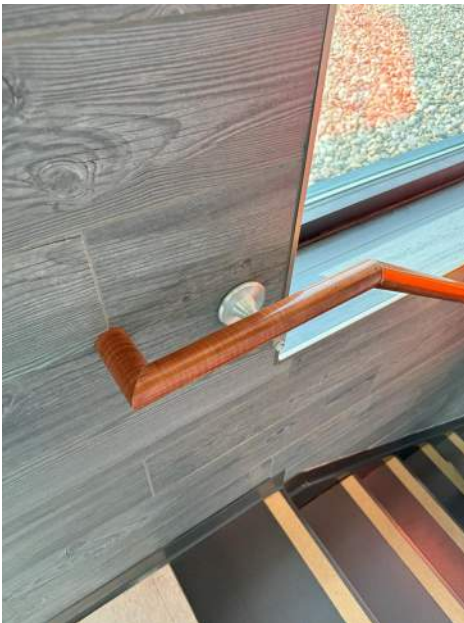
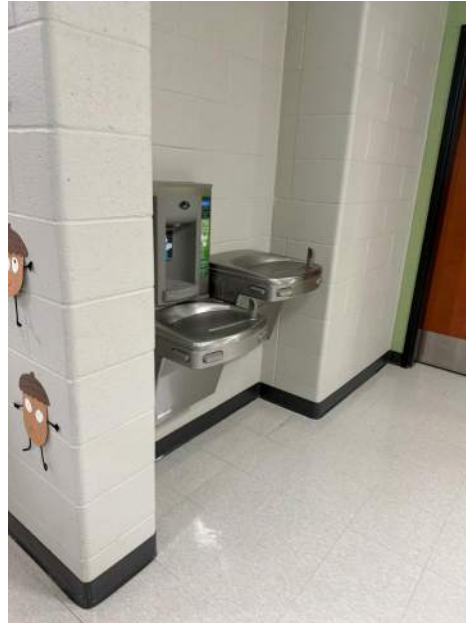
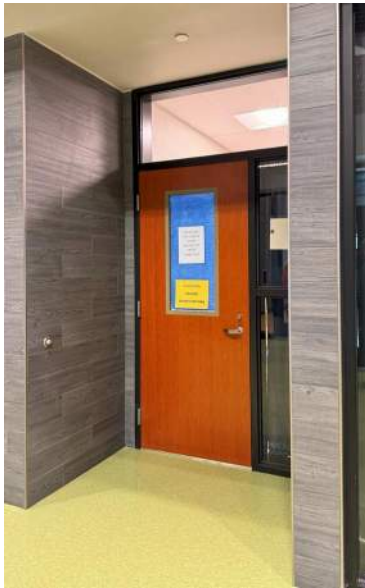
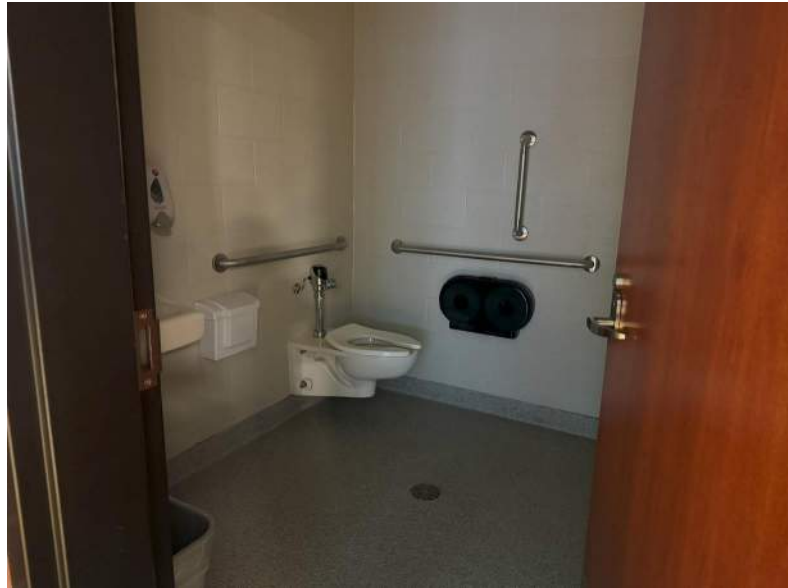
Toilet rooms are accessible.

Door hardware throughout the building has ADA compliant lever-style handles. There is an elevator that serves both floors.

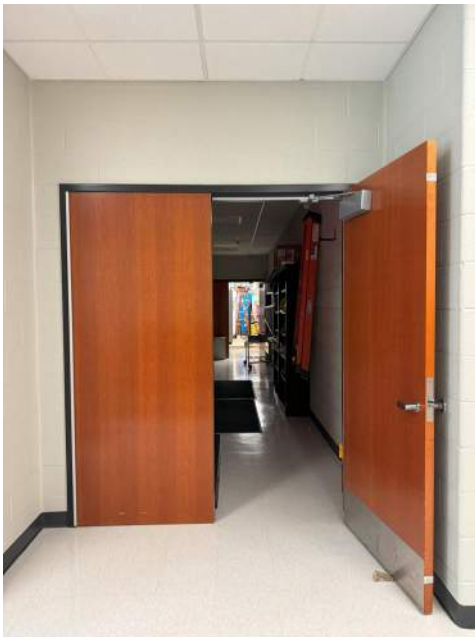
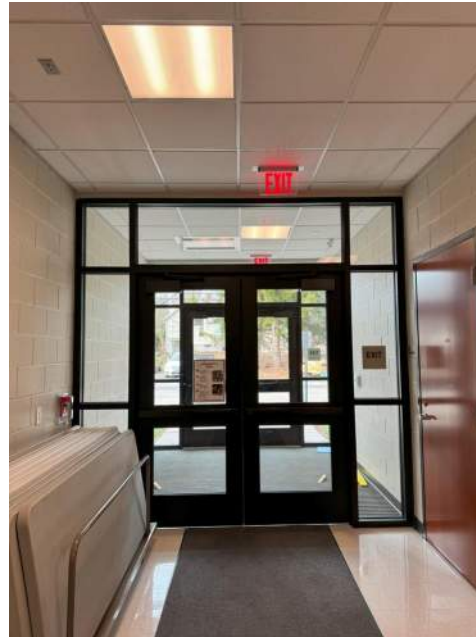
Interior doors are wood and are in good condition. Interior aluminum doors are also in good condition.

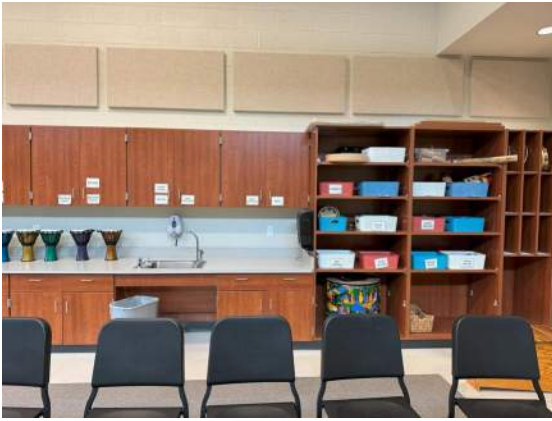
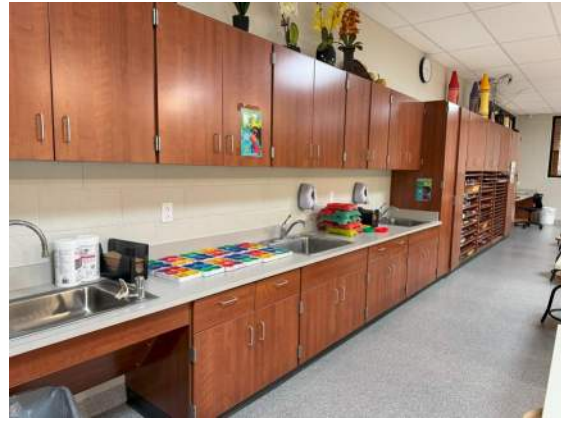
Interior casework is in good condition. Casework underneath the sinks throughout the building allow for a forward approach for accessibility.

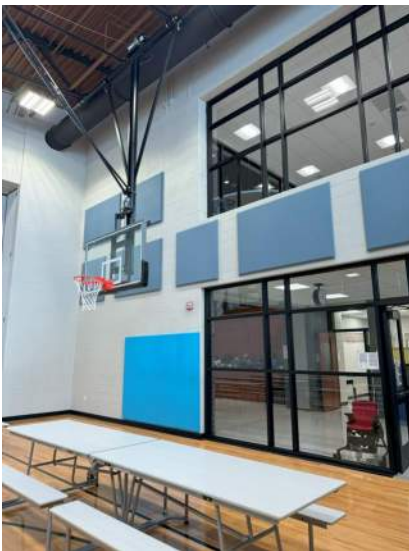
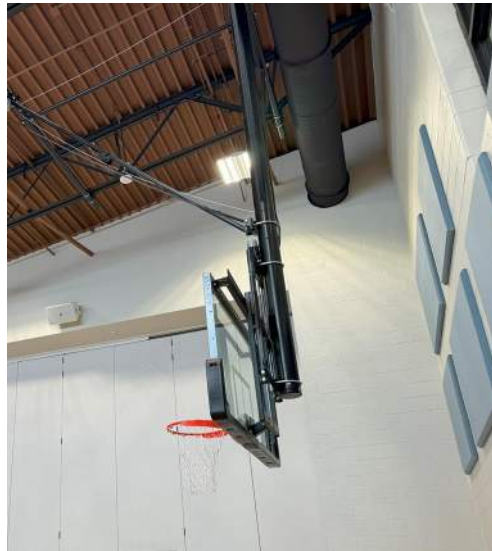
The multi-purpose room equipment consists of retractable basketball backstops. There is a folding wall partition for the multi-purpose room. All are in good condition. The stage curtain and lighting are also in good condition.

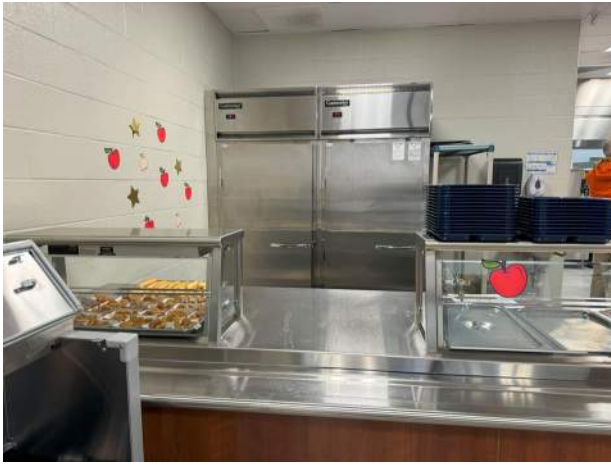
The kitchen was a 100% replacement as part of recent construction project completed in 2019, due to this the kitchen is in good/new condition.

- None at this time, due the new/good condition of the entire kitchen, no large expenditures should be planned at this time, beyond routine maintenance and/or equipment issues that might occur periodically and be budgeted in a yearly food service capital budget.

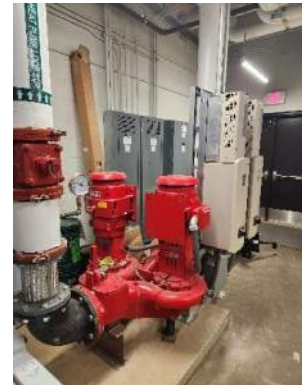
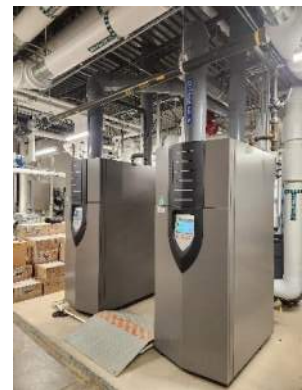
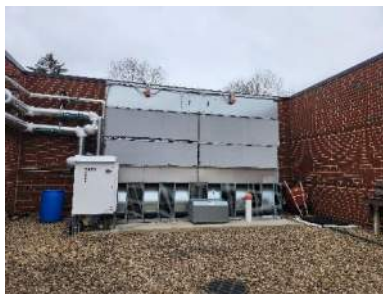
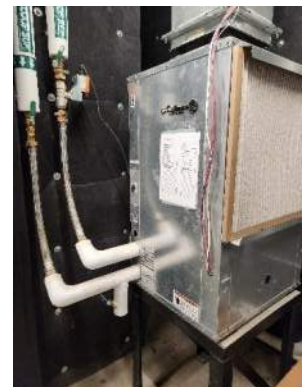
- The tower fan shafts are showing signs of corrosion. Clean and refinish to extend the life.
- Lochinvar Crest high efficiency gas boilers are utilized to heat the loop during the heating season. The boilers were found to be in good condition.

- Implement freeze protection flow strategies on the existing tower system.
- Clean and refinish the tower fan shafts.
- Test and verify water chemistry and glycol concentration.
- Clean classroom heat pump closet plenums.
