## 6 | Easterly Parkway Elementary School

<b>Address:</b>	234 Easterly Parkway State College, PA 16801
<b>Construction Timeline:</b>	Originally constructed in 1955; renovation/addition in 2002.
<b>Building Square Footage:</b>	55,895 sf
<b>Site Acreage:</b>	11.4 acres

Easterly Parkway Elementary School is a 2-story building located in State College Boro, State College, PA. The school currently houses grades K-5. The property is served by public water, sewer and natural gas.

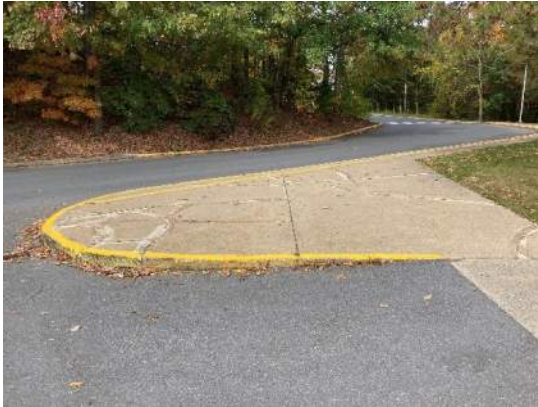
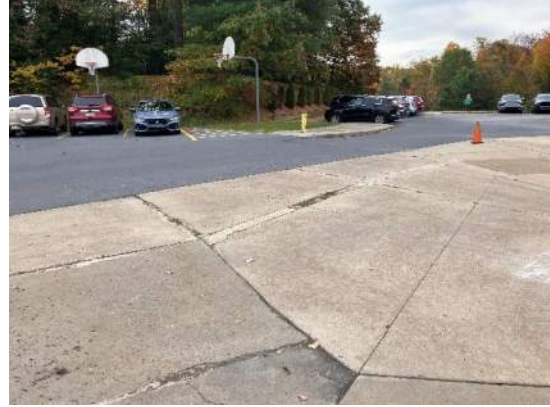
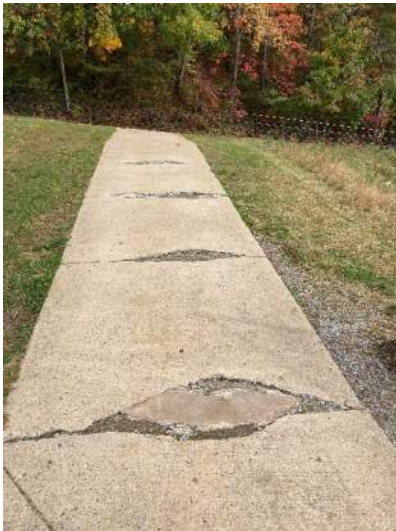
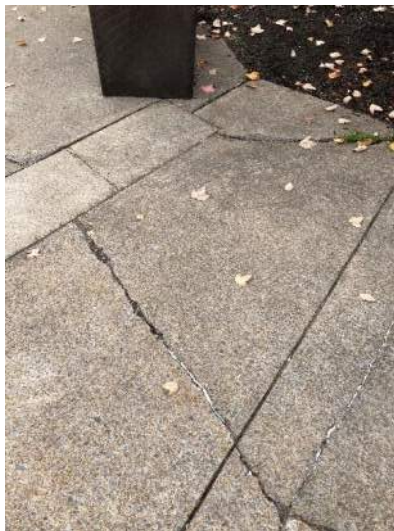
Paving and walkways are cracked and spalling in many locations. Some are original to the original construction in 1971 and is in poor condition.

- Vehicular circulation should be improved to clearly separate buses and parents, however, while this is a recommendation it appears to not be able to be achieved due to the constrained site.
- Parking for staff should be consolidated to prevent being distant from the school. Again, this appears to not be achievable at the existing site location.
- Paving and walkways should be repaved or patched to remove cracks and/or fill in missing pavement. Consideration should be made to do a mill and overlay for the paving and concrete replacement with any comprehensive renovation project or if the building is maintained.

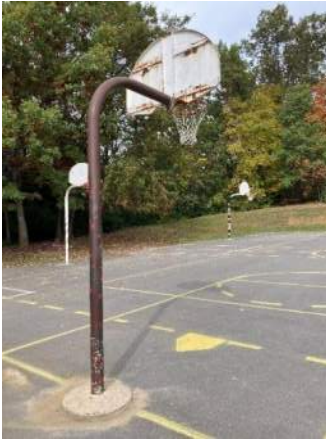
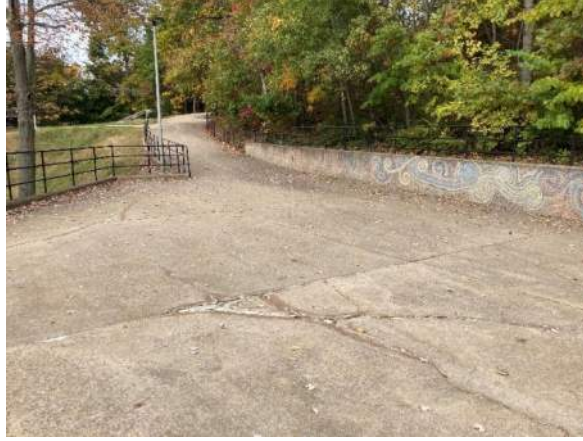
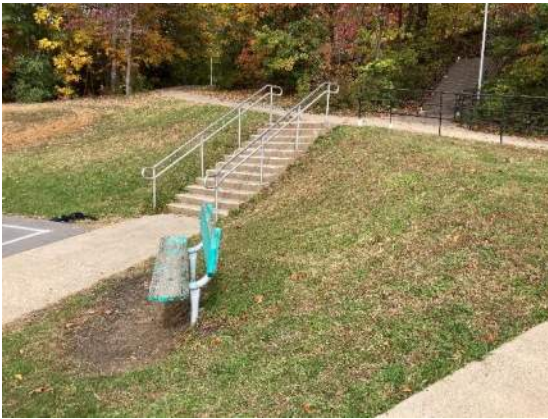
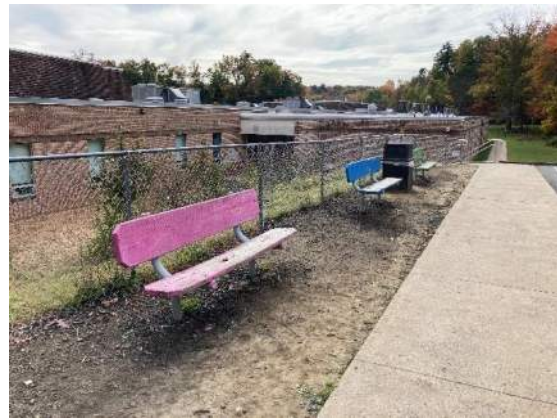
The site has one hard-surface play area with one main basketball court and multiple basketball backboards. The basketball backboards are rusting and in poor condition. There are benches that surround the hard-surface play area that are also in poor condition. There is a hard-surface patio area at the north end of the school which is heavily cracked and floods during heavy rain. The site also has two play/baseball fields in fair condition.

- Replace basketball backboards and benches.
- Patch and repair paved areas.

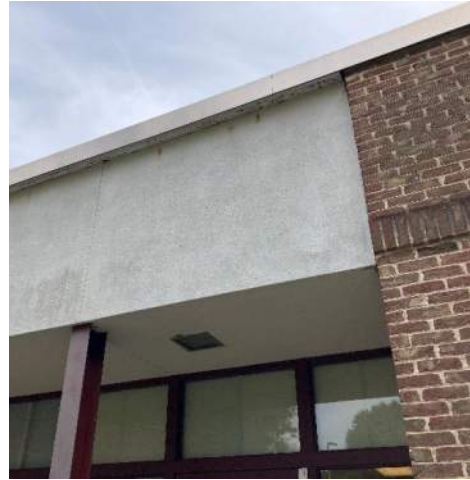
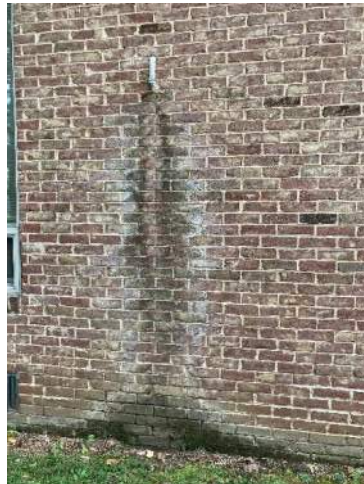
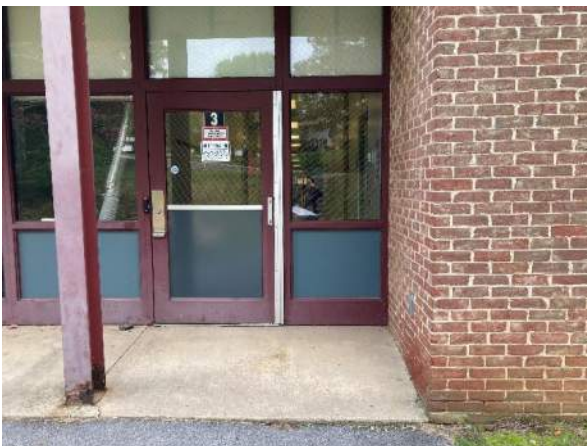
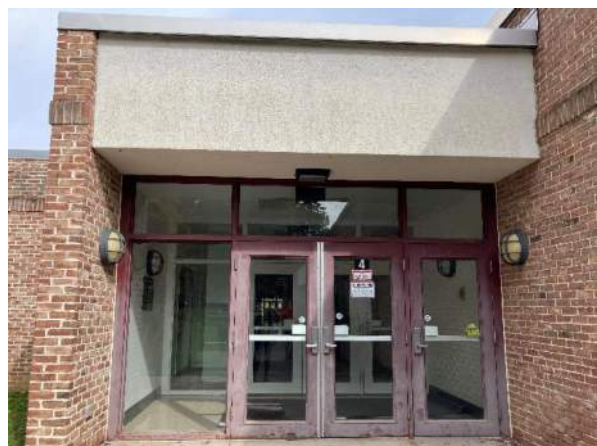
The building exterior consists of insulated masonry cavity walls with brick veneer and CMU backup. Window stools are a sloped brick rowlock course and show signs of staining and efflorescence in addition to some of the mortar joints beginning to spall and deteriorate. The soldier brick course going around the top of the exterior walls is stained and darkened in several areas as well as areas above the soldier course and along finish floor. Some of the mortar joints where this is happening the worst are also beginning to

spall and deteriorate. This is a sign of moisture getting trapped behind the face brick and either the weep holes being clogged or nonexistent.

Some exterior EIFS/Exterior Portland Cement Plaster has cracking and is beginning to stain.

There is exposed exterior steel at some of the entrances and the steel is beginning to deteriorate at the base where the steel meets the ground.

- Clean exterior brick veneer to remove efflorescence and staining.

- Inspect weep holes at the base of the exterior walls to make sure they are not blocked and trapping moisture within the wall cavity. If weep holes are nonexistent will have to remove brick and install through wall flashing, cavity drainage material and weep holes and/or cavity vents.
- Cap all brick rowlock windowsills with metal.
- Repair exposed steel at base and re-paint.
- Repair and clean EIFS/Exterior Portland Cement Plaster.

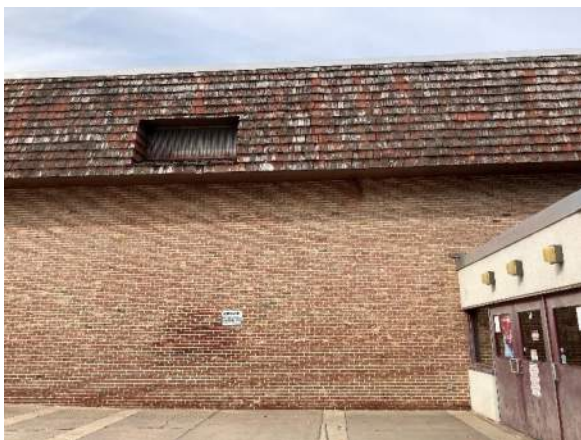
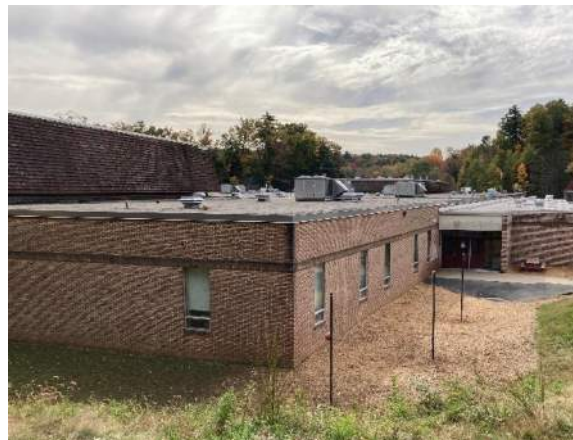
The roofs that are lighter in color on the plan below were roofs replaced in 2015 with a white TPO/EPDM membrane roofing system. The remainder of the flat roofs are built-up roofs that were replaced in 2009. One of the higher roofs has a mansard style roof with wood shingles and a flat roof in the middle that was one of the roofs replaced in 2015. The wood shingles appear to be in fair to poor condition. Rainwater is collected via roof drains and the internal roof water conductors run vertically to a point underground. From there they run horizontally and tie into exterior underground storm water piping.

- Replace wood shingles with asphalt shingles or reconfigure the mansard style with a vertical surface and accent the building with metal wall panels to give the building a modern and fresh look.

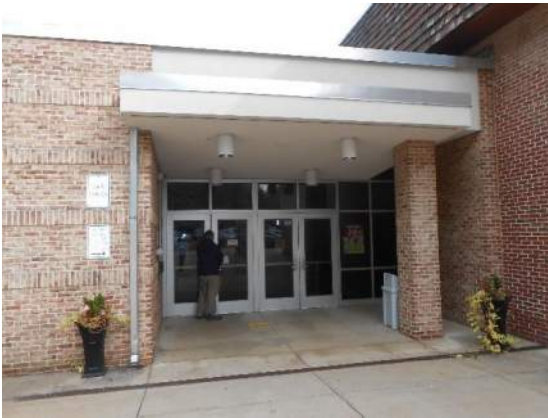
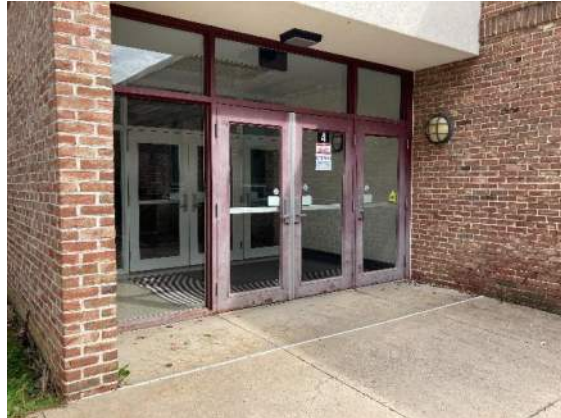
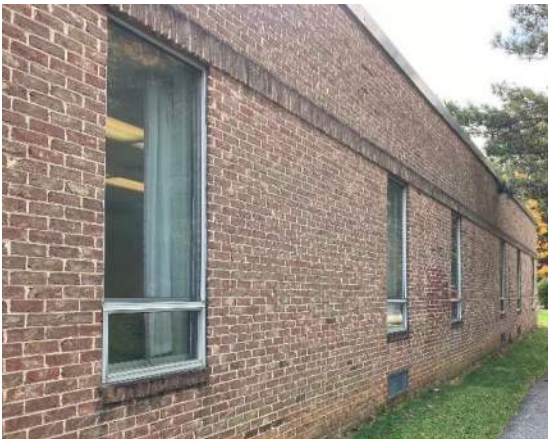
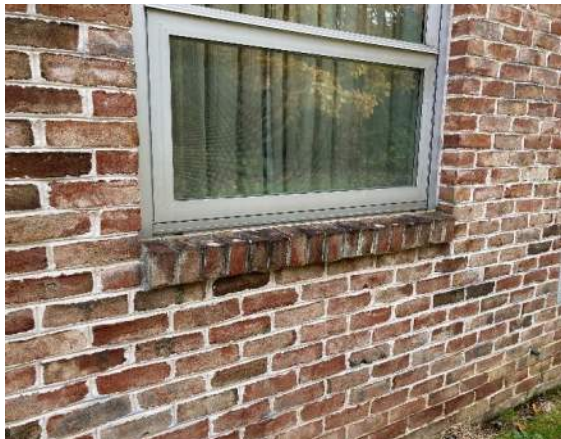
Windows are a combination of operable awning type windows with fixed glass above. The frames are clear anodized and may have been replaced with the 1995 addition and renovation project and are in fair condition. Entrances for the most part are clear anodized aluminum storefront. Doors are the wide style but do not have the intermediate horizontal stile where the panic hardware is usually mounted on. Some of the storefront framing and entrance doors appear to have been painted perhaps to extend the life of the storefront. Those doors and frames appear to be rusting and chipping and are in poor condition.

- Replace all windows and entrance framing and doors with any potential renovation project.

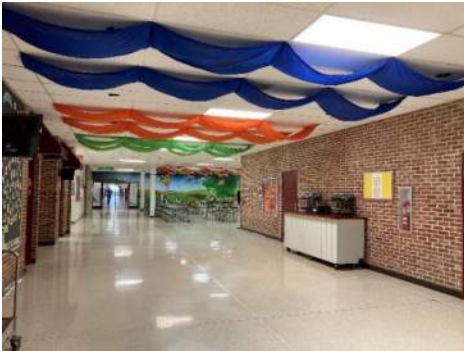
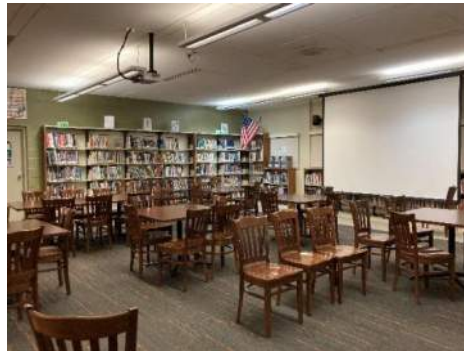
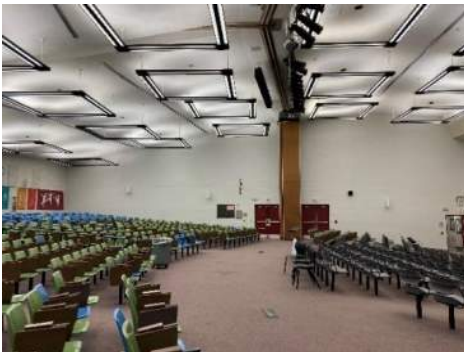
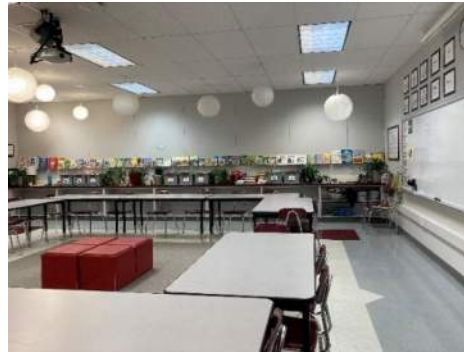
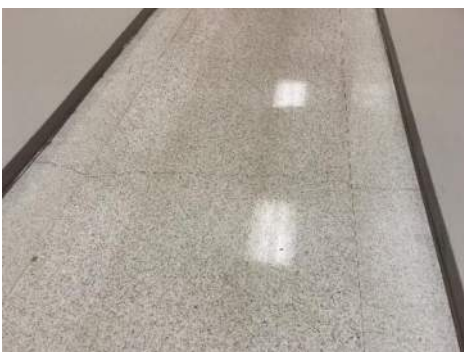
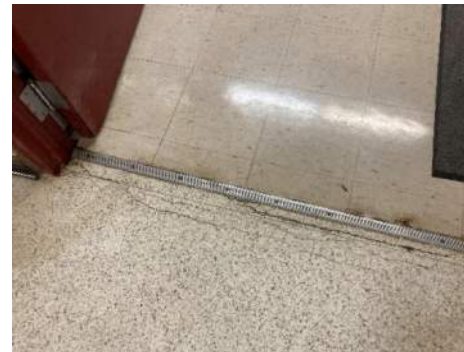
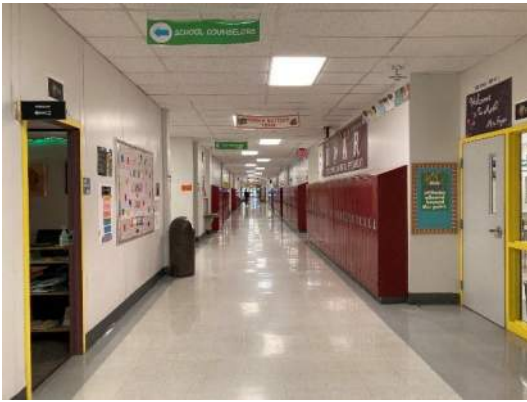
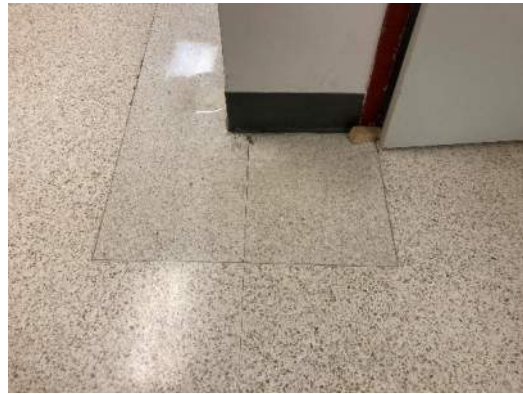
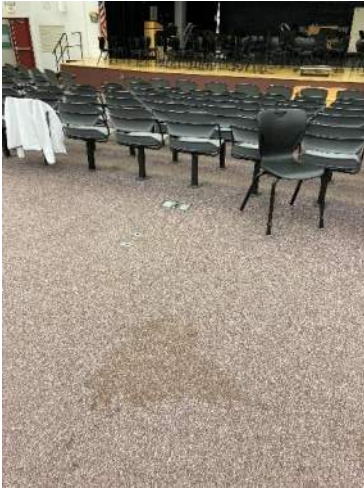
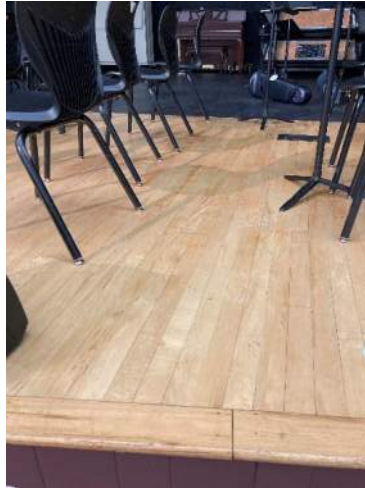
VCT and terrazzo exist throughout most of the school. The terrazzo is located in the corridors, while the VCT is located in the classrooms and also in some of the corridors, where it was part of a floor replacement project. There is significant cracking in some areas of the terrazzo as well as some terrazzo patching that has already occurred.

Carpet is in the main office, library, and auditorium. The carpet in the auditorium has stains and is showing signs of age.

There is a solid wood floor on the stage in the auditorium and appears to be in good to fair condition.

- Replace carpet in the auditorium.
- Repair and/or recondition the terrazzo floors throughout.
- Refinish wood floor on auditorium stage with any renovation project.

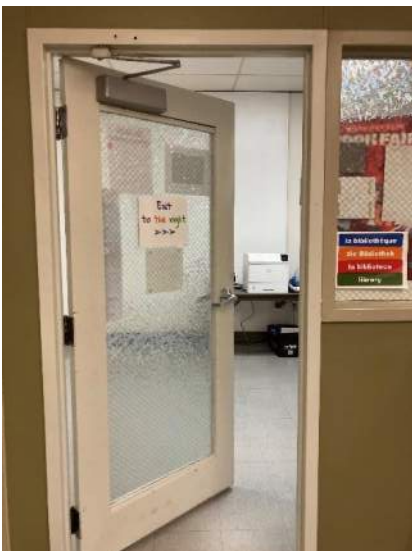
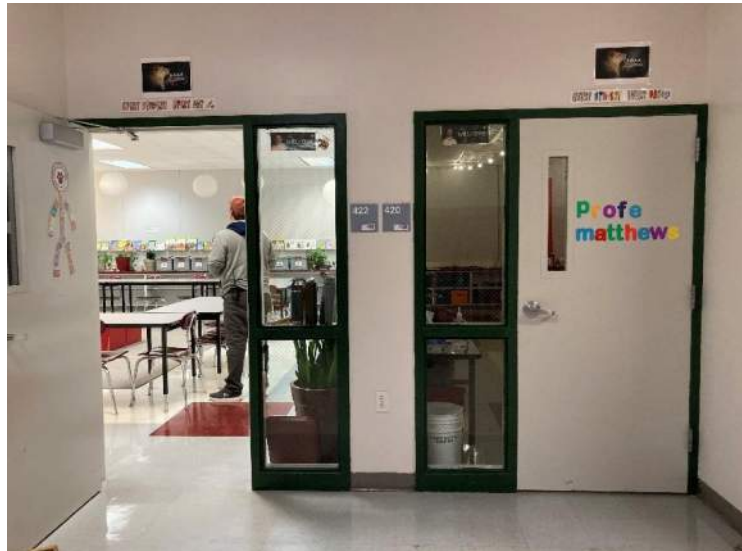
Interior doors are painted wood or painted hollow metal in painted hollow metal frames. Some interior doors have wire glass in the door or in the adjacent sidelight.

- Replace wire mesh in glazing with glazing that is code compliant.

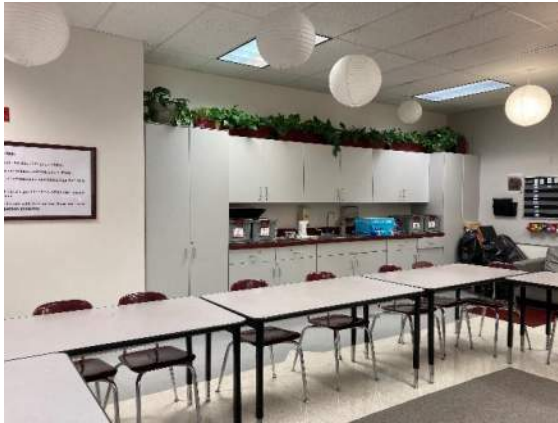
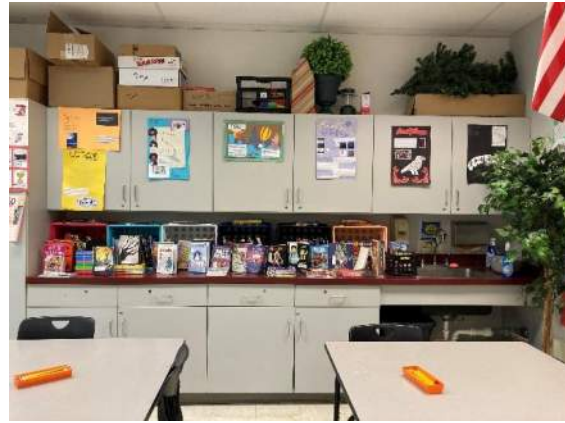
Interior casework is plastic laminate and in fair condition. Not all casework underneath the sinks allows for a forward approach for accessibility.

- Casework should include sinks that meet ADA accessibility guidelines.

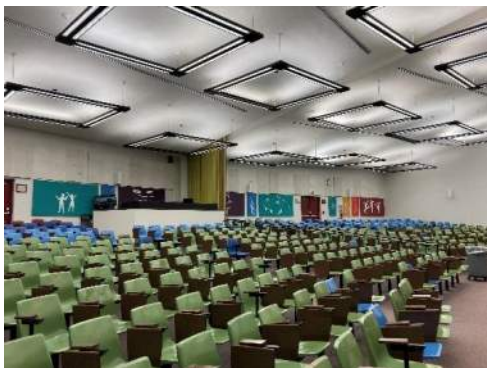
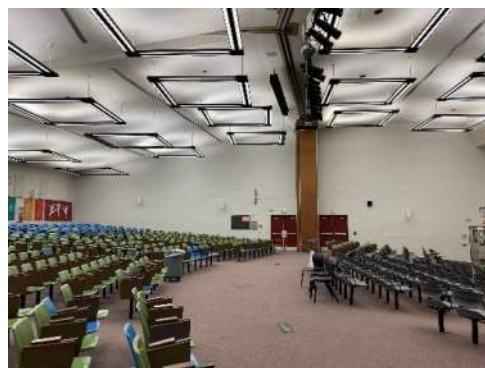
Auditorium seating is original to when it was installed in the building and is at the end of its useful life.

There is minimal acoustical treatment to the walls in the auditorium and no suspended clouds from the roof deck.

- Replace peeling fabric on folding partitions in the classrooms.
- Replace auditorium seating.
- Improve acoustics in auditorium.
- Relocate lighting to open the folding partition in the auditorium.

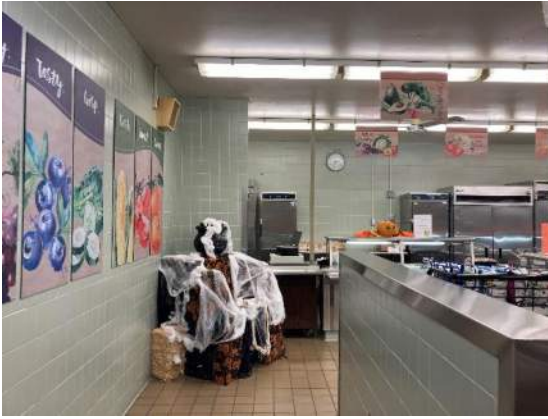
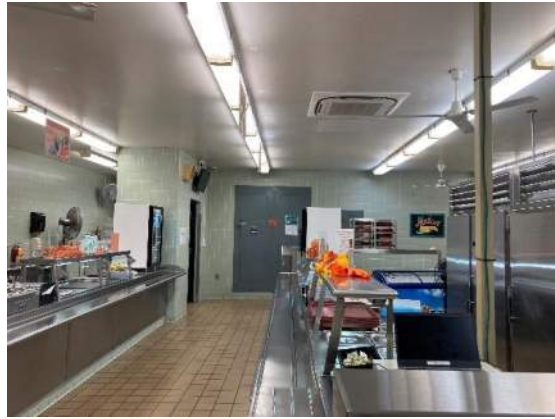
Food Service equipment is in fair condition and equipment has periodically been replaced over the life of the building. However, much of the equipment and serving lines is built into the building. With the knowledge that a renovation or replacement was going to occur at some point in the past 10+ years, SCASD purposely did not replace equipment for the entire kitchen to be efficient with financial resources and allow a large construction project to address concerns and layout changes.

- Due to SCASD Board of Directors decision to plan for a new construction option for Park Forest's Middle Schools future, the existing kitchen will eventually be replaced and or demolished in the next 5 years. At this time, it is recommended to maintain the existing kitchen through routine maintenance, but not to spend additional dollars at this time that can be focused to funding o the new construction. It should be anticipated that due to the age and built nature of the majority of existing equipment, that no equipment would be repurposed to other schools after the new school is completed.

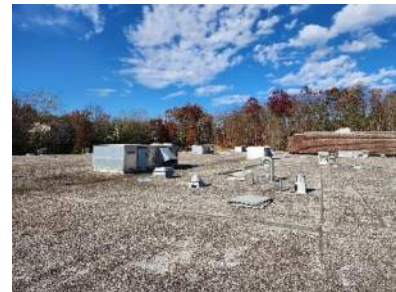
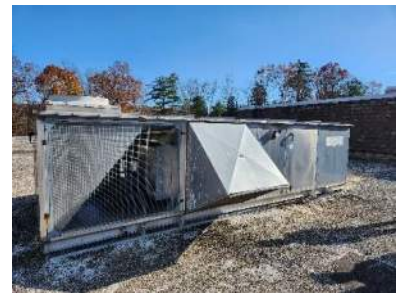
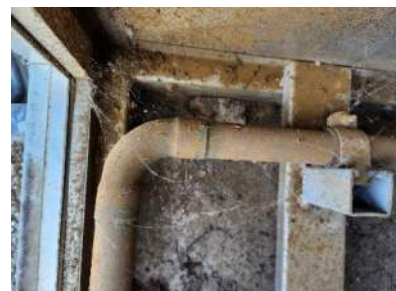
- Rooftop packaged multizone units and split system DX cooling units with electric heat coils are used to serve most areas of the school. The units are no longer manufactured or supported by the original manufacturer. While required maintenance and repairs have resulted in some upgraded components, most of the units are original and in need of replacement.

- The HVAC units utilize R-22 refrigerant. R-22 refrigerant was phased out of production in 2020 due to its ozone depleting characteristics. Any new equipment should utilize current refrigerants.

- Complete HVAC system replacement.
- Provide systems that meet current codes and accepted design standards.

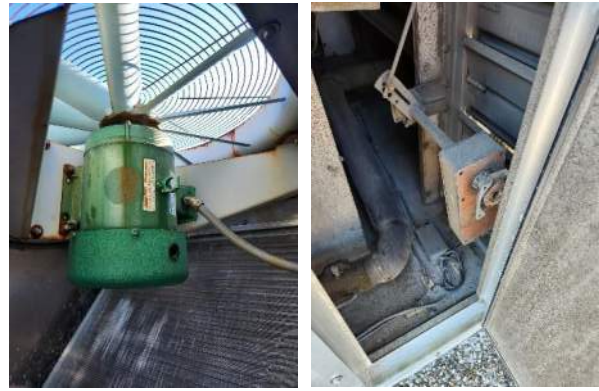
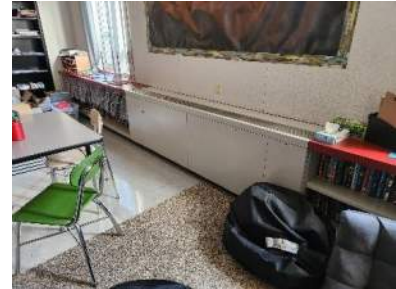
- Exhaust fans throughout are original but appear to be in fair to poor condition. Some are no longer operating properly. Most do not comply with current air volume standards.

- The dust collection system was installed in 2008 and is in good condition.

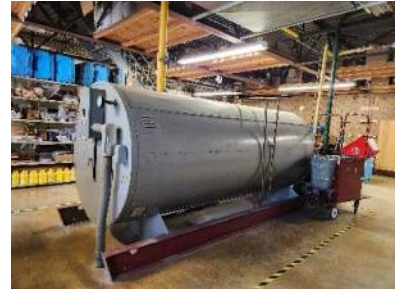
- Domestic hot water is developed from a large horizontal storage tank with electric coils. The tank is dated 1970 and is original to the building construction. The electric coils have been replaced over the years as they fail. The tank is well beyond its expected lifecycle.
- The hot water recirculation pumps are not original and have been replaced over the years.
- The recirculation system does not meet current standards.
- It was noted that there are other electric water heaters in the building to provide specific needs or to boost the temperature. All the units are electric.
- Insulation on the domestic water piping does not meet current energy codes.

- Replace/upgrade the entire domestic water heating and recirculation systems.

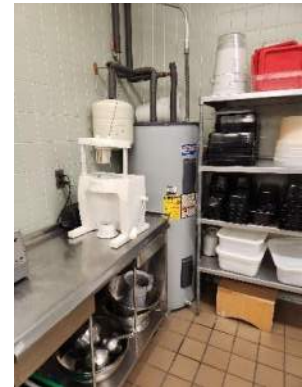
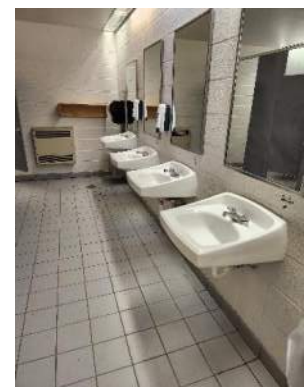
- Plumbing fixtures throughout appear to be in good condition.
- Water closets and urinals utilize manual flush valves.
- Lavatories utilize manual faucets.
- Faucets are mainly aged and in need of replacement.
- Toilet rooms and fixtures do not generally comply with current ADA standards.
- Water coolers and drinking fountains do not appear to be ADA compliant. Some are aged and may not meet current lead free standards.

- Replace faucets.
- Install hands free fittings on lavatories.
- Upgrade system to be ADA compliant.
- Replace older water coolers.

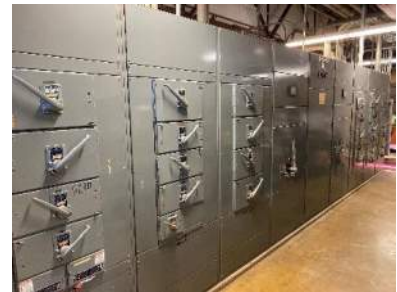
- The existing electrical service is 480/277-volt, 3-phase, 4-wire, and fed from an exterior utility pad mounted transformer. A 4000-amp QMB switchboard is installed, it has two 2000-amp main bolt-loc switches and fusible distribution disconnects. The bolt-loc main switches can be unreliable and the switchboard is obsolete. The switchboard does not meet current code requirements and is over 50 years old. The switchboard is in poor condition.
- Dry-type transformers are used to step down voltage 208/120-volt.
- 480/277-volt and 208/120-volt branch circuit panelboards provide power throughout the building. The panelboard types are obsolete.
- There are a few branch circuit panelboards that were manufactured in 1994 that were part of a building addition that are in poor to fair condition.
- Electrical distribution equipment was manufactured by Square D and Cutler Hammer/Westinghouse.

- Most of the existing equipment is over 50 years old. All the electrical distribution equipment and all associated distribution wiring should be replaced.

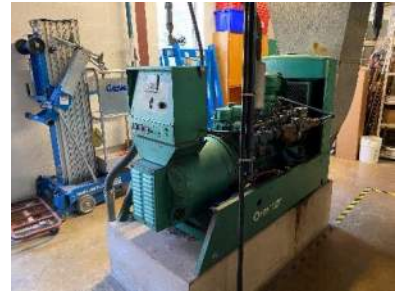
- A 208/120-volt, 3-phase, 30KW natural gas generator is installed. It is manufactured by Onan and appears to be original to the building. It is in poor condition.
- A replacement Cummins automatic transfer switch and area protection panel appear to have been installed in 2017 and are in good condition. The location of the automatic transfer switch does not meet the requirements of the codes.
- Self-contained exit signs with battery back-up are being used throughout the building and most are in poor condition.
- Designated recessed downlight luminaires are connected to the emergency system and are used for emergency lighting.

- Install new generator, life-safety and optional equipment automatic transfer switches, distribution equipment, and new raceways and wiring.

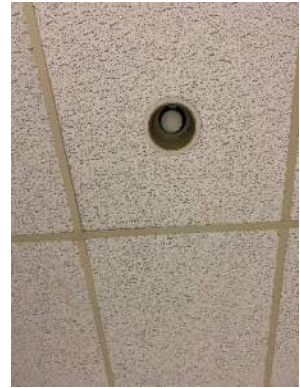
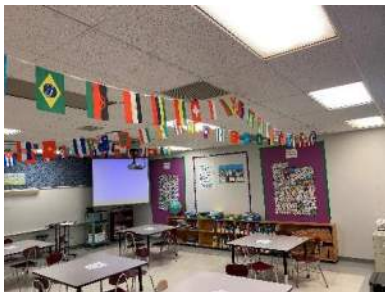
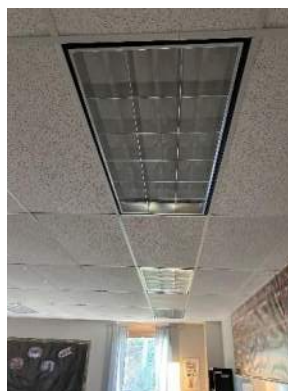
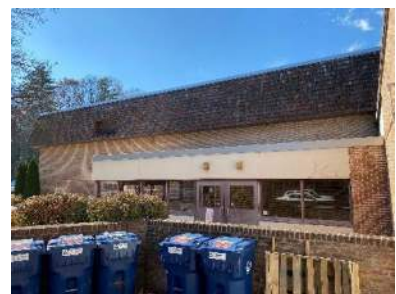
- The multi-purpose room appears to be using high-bay type fluorescent luminaires.
- Existing luminaires use 120-volt and 277-volt for power.
- The Auditorium has pendant stem-mounted luminaires assembled in a square shape using fluorescent lamps.

- Existing lighting controls do not meet current energy code requirements for automatic switching, daylight harvesting, and dimming.
- Exterior lighting consists of luminaires using HID, PL fluorescent lamps and LED lamps.

- Luminaires are outdated and in poor to fair condition and should be replaced with new LED luminaires.
- Install new lighting controls that will meet the energy code requirements.
- Replace exterior luminaires that have not already been replaced with new luminaires with LED lamps.

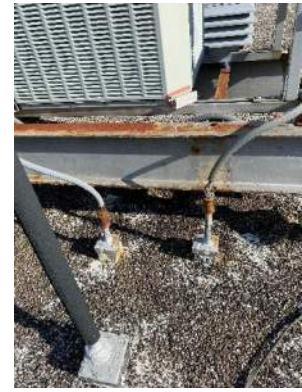
- The wiring devices are in poor to fair good condition.
- Receptacles do not meet current codes.
- Auditorium floor receptacles are flush mounted without protective covers and do not meet the code requirements.
- Equipment wiring on roof is in poor condition. Broken raceways and open conductors have been observed.

- Repair worn out raceways/wiring used for equipment connections on roof.
- Wiring devices and branch circuit wiring should be replaced for any building renovation.
- Receptacles should be replaced with Tamper-Resistant type for any building renovations.
- Current code requires receptacles to have ground-fault circuit interruption protection at additional locations. Devices should be changed for personnel protection.

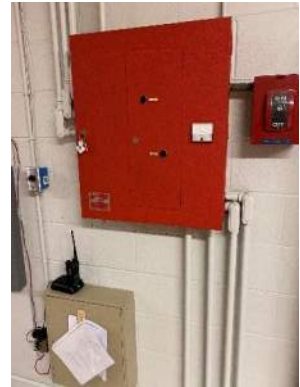
- A Simplex 4100 panel and an addressable controller panel are in use in this building.
- Notification devices and their installations do not meet current code requirements.
- Classrooms do not have the code required notification devices in them.
- An Edwards fire alarm system panel and pull stations appear to still be in use from the original building construction in 1971.

- Completely replace existing fire alarm system and devices with a new fire alarm system.
- A new system will be required to be voice-based speaker notification devices to meet NFPA requirements.

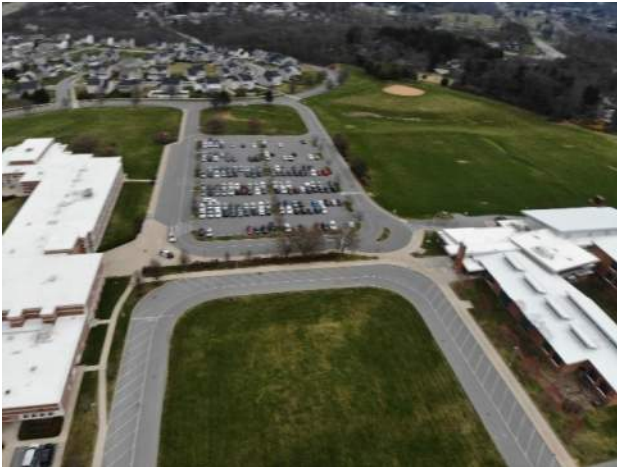
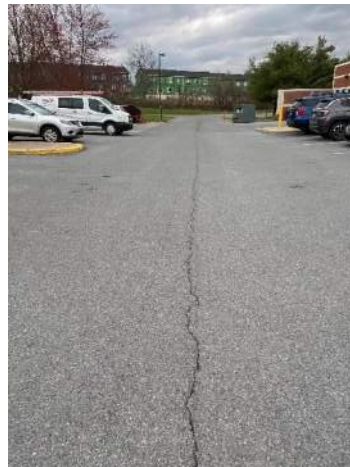
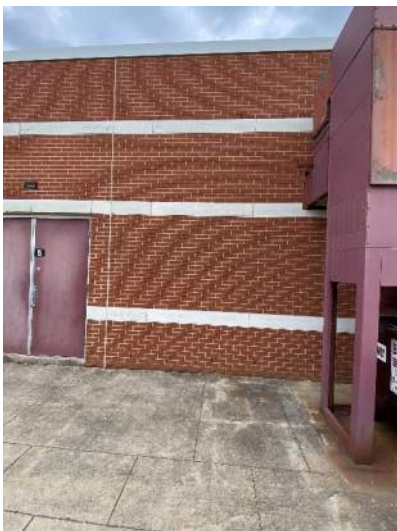
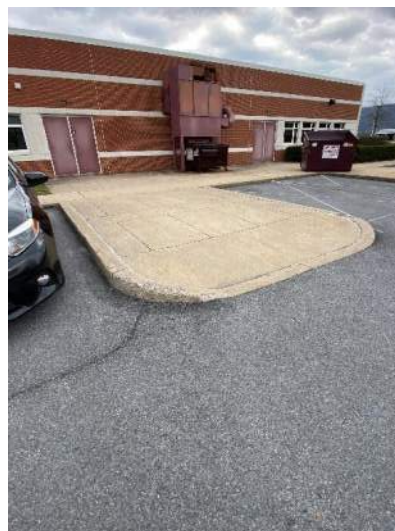
Vehicular access to the site is from Brandywine Drive. Parents and buses pick up and drop off from the drive loop at the front of the school. These pick up and drop off areas are shared with the elementary school on the opposite side of the parking area. The pick up and drop off times of the two schools are different which helps with traffic, however traffic can be problematic, particularly in the afternoon with the number of parents picking up their children varies with after school activities. Paving and concrete walkways are in good condition at the drop off area with some cracking occurring down the middle of some of the paved access drives and also the concrete walks in the rear of the building, that were installed when the building was constructed, are showing signs of aging.

- Use pourable sealer on crack and monitor to see if crack increases in size. Provide seal coat over rear parking area.
- Replace concrete in rear of building with any renovation project.

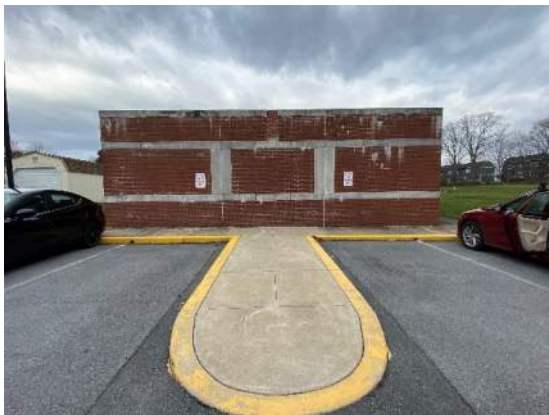
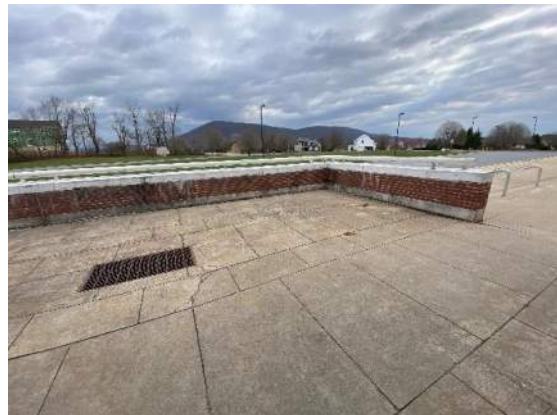
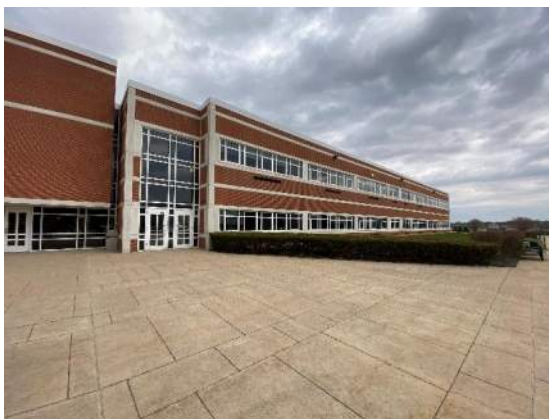
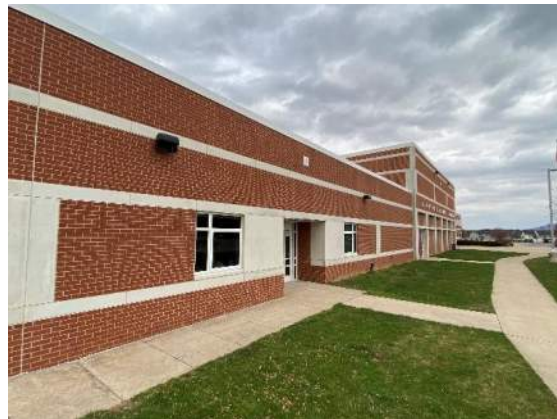
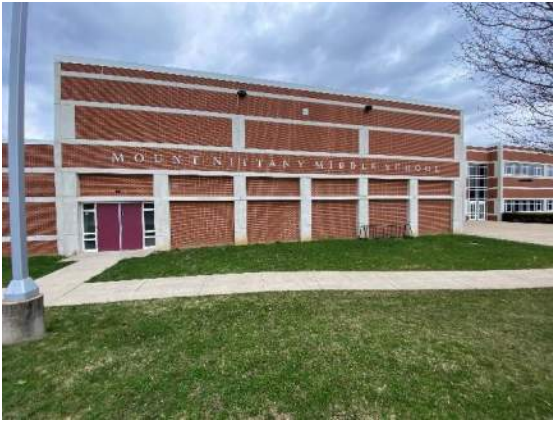
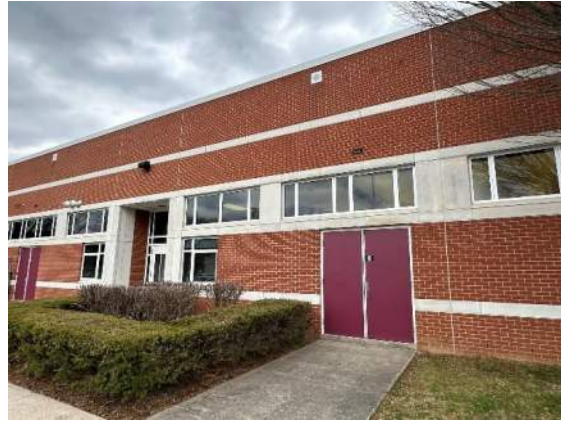
Masonry screen walls with precast or cast stone caps and accent bands in the rear of the building are badly stained with efflorescence and dirt. Masonry seat walls with precast or cast stone caps outside the Gymnasium entrance are also badly stained with efflorescence and dirt.

The paint on the exterior hollow metal doors and frames is faded.

- Clean exterior brick veneer to remove efflorescence and staining on masonry screen and seat walls that were not part of the building cleaning in 2023.
- Prep and paint exterior hollow metal doors and frames.

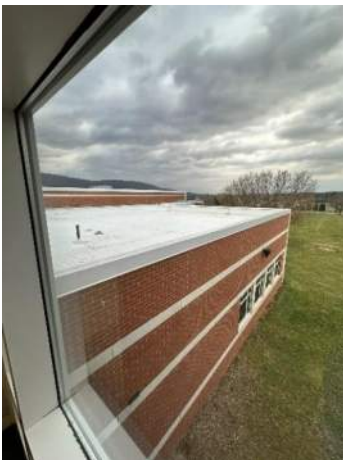
The roof on the building was replaced in 2016 with a white fully adhered TPO roofing system and is in good condition. Rainwater is collected via roof drains. Roofing and rainwater conveyance appear to be in good condition.

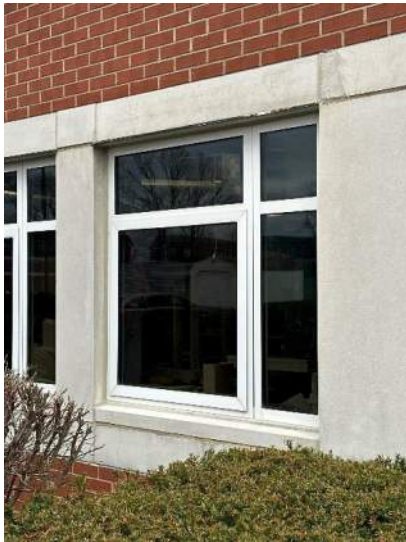
Windows are a combination operable, casement-style and fixed white anodized aluminum window units. Aluminum windows are original to when the building was built and showing signs of age.

Entrances are clear anodized aluminum storefront with custom wide stile insulated aluminum doors. Aluminum doors and entrances are original to when the building was built and showing some signs of age.

- Replace aluminum windows, doors and entrances with any new renovation project as they are at the end of their life expectancy. However, if maintained life can be extended 10+ years and not to be added to the current capital budget.

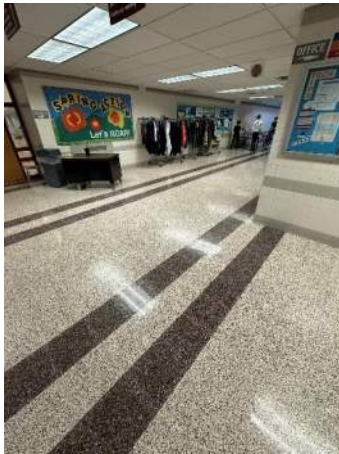
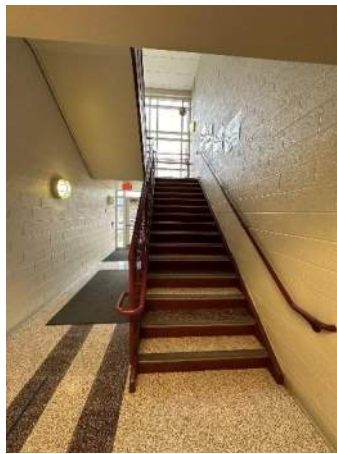
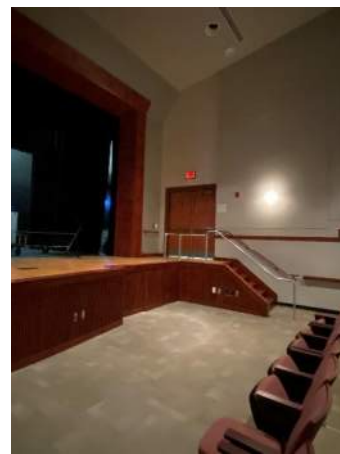
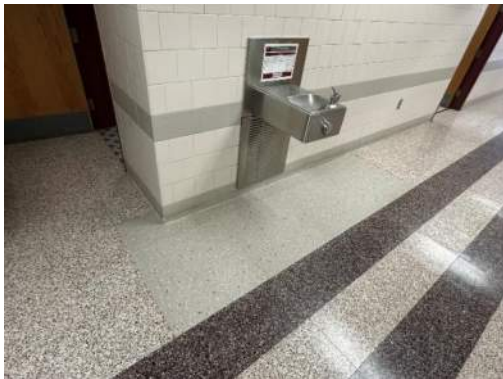
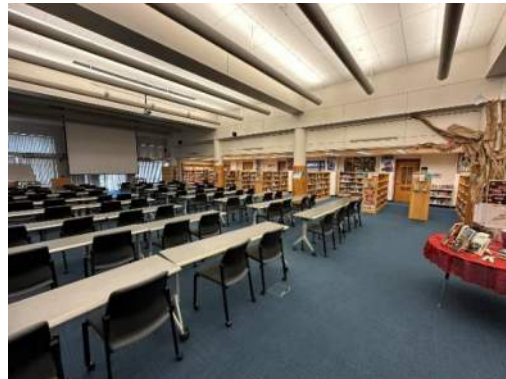
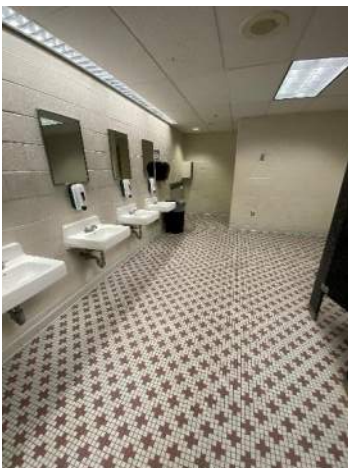
VCT and terrazzo tiles (Fritz Tile) exist throughout most of the school. The terrazzo tiles are located in the corridors and stair towers (including stair treads), while the VCT is located in the classrooms. Over the years the terrazzo tiles were replaced with thinset terrazzo at each of the water coolers as water was getting under and loosening the tiles.

Carpet is found in the main office, miscellaneous offices throughout the school, Media Center, and Auditorium. Carpet throughout is showing signs of age.

Acoustical ceilings throughout for the most part are in good condition with the exception of miscellaneous stains on tiles.

- Replace carpet throughout with any renovation project.
- SCASD staff indicated they are also investigating replacement of the corridor floors in the future, investigate further with interiors team and SCASD.

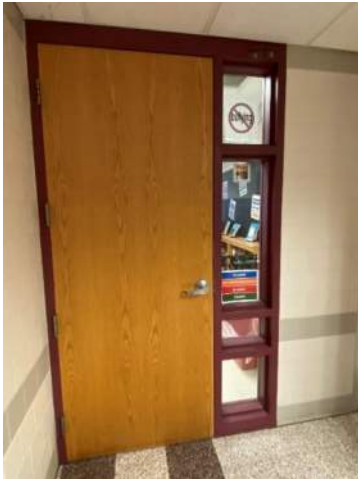
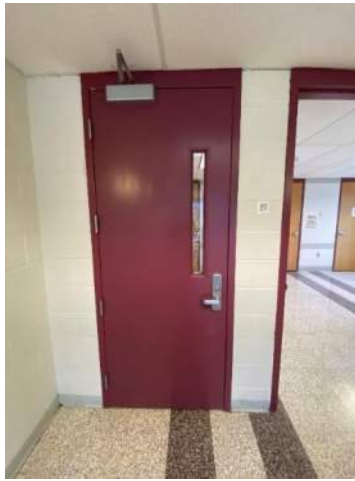
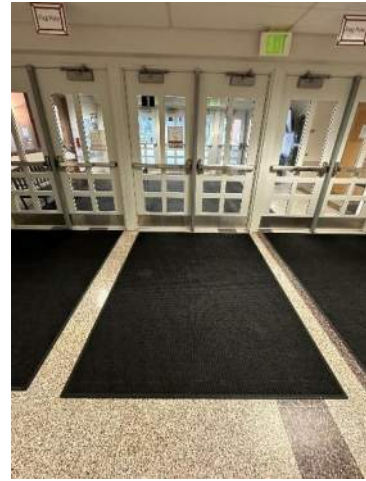
Interior doors are solid core wood or painted hollow metal in painted hollow metal frames. Most of the interior doors and side lites have glazing with wire mesh which does not meet the current code.

Where interior aluminum entrance doors in aluminum frames occur at interior vestibules, doors and frames are in fair condition.

- Replace wire mesh in glazing with clear glazing that is code compliant.
- Replace aluminum entrance doors and frames with any new renovation project as the existing doors and frames are at the end of their life expectancy.

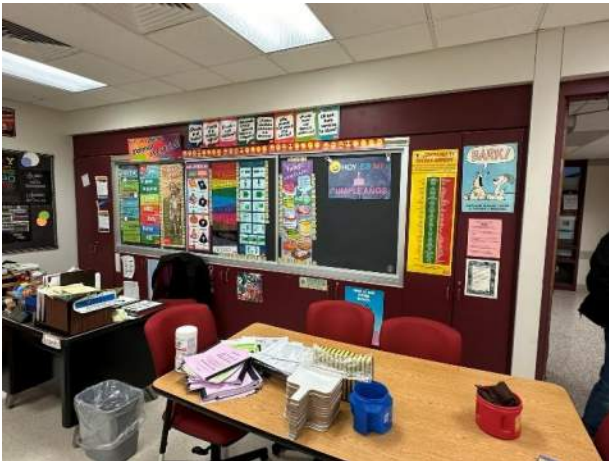
Interior casework is plastic laminate and in good condition.

- The casework is at the end of its life expectancy and should be replaced with any renovation project.

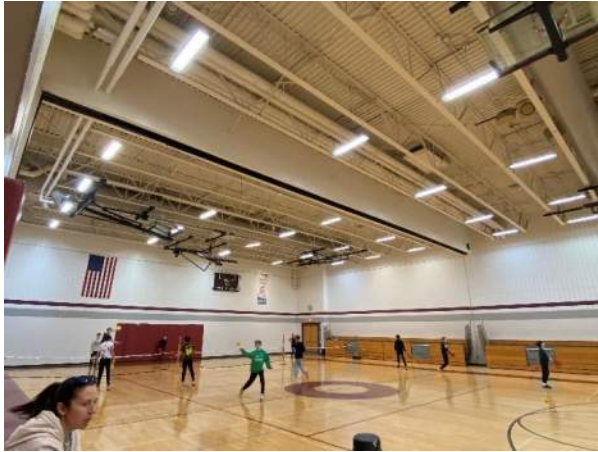
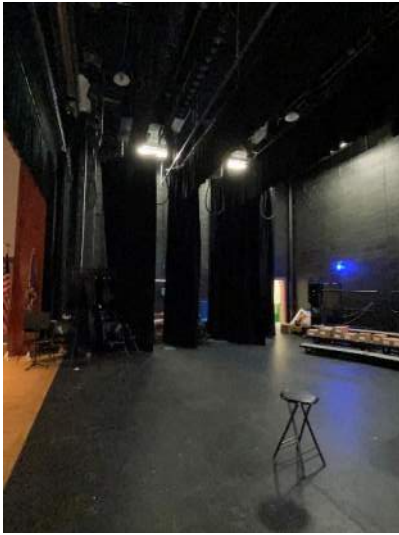
Gymnasium equipment consists of retractable, ceiling-hung basketball backstops, scoreboard, wood bleachers and folding partitions. All are in fair to good condition. The folding partitions are electrically operated and are in working order. It appears that the staff does periodically have issues with the backstops going up and down. The wood bleachers are not ADA compliant.

Athletic welded steel lockers in the locker rooms as well as the wood benches appear to be in good condition, however provisions for an ADA compliant locker and bench were not provided.

The metal corridor lockers appear to be in good condition, however that are no lockers labeled to be ADA compliant lockers.

The auditorium seating appears to be original to when the building was constructed and is in fair condition. Some of the seats do not fold up when they are not being used.  
The rigging and lighting on the stage are original to when the building was constructed.

- Replace the athletic equipment and folding partitions with any renovation project as it has exceeded its life expectancy.
- Renovate a portion of the existing corridor lockers to be ADA compliant lockers.

- Replace the auditorium seating and stage rigging and lighting with any renovation project as they have exceeded their life expectancy.
- Renovate a portion of the existing welded steel lockers in the locker rooms to be ADA compliant lockers and add a separate 24"x48" ADA compliant bench.

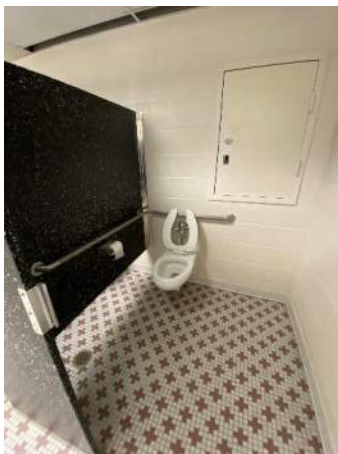
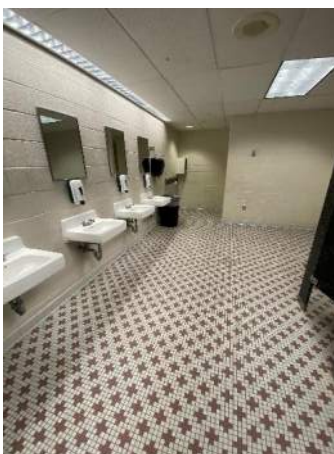
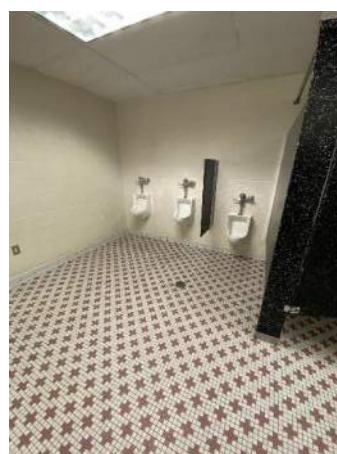
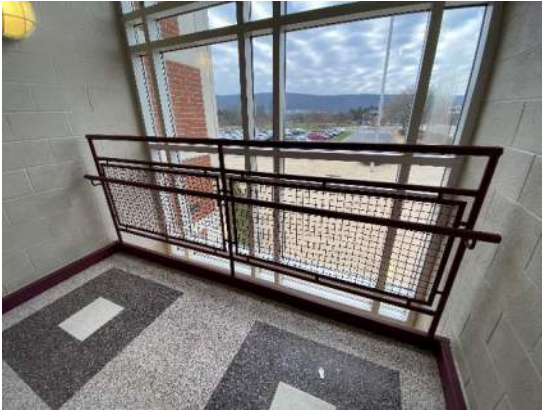
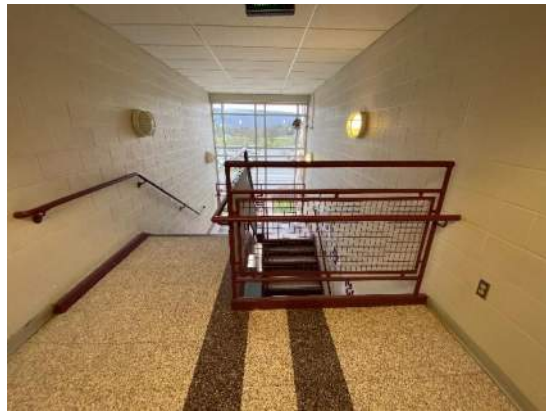
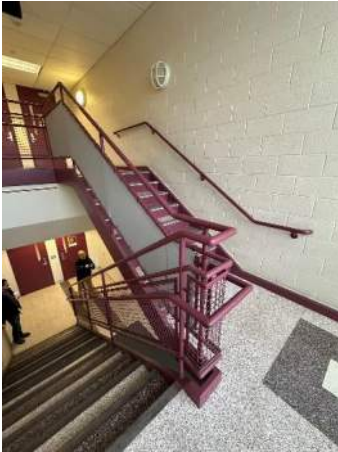
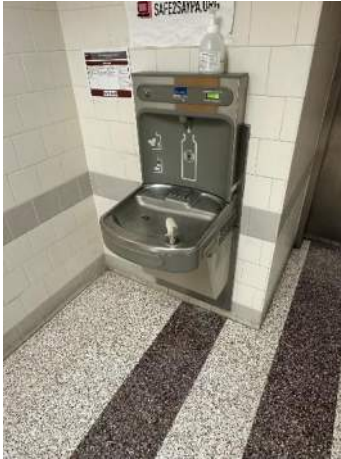
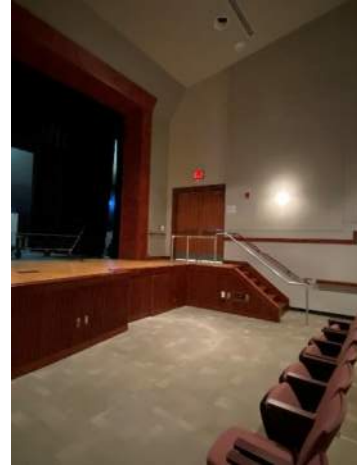
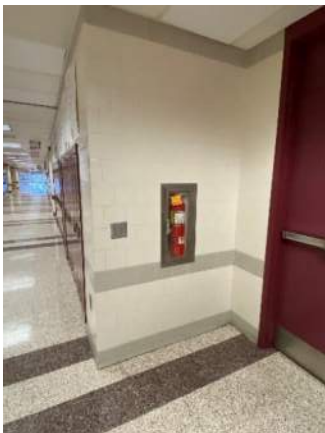
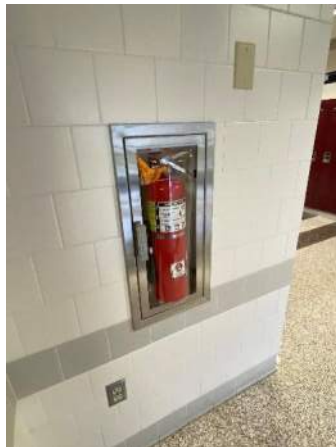
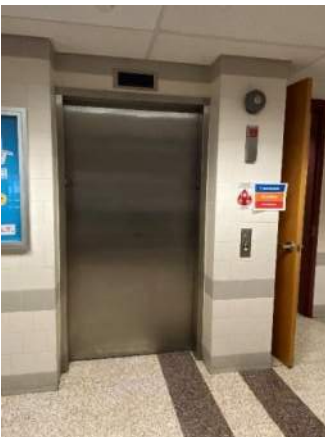
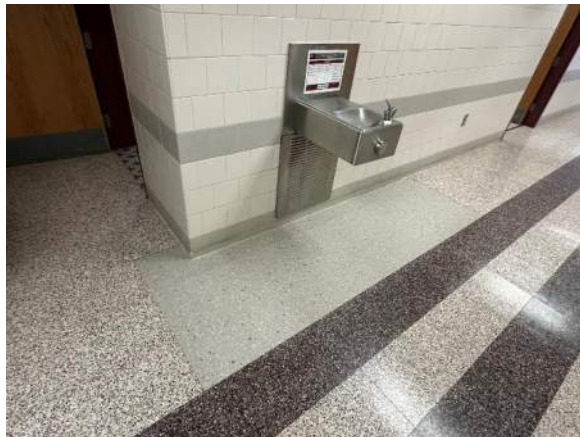
Most of the electric water coolers are original to when the school was constructed and are not compliant to the visually impaired. Some of the water coolers have been replaced with one's that include the bottle fillers and are ADA compliant.

- Update grab bars in toilet rooms and add additional intermediate horizontal handrail or mesh to reduce the open space between handrails to be 4" maximum.
- Replace all original electric water coolers with ADA compliant water coolers or possibly find an apron that can be added to the bottom of the water cooler to meet the requirements of the visually impaired.
- Install a chair lift in the Auditorium to access the stage from the seating area.
