## 6 | Easterly Parkway Elementary School

<b>Address:</b>	234 Easterly Parkway State College, PA 16801
<b>Construction Timeline:</b>	Originally constructed in 1955; renovation/addition in 2002.
<b>Building Square Footage:</b>	55,895 sf
<b>Site Acreage:</b>	11.4 acres

Easterly Parkway Elementary School is a 2-story building located in State College Boro, State College, PA. The school currently houses grades K-5. The property is served by public water, sewer and natural gas.

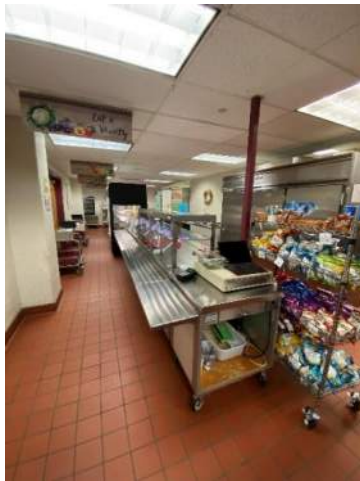
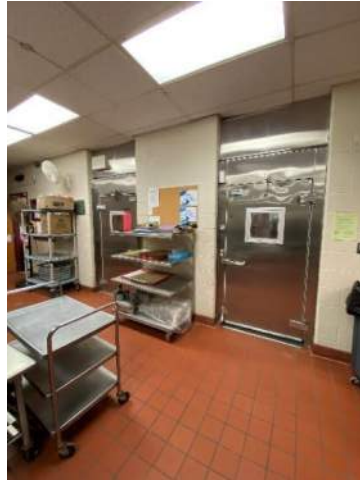
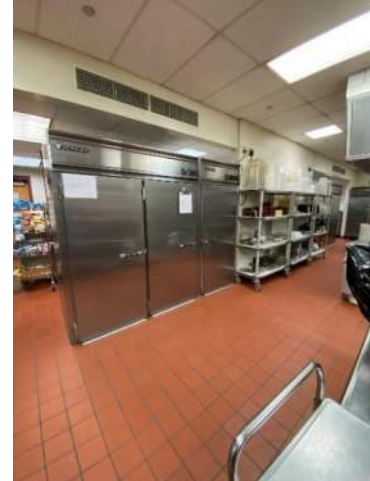
Most of the food service equipment is original to the building's construction and is in good to fair condition. SCASD is currently planning to replace the hoods and HVAC equipment serving the kitchen in 2024. Additional work includes replacement of the serving lines and the diswash equipment was replaced in 2019.

- While some of the equipment is approaching 30 years the current projects in process at this time along with routine capital budgeting will maintain the equipment into the foreseeable future.

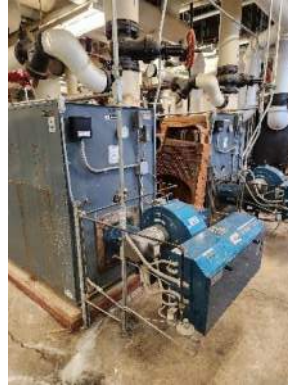
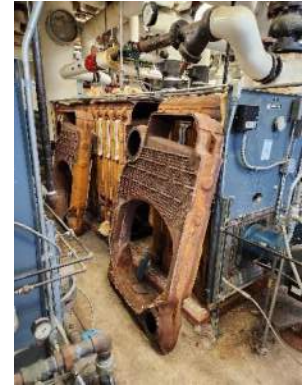
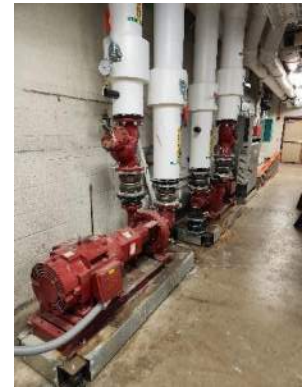
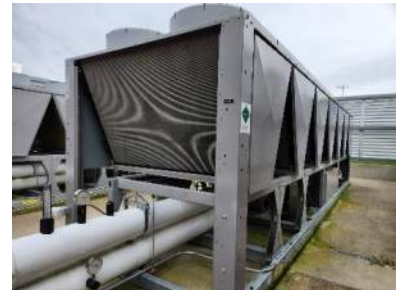
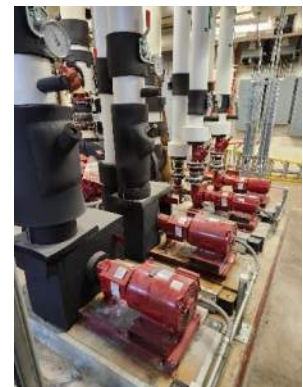
- Three Weil McLain Series 88 cast iron boilers with gas fired burners develop heating hot water for the school. The boilers appear to be in fair to good condition. One boiler was disassembled and under repair due to a cracked section. Note that the Series 1 version of these boilers has been discontinued and no longer serviced. Obtaining sections and related parts can be difficult. We suggest that the district plan for replacement in the next few years.

- Blend pumps for the boilers appear to be in good condition.
- Two Carrier packaged air cooled chillers develop chilled water for cooling. The chillers were manufactured in 2019 and utilize R-134a refrigerant. They were found to be operating well and in good condition.

- The piping for the chiller is buried between the remote chiller enclosure and the pumps in the mechanic room. The age and condition of this piping system was unknown. We highly recommend that this be further evaluated as accessing the pipe for an unplanned repair will be difficult, expensive, and time intensive.

- The chilled water pipe insulation is deteriorating in many areas. This is a sign of age and high humidity. We recommend that all wet or damaged pipe insulation be replaced.

- Replace the boilers.
- Test and inspect the underground chilled water piping system.
- Reinsulate the chilled water piping system.
- Replace strategic HVAC valves for improved maintenance serviceability.
- Replace the HVAC equipment and provide humidity control as part of any planned renovation or system upgrade.

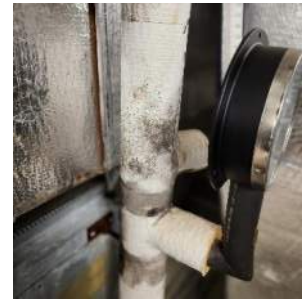
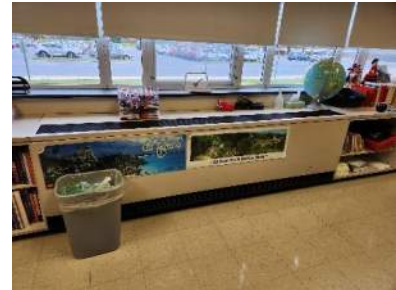
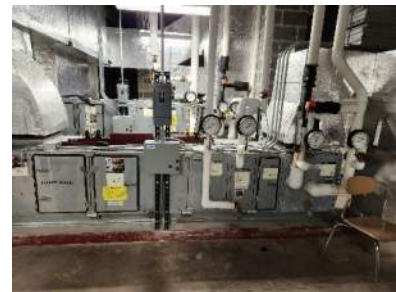
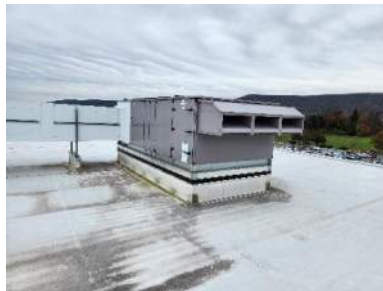
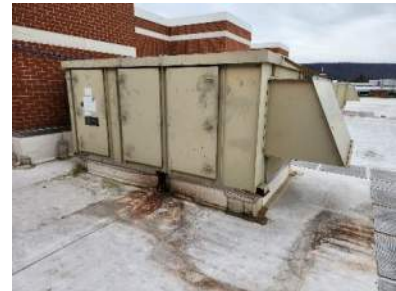
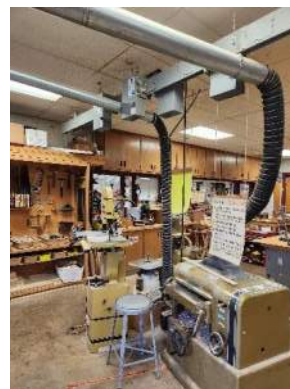
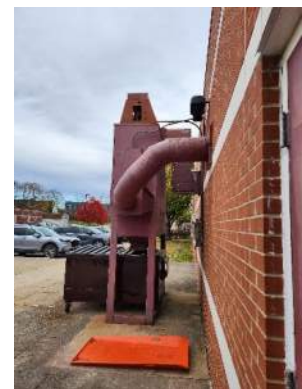
- Classrooms are served by vertical 4-pipe unit ventilators on the exterior walls. The units are vintage 1994 and do not have integral reheat for humidity control.

- Larger spaces are served by constant volume Trane 4-pipe indoor and outdoor air handlers that were installed in 1994. The indoor units appear to be in good to fair condition and the outdoor units are in fair to poor condition. All 1994 units are beyond normal lifecycle. The units could be refurbished to extend their life if desired, but replacement should be considered and planned. There was one newer Carrier unit on the roof that was installed in 2019 and found to be in good condition.

- DX cooling units are installed in several areas including the office, library, and server room. The units are original and utilize R-22 refrigerant. R-22 refrigerant has been phased out of production in 2020 due to its ozone depleting characteristics. We highly recommend that the units be replaced with new units that use current refrigerants and provide improved energy efficiency.

- Exhaust fans throughout are a mix of original and replacement units. All appear to be operating and in good condition.
- The dust collection system does not meet current standards and is aged. We recommend replacement with any planned wood shop renovation.

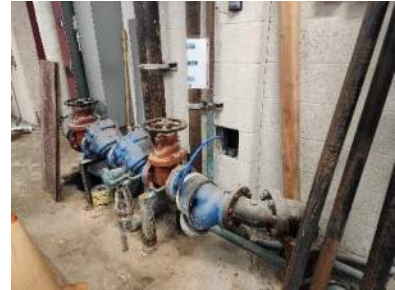
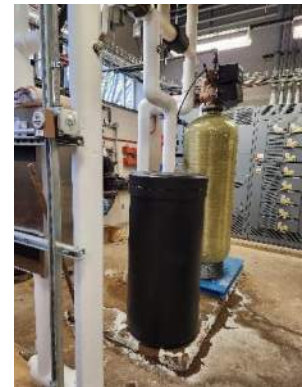
- The school is served off a public water service. The 4" service size is adequate for the school's needs. There were not any observed or noted issues.
- The water service includes a code compliant backflow prevention device that appears to be operational.
- The piping system was reported to be in good condition with no known pipe issues.
- Plumbing valves throughout are original. It was noted that some of the valves no longer hold, making service and maintenance difficult. We recommend that key valves be replaced when a comprehensive upgrade occurs.
- The domestic water system includes a simplex water softening system that was recently installed. We recommend that additional softeners be provided to provide redundancy and to allow regeneration based on use. We also noticed that the system was leaking and in need of repair.

- Replace strategic plumbing valves for improved maintenance serviceability.
- Provide redundancy for the water softening system and repair leak.

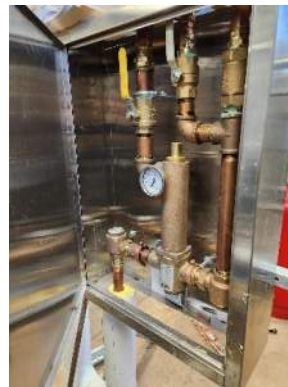
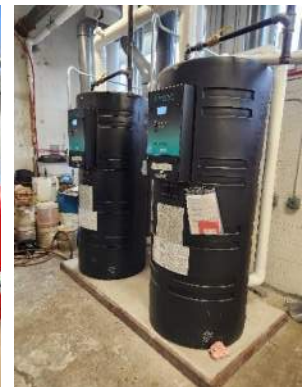
- Domestic hot water is developed from two PVI high efficiency gas water heaters that were installed in 2022. They are in good condition and do not need any attention.
- The domestic hot water mixing valve and the recirculation pumps were also replaced in 2022 and appear to be in good condition.

- None.

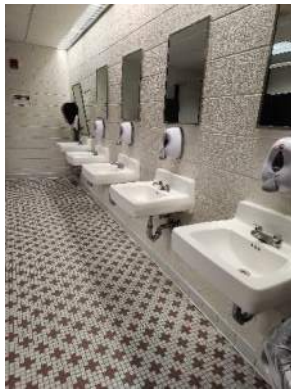
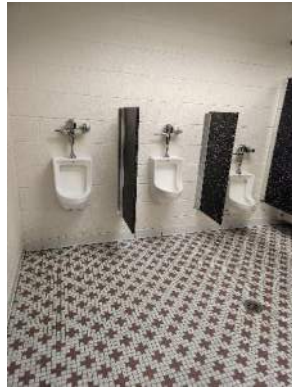
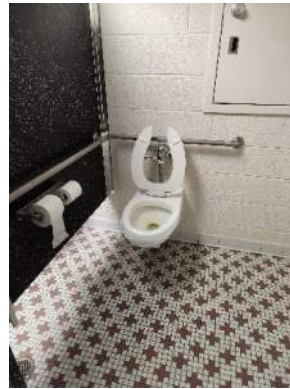
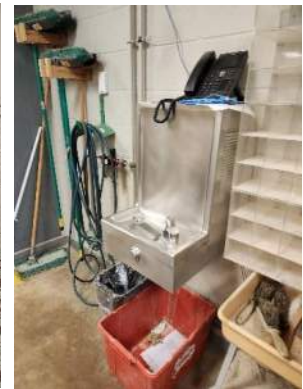
- Plumbing fixtures throughout appear to be aging but in good condition, but they do not appear to comply with current ADA standards.
- Water closets and urinals utilize manual flush valves.
- Wall hung lavatories are utilized with manual faucets.
- Water coolers do not appear to comply with current ADA standards.

- Install hands free faucets on lavatories.
- Provide ADA upgrades where required.

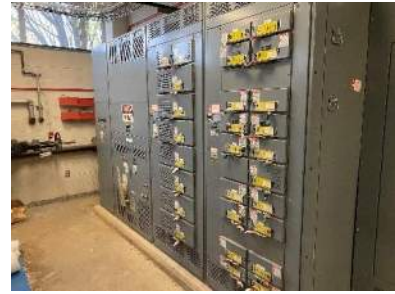
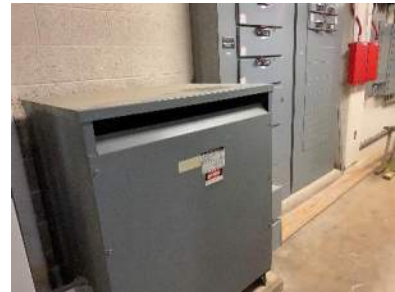
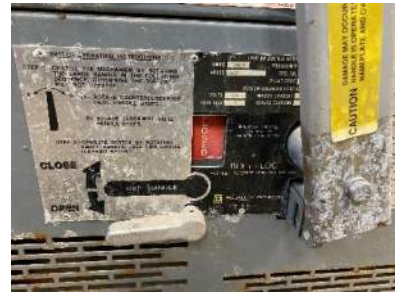
- The electrical distribution equipment was manufactured by Schneider/Square D and installed during the 1995 construction project. It appears to be in fair condition.

- Feeder wiring and raceways appear to be in fair to good condition.

- The bolt-loc switches can be unreliable and not operate correctly. This switch should be serviced by the manufacture's technicians to service and confirm that the operation will be reliable.
- Replace/Upgrade electrical distribution equipment to meet current code requirements with any building wide renovations.
- Inspect electrical equipment connections including thermal imaging, visual inspection and wire connection torque values confirmed with manufactures requirements.
- Follow the manufacturer's recommended maintenance requirements.
- Have a study completed to identify arc flash and PPE requirements for electrical equipment.

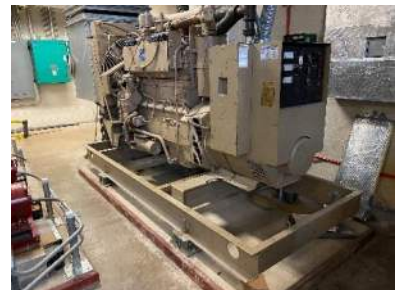
- A natural gas 125KW, 480/277-volt, 3-phase, 4-wire, generator is installed inside the building and appears to be an original installation from 1995.
- A single 225A automatic transfer switch is used for both emergency life safety and optional standby loads.
- All equipment was manufactured by Cummins/Onan.
- Installations do not meet NFPA code requirements. Life safety loads must be separated from optional equipment loads.
- The equipment appears to be in fair condition.

- Separate Life Safety loads from optional equipment loads.
- Have oil tested to determine engine wear.
- Maintain generator system per manufactures requirements.

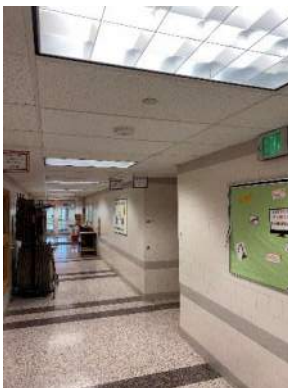
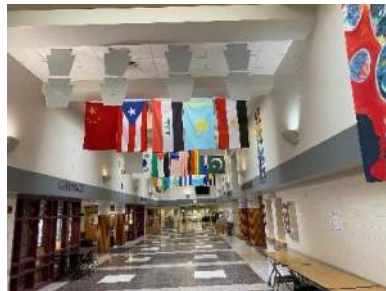
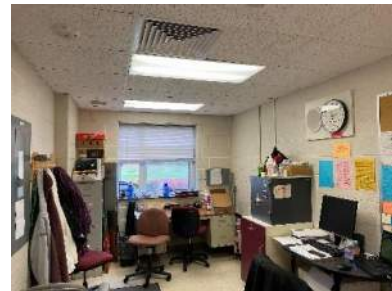
- The Gym appears to have a high bay luminaire using fluorescent lamps and integral occupancy sensors.
- High wall mounted luminaires are used in corridor/lobby for indirect lighting that appear to be using HID and LED replacement lamps.

- Exit signs appear to have been installed in the last renovation and are failing. Some exit signs have been replaced and are self-contained with battery back-up.

- Wall switches are used for controlling luminaires.
- Luminaires are in fair condition.

- Fluorescent lamps and ballast will become more scarce and costly to replace. Interior lighting should be replaced throughout with LED type luminaires and energy code compliant controls with any major building renovation.
- Exterior luminaires should be upgraded to LED type.

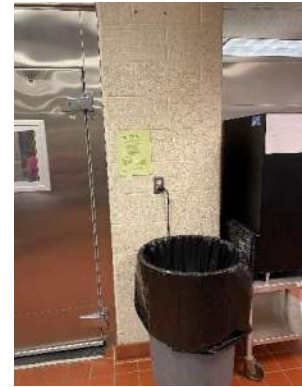
- Wiring devices appear to be original to the 1995 construction. Devices are in fair condition.
- The wiring is in fair to good condition.

- Current code requires ground-fault protection at additional locations. Devices should be changed where required for personnel protection.
- Receptacles should be replaced with Tamper-Resistant type for any building renovations or maintenance.

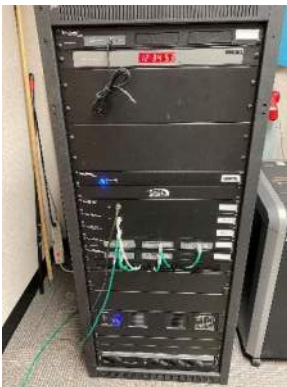
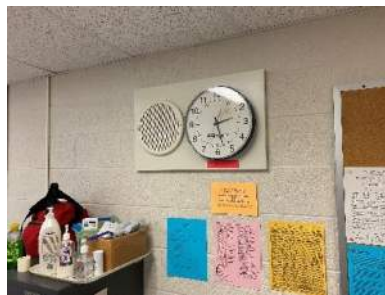
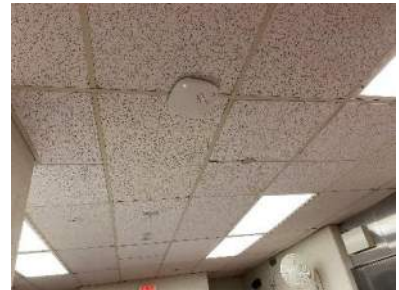
- Cat 6 cables/jacks are used in the building.
- Wi-Fi wireless access devices are installed in classrooms and other learning spaces and appear to be in good condition.
- A new Rauland Telecenter IP intercom system and a Sapling master clock system have been recently installed in the head end equipment rack and are in new condition. Existing intercom speakers and clocks have not been replaced and are still in use with this system.
- Combined wall mounted speaker/analog clock assemblies are used in the classrooms and other learning areas. The clocks are manufactured by Lathem. They appear to be original to the 1994/1995 construction of the building. Clocks are starting to fail and will need to be replaced.
- A VoIP phone system appears to be in use in the building.

- Upgrade data telecommunications system as needed to meet the School Districts requirements with any planned building renovation.
- Upgrade/replace the existing intercom speakers, clocks, and wiring with new equipment with any planned building renovation.

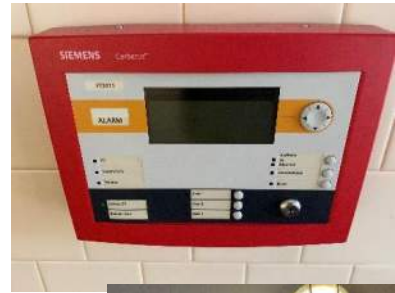
- A new Siemens Cerberus fire alarm system and associated equipment with new notification speaker/strobe devices and wiring has recently been installed and is in a new condition.
- A rescue assistance system is installed. It appears to be in good condition.

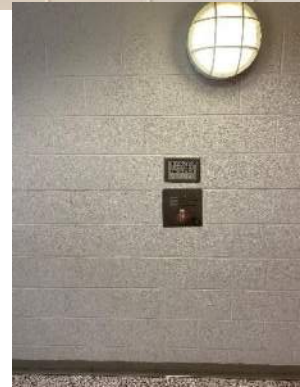
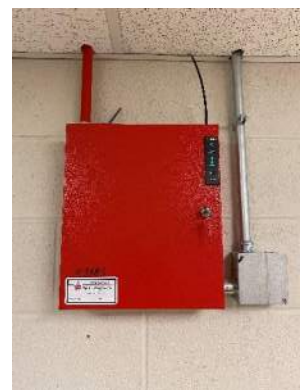
- Card access readers are in use at selected exterior doors.
- An audio-visual intercom system is being used at the main entrance.
- CCTV cameras are in use at the interior and exterior locations of the building.
- Panic buttons are used in receptionist areas.

- Systems appear to be in good condition. Upgrade systems as needed to meet the School District requirements.
- Maintain systems per manufactures requirements.
