## Canutillo ISD - Facility Condition Assessment

### Facility Condition by Campus

# **Facility Condition Assessment** Canutillo H. School Condition Assessment

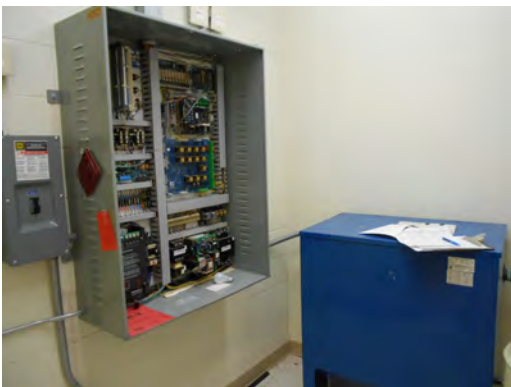
Canutillo\_HS Elevator H Wing not working

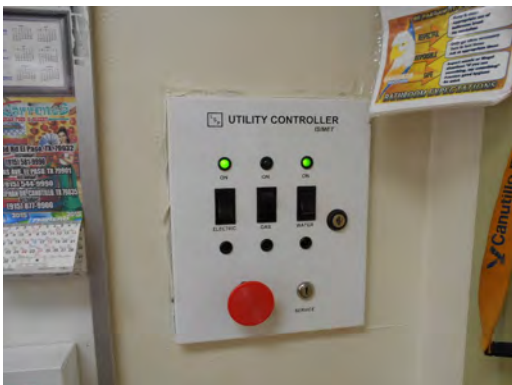
Canutillo\_HS Gas control modules out of date and not functional for class use

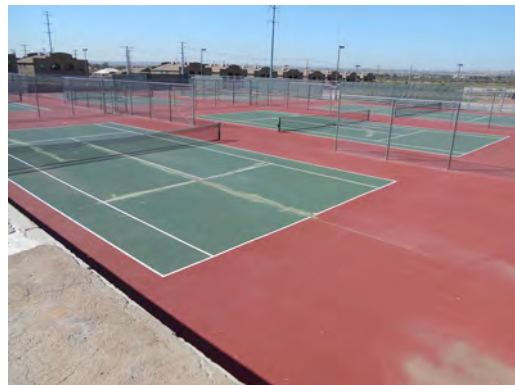
| Deficiency | Category | Qty | UoM | Priority | Repair Cost | ID |
|---|---|---|---|---|---|---|
| Paved Play Requires Recoating And Resurfacing<br><b>Note:</b> Play surfaces are deteriorated, peeling, and no longer functional, replace.<br><b>Location:</b> Tennis courts and Basketball courts | Repair | 68,000 | SF | 5 | \$830,148 | 124 |

Canutillo\_HS Basketball and tennis courts pavement failure

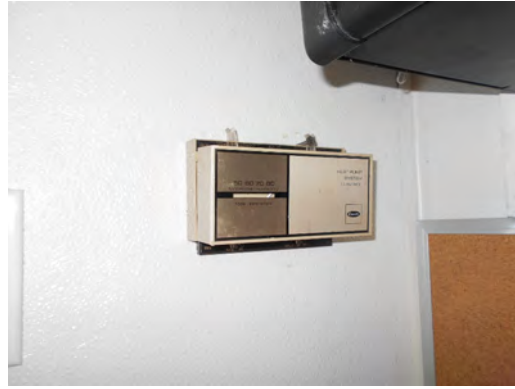
NW\_Early\_College\_Campus Old HVAC controls

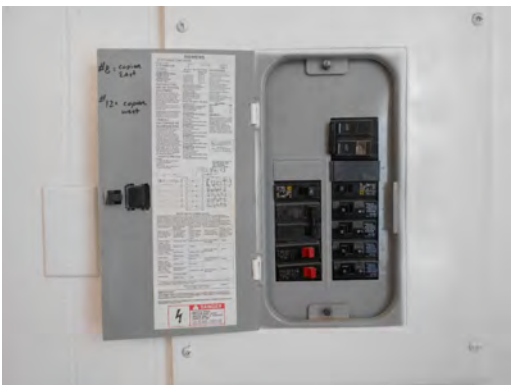
NW\_Early\_College\_Campus Electrical panelboard in classrooms

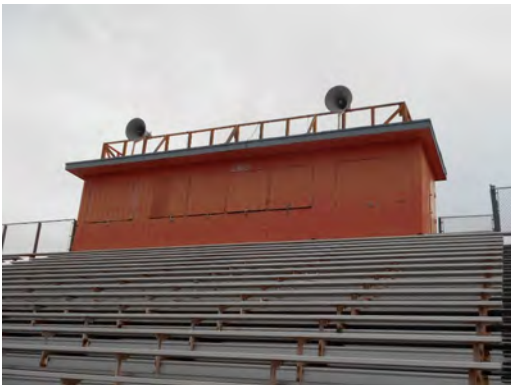
Canutillo\_MS Press Box, abandoned, not structurally safe

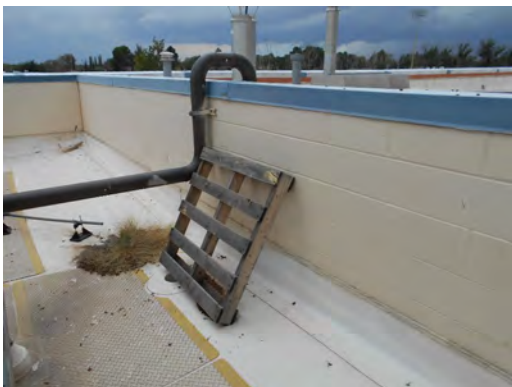
Canutillo\_MS Unsafe roof access, wood pallet used as ladder

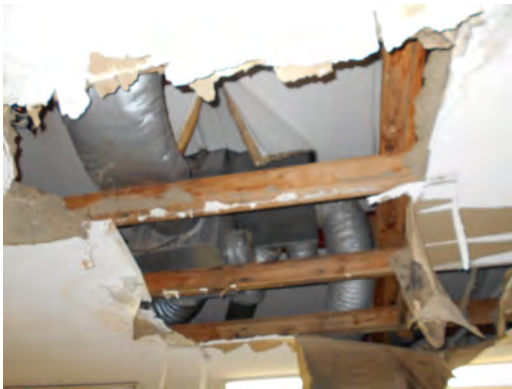
Canutilo\_MS Warehouse interior ceiling

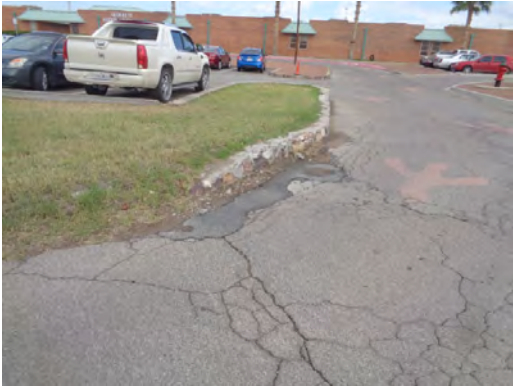
Alderete\_MS Parking lot damaged, replace and restripe

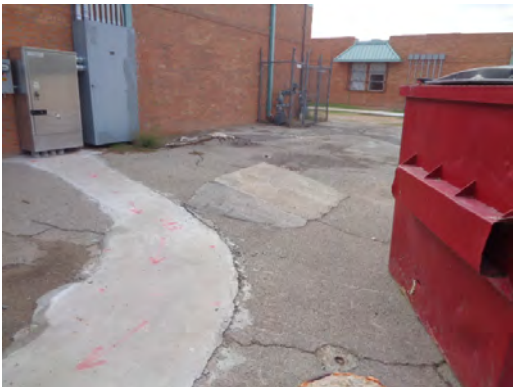
Alderete\_MS Pavement, sidewalks cracked and missing

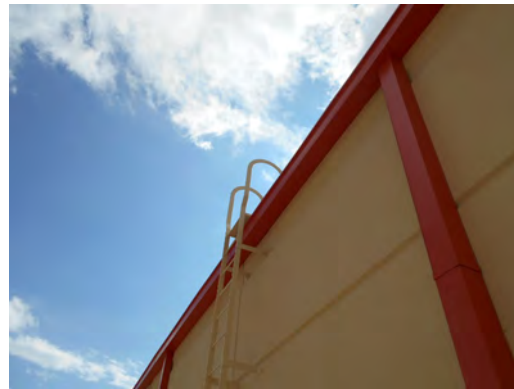
Alderete\_MS New Gym building, the roof ladder needs additional safety rails. The ladder is at the edge of a steep exterior wall with no parapet or additional protection.

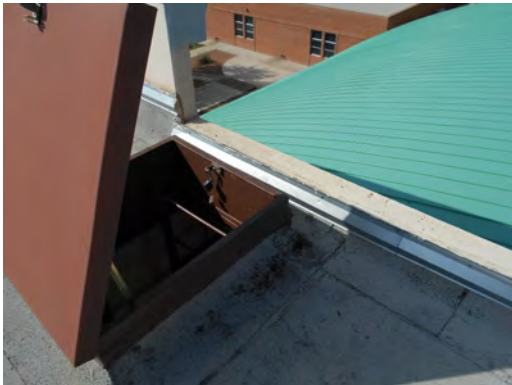
Alderete\_MS Science building, roof hatch system opens onto a ledge. Safety fall hazard. Orient the hatch system correctly

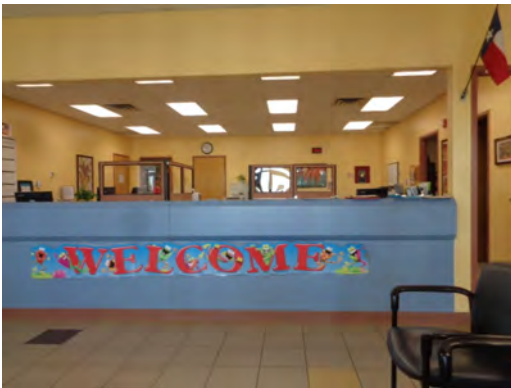
Canutillo ES\_Countertop does not meet ADA

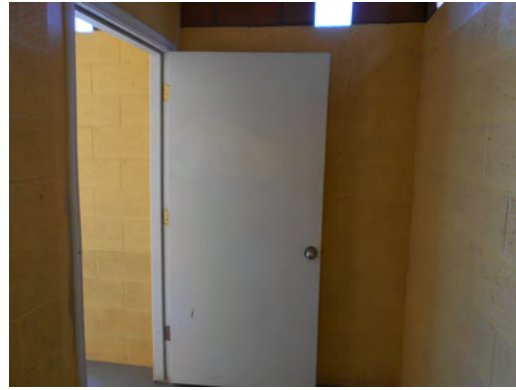
Canutillo ES\_Interior doors need repainted

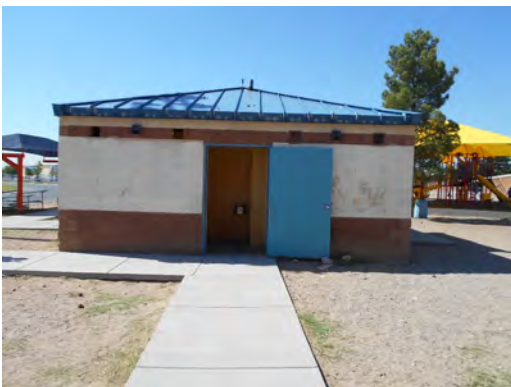
Canutillo ES\_Repaint exterior door

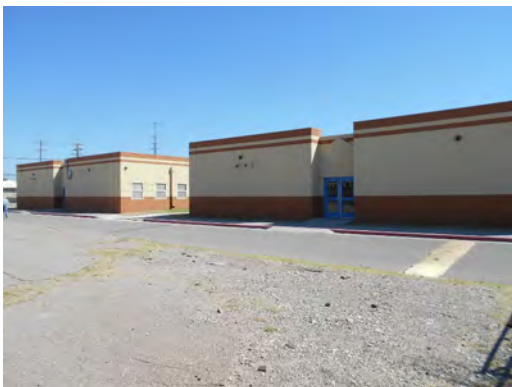
Canutillo ES\_Site drainage inadequate

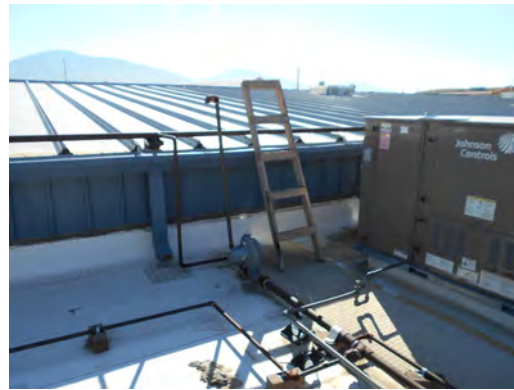
Canutilo ES\_Unsafe roof access 2

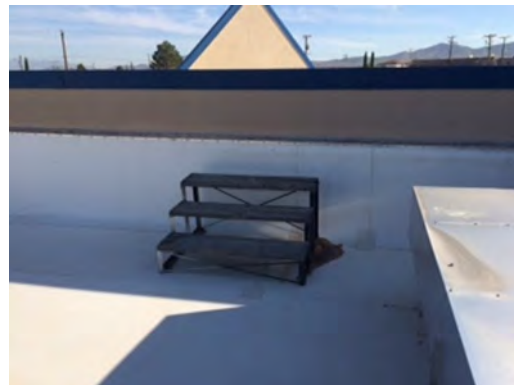
Davenport\_ES unsafe roof access

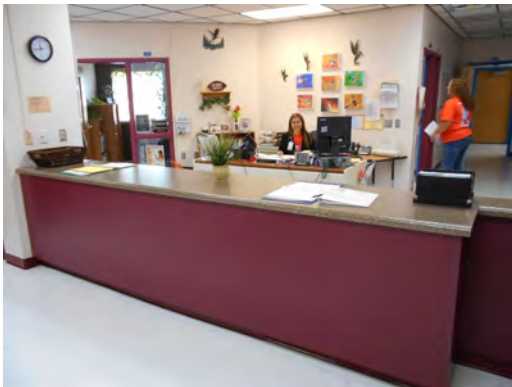
Davenport\_ES Counter is not ADA Compliant

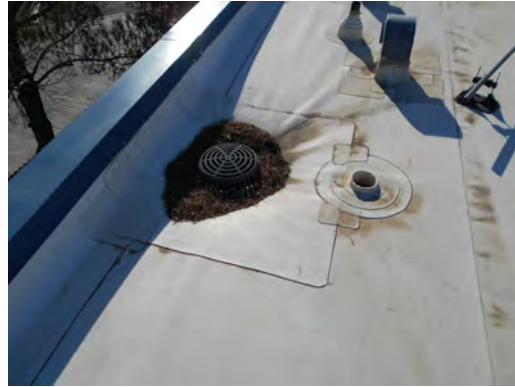
Davenport\_ES Clean roof and install debris covers on overflow drains

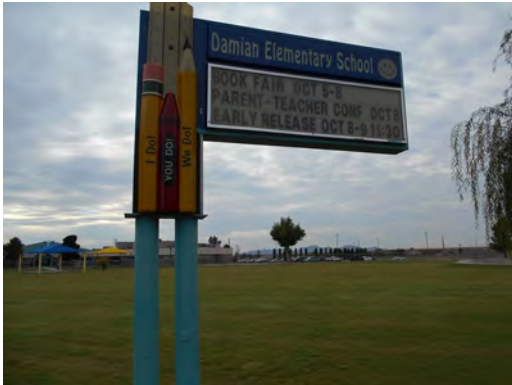
Damian\_ES Marquee is old and in need of replacement

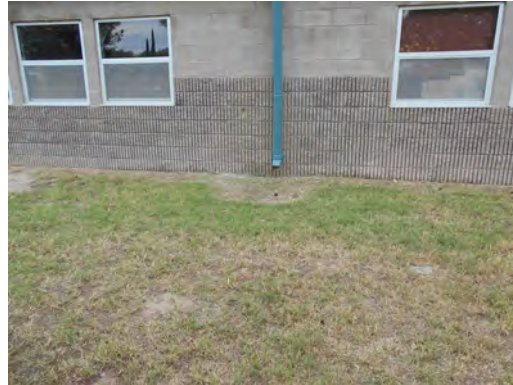
Damian\_ES Splashpads required to prevent erosion

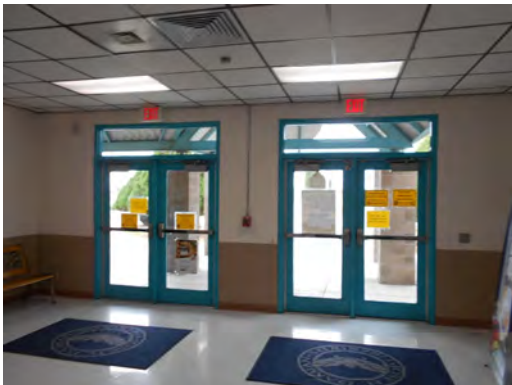
Damian\_ES Entry doors require ADA assist device

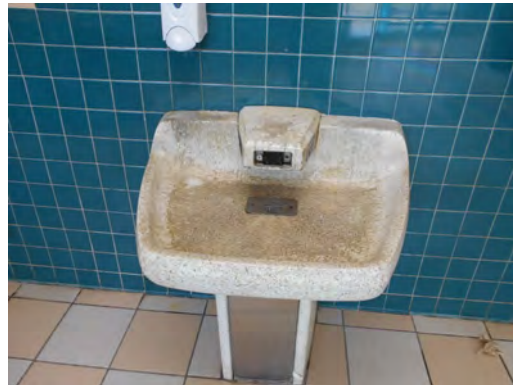
Damian\_ES Replace non working restroom lavatory

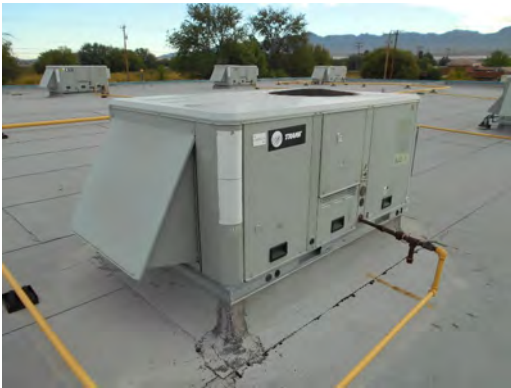
Damian\_ES Roof top HVAC, old TRANE units

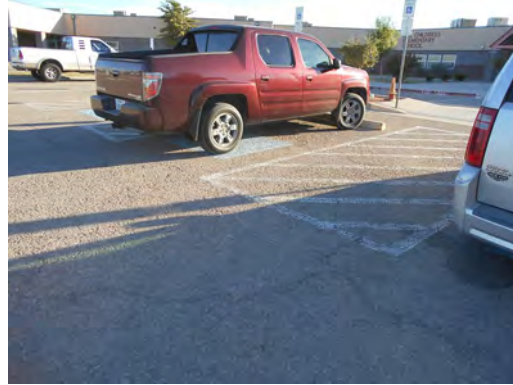
Childress ES\_ADA accessible parking spaces not properly striped

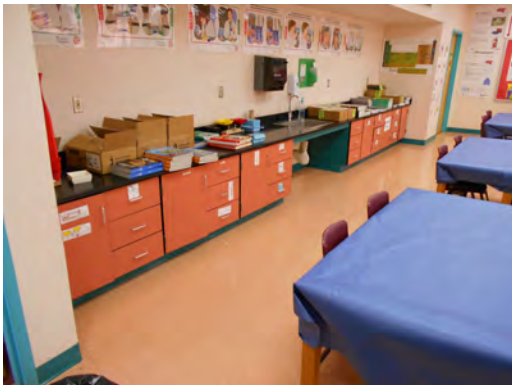
Childress ES\_Base storage cabinets require replacement

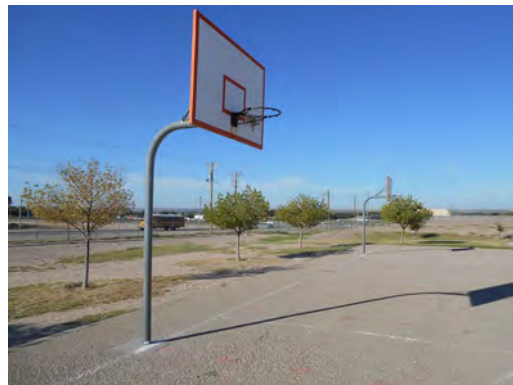
| Deficiency | Category | Qty | UoM | Priority | Repair Cost | ID |
|---|---|---|---|---|---|---|
| Asphalt Paving Requires Replacement | Repair | 112 | CAR | 4 | \$220,618 | 133 |
| <b>Note:</b> Asphalt Paved Play Area to be replaced. Basketball Court. Replace 7200 SF.<br><b>Location:</b> Asphalt Paved Play Area to be replaced. Basketball Court. Replace 7200 SF. | | | | | | |

Childress ES\_Basketball court asphalt paving requires replacement

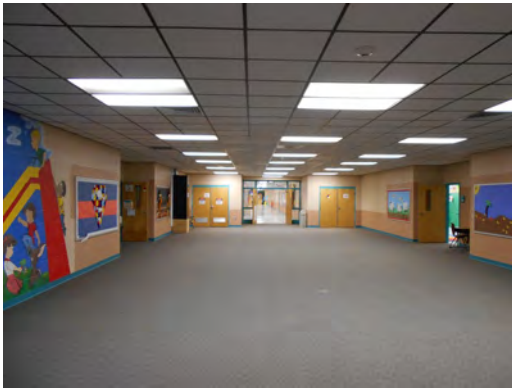
Childress ES\_Carpet requires replacement

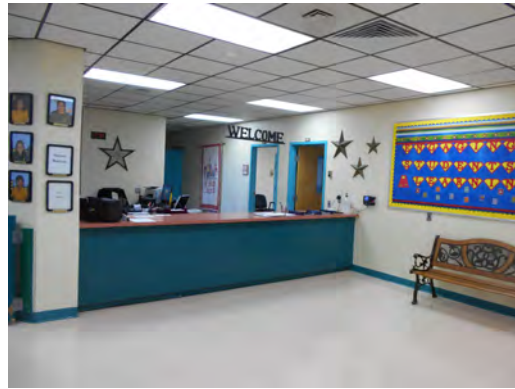
Childress ES\_Main Office counter exceeds max ADA height

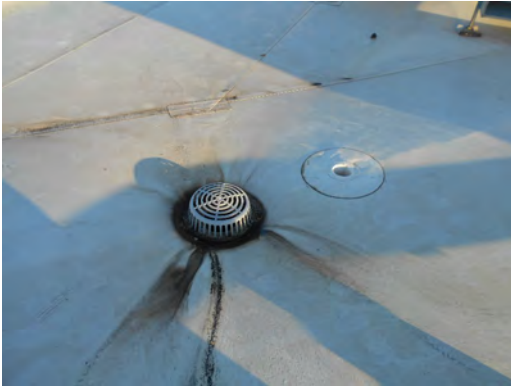
Childress ES\_Roof drains require cleaning

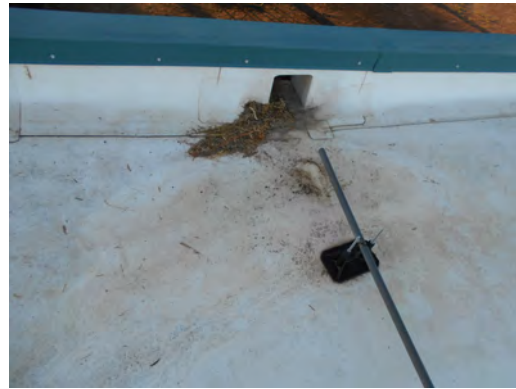
Childress ES\_Roof requires cleaning

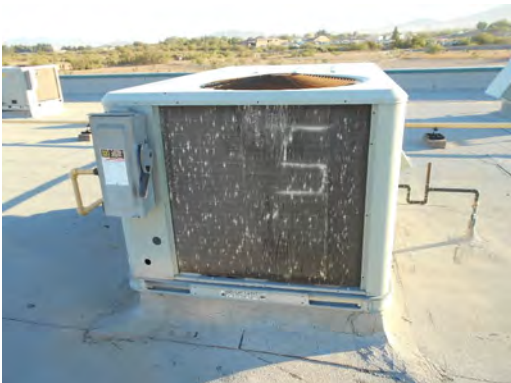
Childress ES\_Roof Top Units require replacement

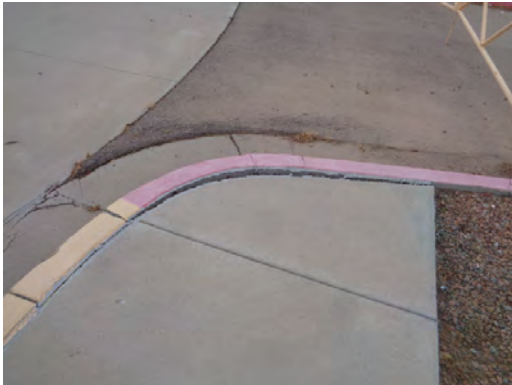
Garcia\_ES Sidewalk settlement, trip hazard,

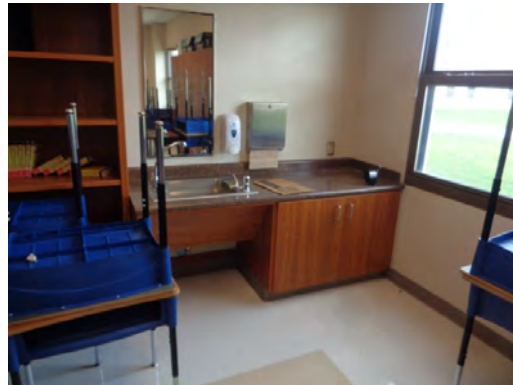
Garcia\_ES Wall damage under windows

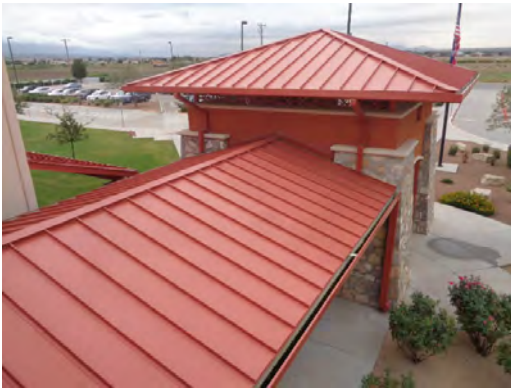
Garcia\_ES Gutter joints leak, seal joints

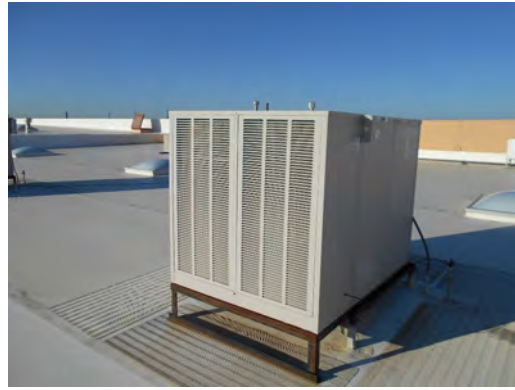
Canutillo\_Central\_Office Old evaporative coolers

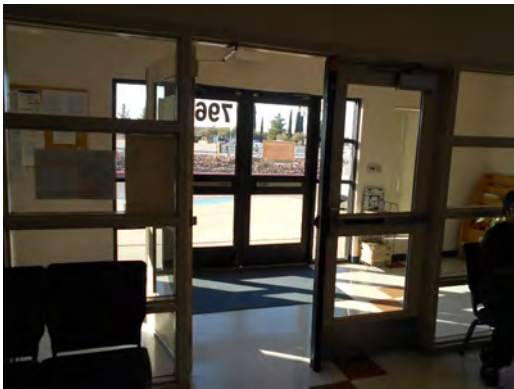
Canutillo\_Central\_Office Main Entry not ADA Compliant

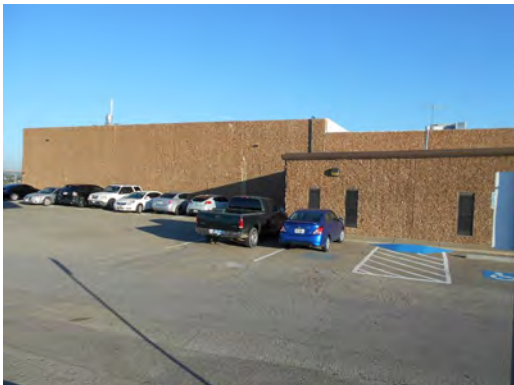
Canutillo\_Central\_Office No safe roof access from upper level  
(roof hatch) to to the lower level over offices

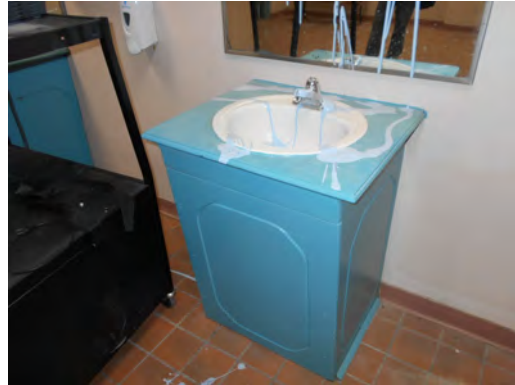
Lone\_Star\_Buildings Unused bld, interior vandalism damage

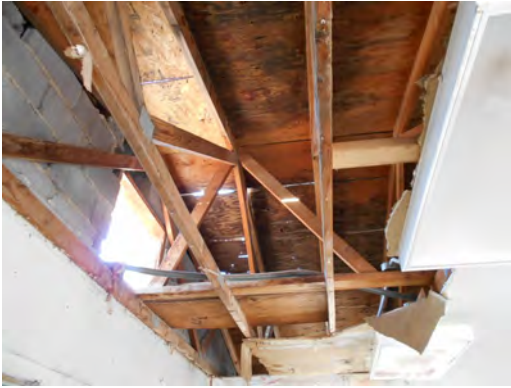
Lone\_Star\_Buildings Cottage 1, Interior damage

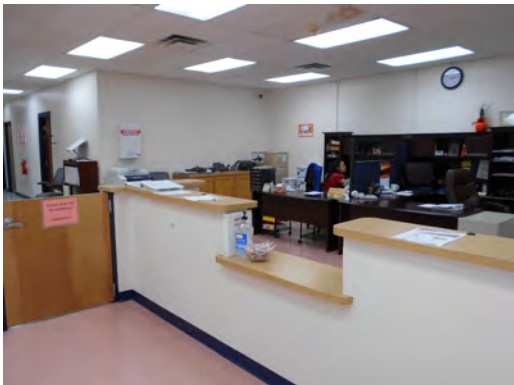
Canutillo\_Facilities\_Transportation Countertop not ADA compliant

| Deficiency | Category | Qty | UoM | Priority | Repair Cost | ID |
|---|---|---|---|---|---|---|
| <b>Note:</b> Replace Administrative counter with ADA compliant | | | | | | |

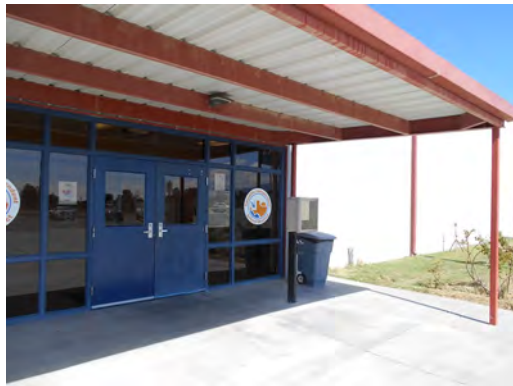
Canutillo\_Facilities\_Transportation Entry doors not ADA Compliant

| Deficiency | Category | Qty | UoM | Priority | Repair Cost | ID |
|---|---|---|---|---|---|---|
| <b>Note:</b> Missing ADA door power assist | | | | | | |
