FACILITY CONDITION ASSESSMENT & NETZERO ENERGY AUDIT

Dresden Athletic Fields
221 US Route 5 South
Norwich, Vermont 05055

December 13, 2022

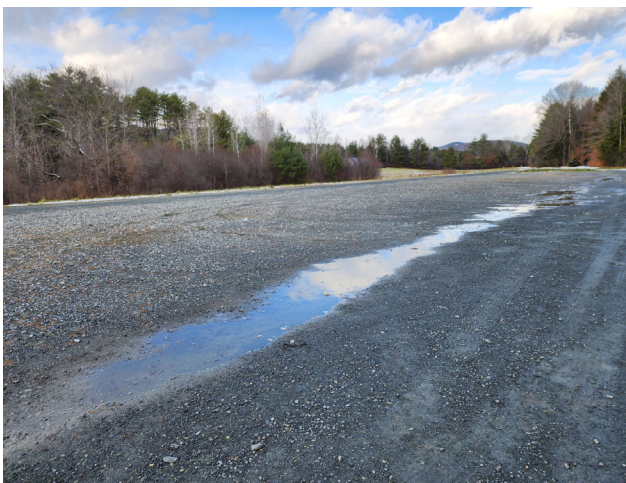
11 - PARKING AREA

There is an unstriped gravel parking area near the sports fields. A few potholes were observed on the driveway leading to the parking area. Repair of the damaged pavement is recommended. There is no on-site lighting at the property. According to the point of contact, complaints about inadequate site lighting have not been reported. Landscaping and lawn maintenance are reportedly done weekly or as needed. The baseball and softball fields each have two dugout ancillary buildings.
