FACILITY CONDITION ASSESSMENT & NETZERO ENERGY AUDIT

Marion Cross School
22 Church Street
Norwich, Vermont 05055

158531.22R000-002.379

November 17, 2022

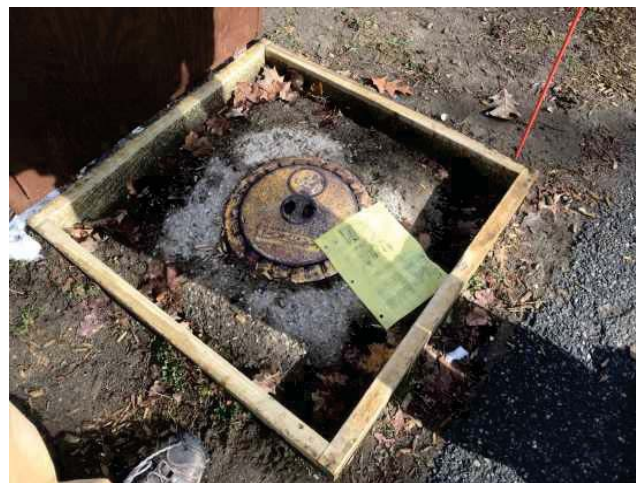
24 - UNDERGROUND FUEL STORAGE TANK

Dead River provides the fuel oil to the facility. The deliveries are made on an as-needed basis. The underground storage tanks are located near the front playground.
