Middle School Facilities Assessment

Albemarle County
Public Schools

FACILITIES ASSESSMENT REPORT

Burley Middle School

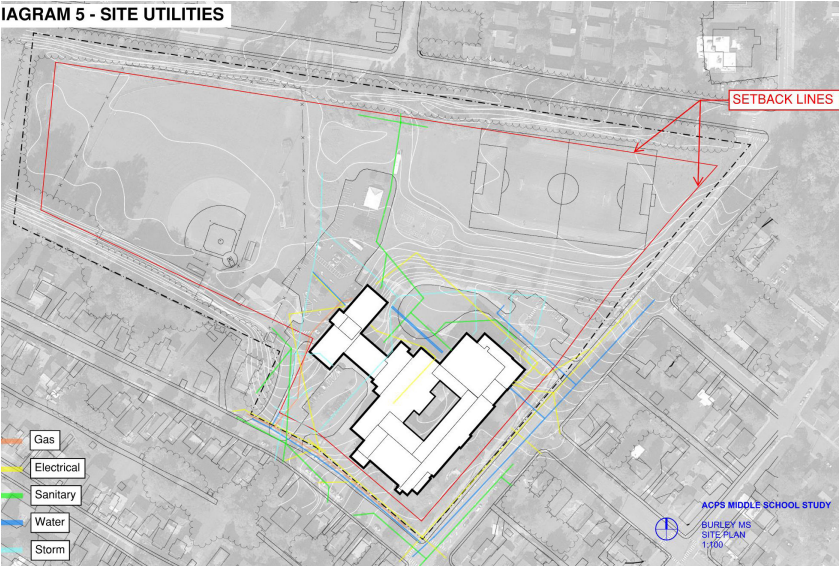
Burley Existing Site Utilities

There is existing public sanitary sewer and public water connections available and in place servicing the building. There are also existing telecom and power services to the site and existing building. Any future expansions would warrant an evaluation of the capacity of each utility for adequacy. Around the perimeter of the building, generally good drainage exists with positive relief away from the building. Two storage containers by the baseball field were noted on site. The site lighting appears to be LED and adequate coverage, however this is based on visual inspection only and is not an evaluation of photometrics levels.

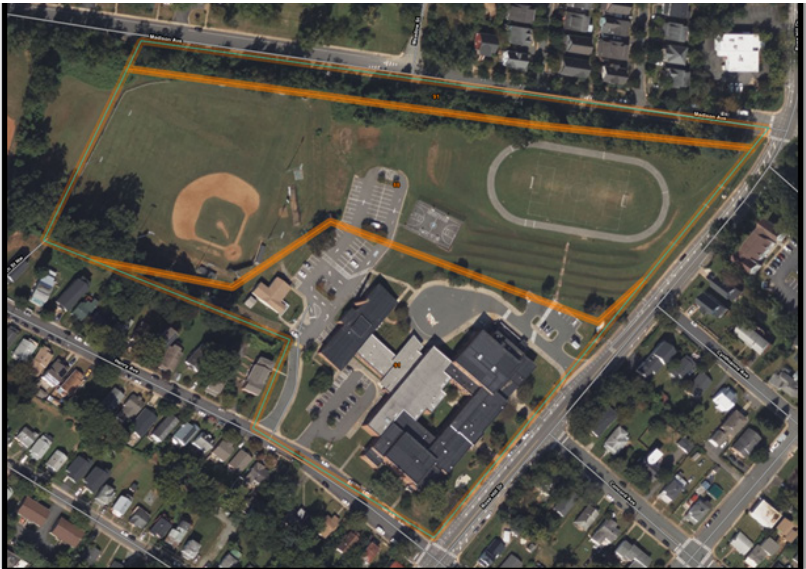
Burley Soils Map

The soils on site are a mixture of 91-Urban Land (55%) and 88-Udorthents (45%). Generally, the Urban Land is in areas of prior development on site and the Udorthents is in the lower lying areas on site (baseball & multipurpose field). It is recommended a geotechnical investigation be performed in support of any future development requiring significant foundations, earthwork, or paving.

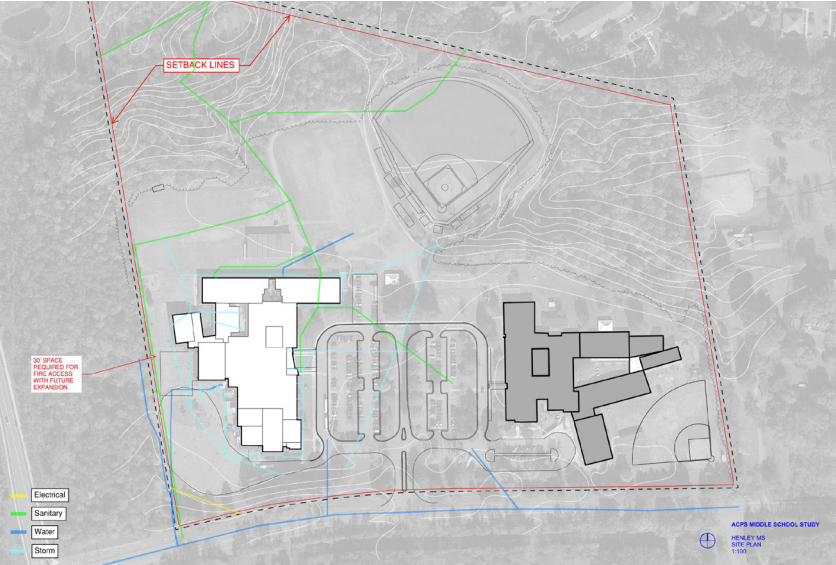
Henley Existing Site Utilities

There is existing public sanitary sewer and public water connections available and in place servicing the building. The sanitary sewer service for the building connects to the public sewer line for treatment as the site is within the Albemarle County Service Authority service area and has been confirmed by ACSA all sewage effluent connects to ACSA and RWSA sewer. However, there also appears to be a sewage disposal pond on site from the original construction. The status of this disposal pond is unknown at this time and warrants further investigation. It is recommend a study be commissioned to discover the status of the sewage disposal pond and proper abandonment. The sewage pond appears to have algae blooms which creates the interest to confirm proper disconnection and abandonment. There are also existing telecom and power services to the site and existing building. Any future expansions would warrant an evaluation of the capacity of each utility for adequacy. Several sheds were noted spaced around the site. The site lighting appears to be LED and adequate coverage, however this is based on visual inspection only and is not an evaluation of photometrics levels.

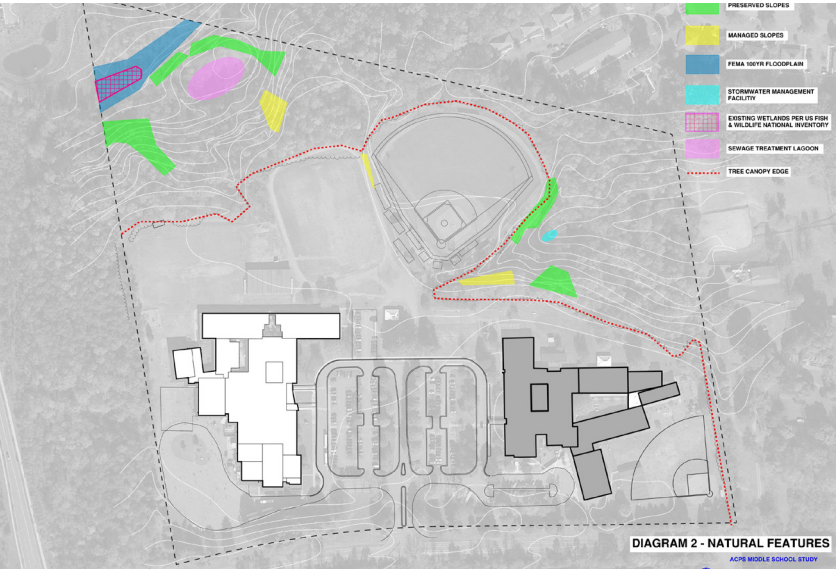
Henley Critical Slopes

The site is generally fairly flat in the areas of previous development. The forested areas (approximately 30% of site area) to the north and east have steep topography generally not conducive for development without substantial site work costs. There appears to be some opportunity to develop approximately 1.5 acres of forested area north of the central multipurpose filed where topography in the forested area is flatter. There are preserved and managed slopes on the site shown in the graphic below (green – preserved, yellow – managed). The preserved slopes are more difficult to impact and may require an application to and approval by the Board of Supervisors. The managed slopes can generally be impacted by development during the site plan process with proper justification. The land cover on the site is fair to poor with large areas of bare earth. Generally, the building has good positive drainage away however some areas with

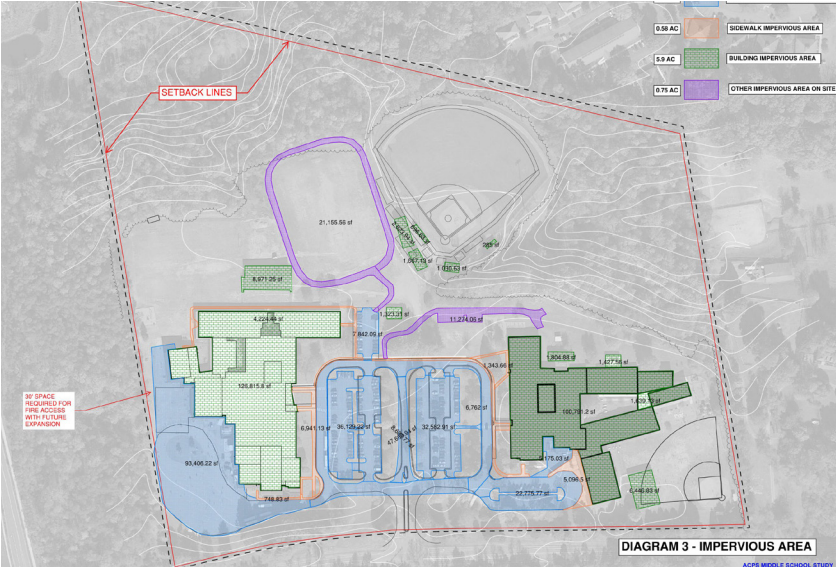
Henley Existing Impervious Site Area

Existing stormwater management on the site appears to be sparse which is likely due to the 1966 construction preceding stormwater regulations. It should be assumed that any development on the site will be required to provide stormwater management practices to serve the areas of land disturbed with the project. Site drainage is generally good with positive relieve away from the building with the only exception noted in the northeast corner. The site does have one existing dry pond providing a small amount of detention. The system appears to be stressed with downstream channel erosion and frequent overtopping of the small dam of the pond. Future development on the site should consider this apparent inadequacy. The storm drainage off of the site is distributed with two discrete outfall points and sheet/shallow concentrated flows. This existing pond appears to have approximately half of the site drain through it.

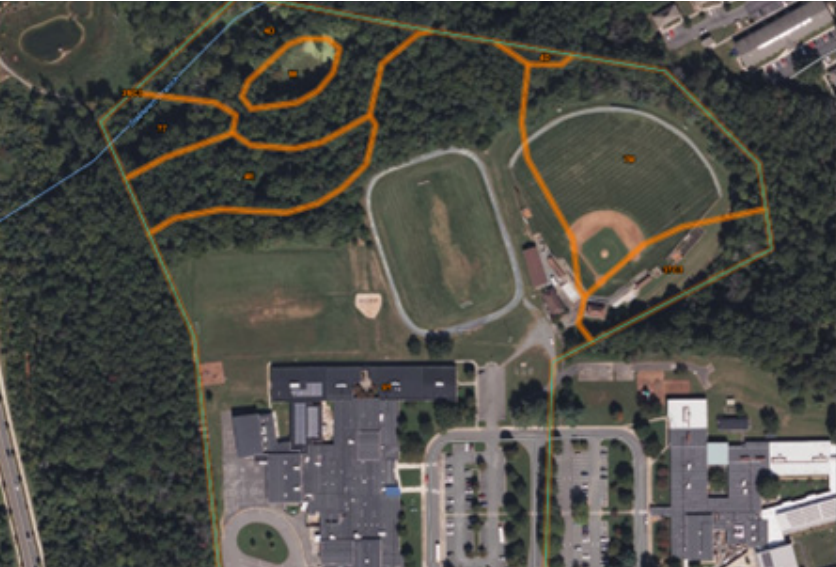
Henley Soils Map

The soils on site are a mixture of 91-Urban Land (68%), 37C3-Haysville Clay (11%), 7B-Braddock Loam (11%), and 4D/4E – Ashe Loam (10%). Generally, the Urban Land is in areas of prior development on site and the remaining soil types are within the forested areas and baseball field. It is recommended a geotechnical investigation be performed in support of any future development requiring significant foundations, earthwork, or paving.

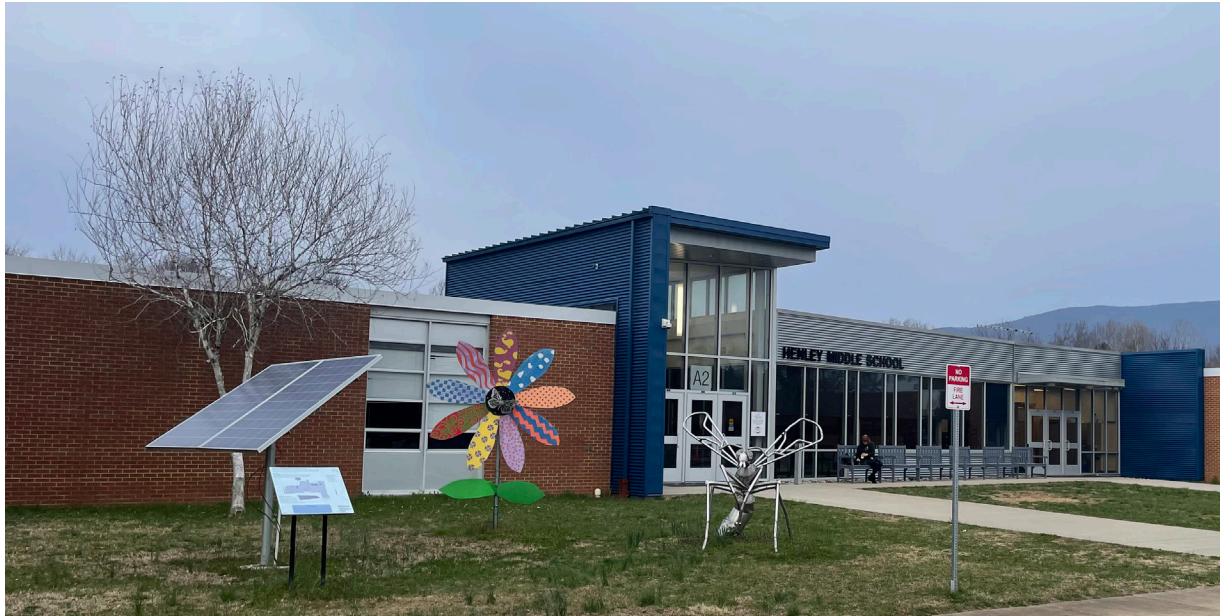
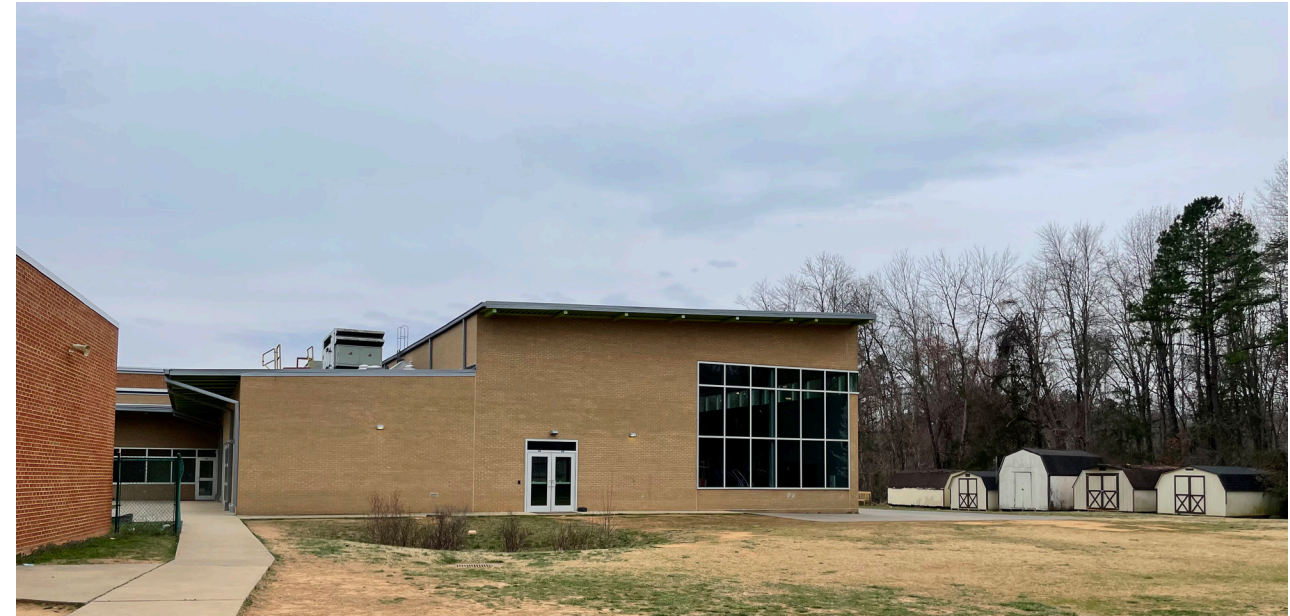
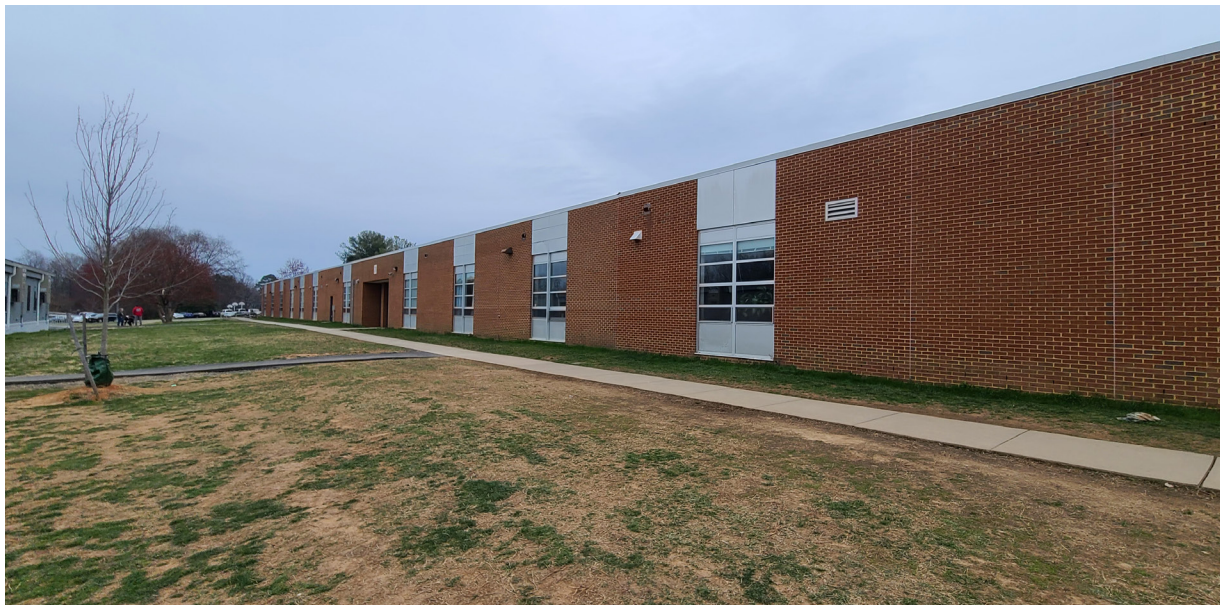
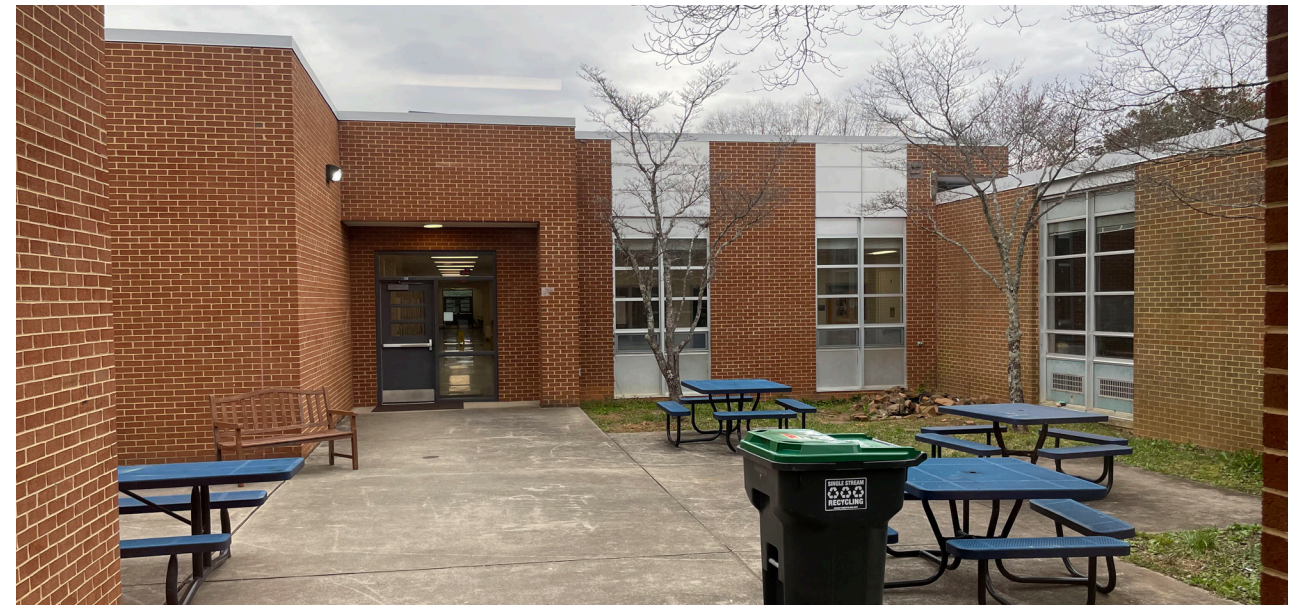
- Brick weeps were not seen in all the walls of the original building.
- Most vertical expansion joints (EJ) have failed sealant due to age.
- The cast stone sills under the windows have failed sealant head joints due to age.
- A few brick lintels are rusting.

- A few vertical CMU cracks occur at isolated locations.
- The interior CMU control joints in the gym need new sealant.
- Around the interior of the Gym, there were about (3) high diagonal cracks in the CMU.
- No major settlement or cracking were seen in the floor slabs or in the walls.

In general, the buildings are in very good shape for their different ages.

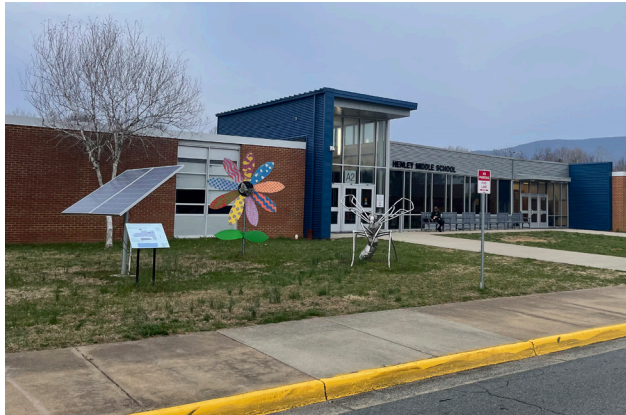
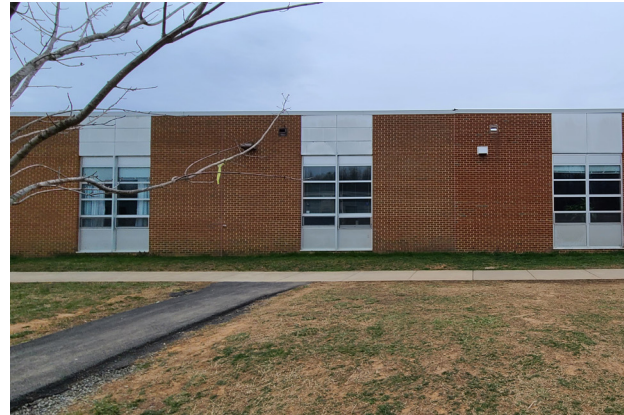
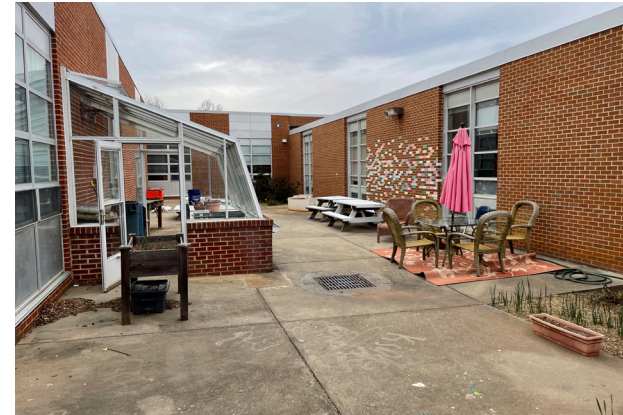
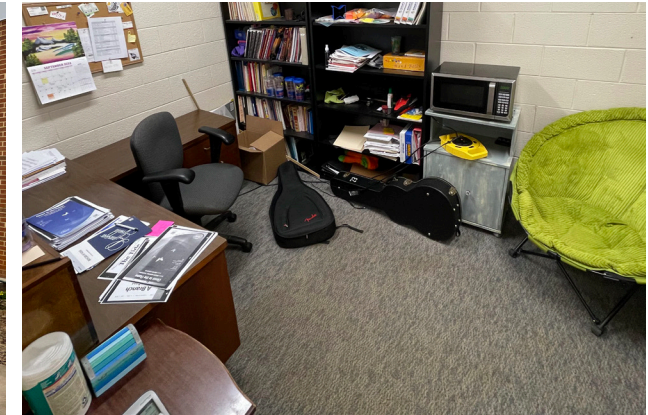
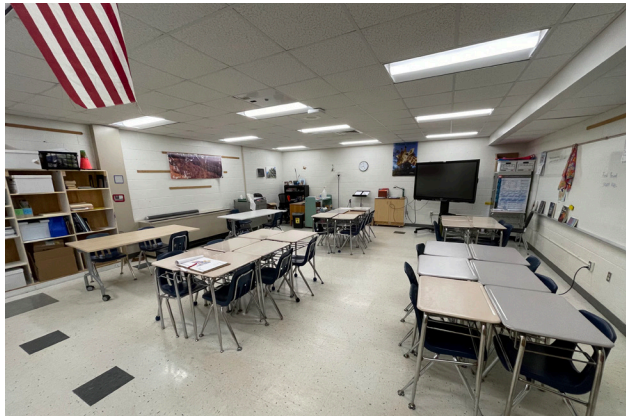
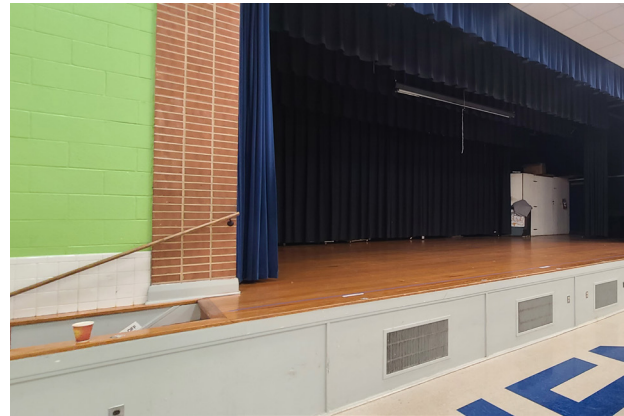
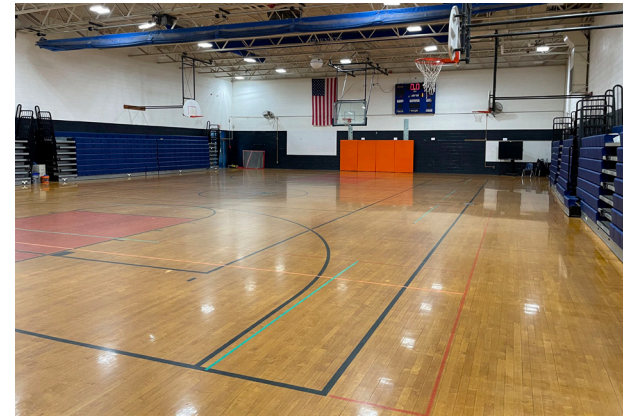
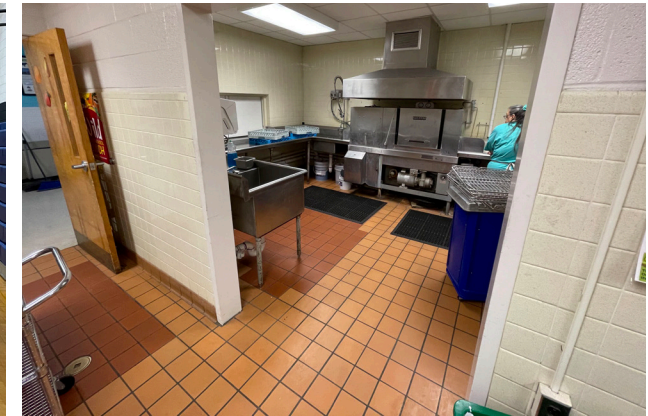
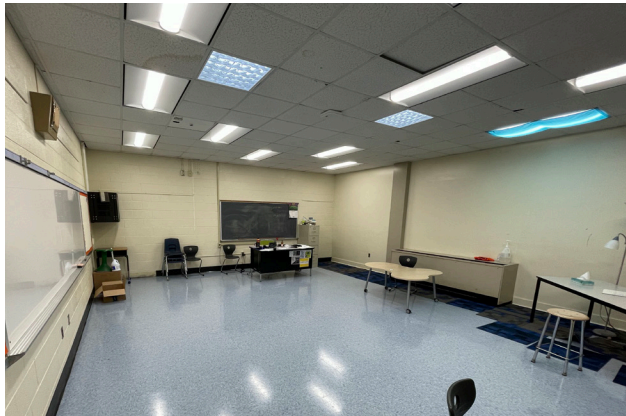
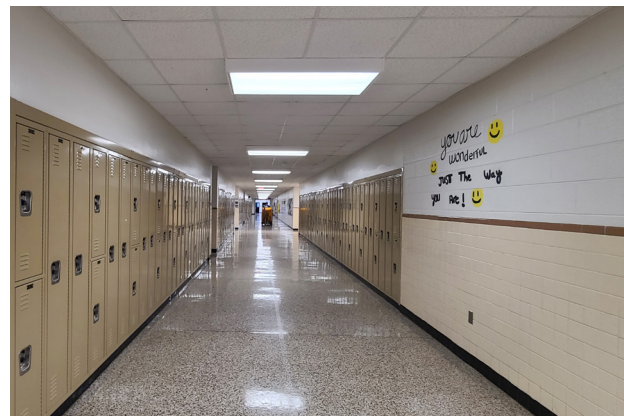
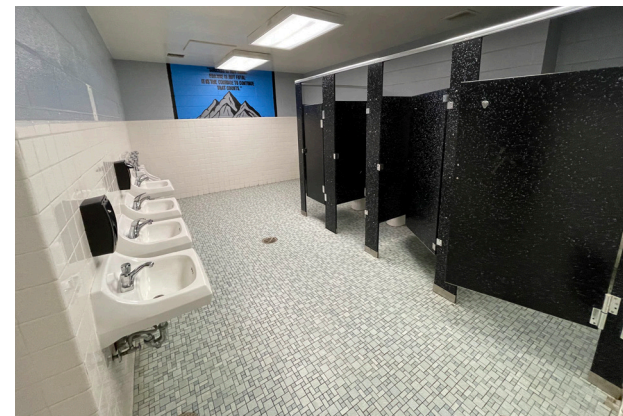
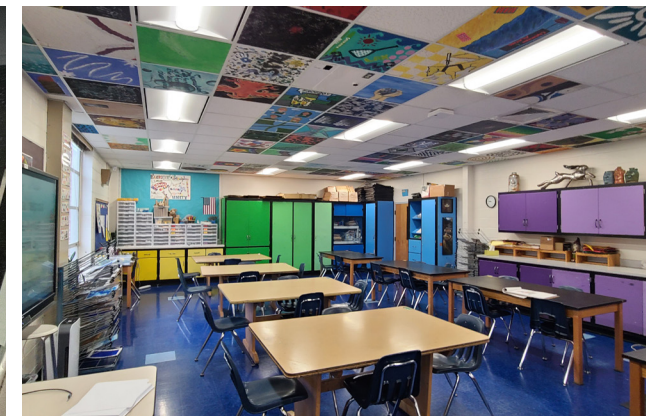
- Except for a few edge conditions where overlapping membranes have started to separate, the overall roof at Henley is in good condition. ACPS anticipates membrane roof replacements every 20-30 years, budgeting in the 10-year CIP plan at or around the 15-year mark. The majority of Henley’s membrane roofs were replaced in 2018 and 2021, and anticipated replacements of these roofs should occur around FY2043-46. It is recommended that membrane roof replacements include removing existing roof assemblies down to the structural deck and replacing them with a new roof assembly with increased roof insulation to improve envelope performance.

- The exterior skin is a mix of brick veneer, metal panel, and storefront and unit windows. The wall assemblies of the original building and 1998 addition do not meet current energy codes, but newer additions in 2004, 2015 and 2018 do meet current energy codes. Masonry repairs were performed in 1993. See structural narrative for additional exterior finish observations and recommendations.

- Original windows are metal with single-pane glass and operable panels in the classrooms and are generally in fair-good condition but could be replaced to improve air-tightness and overall building energy performance. Windows in 1998 are metal, with operable panels, and generally are in good condition. Unit windows and storefronts associated with the 2004, 2015, and 2018 additions are aluminum-framed, with “hopper” style sections in the classrooms to match the original window styles. Their condition is generally good. Storefront entry doors match windows and are generally in good condition.

- Original floors in the school consist mostly of asphalt tile, with terrazzo in the corridors and vinyl asbestos tile in the lobby, corridors, cafeteria, and some storage spaces. Despite their age, these floors are generally in good condition. The newer additions and renovations were constructed with 12”x12” VCT flooring and carpet, and are generally in good condition. While the typical life expectancy

- Student lockers are located throughout the public corridors and appear to be in good condition

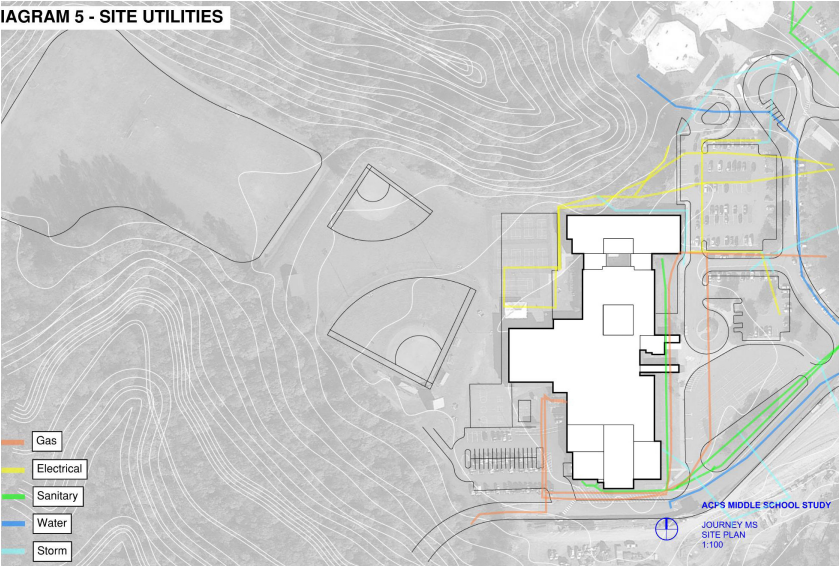
Burley Existing Site Utilities

There is existing sanitary sewer and public water connections available and in place servicing the building. The sanitary sewer flows into a newly constructed pump station built with the Boys and Girls Club and maintained by ACPS. There are also existing telecom and power services to the site and existing building. Any future expansions would warrant an evaluation of the capacity of each utility for adequacy. Around the perimeter of the building, generally good drainage exists with positive relief away from the building. Several sheds were noted spaced around the site. The site lighting appears to be LED and adequate coverage, however this is based on visual inspection only and is not an evaluation of photometrics levels.

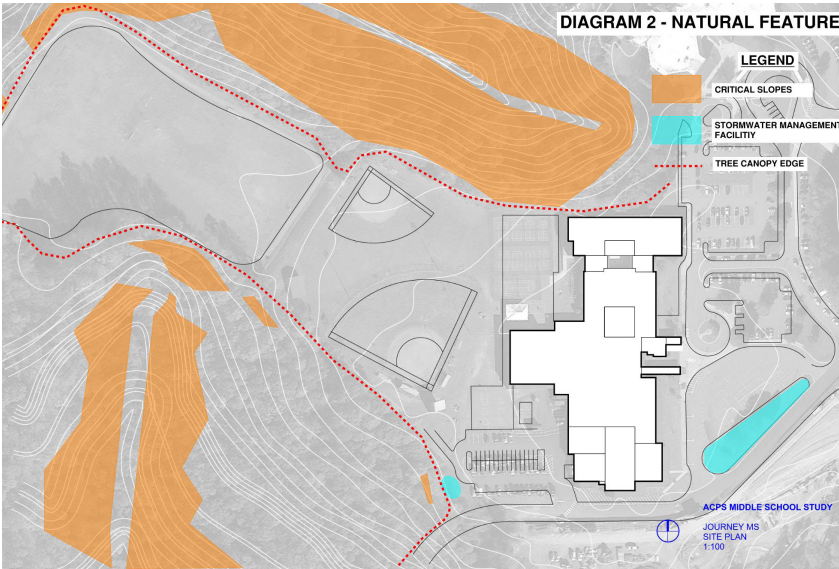
Burley Critical Slopes

to develop approximately 3.5 acres of forested area in two separate pockets south of the baseball and lacrosse fields where topography in the forested area is flatter. There are critical slopes on the site shown in gold on the graphic below. Disturbance of critical slopes requires a waiver and Board of Supervisors approval of the request. The land cover on the site is generally good with few and isolated areas of bare earth. Generally, the building has good positive drainage away and no Floodplain present on site. Lastly it should be noted the site is within a leaking tank 2000 ft buffer which appears to be identified as the on site ACPS owned fuel station.

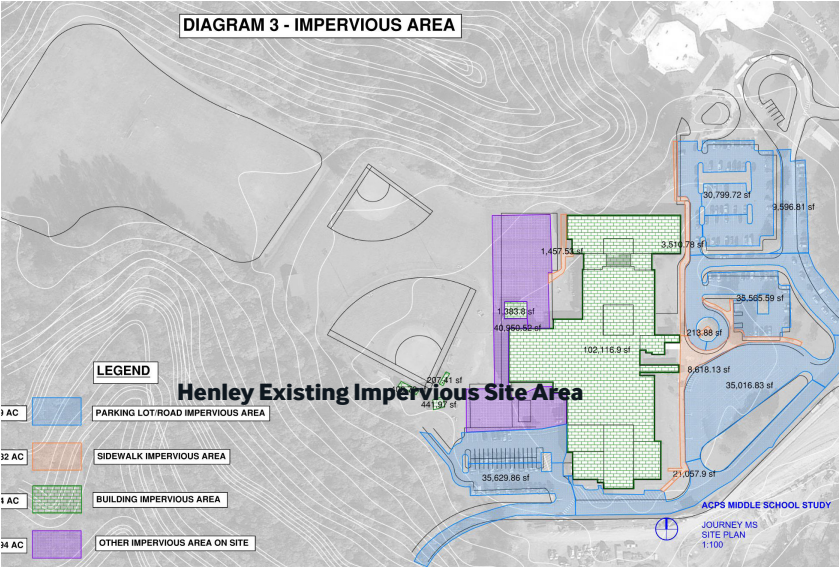
Burley Existing Impervious Site Area

Existing stormwater management on the site appears to be sparse which is likely due to the 1966 construction preceding stormwater regulations. It should be assumed that any development on the site will be required to provide stormwater management practices to serve the areas of land disturbed with the project. Site drainage is generally good with positive relieve away from the building with the only exception noted in the northeast corner. The site does have two bioretention facilities located in the island south of the bus parking and west of the rear parking lot. Both bioretention systems appear to be in good function and health with ample vegetated cover.

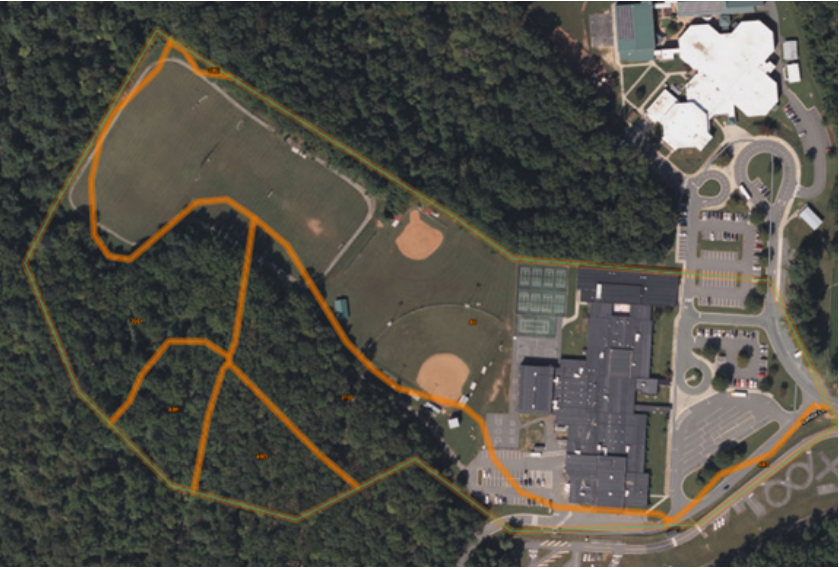
Burley Soils Map

The soils on site are a mixture of 88-Udorthents (39%), 39D/39E-Hazel Loam (36%), 48B- Philmont Sandy Loam (10%), 21B/21D – Culpepper Fine (11%), and 4E- Ashe Loam (4%). Generally, the Udorthents is in areas of prior development on site and the remaining soil types are within the forested areas. It is recommended a geotechnical investigation be performed in support of any future development requiring significant foundations, earthwork, or paving.

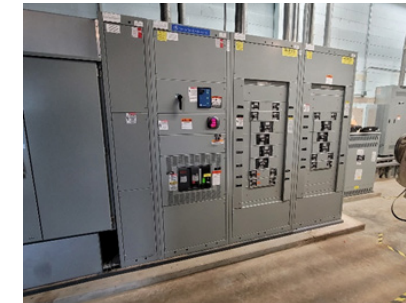
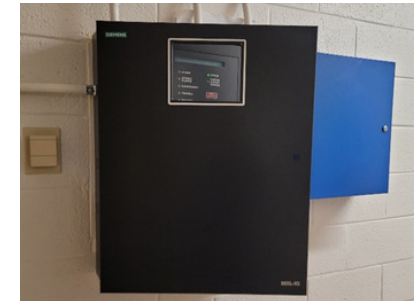
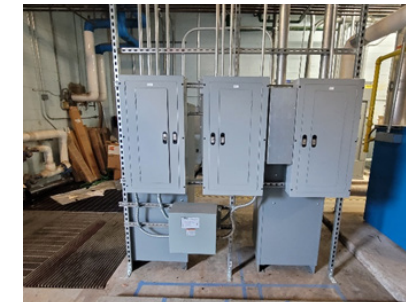
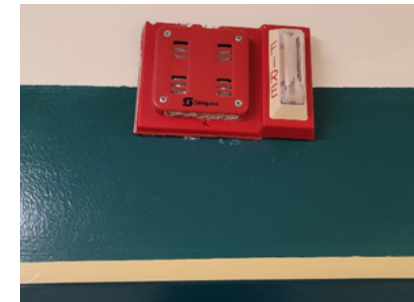
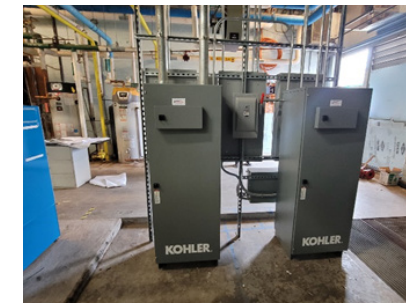
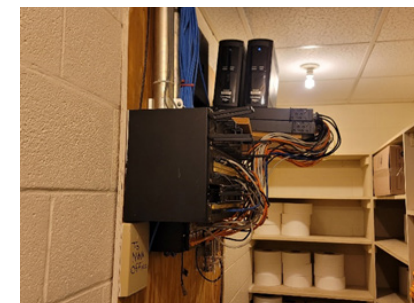
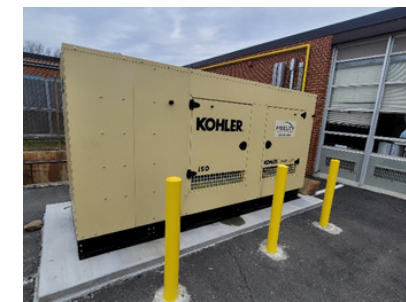
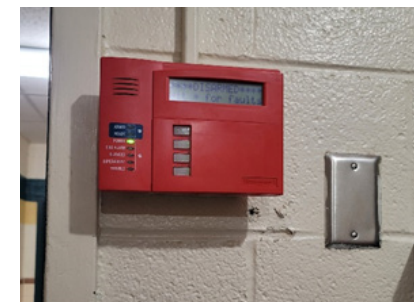
LOW-VOLTAGE SYSTEMS COMMENTS

- The building features an addressable public address system manufactured by Telecor, an intrusion detection system, security management system, and video management system. Systems all seem to be in functional order and in good condition. Low-voltage wiring closets are located throughout the building; but dedicated closets with cooling/heating are not provided.

- Ensure all systems are compliant with current county standards and evaluate for replacement/expansion during the next major renovation. Establish dedicated IT closets with cooling/heating to meet BICSI standards.

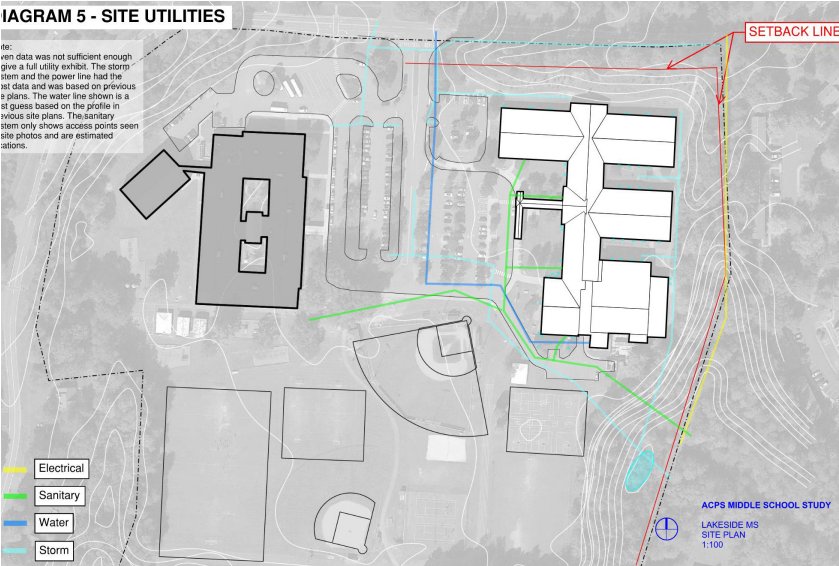
Lakeside Existing Site Utilities

Existing stormwater management on the site appears to be nonexistent which is likely due to the 1966 construction preceding stormwater regulations. It should be assumed that any development on the site will be required to provide stormwater management

practices to serve the areas of land disturbed with the project. Site drainage is generally good with positive relieve away from the building around the perimeter with roof drains undergrounded.

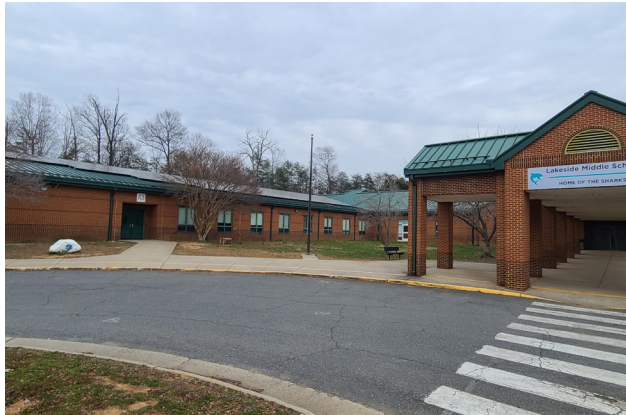
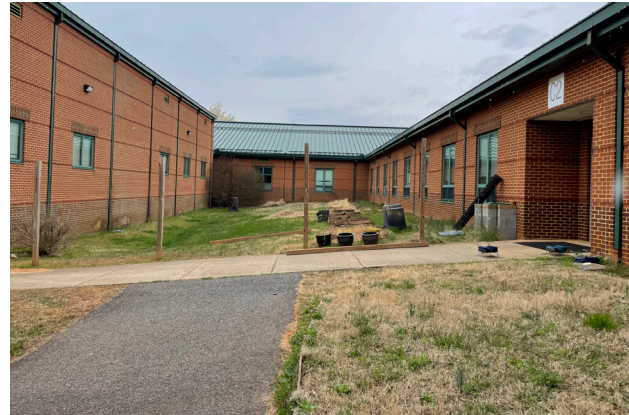
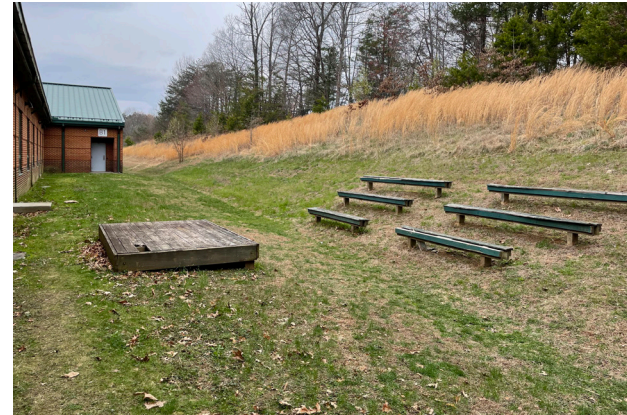
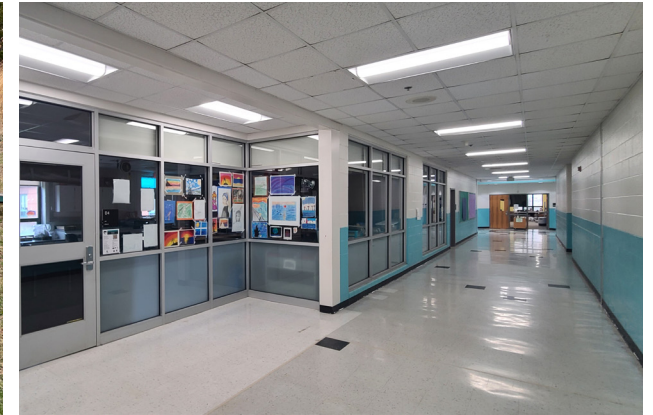
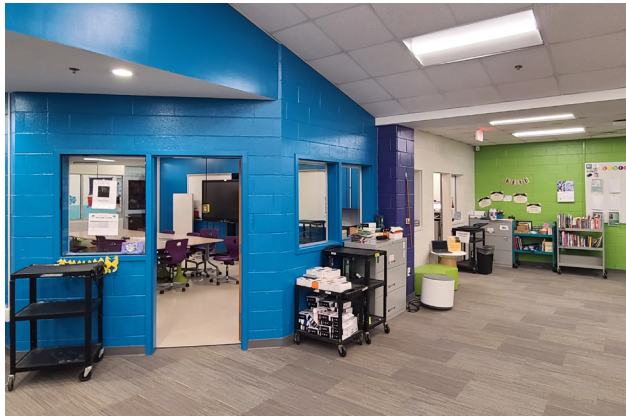
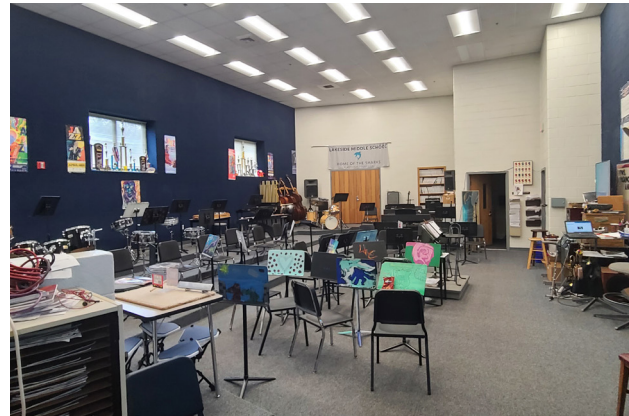
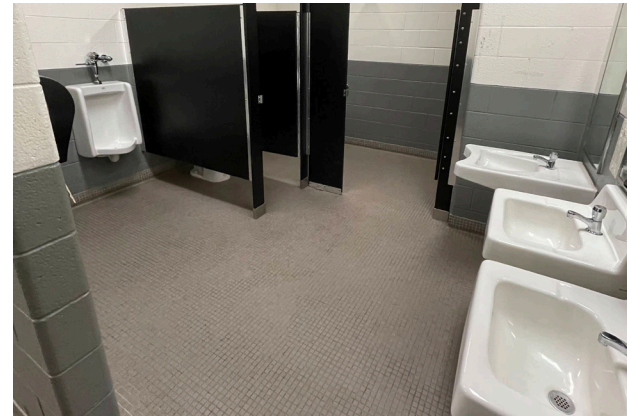
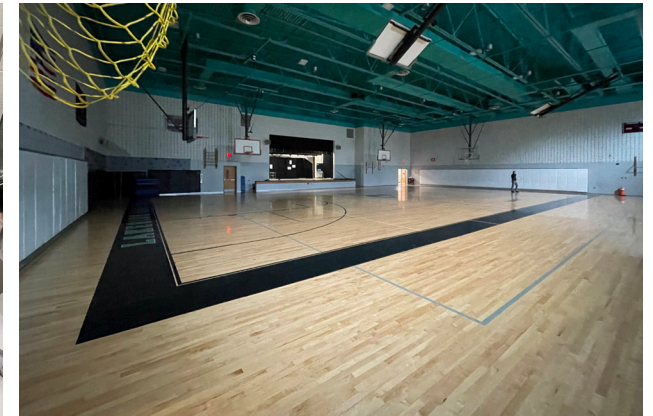
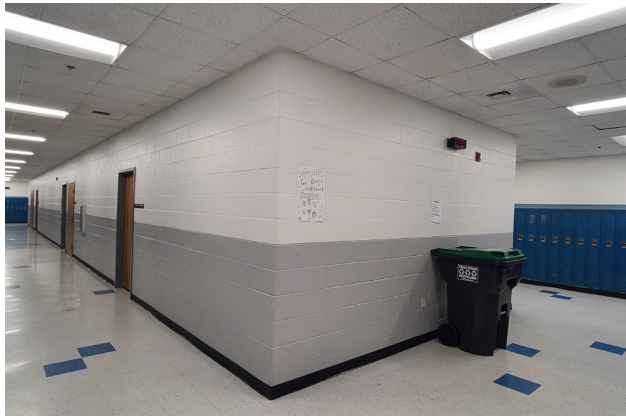
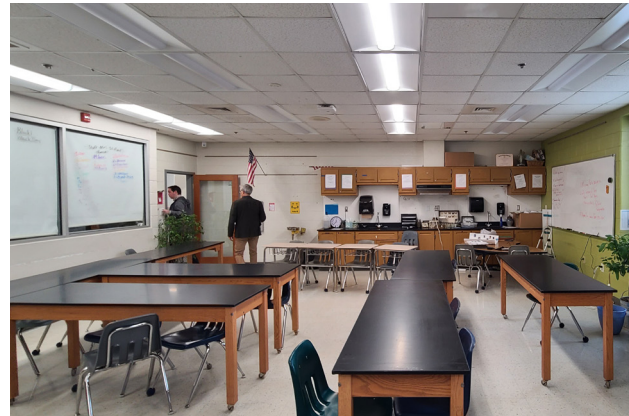
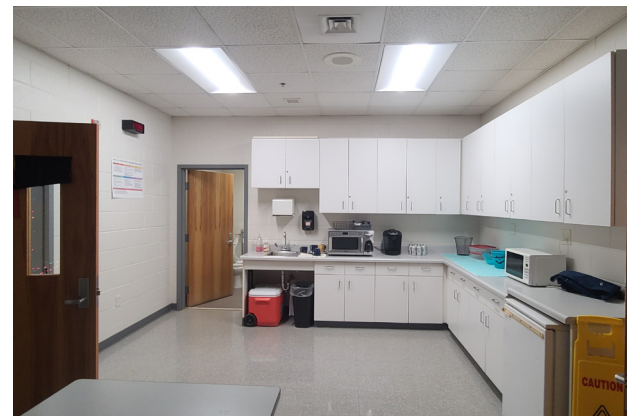
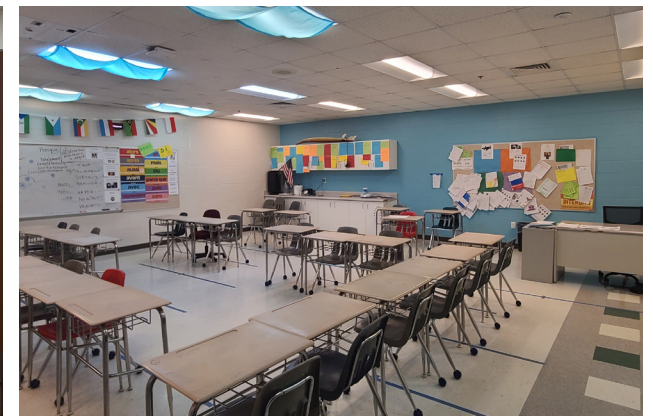
- The original 1994 standing seam metal roof is in good condition. Recommend replacing after another minimum 15 years (FY2038) after ongoing assessment of its condition

- The exterior skin is brick veneer, storefront and unit windows with metal panel infill. The wall assemblies of the original 1965 building do not meet current energy codes. As improvement budgets allow, future envelope improvements, including adding insulation to the interior wall side (or exterior wall side if exterior skin is replaced), and sealing at windows, doors, and other openings would significantly improve energy performance.
- Masonry repairs were performed in 2013. Recommend cleaning brick and pre-cast sills where visible stains and efflorescence has occurred. See structural narrative for additional exterior finish observations and recommendations.

- Original windows are painted storefront with operable panels in the classrooms and are generally in good condition.

- Lakeside features an open-air courtyards between classroom wings that could be improved to encourage outdoor learning. The Benches made of pressure-treated wood at the outdoor amphitheater are showing signs of wear and may need selective replacement over time.

- Original floors in the school consist mostly of 12”x12” VCT and are generally in good condition. While the typical life expectancy of VCT flooring is about 20 years, VCT at Burley should continue to be maintained with ongoing assessment to determine future replacement needs.
- Carpet tile and sheeting in administrative spaces, media center, music classrooms, and some classroom support spaces are generally in good condition. Replace carpet where wear and tear has occurred.
- Wood flooring in the gym is in good condition.
- Bathrooms and locker rooms have ceramic floor tile. Conditions are generally good. Recommend replacement of floor tile in some cases.
- Kitchens have original 4x4 quarry floor tile. Conditions are generally good.

- Most of the building features suspended ACT ceilings with recessed LED lighting. Some back of house spaces remain fluorescent lighting. Recommend upgrading all fluorescent lighting to LED lighting. See electrical narrative for further lighting observations and recommendations. Some ACT ceilings throughout the school are fairly dated, most have been replaced and are in fair-good condition, but it is recommended that all ACT ceilings be replaced with new APC (Acoustic Panel Ceilings) in future renovations.
- Dropped gypsum ceilings in the bathrooms and locker rooms are generally in good condition.

- Typical interior corridor walls are painted CMU block and are generally in good condition. Other interior walls are gypsum wallboard that are generally in good condition. Toilet rooms and locker rooms have CMU block and/or ceramic wall tile, generally in good condition.

- Most interior doors are stained or painted solid wood doors in hollow metal knock-down frames and stainless-steel hardware. Some doors show signs of their age - condition is fair to good. Lakeside has phenolic bathroom partitions, which have been recently installed and are in good condition.

- Existing casework is a mix of solid wood, wood veneer, and plastic laminate, and has generally been well-maintained. Art rooms feature solid surface countertops and solid wood cabinets and are generally in good condition.
- Office and lounge cabinetry feature solid surface and laminate countertops, with wood or laminate upper and lower cabinets, and are generally in good condition.
- Wooden instrument storage bins in the music rooms are dated but otherwise function ok for their use. Recommend replacing them with new modern equipment storage during renovations.

- Classroom desks and chairs are mostly in good condition with few exceptions. The existing furniture could remain in place and continue to function, it is recommended that classroom desks and furniture be replaced with modernized, flexible furniture that supports the needs of 21st century learning and instruction. Some classrooms and labs are equipped with new furniture and are in good condition.
- Administrative and teacher work desks are a mix of wood, metal, and laminate furniture, and include a variety of different chair types and are generally in good condition. It is recommended that these be replaced with modernized, flexible furniture as budgets allow.
- Wood and laminate shelving in the media center is in good condition.

- Student lockers are located throughout the public corridors and appear to be in good condition.

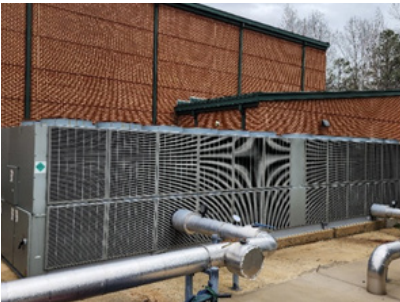
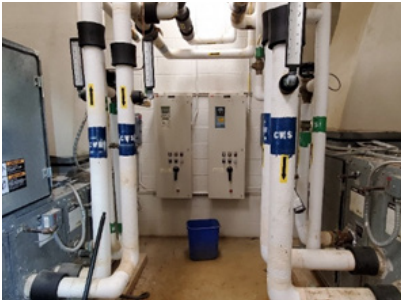
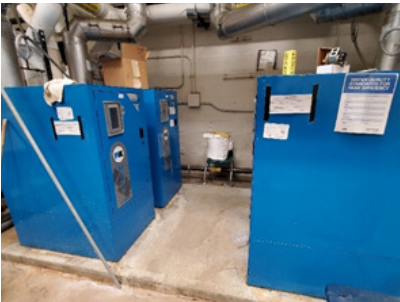
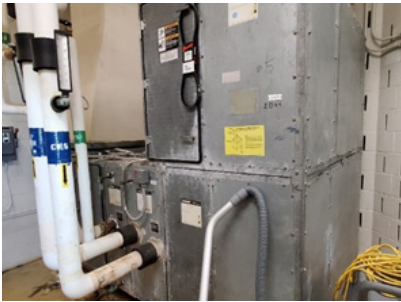
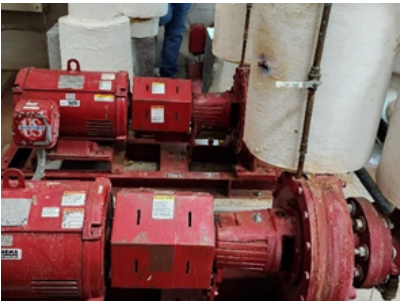
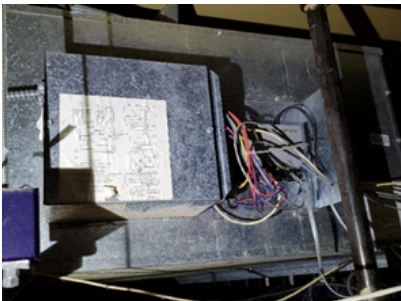
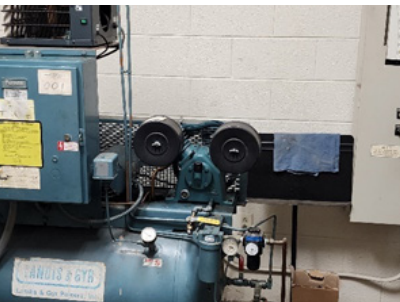
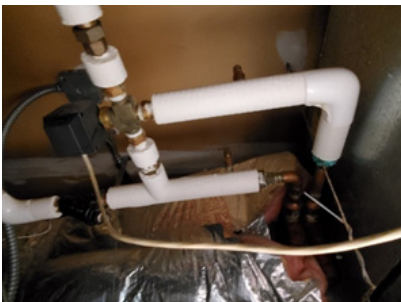
- Lakeside Middle School's HVAC system is served by central heating and cooling elements with distributed air handlers and terminal units for local thermal control and ventilation. The central source of cooling for the school is the air cooled chiller located in the mechanical yard outside of the main mechanical room. This chiller was installed in 2018 as a replacement for the original chiller with thermal storage system. This chiller is only five years old and appears to be in excellent condition. The chilled water pumps were also replaced in 2018 along with this new chiller. These pumps appear to be in good condition, but they are housed deep in a mechanical room with almost no access for maintenance.

- Four boilers in the main mechanical room provide heating source for the entire building. These units were replaced in 2016 along with the hot water pumps. These newer boilers are high efficiency type with modulating turndown. The boilers appear to be in good condition, while the hot water pumps show more age and wear than expected for pumps less than 10 years of age.

- Suggest replacement of science exhaust system and determination if true science hood with dedicated exhaust is required, also add space exhaust for the science classroom. Add space exhaust for the art classroom. Determine if dust collection system meets NFPA requirements, if so leave in place as it seems to serve the space needs.

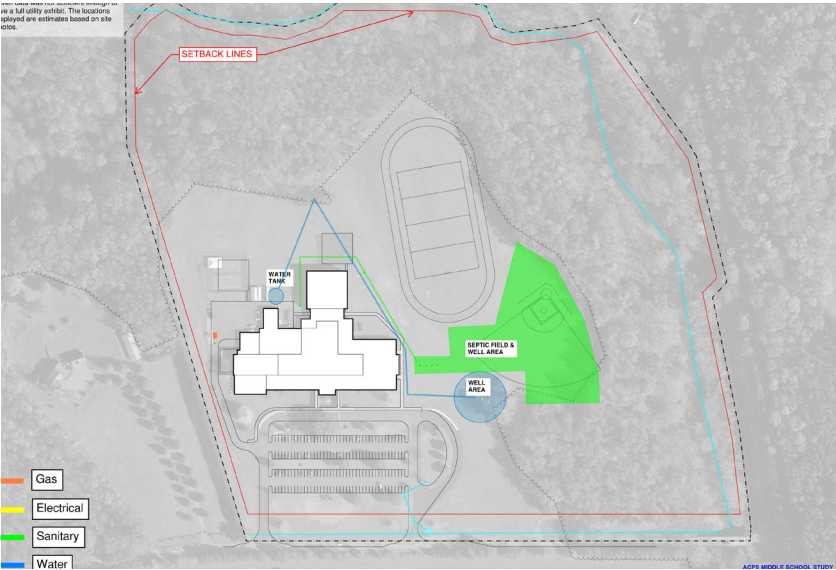
Walton Existing Site Utilities

There is existing sanitary sewer and water available on site servicing the existing building. The sanitary sewer service for the building is a septic field to the east of the school under the large grass areas and south of the multipurpose field and track. This septic field appears to be original to the school construction (1972) with a recent/current project to replace the septic tanks. It is assumed with that project the drain fields were assessed and found to be in good function and condition. Given the typical lifespan of septic is 20-40 years it is recommended a budget is carried in future years for potential drain field replacement/rehabilitation given the age of the system is already beyond the typical useful life. The water for the school is provided by an onsite well in the small grove of trees east of the school which gets pumped around the back and into the water tank by the loading area. The water and sewer facilities are critical infrastructure which should be avoided. Relocation of the gravity sewer lines to the septic tanks may be possible and similarly the water lines from well/pump to tank could be relocated if impacted with future development. There are also existing telecom and power services to the site and existing building. Any future expansions would warrant an evaluation of the capacity of each utility for adequacy. Two large storage sheds were noted on
