Middle School Facilities Assessment

Albemarle County
Public Schools

FACILITIES ASSESSMENT REPORT

Burley Middle School

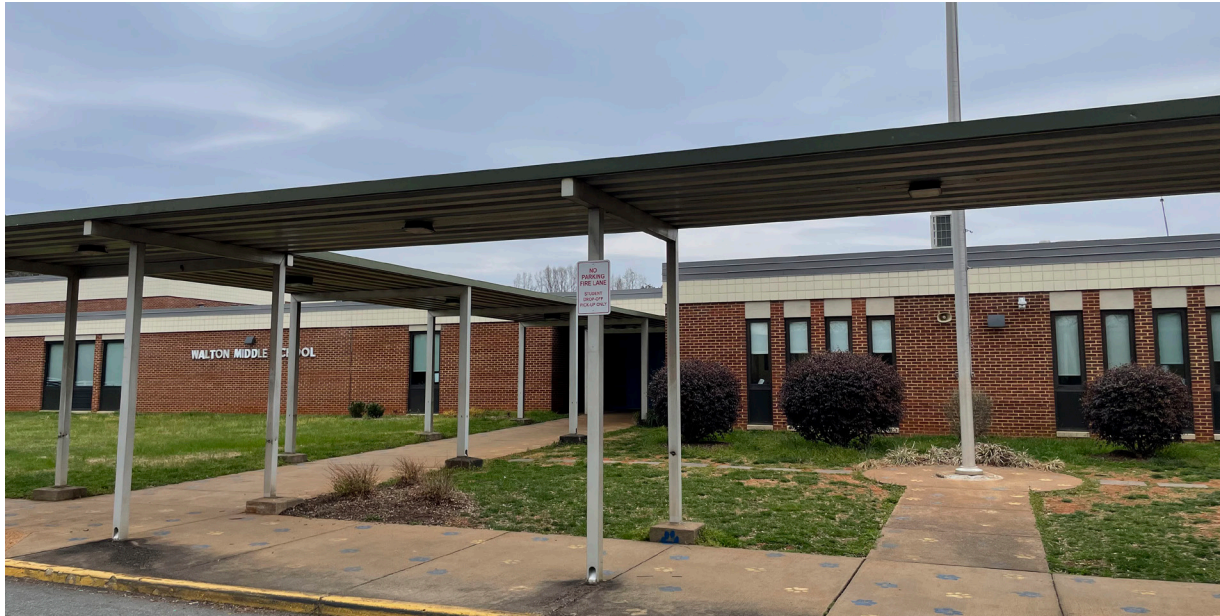
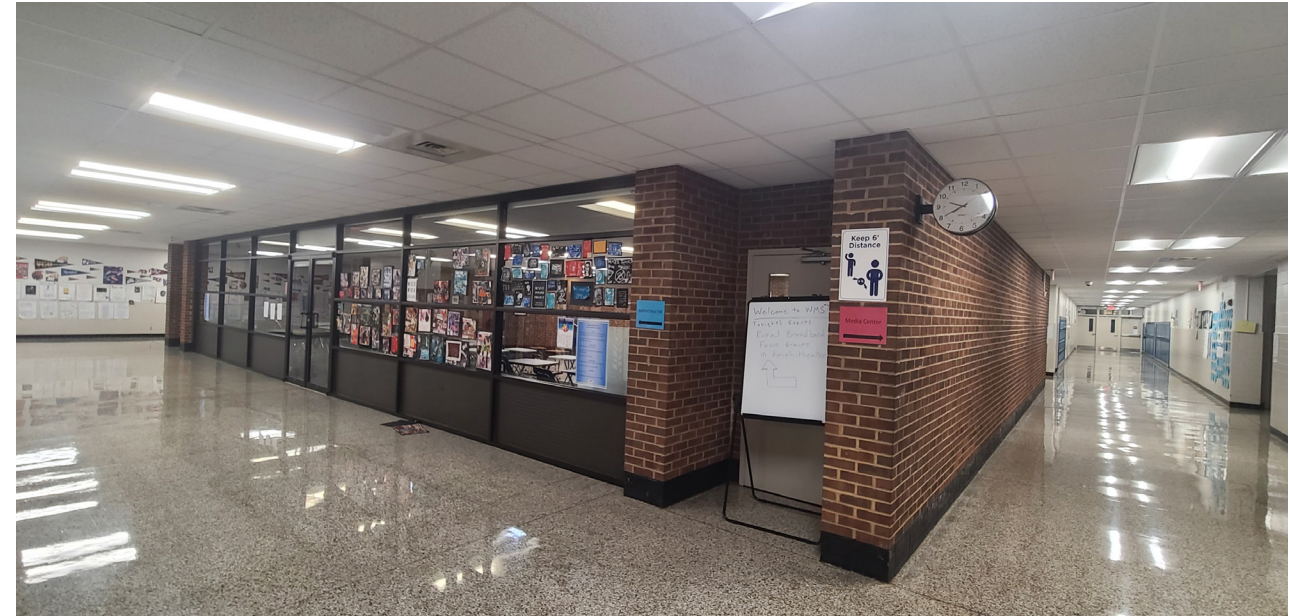
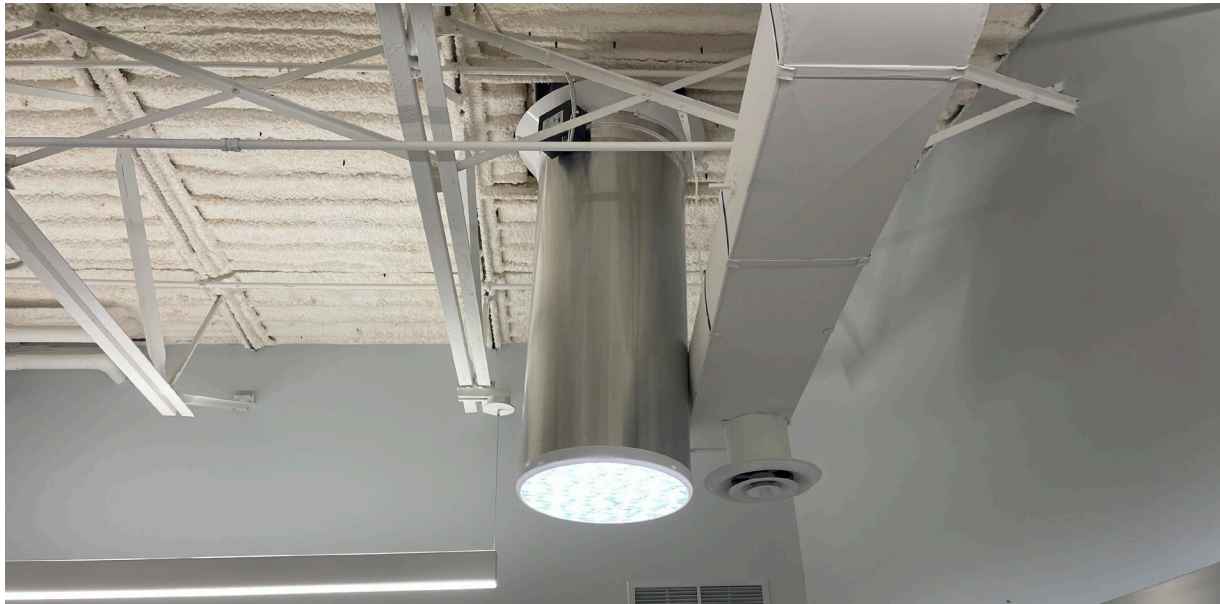
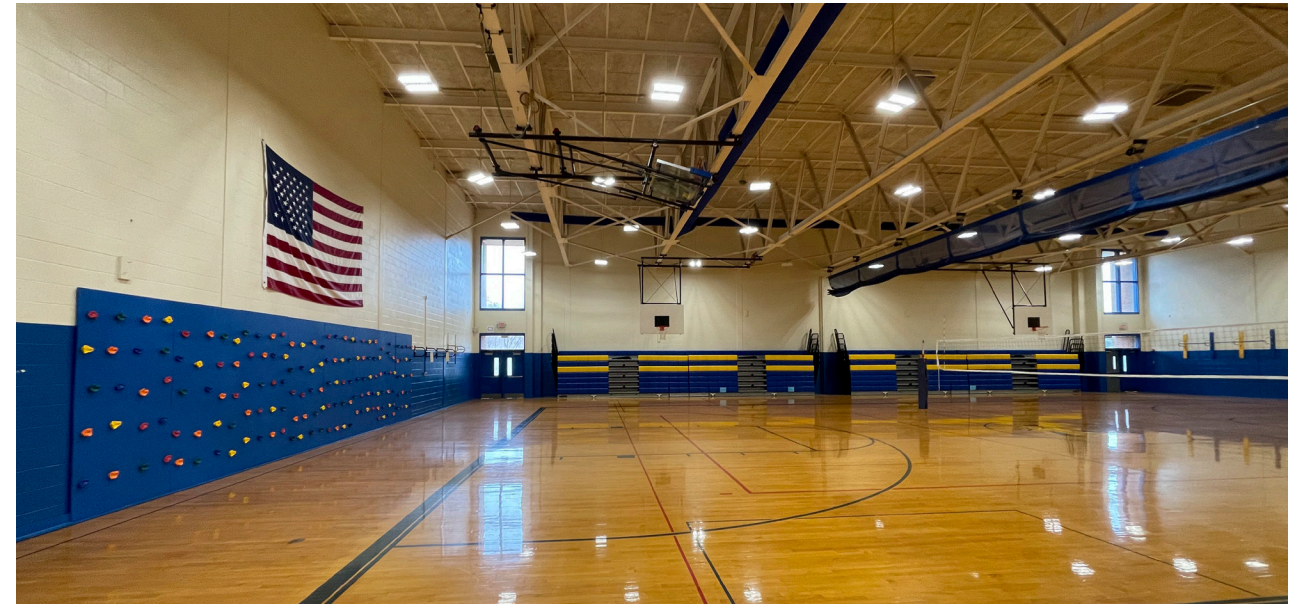
- Brick chord weeps were seen in the walls of the building.
- Most vertical expansion joints (EJ) have failed sealant due to age.
- Only a few isolated locations of spalled mortar joints due to rusting masonry joint reinforcement occur scattered around the elevations of the building.
- On the south elevation, 3 bays of high mortar joints have decayed probably to due roof water overflow.
- The northeast classroom wing’s elevation shows water staining and lichen

- growth at the base due to too much water and lack of proper slope.
- The cast stone sills under the windows have failed sealant head joints due to age.
- A few brick lintels are rusting but most just need cleaning and painting

- No significant vertical CMU cracks were noted.
- No major settlement or cracking were seen in the floor slabs or in the walls

In general, the building is in good shape for its age.

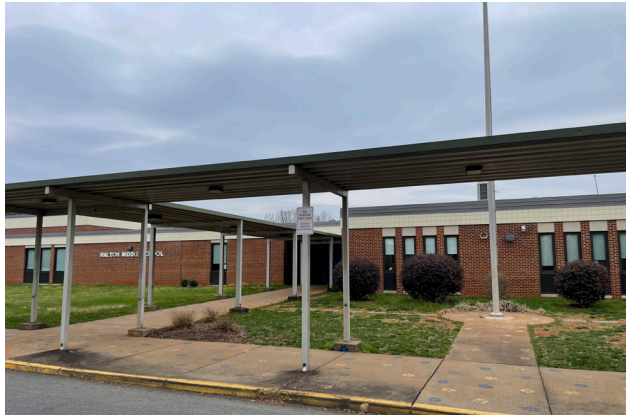
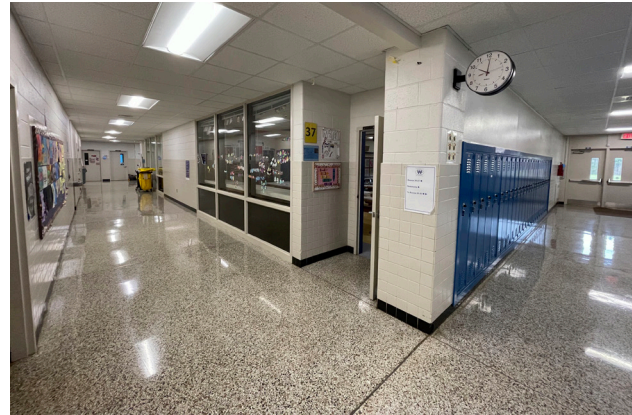
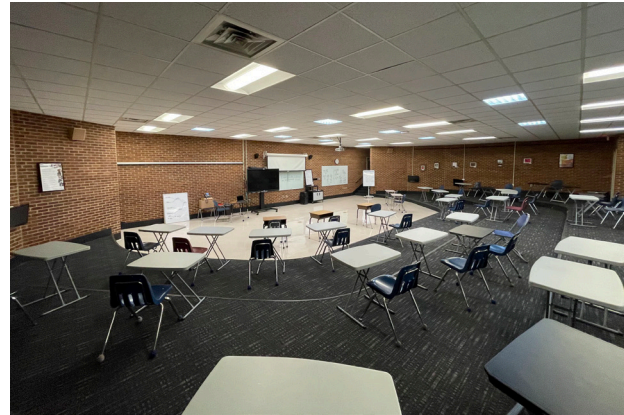
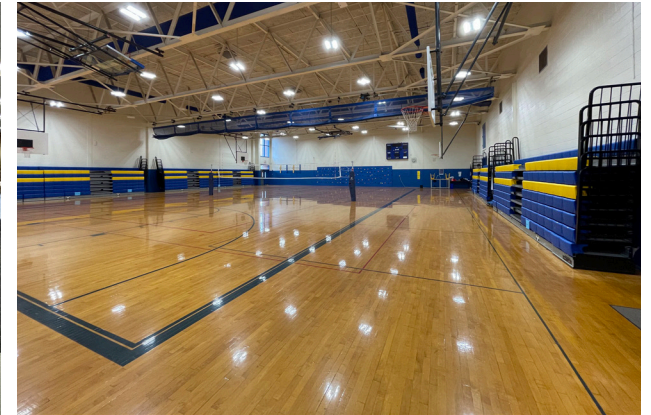
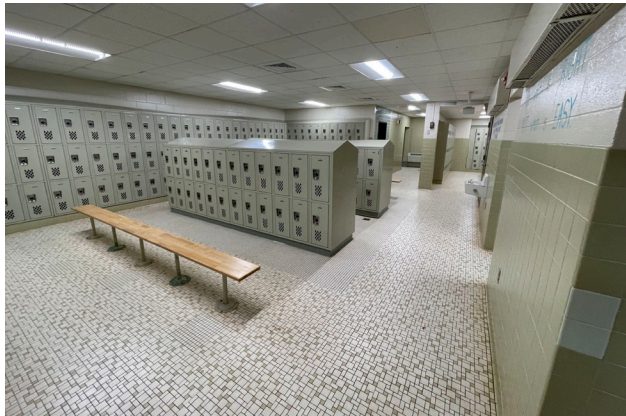
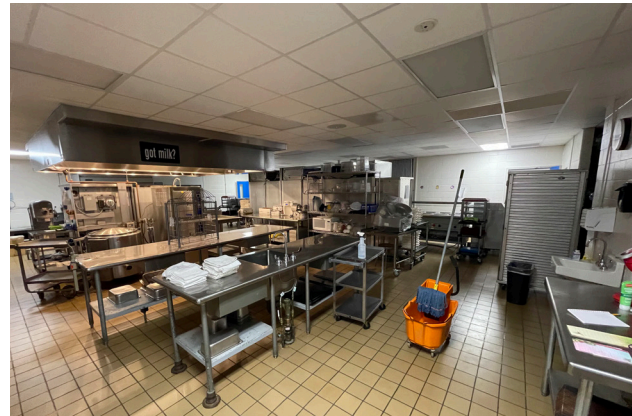
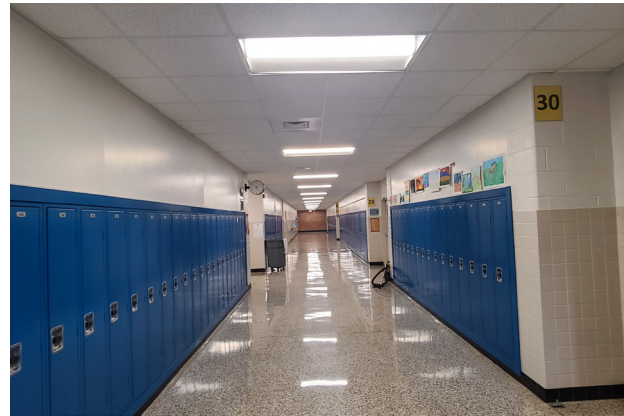
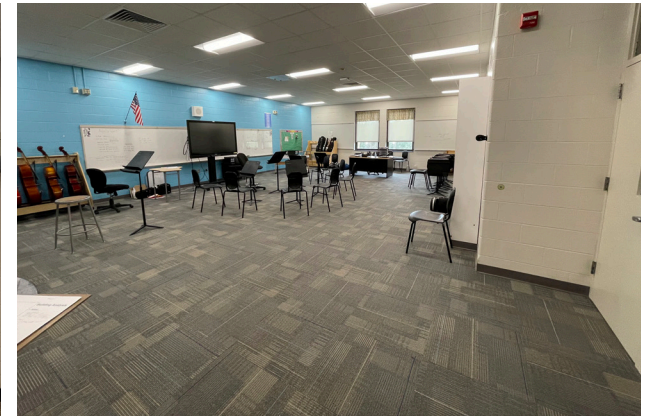
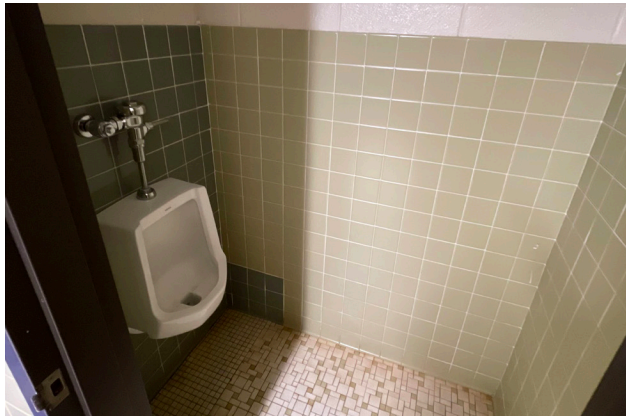
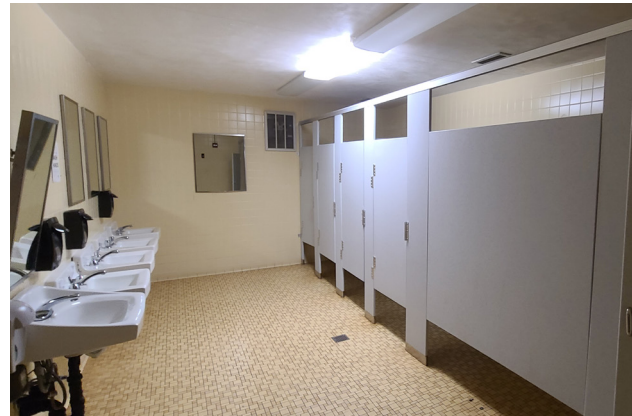
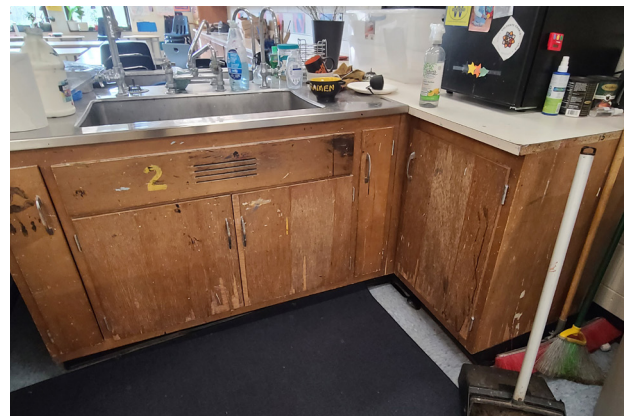
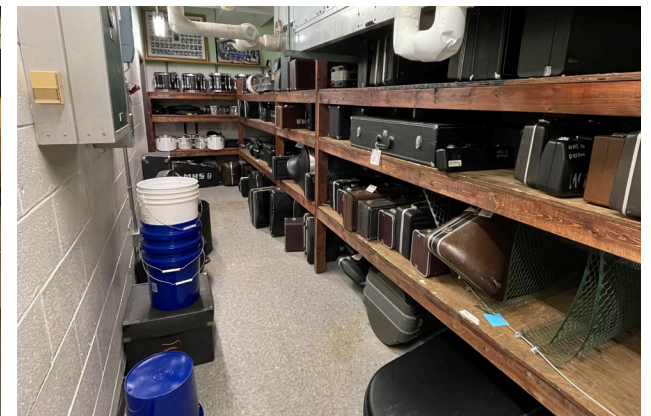
- ACPS anticipates membrane roof replacements every 20-30 years, budgeting in the 10-year CIP plan at or around the 15-year mark. Roof replacements at Walton occurred in 2020 and 2022. Future roof replacements at Walton should be budgeted around FY2035-37, with anticipated replacements around FY2045-47. It is recommended that roof replacements include removing existing roof assemblies down to the structural deck and replacing them with a new roof assembly with increased roof insulation to improve envelope performance.

- The exterior skin is brick veneer with a scored block fascia, and storefront and unit windows with stucco infill. The wall assemblies of the original 1972 building do not meet current energy codes. As budgets allow, future envelope improvements, including adding insulation to the interior wall side (or exterior wall side if exterior skin is replaced), and sealing at windows, doors, and other openings would significantly improve energy performance.
- Masonry repairs were performed in 2013. Recommend cleaning brick and pre-cast sills where visible stains and efflorescence has occurred. See structural narrative for additional exterior finish observations and recommendations. The front canopy and concrete support piers are in fair condition and in need of repair.

- Original windows are metal with single-pane glass and operable panels in the classrooms and are generally in fair-good condition but could be replaced to improve airtightness and overall building energy performance.

- Original floors in the school consist mostly of terrazzo in the corridors and vinyl asbestos tile in the classrooms, cafeteria, and some storage spaces. Other floor finishes include 12"x12" VCT flooring and carpet, and are generally in good condition, however there are several instances where VCT flooring is visibly cracking. These areas should be investigated to determine the cause and remedies for repair. While the typical life expectancy of VCT flooring is about 20 years, VCT at Walton should continue to be maintained with ongoing assessment to determine future replacement needs. All asbestos tile floors will need abatement if replaced. Linoleum floors in the 2017 renovated lab spaces are in very good condition.

- Wood flooring in the gym and stage is showing signs of age and wear.

- Student lockers are located throughout the public corridors and appear to be in good condition.

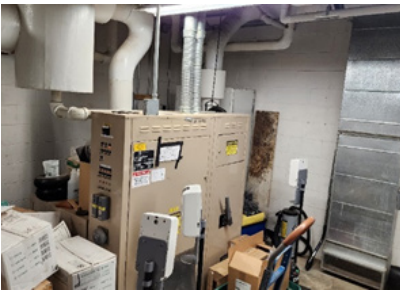
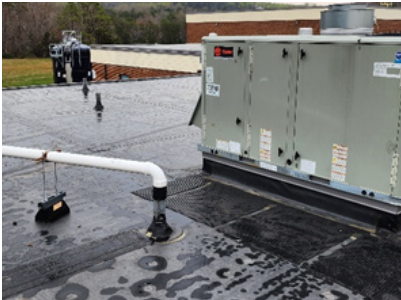
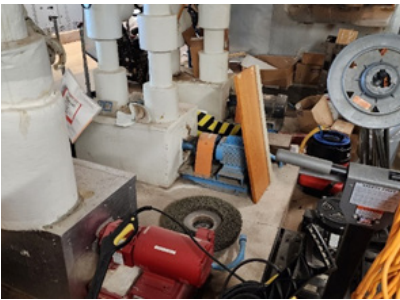
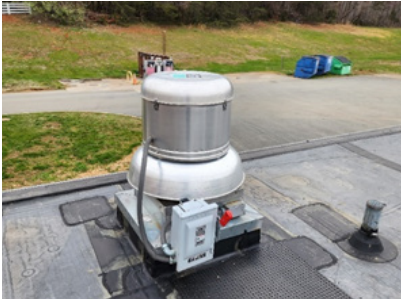
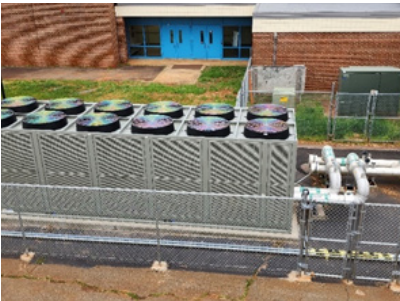
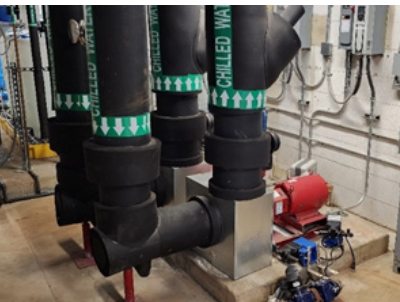
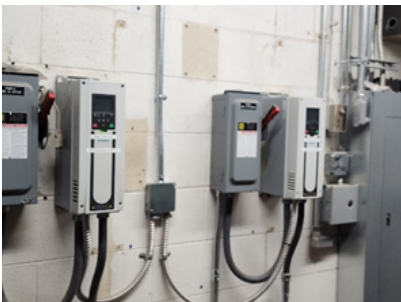
- Replacement of the cafeteria and stage unit is suggested at the earliest convenience. The rooftop unit in particular is in poor condition, while the indoor unit is in good condition and could remain for some time.
- The gymnasium units appear to be in fair condition and should be replaced in approximately 10 years time.

- The main portion of the building is classroom spaces served by two primary system types. The first system last renovated in 2004 is the 4-pipe system utilizing local floor or ceiling mounted fan-coils to provide local conditioning with rooftop mounted air handlers for space ventilation. These rooftop units appear to all be from that original renovation and are packaged DX type units that can heat and cool the incoming ventilation air independently from the central boiler and chiller system. While some units show significant wear on the casing and coils, many of them appear to be in generally decent and serviceable condition but are definitely past the end of their useful life. The fan-coil units are similarly aged and near or past the end of their useful life.

- There are also a few indoor air handling units serving the music and instrument storage spaces. These units appear to be in good condition for their age. The presence of a dehumidification system in these spaces indicates that the units are undersized to serve their purpose or otherwise do not have capability to maintain desired space temp and humidity levels.

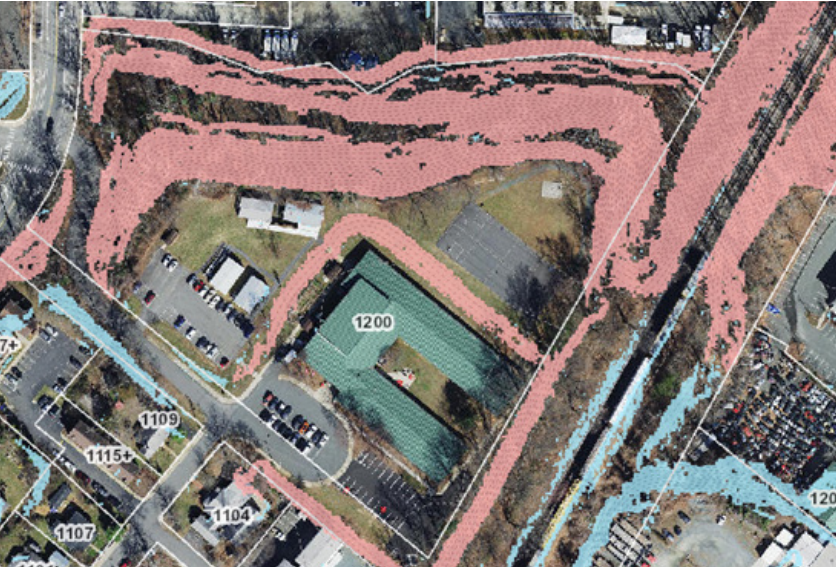
Community Lab Critical Slopes

The site topography could be a limiting factor on this site for building additions and accessibility goals. Critical slopes on the north and west of the existing building are

present (see graphic below for red — lot regulation critical slopes) which are more difficult to disturb in the City of Charlottesville. Disturbance of the red critical slopes requires a modification or waiver reviewed by Planning Commission and ultimately approved by City Council. Areas outside of the previously developed spaces on the site are predominantly steeply sloping and forested terrain with little to no value for future development.

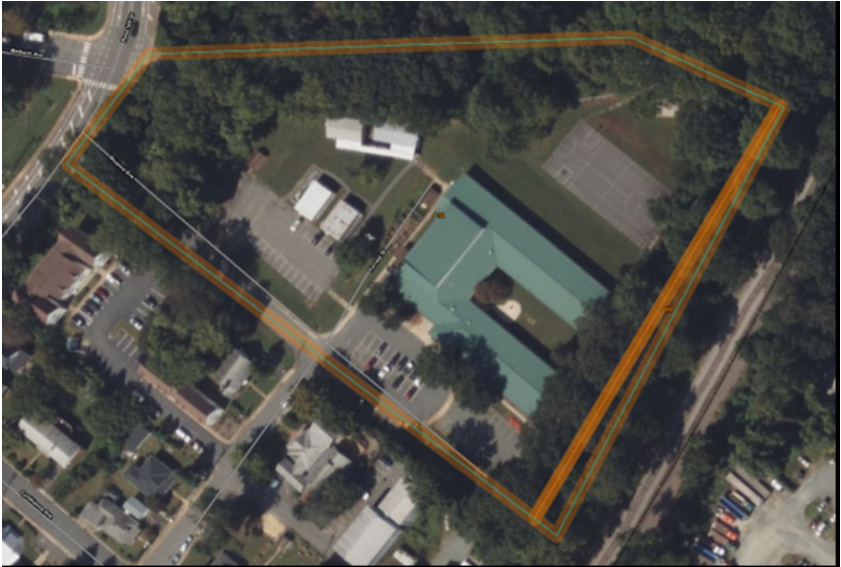
Community lab Soils Map

The soils on site are a mixture of 91-Urban Land (95%) and 88-Udorthents (5%). Generally, the Urban Land is in areas of prior development on site and the Udorthents is a small strip along the east property line adjacent to the railroad tracks. It is recommended a geotechnical investigation be performed in support of any future development requiring significant foundations, earthwork, or paving.

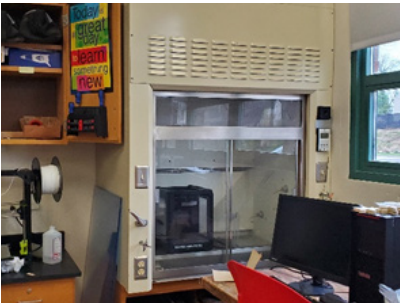
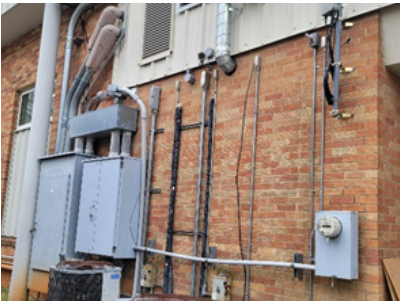
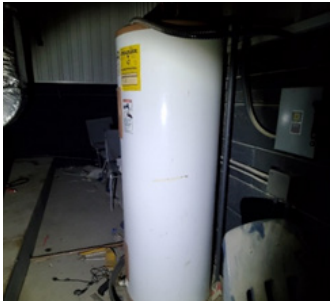
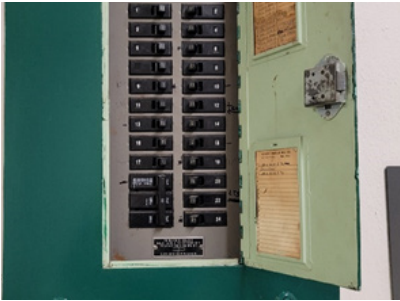
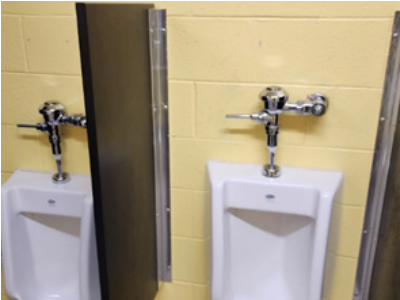
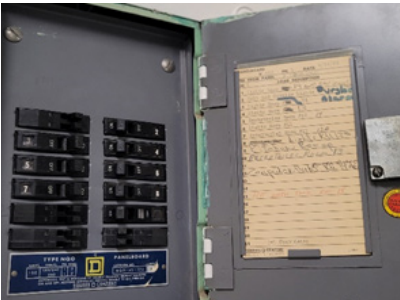
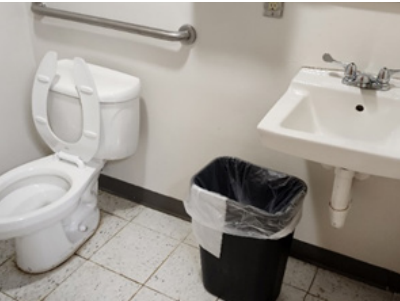
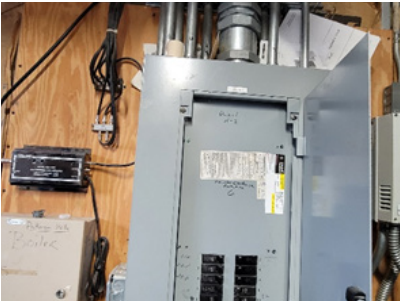
- The building electrical service is 3-phase 120/208V. The main service equipment is a 1,200A distribution panelboard. The electrical distribution panelboard was installed in 2004. It is in good working order and has been maintained well. The main distribution panelboard is in an enclosure on the building exterior.
- Electrical panels are located throughout the building. Panelboard manufacturers vary and most panelboards are in good condition with panel schedules. Some panelboards are in locked rooms, but others are in the corridors.

- Most of the electrical equipment is in good shape and does not need to be replaced. However, some branch panelboards are past their expected useful life and should be replaced soon. Any panelboards in corridors should be locked to prevent access by students or other unauthorized personnel.

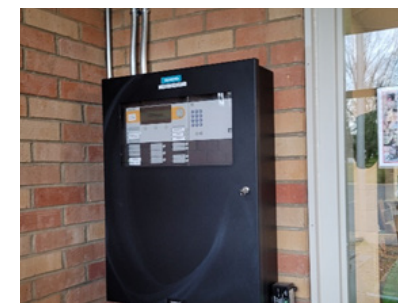
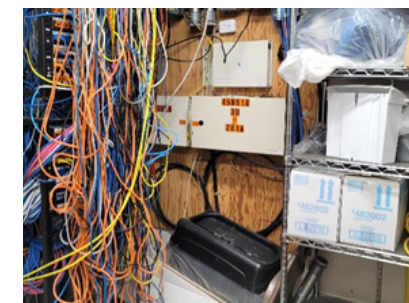
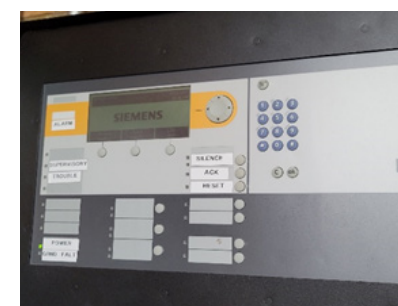
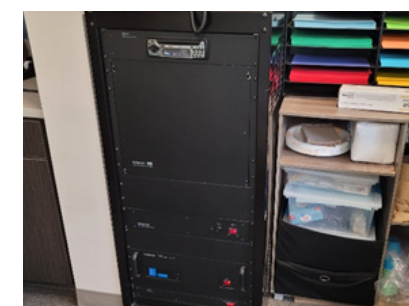
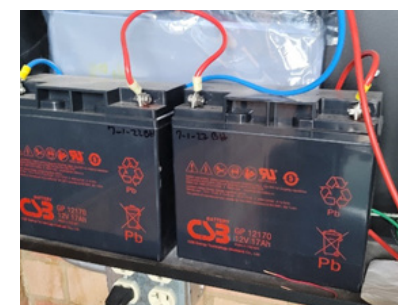
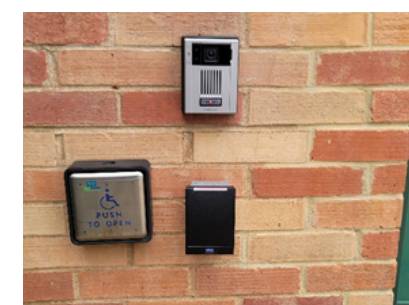
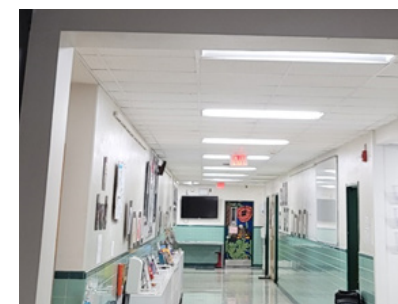
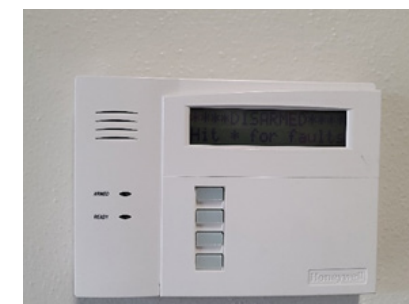
- The building features an addressable public address system manufactured by Telecor, an intrusion detection system, security management system, and video management system. Systems all seem to be in functional order and in good condition. Low-voltage wiring closets are located throughout the building; but dedicated closets with cooling/heating are not provided.

- Ensure all systems are compliant with current county standards and evaluate for replacement/expansion during the next major renovation. Establish dedicated IT closets with cooling/heating to meet BICSI standards.
