# FACILITY CONDITION ASSESSMENT

**Richmond Public Schools**  
301 North Ninth Street  
Richmond, VA 23219

Lucille M. Brown Middle School  
6300 Jahnke Road  
Richmond, VA 23225

*May 21, 2024*

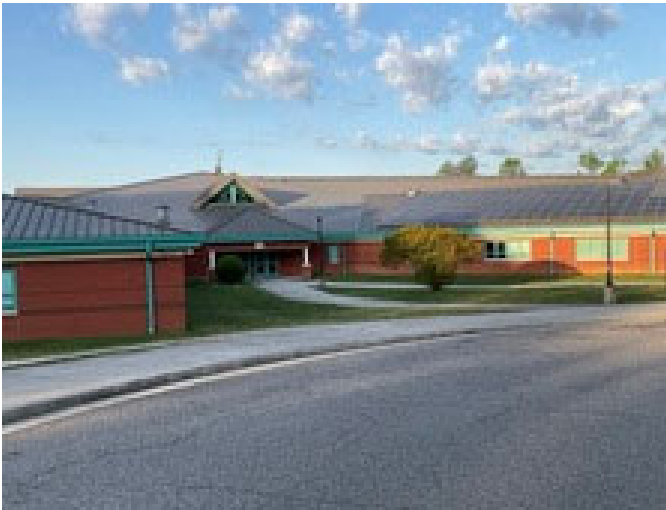
7 - PRIMARY ROOF OVERVIEW

The roof of the building consists of a sloped metal finish and appears to be original. Evidence of roof leaks was not reported or observed during the on-site visit. The exterior brick veneer walls were observed to have little to no areas of cracking. According to the point of contact, there are no issues with building movement or settlement. Routine maintenance checks on the foundation are recommended in the reserve term. Exterior doors and windows are original and appear to be in overall fair condition.

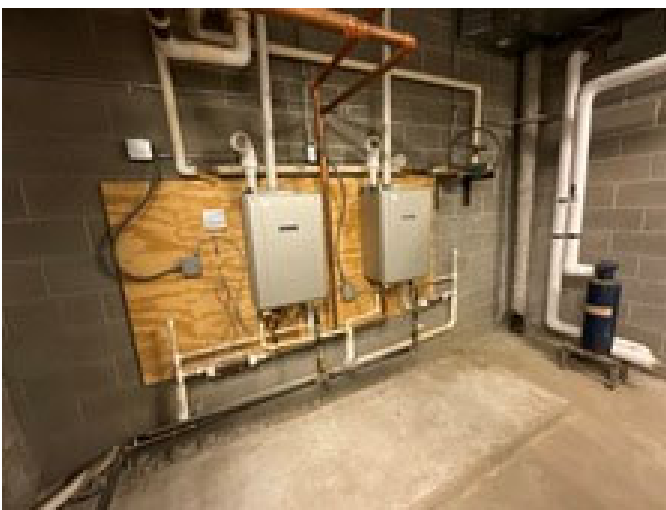
17 - DOMESTIC HOT WATER SUPPLY

Domestic hot water is supplied by two tankless water heaters. Typical commercial plumbing fixtures are utilized in the restrooms. Plumbing leaks and water pressure problems were not observed or reported.

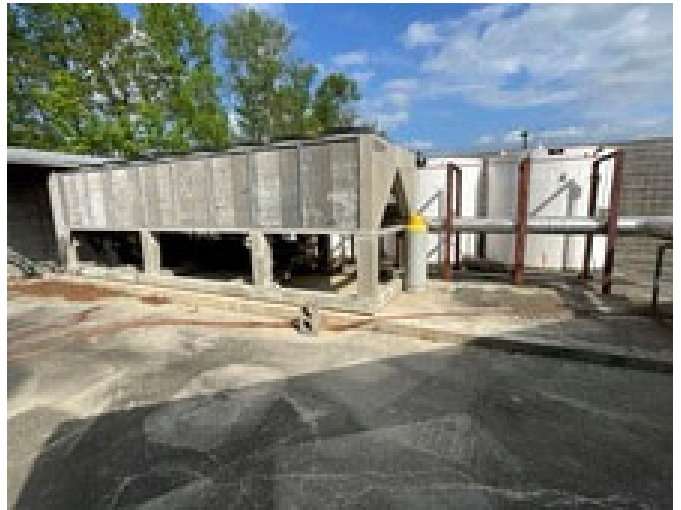
20 - CHILLERS AND PUMPS

The HVAC system consists of a central boiler and chiller system feeding air handlers and terminal units throughout the building. The boiler system was replaced in 2024, and the chiller was replaced in 2009. The point of contact reported some inconsistency with the chiller system. Repairs are recommended as part of the routine maintenance program. Also, there is a building automated system in place that is aged and recommended for replacement.

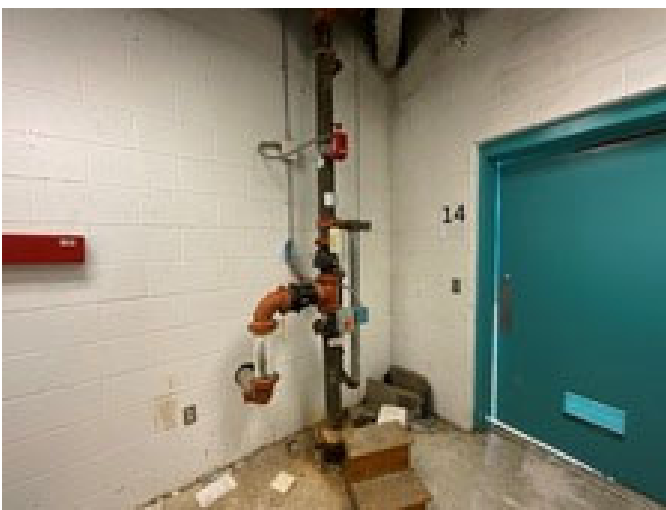
23 - FIRE SUPPRESSION SYSTEM

Fire suppression consists of a sprinkler system that serves the entire building. The fire alarm control panel was replaced this year and is in excellent condition.

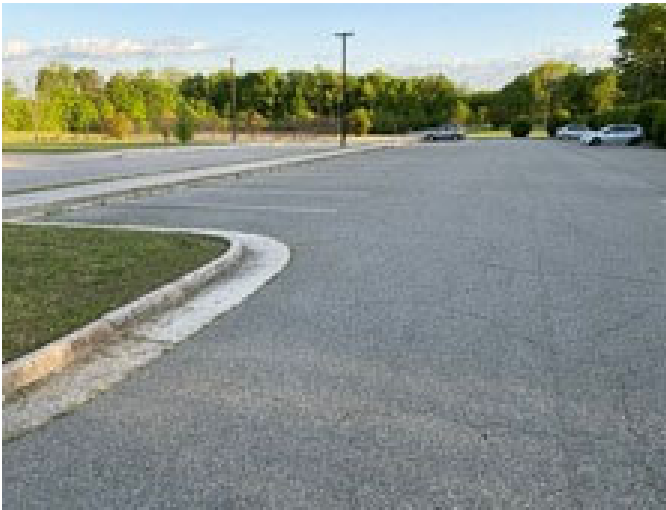
1 - MAIN PARKING AREA

The parking lot is asphalt paved and has only minor areas of cracking. Seal and striping was reportedly last done in 2021. Some potential tripping hazards caused by damaged stair railings and sidewalks were observed and are recommended for repair. The masonry chiller enclosure has significant cracking on one corner and is at risk of splitting. Site lighting appears to be adequate for the facility's needs.
