FACILITY CONDITION ASSESSMENT

Richmond Public Schools
301 North Ninth Street
Richmond, VA 23219

Mary Scott Preschool
4011 Moss Side Avenue
Richmond, VA 23222

May 20, 2024

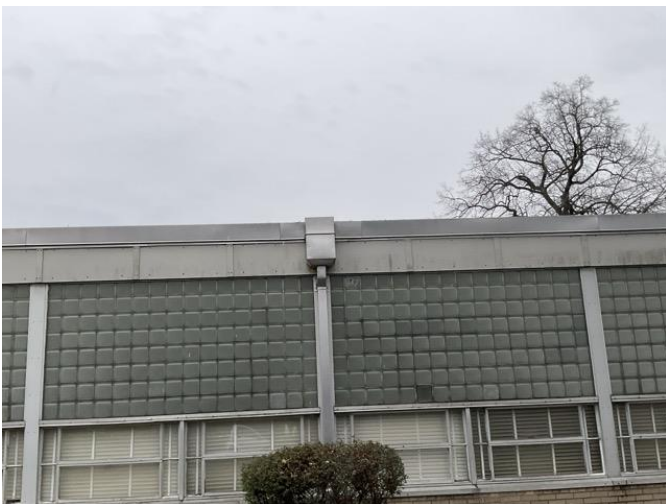
5 - GLAZING

The building has original glass block glazing, with many of these sections broken/compromised. Most of the interior furnishings are antiquated and are likely original to construction. The built-up roof has occasional leaks but appears to have been well-maintained. Typical lifecycle based on interior and exterior finish replacements are budgeted and anticipated.

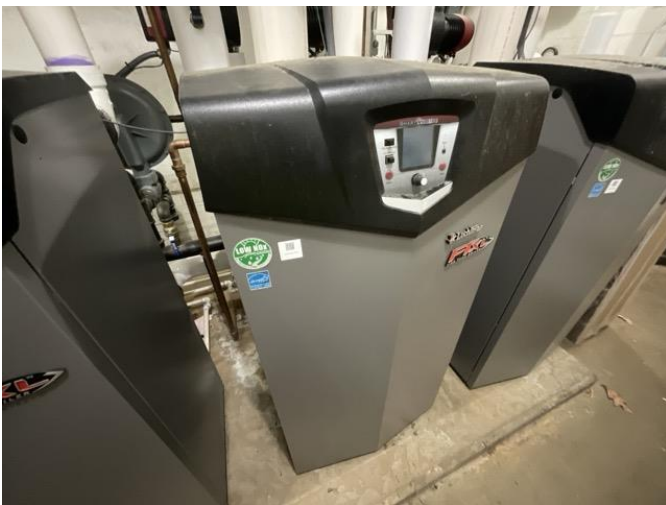
9 - MECHANICAL ROOM - HVAC BOILERS

Building heating needs are served by new boilers and unit ventilators having been replaced in 2021. The current cooling needs utilize rooftop split system condensing units feeding small fan coil units inside the classrooms. This system will be replaced with a new central chiller plant planned to be completed by summer of this year. Electrical service is reported to have no issues. Domestic hot water is provided to the kitchen, custodial and staff restrooms only; a new tankless water heater was installed in 2020. Many of the plumbing fixtures are original equipment and would benefit from updated fixtures. Fire suppression is limited to fire extinguishers. The fire alarm system is fully addressable with strobes and pull stations. Lifecycle replacement of the majority of the MEPF equipment is anticipated.

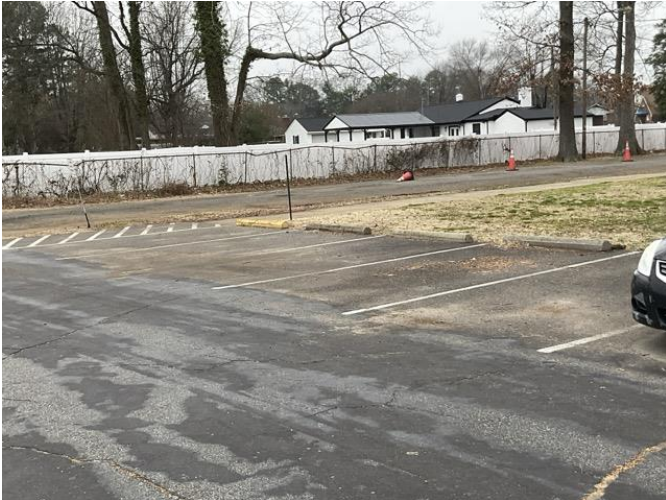
1 - MAIN PARKING AREA

Parking lot and driveway asphalt is in poor condition with several sections consisting of loose gravel. There is lack of proper drainage during rainstorms which causes ponding in the student pick-up area. The playground area behind the school building has been kept in good condition and contains a medium-sized play structure, shade canopy, and park benches. The building-mounted lighting would benefit from LED lighting upgrades.
