FACILITY CONDITION ASSESSMENT

Richmond Public Schools
301 North Ninth Street
Richmond, VA 23219

August 15, 2024

Mary Munford Elementary School
211 Westmoreland Avenue
Richmond, VA 23226

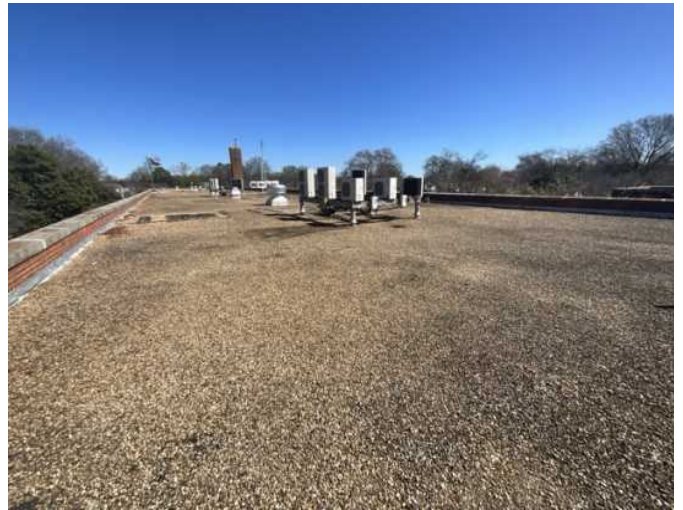
6 - Roof Overview

Roofing in Poor condition.

Roof system is very old and plagued with recurring leaks. - AssetCALC ID: 7568491

Uniformat Code: B3010
Recommendation: **Replace in 2026**

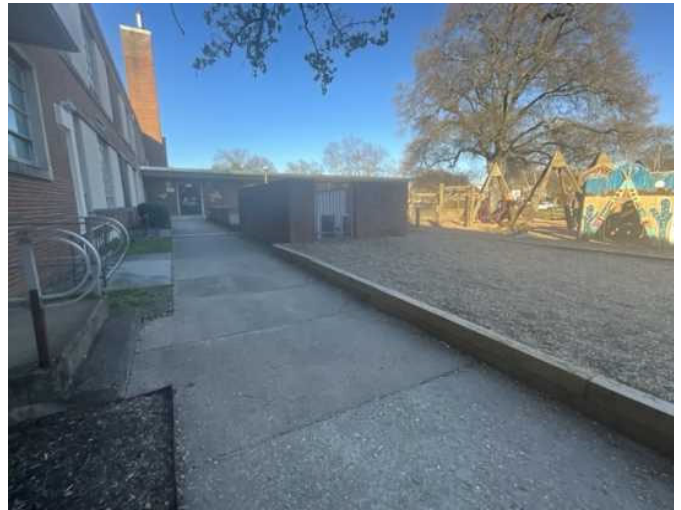
2 - SITE, WALKWAYS

Sidewalk in Poor condition.

Damaged and ware to concrete pavers - AssetCALC ID: 7442421

Uniformat Code: G2030
Recommendation: **Replace in 2026**

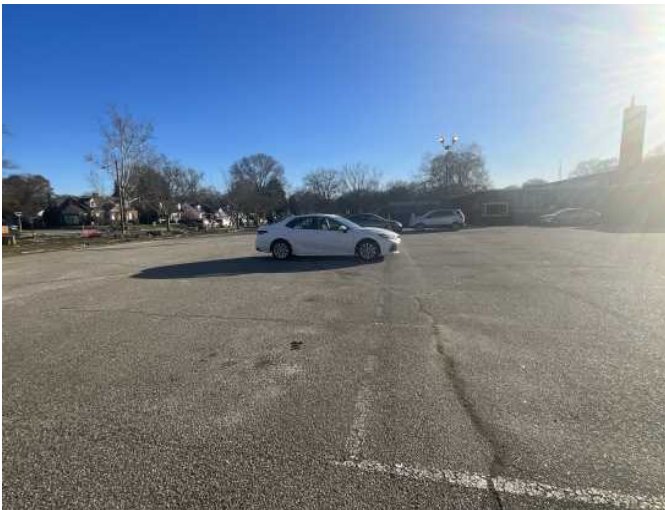
3 - SITE, PARKING AREA

Parking Lots in Poor condition.

Uniformat Code: G2020
Recommendation: **Seal & Stripe in 2025**

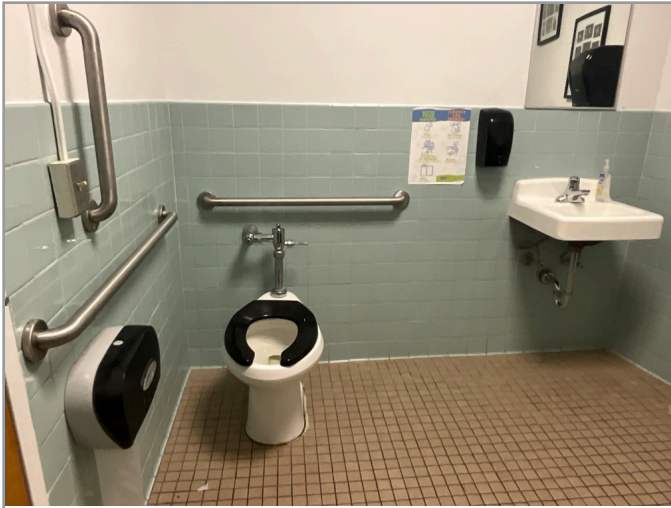
TOILET STALL OVERVIEW

| Question | | Yes | No | NA | Comments |
|---|---|---|---|---|---|
| 4 | Is the plumbing piping under lavatories configured to protect against contact ? | | ✗ | | Piping insulation missing |
