FACILITY CONDITION ASSESSMENT

Richmond Public Schools
301 North Ninth Street
Richmond, VA 23219

George W. Carver Elementary School
1110 West Leigh Street
Richmond, VA 23220

June 21, 2024

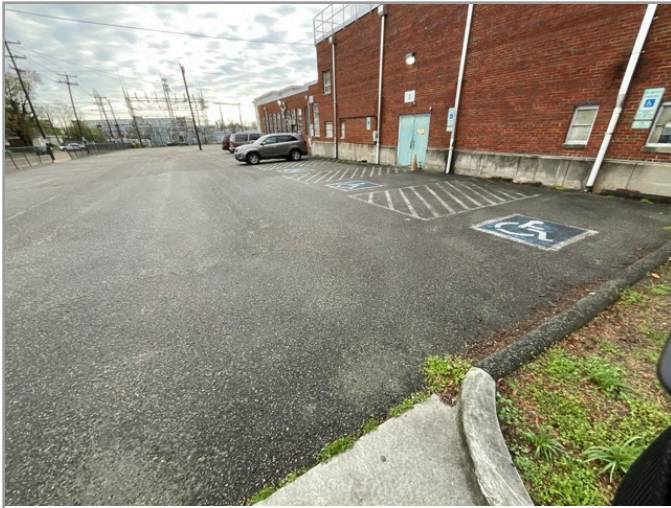
OVERVIEW OF ACCESSIBLE PARKING AREA

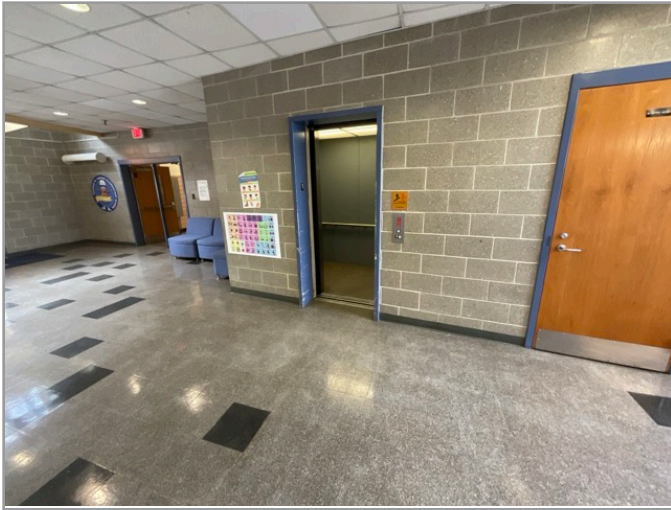
LOBBY LOOKING AT CABS (WITH DOORS OPEN)
