# FACILITY CONDITION ASSESSMENT

**Richmond Public Schools**  
301 North Ninth Street  
Richmond, VA 23219

Maury Street Property (Altria)  
2325 Maury Street  
Richmond, VA 23230

*February 29, 2024*

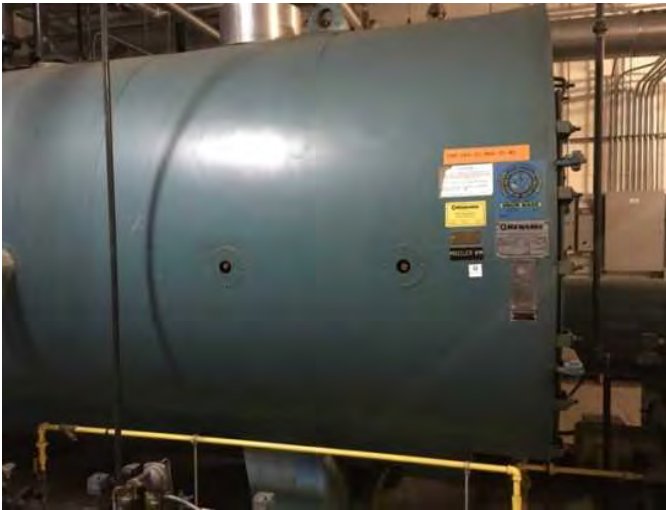
31 - BOILER

The main heating system is served by two large steam boilers that feed air handlers, unit heaters and unit ventilators throughout the office. The boilers are aged and have steam leak issues throughout the facility. Hot water boilers are being considered as replacements. There are a large number of condensing units which are in poor condition and past their useful life. Many are not functional and replacements should be considered in the short term. The fire pump building contains old obsolete boilers and additional out of service equipment.
