FACILITY CONDITION ASSESSMENT

Richmond Public Schools
301 North Ninth Street
Richmond, VA 23219

J.B. Fisher Elementary School
3701 Garden Road
Richmond, VA 23235

May 11, 2024

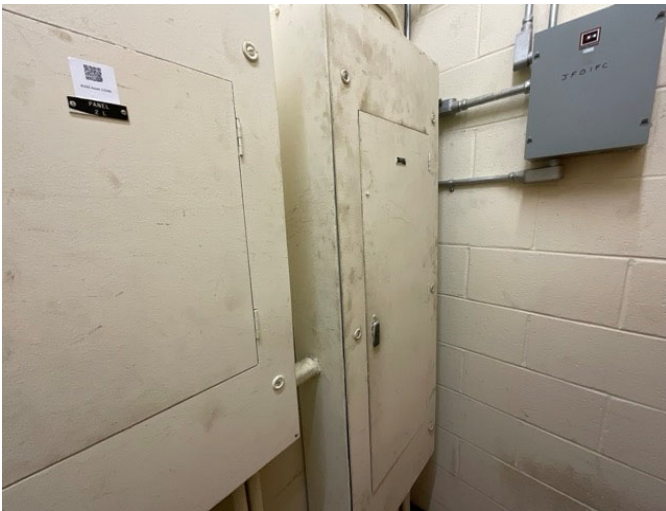
Replace Federal Pacific panel, poses a safety risk. - AssetCALC ID: 7496593

33 - FEDERAL PACIFIC ELECTRICAL PANELS
