# FACILITY CONDITION ASSESSMENT

J.H. Blackwell Elementary School  
300 East 15th Street  
Richmond, VA 23224

*166385.24R000-002.468*

*May 28, 2024*

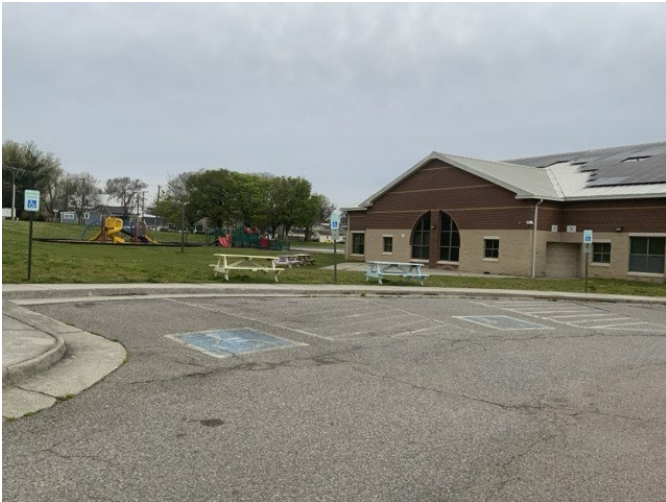
3 - PARKING LOT

There is a playground consisting of a swing set and large playground structure. The asphalt athletic court has grass growing in between the cracks and needs a mill and overlay. The parking lot has cracks throughout and faded stripes.

Cracks throughout - AssetCALC ID: 7508849

Uniformat Code: G2020  
Recommendation: **Mill & Overlay in 2025**

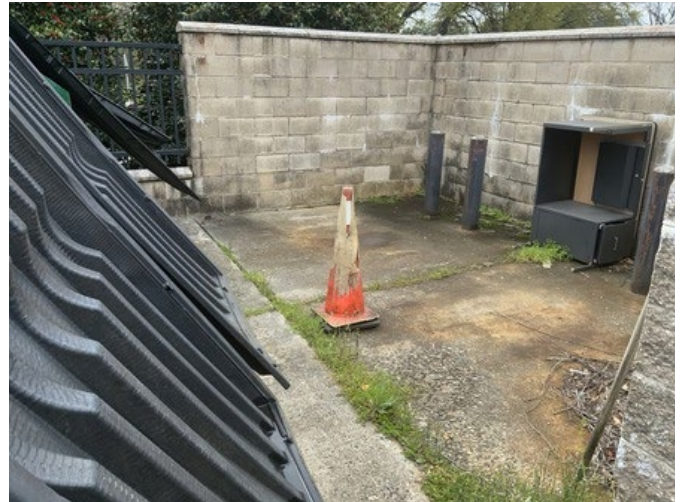
4 - DUMPSTER ENCLOSURE

There are two public parking lots that serve the elementary school, but both are shared with the public pool building and J.H. Blackwell Preschool. A private lot on the right-hand side of the building has limited parking and contains the dumpster enclosure, which has vertical cracks on both sides of the rear.

Wall is crack on both sides - AssetCALC ID: 7499853

Unifomat Code: G2060  
Recommendation: **Replace/Install in 2026**

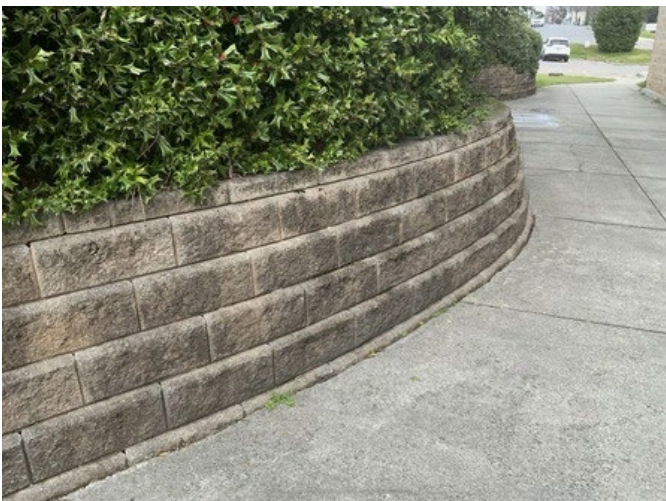
5 - RETAINING WALL

The retaining wall that separates the public pool from the school property line has a few broken off bricks that need repair.

Unifomat Code: G2060  
Recommendation: **Replace in 2025**
