# FACILITY CONDITION ASSESSMENT

**Richmond Public Schools**  
301 North Ninth Street  
Richmond, VA 23219

Barack Obama Elementary School  
3101 Fendall Avenue  
Richmond, VA 23222

*May 28, 2024*

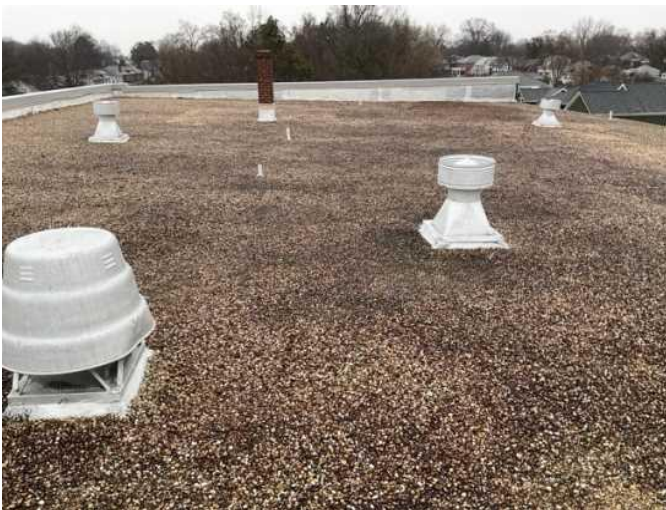
5 - ROOFING

#### Roofing in Poor condition.

Roof leaks reported throughout - AssetCALC ID: 7450431

Uniformat Code: B3010  
Recommendation: **Replace in 2025**

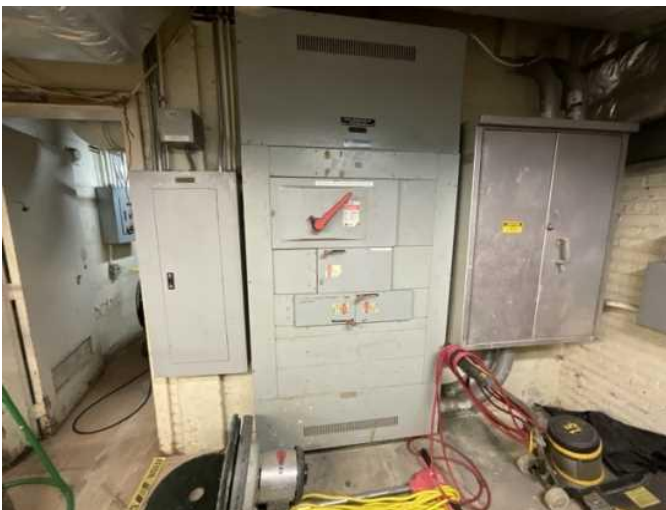
11 - DISTRIBUTION PANEL

**Distribution Panel in Poor condition.**

Uniformat Code: D5020  
Recommendation: **Replace in 2025**
