# FACILITY CONDITION ASSESSMENT

**Richmond Public Schools**  
301 North Ninth Street  
Richmond, VA 23219

Southampton Elementary School  
3333 Cheverly Road  
Richmond, VA 23225

*May 15, 2024*

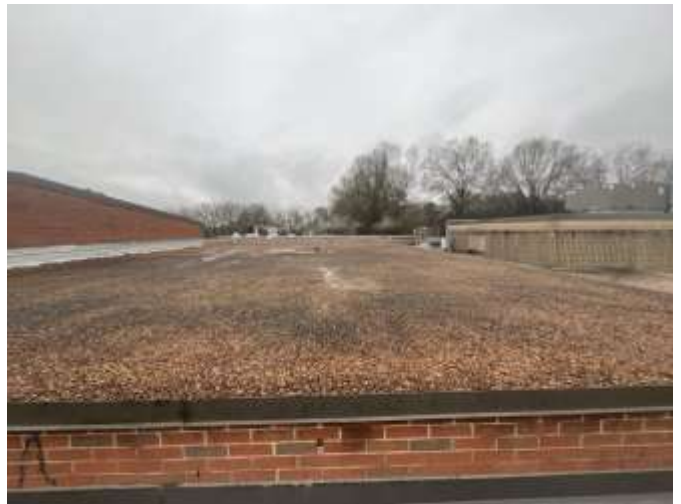
No significant issues were observed in the building structure, roofing material, and façade. However, vegetation and moss were found throughout the roof and this problem will require immediate attention to avoid any negative implications to the roof structure. Also, the interior finishes such as flooring, cabinetry, and doors appear to be worn out. The exterior windows were the largest issue observed and reported during the site visit. Many teachers complained that it gets too hot during the summer and too cool during the winter. It is recommended to upgrade the windows from single to double pane. Overall, the architectural components are in fair condition, but a significant capital expenditure program is needed in both the short and middle terms to make the building in good condition.

4 - ROOF OVERVIEW
