FACILITY CONDITION ASSESSMENT

Richmond Public Schools
301 North Ninth Street
Richmond, VA 23219

Oak Grove-Bellemeade Elementary School
2409 Webber Avenue
Richmond, Virginia, 23224

October 9, 2024

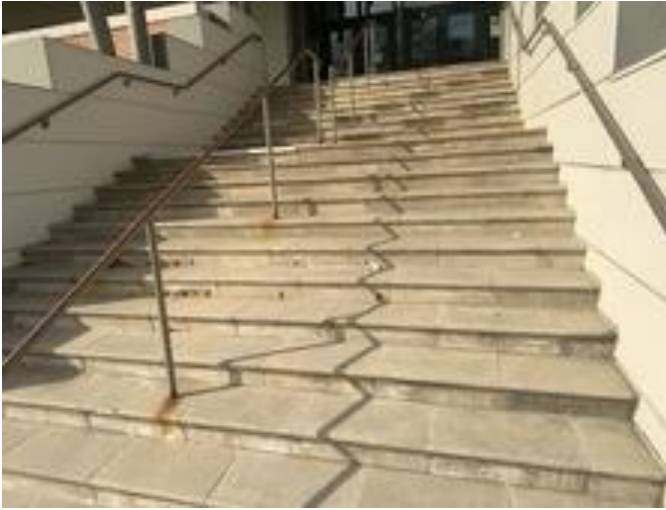
1 - PRECAST CONCRETE STAIRS

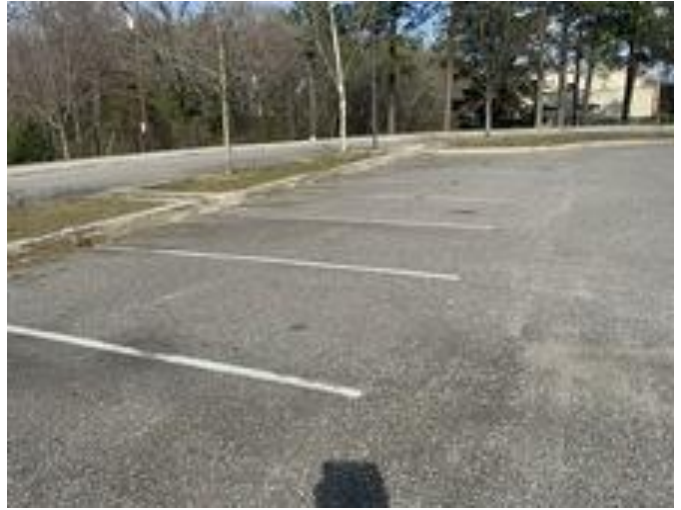
2 - ASPHALT PARKING LOT

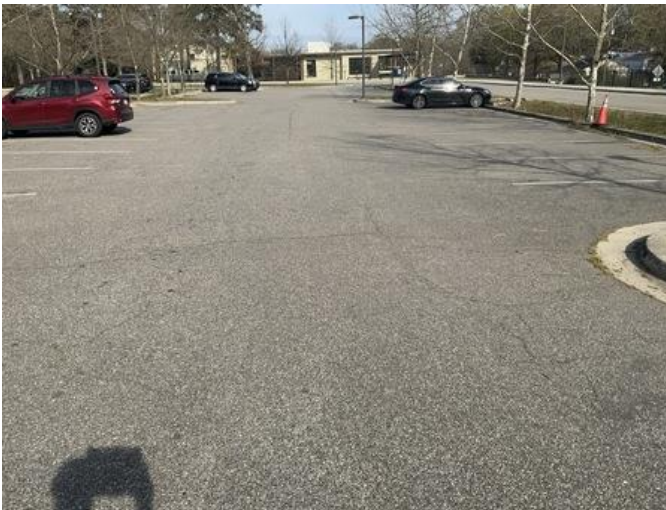
3 - ASPHALT PARKING LOTS
