# FACILITY CONDITION ASSESSMENT

**Richmond Public Schools**  
301 North Ninth Street  
Richmond, VA 23219

Richmond Success Academy  
119 West Leigh Street  
Richmond, VA 23220

*October 11, 2024*

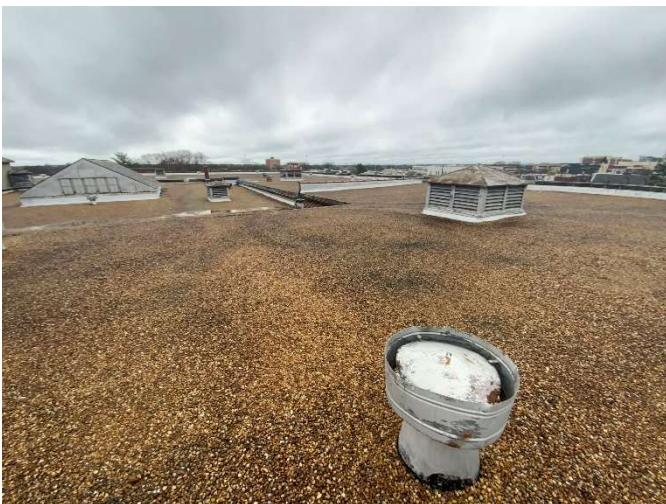
5 - ROOF

The field of the roofs have damaged and missing shingles. The entire roof requires replacement. - AssetCALC  
ID: 7419236

Uniformat Code: B3010  
Recommendation: **Replace in 2024**

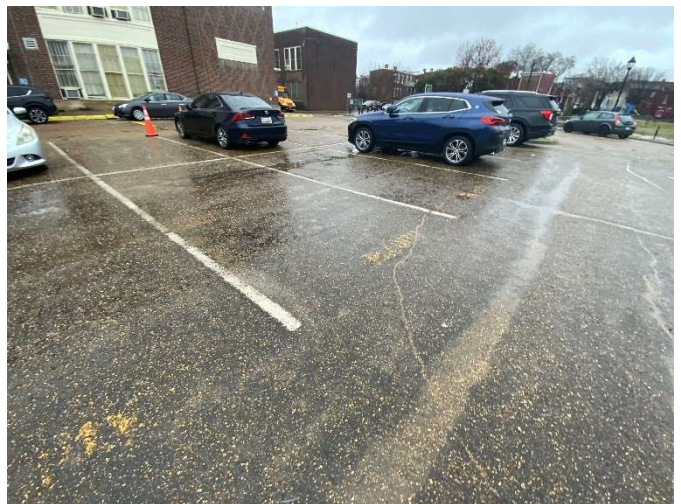
6 - PARKING

The site contains two asphalt parking areas and drive aisles connecting site features along the east elevation of the building. The south parking section was observed with significant wear and potholes and will require repairs in the short term. A gravel lot is located at the rear of the two-stories building section. The concrete walkways were observed in good condition. Site lighting is furnished by a series of building-mounted LED fixtures. Widespread areas of chain-link fencing were observed throughout. Storm water from the roofs, landscaped areas, and paved areas flows into a drain pond with underground piping connected to the municipal storm water management system. Landscaped areas interspersed throughout the site mostly consists of grass lawns and shrubs.
