# FACILITY CONDITION ASSESSMENT

**Richmond Public Schools**  
301 North Ninth Street  
Richmond, VA 23219

Swansboro Elementary School  
3160 Midlothian Turnpike  
Richmond, VA 23224

*May 12, 2024*

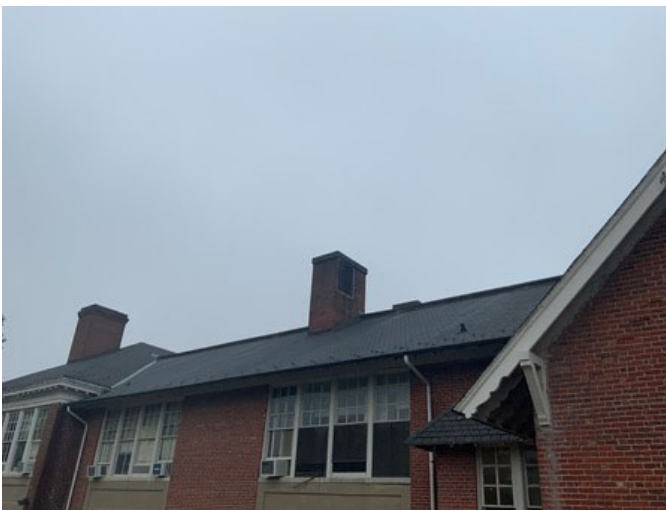
5 - SHINGLE ROOF

Most of the roof consists of asphalt shingles which need to be replaced all at one time instead of having sections of roof patched up when leaks happen. The flat built-up portion of the roof is uneven and has water pooling throughout.

Shingles missing and patch work looks old - AssetCALC ID: 7500215

Uniformat Code: B3010  
Recommendation: **Replace in 2025**

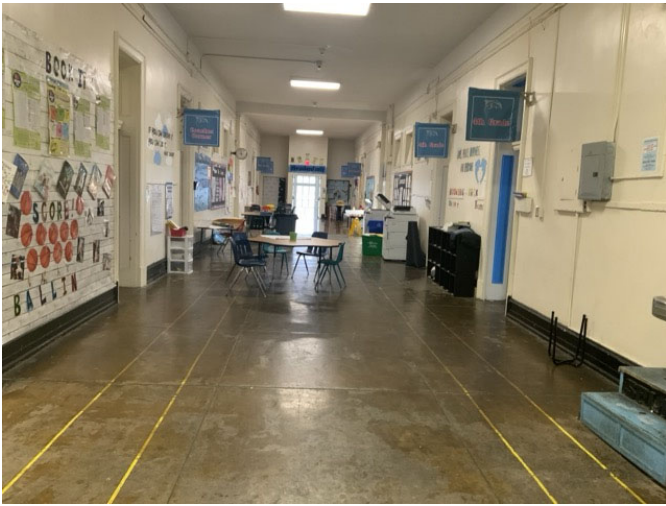
7 - 2<sup>ND</sup> FLOOR HALLWAY

The ceramic tiles in the restrooms are outdated, and tiles are missing or damaged. The flooring in the hallway on the second floor is stained and needs a layer of paint. The wood flooring on the second floor is stained and scarred, and needs to be refinished.

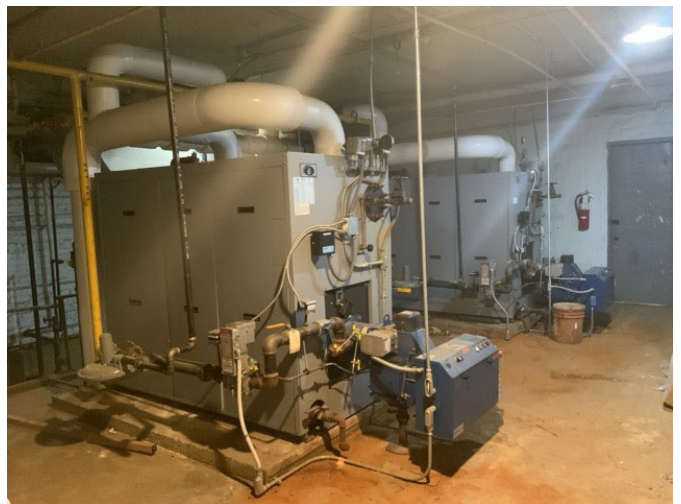
12 - BOILER ROOM

The interior steel door to the boiler has rusting around the frame and paint peeling off. The cabinetry in the kindergarten section is outdated and parts of falling off the hinges. All the exterior wooden and steel doors are deteriorating and need replacement.

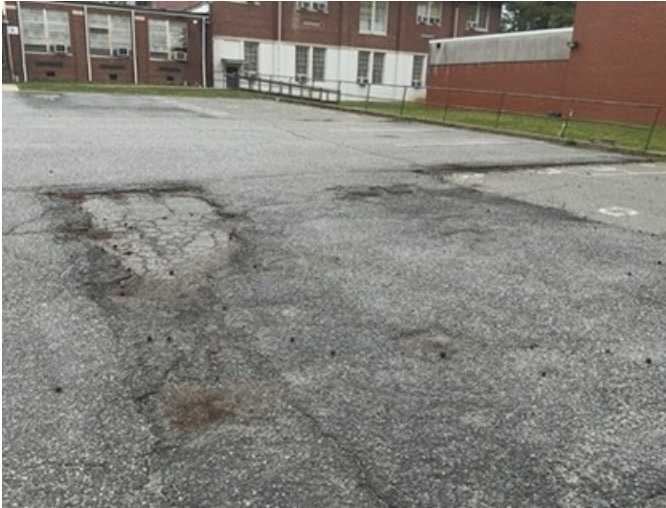
1 – REAR PARKING

The park lot at the rear of the building has cracks and potholes throughout. The metal tube fencing along the rear parking lot is leaning down towards the ground and needs replacement. The chain fencing in the front of the building has parts that are disconnected and hanging off. A replacement/repair cost has been included.

Uneven asphalt, alligator cracks, and potholes all around - AssetCALC ID: 7500309

Uniformat Code: G2020  
Recommendation: **Mill & Overlay in 2025**

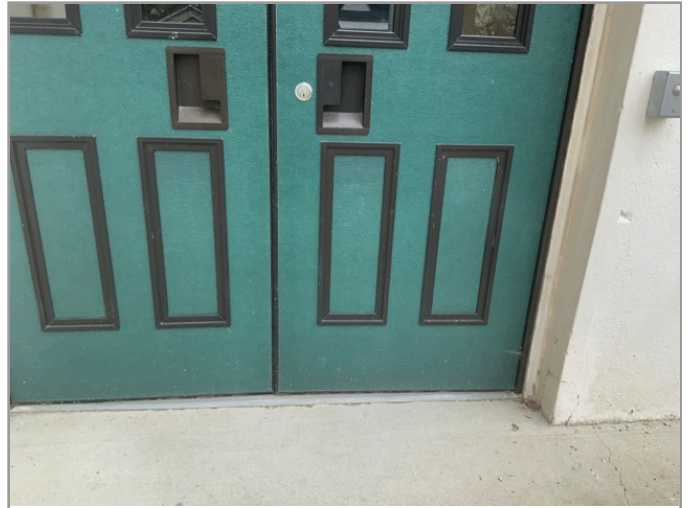
DOOR HARDWARE

The interior doors all have knobs and are not ADA compliant. The sinks in the ADA restrooms do not have insulated pipes. A replacement cost to replace doorknobs with levers and to install insulation on sink plumbing is included.
