Harrisburg School District

District Wide Facility Study

June 12, 2023

Crabtree, Rohrbaugh & Associates
Architects

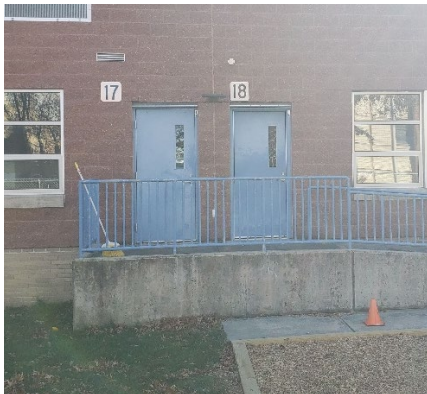
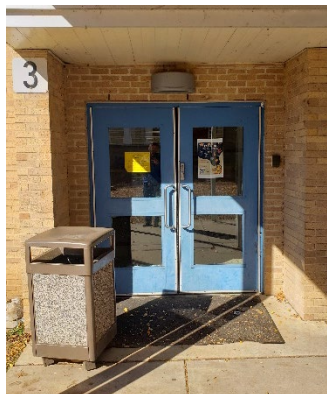
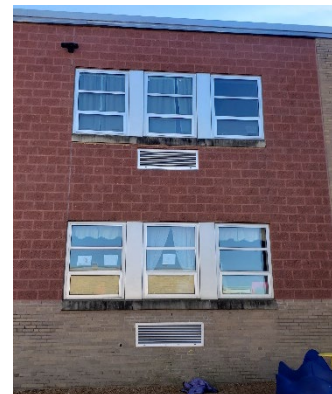
Typical window and entrance systems throughout the building are operable, awning-style aluminum storefront windows. The multi-purpose room has four curtain wall frame systems. Windows are generally in good condition. The door hardware at double door entrances/exits should be replaced so that doors cannot be chained together – a security concern.

Recommendations:

- Scrape and paint hollow metal doors and frames.
- Replace door hardware at exterior doors.

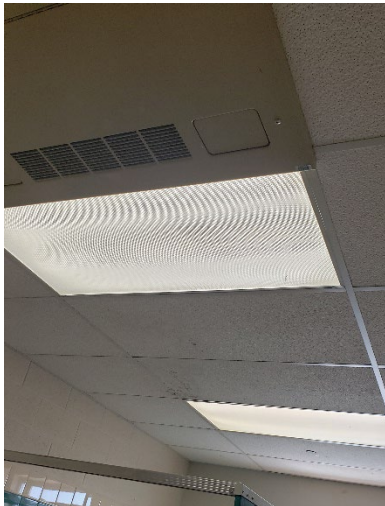
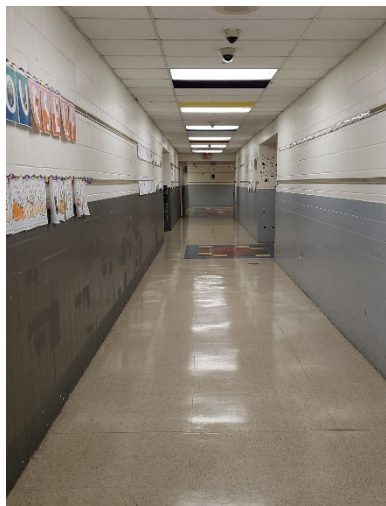
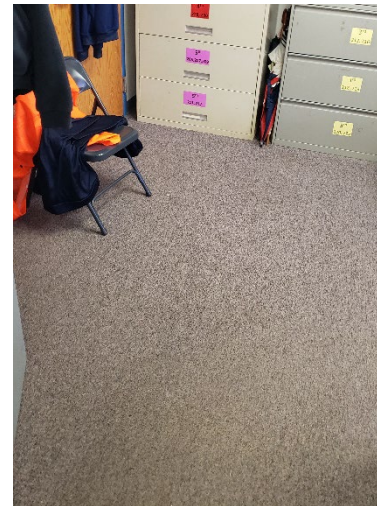
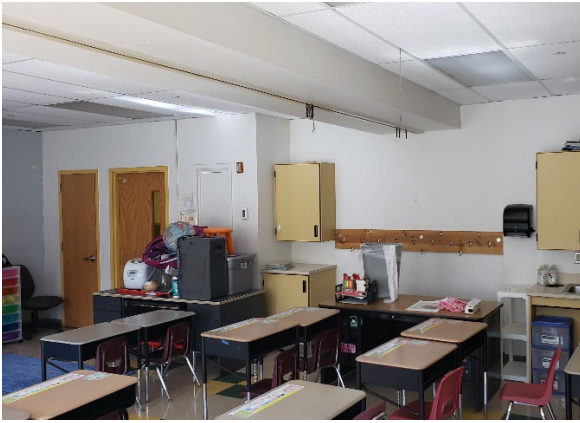
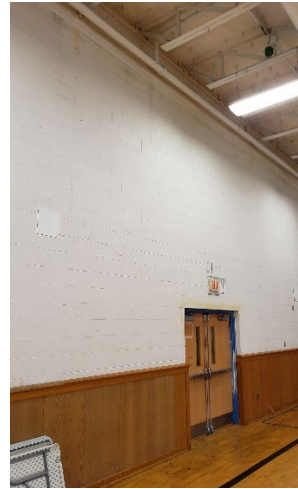
The building has vinyl composition tile (VCT) in the corridors and classrooms, which is in fair condition, although very dirty, and cracking or popping in some areas. VCT in the main office is especially poor. There are also terrazzo floors through the corridors in the original portions of the building. Flooring in toilet rooms is porcelain tile, while in the kitchen the flooring is quarry tile, all in good condition. The wood floor in the multi-purpose room/stage is in fair condition. Office areas have carpeting in fair condition. Transition strips are often missing throughout the building, resulting in VCT getting chipped at flooring changes.

Interior walls are mostly painted GWB, while the corridors have a ceramic tile wainscot, which has been subsequently painted over. Many corridors do not have a cove base which results in dirty corners where the wall meets the floor. Some walls have been painted on an ad-hoc basis by teachers. Many walls are due for cleaning and re-paint. The multi-purpose room walls are painted CMU with a wood panel wainscot and stage surround which shows a lot of wear throughout. Ceramic tile wainscots are in the toilet rooms. These wainscots often have stained grout and residual drywall mounting anchors from toilet accessories since removed.

Ceilings throughout most of the building are either 2'x2' or 2'x4' suspended ACT. Many ceilings are dirty, stained due to leaks, or slightly warped.

Recommendations:

- Replace ceiling tile throughout the entire building.
- Install wall base where missing.
- Replace VCT throughout the entire building.
- Replace carpeting in offices.
- Sand and refinish gymnasium floor if suitable to do so.
- Re-paint the entire building.

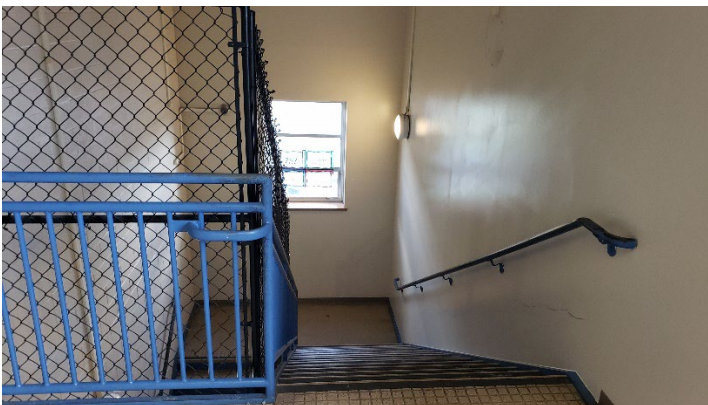
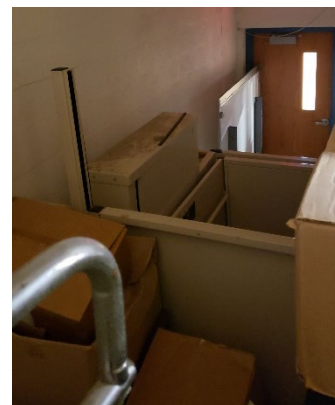
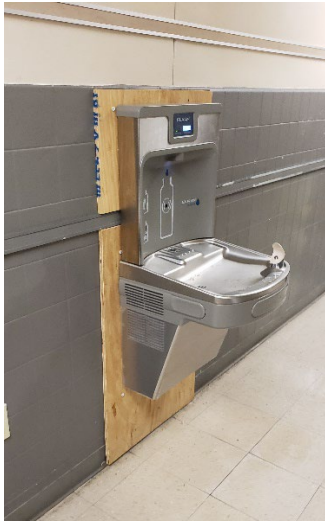
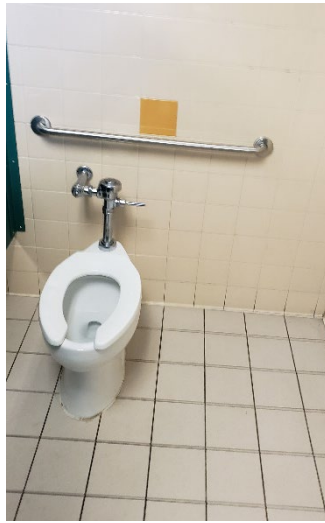
Water closets in accessible toilet stalls do not have the required fixture clearances around them. Grab bars do not meet current ADA requirements, and accessories are not installed within reach range. Faculty toilet rooms are not accessible.

Drinking fountains, while many recently replaced, are often located such that they project into paths of travel, an accessibility concern due to blind persons not being able to sense their presence.

Recommendations:

- Evaluate elevators for any necessary upgrades. Replace communications systems.
- Replace original elevator in its entirety.
- Replace the guard/handrail around the stairs with a new guard and handrail that is compliant with current code.
- Renovate all non-ADA compliant single occupancy toilet rooms to be ADA compliant.
- Modify all ADA toilet stalls to comply with current code by providing ample clearance at water closets, moving accessories within reach range, and providing ADA compliant grab bars.

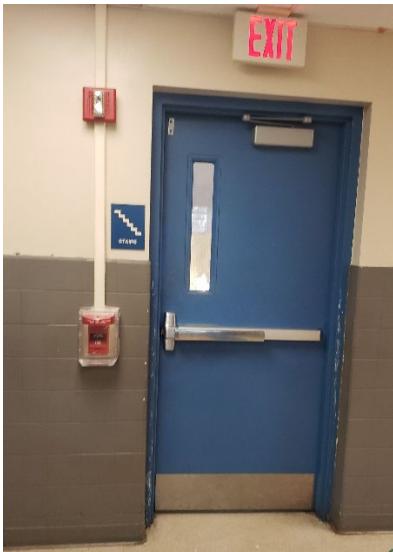
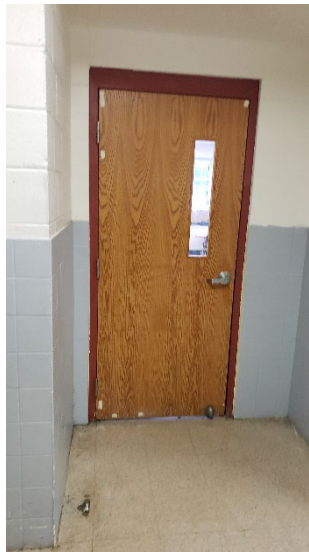
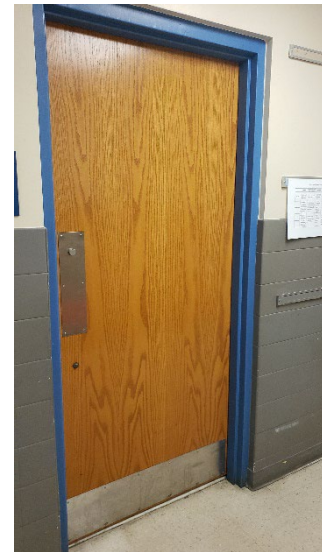
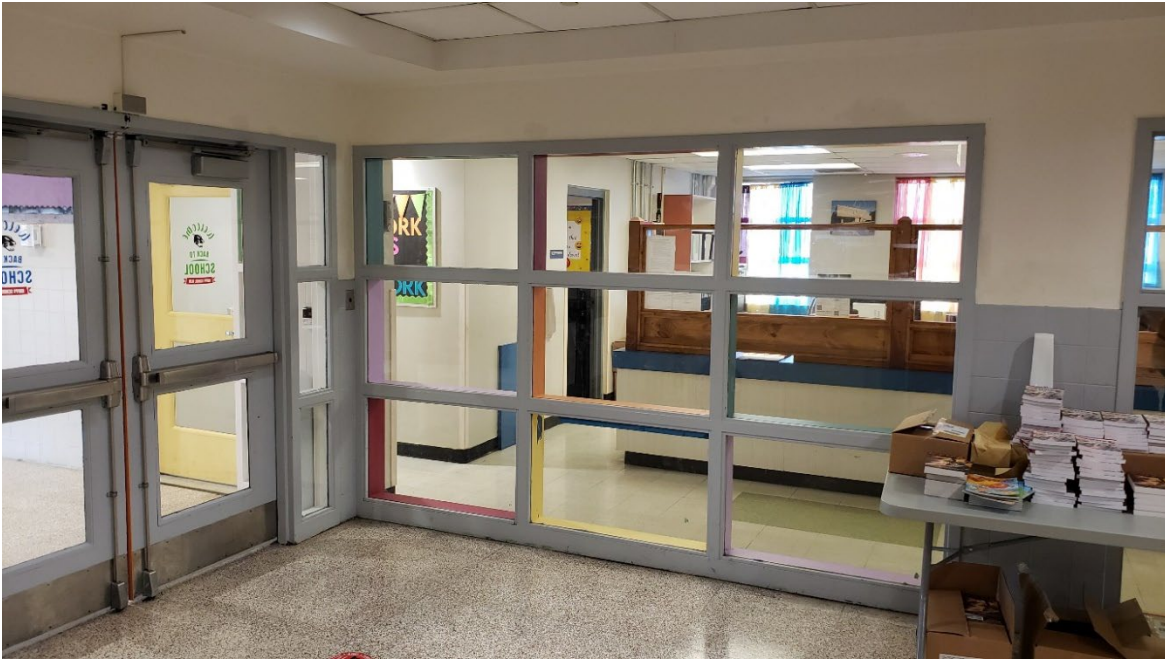
Most interior doors are wood with ADA-compliant hardware in fair condition, with hollow metal frames. Many doors have scratches and residue which remains from items being hung/taped to them over the years. Hollow metal doors and frames are in fair condition, most requiring painting.

Recommendations:

- Replace all interior doors and hardware throughout the building.
- Scrape and repaint hollow metal frames.

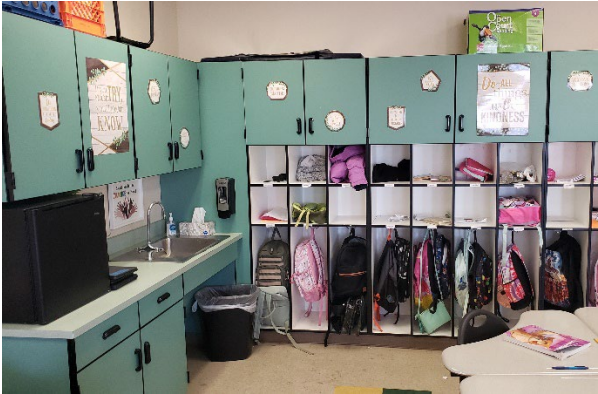
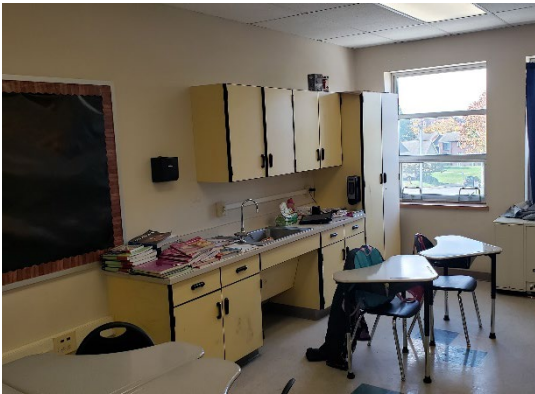
Most of the casework dates from the 2004 renovation. While generally in fair condition, appearances are dated, and cabinets are often scratched and/or dirty.

Typical classrooms have built-in shelving along the exterior wall adjacent to the unit ventilators. If the unit ventilators are removed as part of an HVAC upgrade, this casework would need to be infilled or removed and adjacent finishes patched and repaired.

Recommendations:

- Replace casework throughout the building.

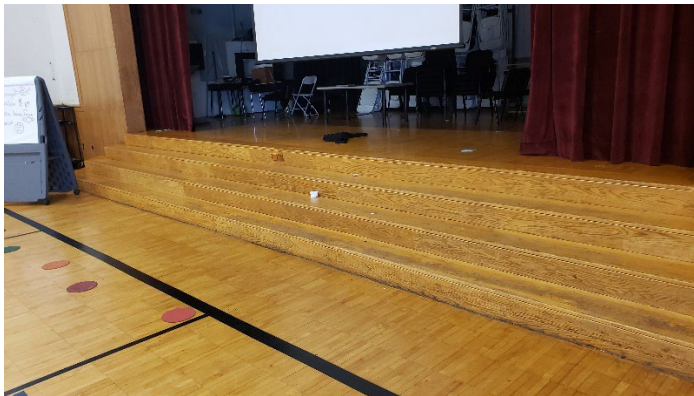
The movable partition in the multipurpose room is at the end of its useful life. The multipurpose room has (1) main basketball court with front-folding backstops at each end. The backstops were replaced since the original construction and are in good condition. There are no wall pads in the space.

The theatrical equipment (curtains, lighting, projection screen) is in good condition. The stage and risers show wear.

Recommendations:

- Provide wall pads around the basketball court, particularly at the end opposite the stage.
- Consider sanding and refinishing the stage floor and risers.

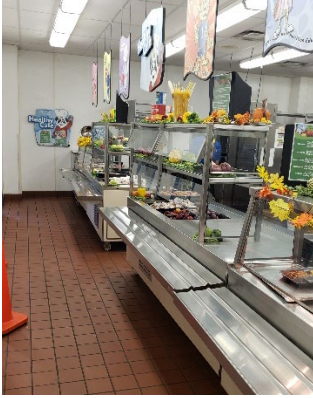
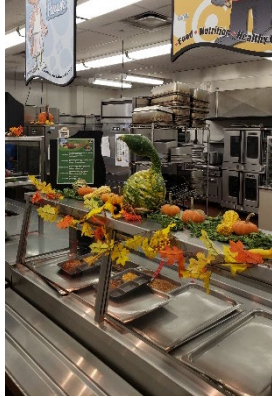
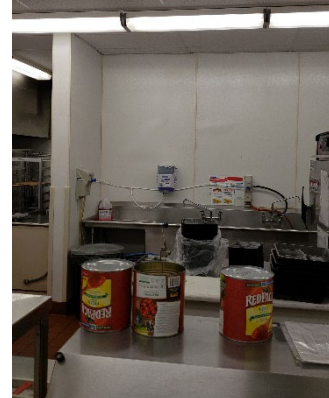
The cooking for Benjamin Franklin Elementary School is done on site. Cold storage space at this school is inadequate, with only reach-in refrigerator/freezer units. The food service equipment was replaced in 2004 and is approaching the end of its useful life. Dry storage space is also limited.

Recommendations:

- Replace food service equipment.
- Consider enlarging the kitchen as part of a major renovation project.

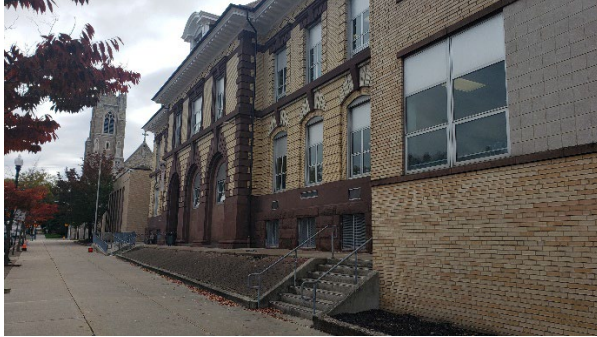
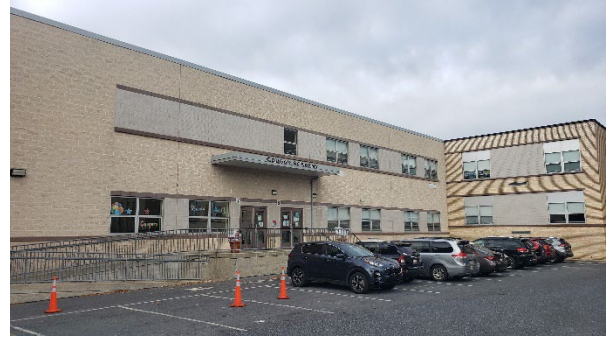
The building exterior consists of a modular brick veneer construction in the original and 1950's addition areas. The 2003 addition has split face CMU veneer on insulated cavity walls with CMU backups. Brownstone stools are included with window embellishments. Masonry walls are in good condition, with a couple areas of staining due to water running down the façade from overflowing gutters.

Recommendations:

- Brick and CMU veneer with stone around the entire façade should be cleaned. Repointing should be done as required.
- Joints should be re-caulked.

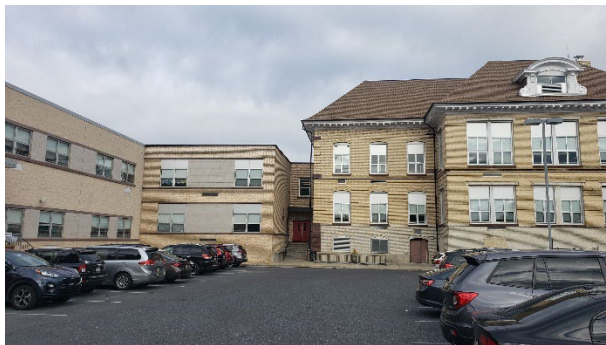
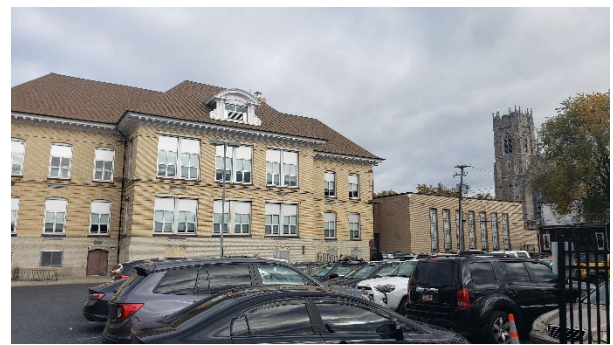
The building has three distinct roofing areas which developed as the building was expanded. The original portion of the building has a Mansard roof. The shingled portion of the mansard roof was recently replaced and is in good condition. The remainder roof, including the flat portion of the Mansard roof is primarily membrane roofing, all coming due for replacement. There are a couple of dormers projecting out from the sloped Mansard roof which have metal roofs which also are due for replacement.

Recommendations:

- Replace membrane and metal roofs.

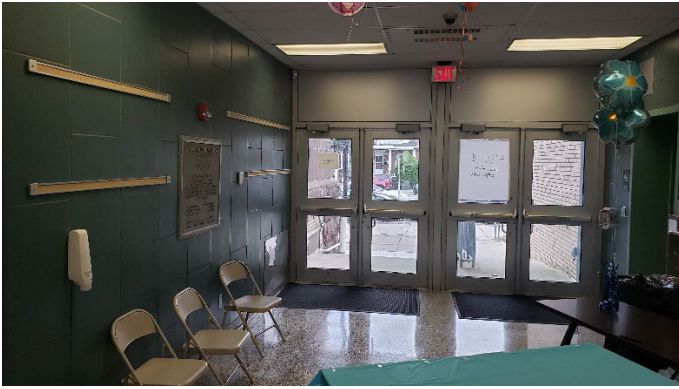
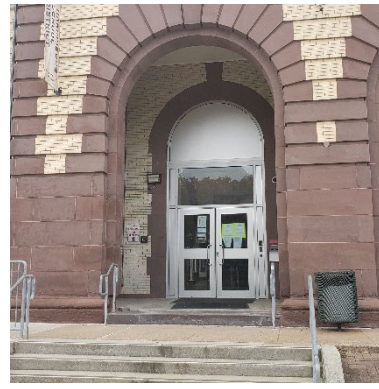
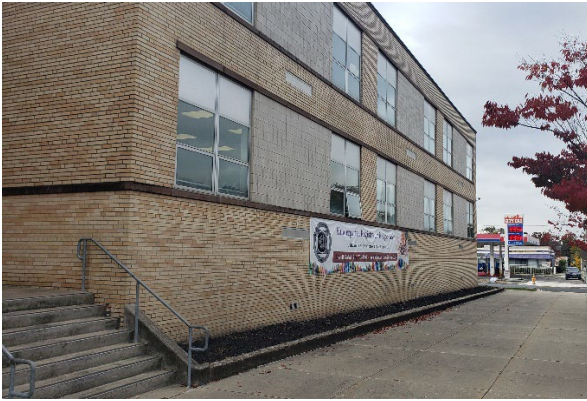
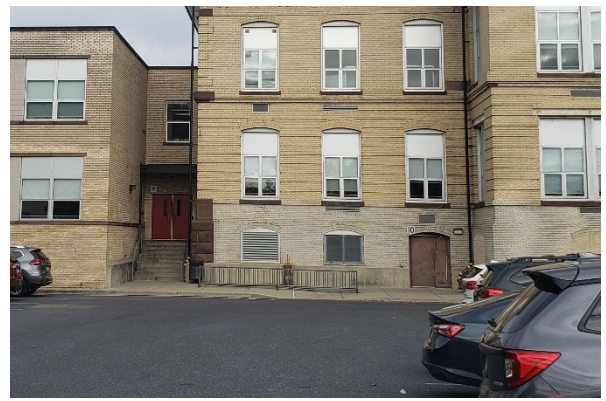
Windows are operable awning style aluminum windows with insulated glass, and were replaced in 2000 along with the additions. Entrances are aluminum storefront glazing systems. Aluminum entrances around the building are in good condition. Hollow metal doors at service areas are due for painting. The doors to the parking lot from the basement are significantly worn and due for replacement. Door pulls at double doors should be replaced with hardware which does not allow double doors to be chained together – a safety and security concern.

Recommendations:

- Paint hollow metal doors and frame to service areas.
- Replace hollow metal doors accessing the basement.
- Replace exterior door hardware.

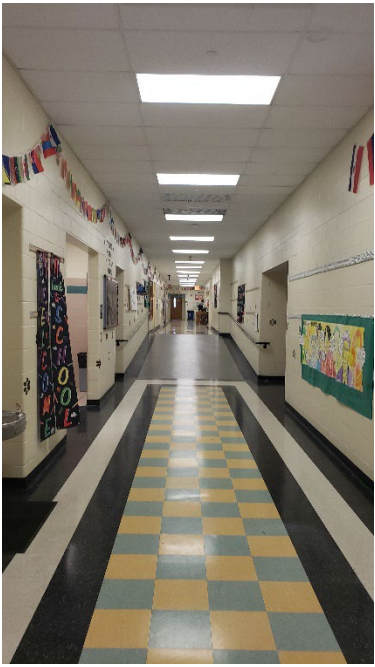
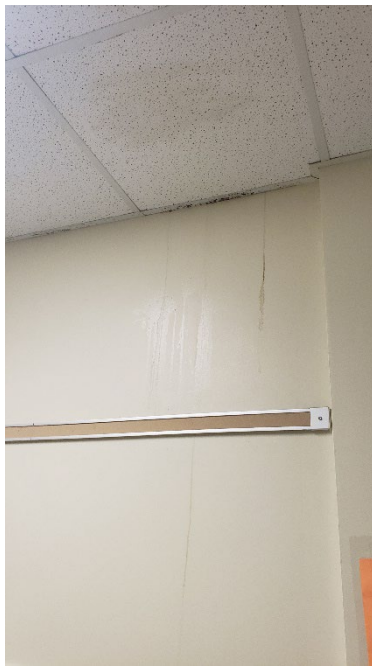
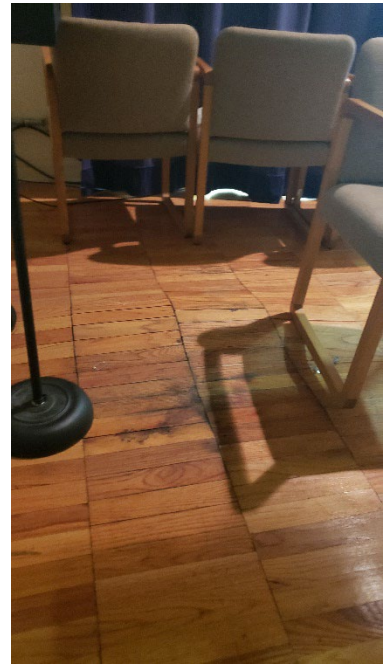
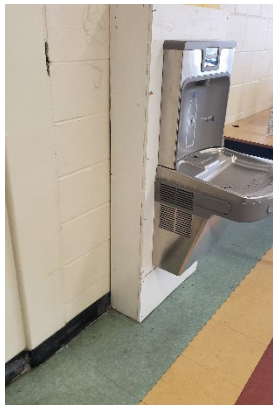
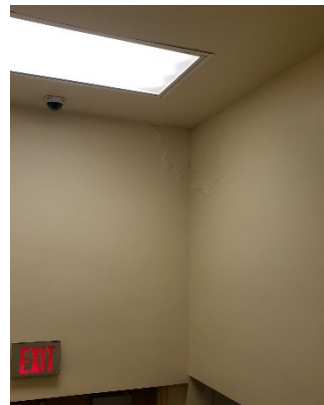
The building has vinyl composition tile (VCT) in the corridors, classrooms, cafeteria and some office areas which is in fair condition with minor wear throughout. The main office area and library are both carpeted – the office carpet is due for replacement. Toilet rooms have ceramic tile floors in good condition. The kitchen floor is quarry tile in good condition. The multi-purpose room floor is a floated wood flooring system which is in good condition, but the stage floor and risers are also wood and due for replacement due to water damage. The multi-purpose room lobby has terrazzo floors in good condition.

Interior partitions are a combination of painted CMU as well as painted GWB/plaster, while toilet rooms are finished with glazed ceramic tile. Most wall finishes are in good condition, with only a few instances of missing wall base, and occasional instances of water damage observed.

Ceilings are generally systems of suspended acoustical ceiling tiles in fair condition, beginning to sag.

Recommendations:

- Replace wood stage in multi-purpose room.
- Replace missing or damaged wall base as required as part of ongoing maintenance.
- Replace carpeting in DAO offices.
- Repair plaster/GWB walls and ceilings damaged from water leaks as required.
- Clean and touch up walls as required.
- Replace ceilings as part of a comprehensive lighting and HVAC replacement.

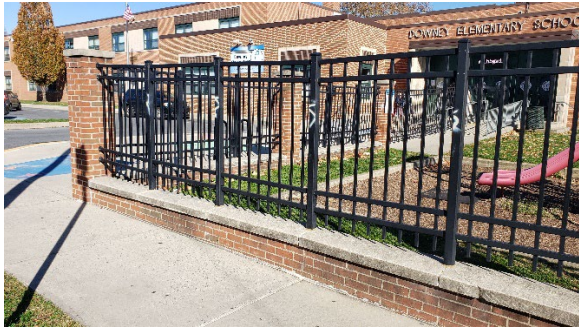
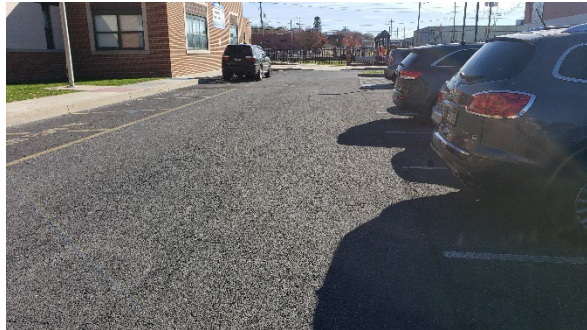
Asphalt pavement is cracking throughout the site and is due for repaving. Concrete sidewalks are in good condition.

- Mill and overlay parking areas.
- Consider replacement of the decorative fence at the corner of Monroe and Cumberland Streets.

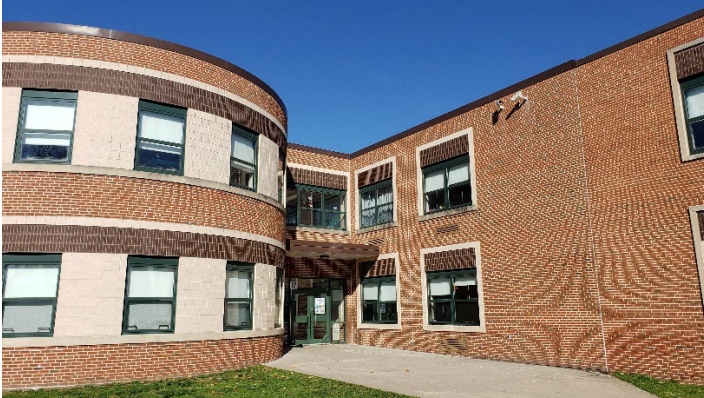
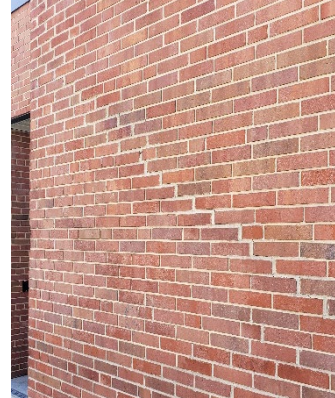
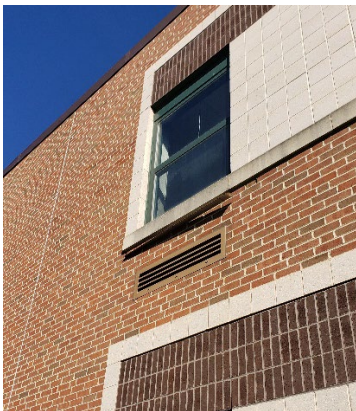
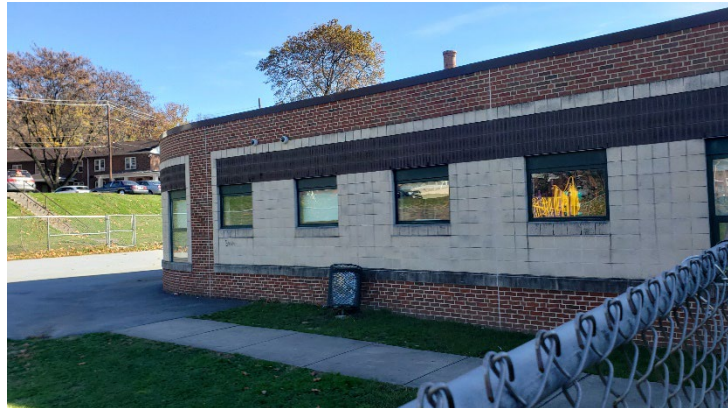
The building exterior consists of masonry walls with modular brick veneers. Older areas of the building are not cavity walls, while newer areas of the building have insulated masonry cavity walls with brick and split face CMU veneers. Portions of the walls in the older areas were replaced on the interior to include insulation and air barriers. Windows are surrounded with precast concrete trim, which is often stained especially on the north- and east-facing sides. The masonry veneer is generally in good condition, although there are areas where it is apparent that cracking has been repaired in the past and should be retreated, particularly in the older portions of the building. There is also some staining on the north- and east-facing parts of the structure which do not get much sun exposure. There are also some locations where the flashing below windows is popping out from the wall.

- Brick veneer should be cleaned around stained areas. Repointing should be done as required.
- Joints should be re-caulked.
- Repair flashing where it has popped out from the wall.

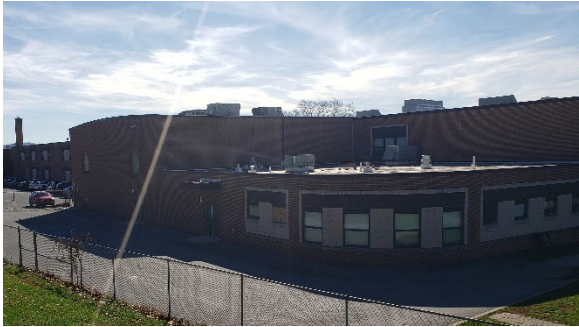
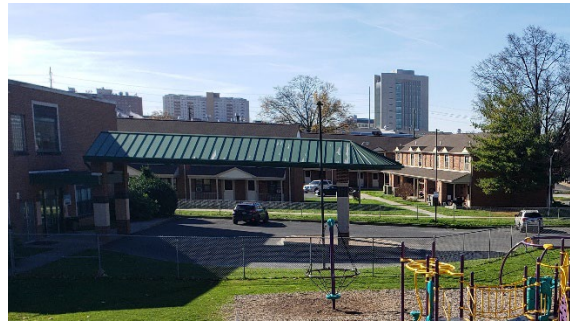
The School has a flat white membrane roof over the entire structure, with the exception of the entrance canopy at the north end of the building. The entrance canopy has a sloped standing seam metal roof which is in poor to fair condition due to weathering over time. The entrance canopy roof should be replaced.

- Replace standing seam metal entrance canopy roof.

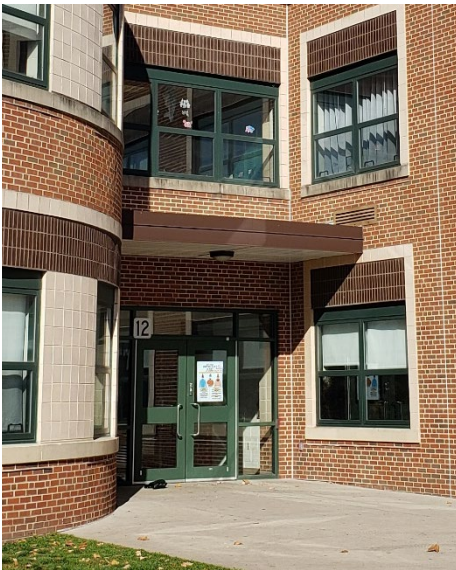
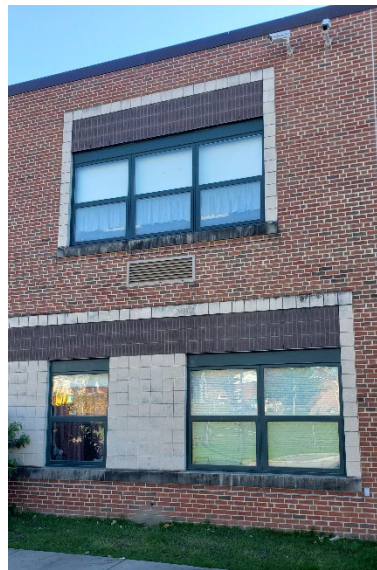
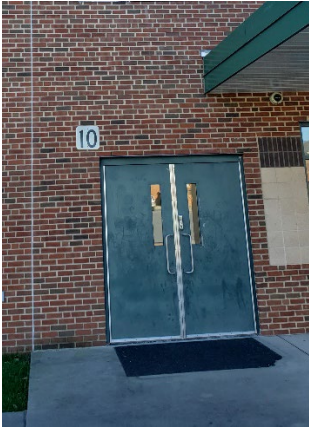
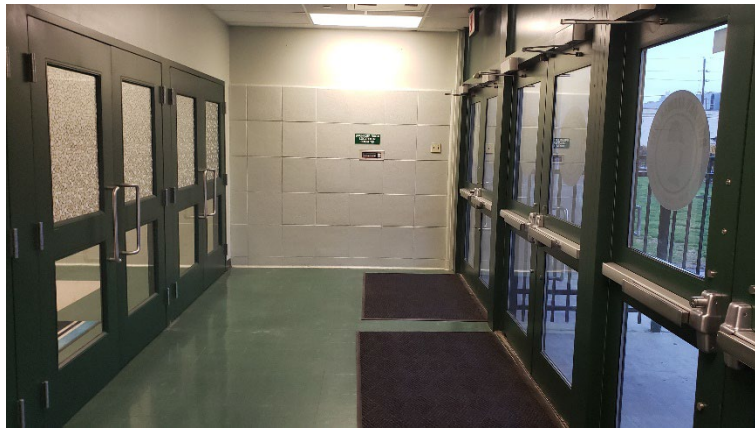
Exterior doors are either set in aluminum storefront systems or hollow metal. The door pulls in the entrance doors should be replaced at double doors, so that doors cannot be chained together from the outside. Hollow metal doors and frames are due for new paint coatings.

- Scrape and paint hollow metal doors and frames.
- Replace door pulls at double doors so doors cannot be chained together from the outside.

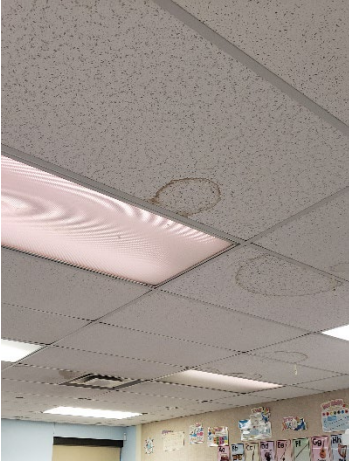
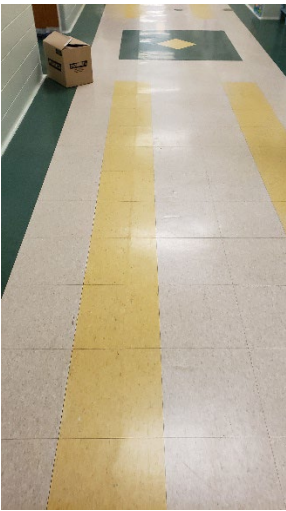
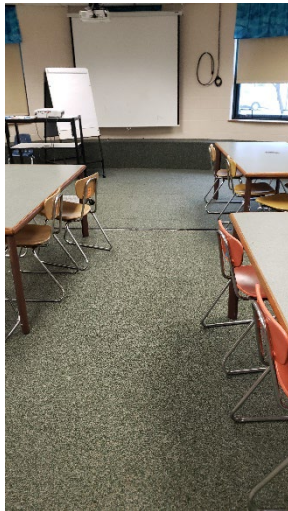
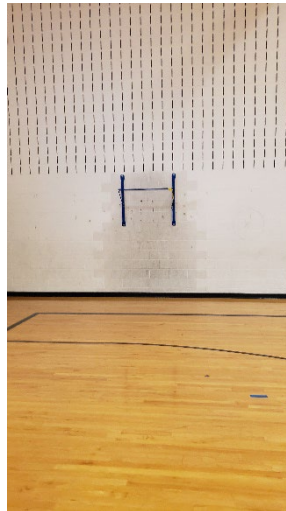
The building has vinyl composition tile (VCT) in the corridors and classrooms, which is in poor condition, being very dirty, and cracking or popping in many areas. VCT in the main office is especially poor. There are also terrazzo floors through the corridors in the original portions of the building. Flooring in toilet rooms is porcelain tile, while in the kitchen the flooring is quarry tile, all in fair condition but often with stained grout. The wood floor in the multi-purpose room/stage is in fair condition, but inappropriate for the room usage, particularly since a new gymnasium was added in 2003. Office areas and the library have carpeting in poor condition. Transition strips are often missing throughout the building, resulting in VCT getting chipped at flooring changes. The library and offices have carpet in poor condition.

Interior walls are mostly painted GWB or plaster, while the corridors have a ceramic tile wainscot, which has been subsequently painted over in some areas. GWB and plaster walls are heavily marked or damaged and due for cleaning, patching and re-paint. Ceramic tile wainscots are in the toilet rooms, sometimes with residual wall anchors from removed accessories.

Ceilings throughout most of the building are 2'x4' suspended ACT. Many ceilings are damaged or stained from various leaks or other causes.

- Replace ceiling tile throughout the entire building.
- Replace VCT throughout the entire building.
- Replace carpeting in offices and library.
- Replace the multi-purpose room wood floor with a more appropriate material for the space.
- Re-paint the entire building.

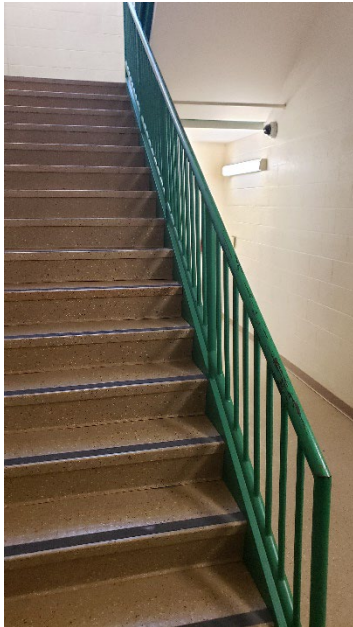
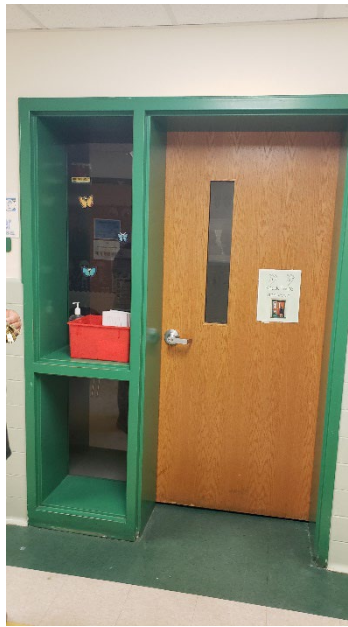
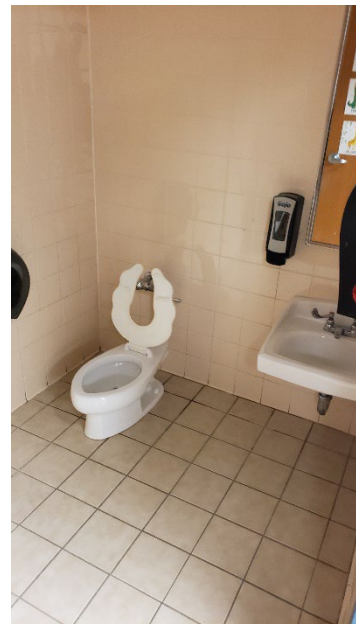
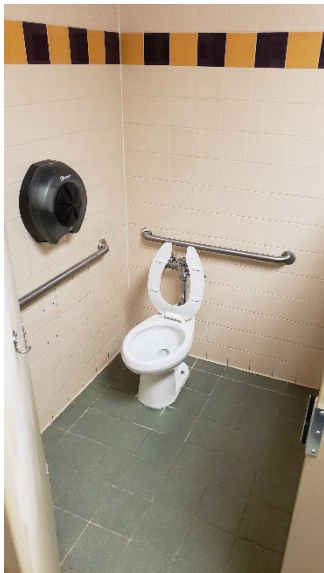
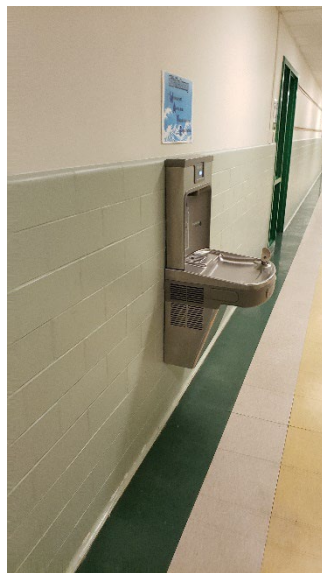
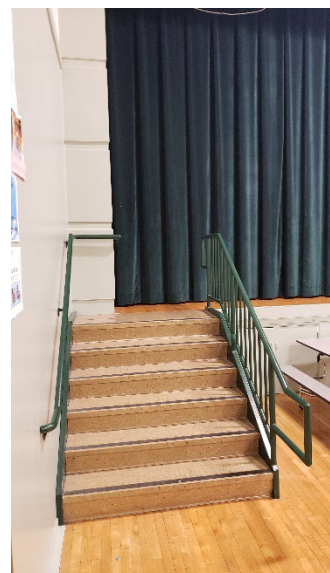
Drinking fountains, while many recently replaced, are often located such that they project into paths of travel, an accessibility concern due to blind persons not being able to sense their presence.

There are doors set in frames that are too deep to accommodate required push/pull clearances adjacent to the door as required by accessibility codes.

Stairs providing access to the stage from the multipurpose room do not have proper clearance / landing area at the top.

- Evaluate elevator for any necessary upgrades. Replace elevator communications system.
- Replace the guard/handrail around stair with a new guard and handrail that is compliant with current code.
- Renovate all non-ADA compliant single occupancy toilet rooms to be ADA compliant.
- Modify all ADA toilet stalls to comply with current code by providing ample clearance at water closets, moving accessories within reach range, and providing ADA compliant grab bars.
- Reconfigure doorways that do not meet accessibility requirements.
- Reconfigure access to stage in multipurpose room.

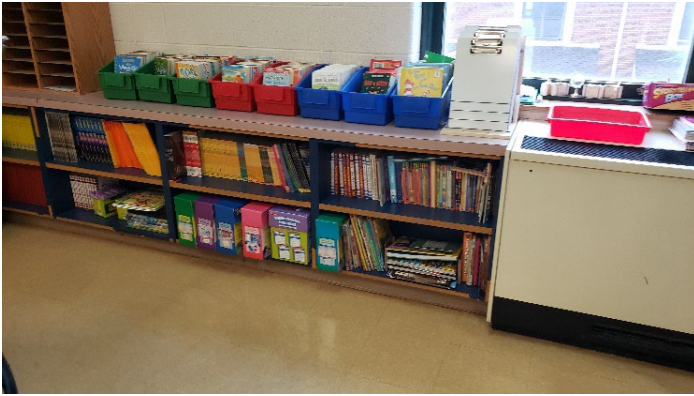
Most of the casework dates from the 2003 renovation. Many units are missing portions of laminates and are due for replacement.

- Replace casework throughout the building.

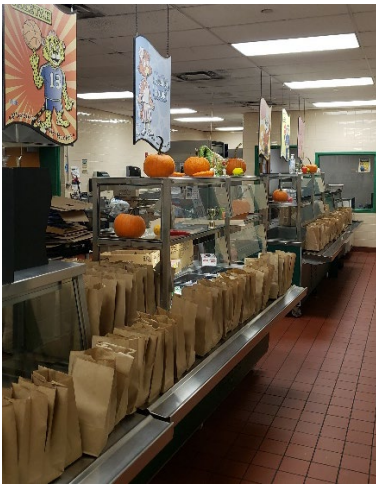
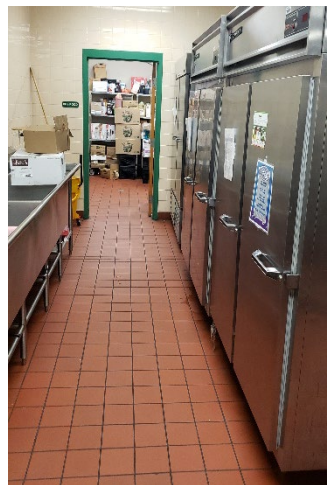
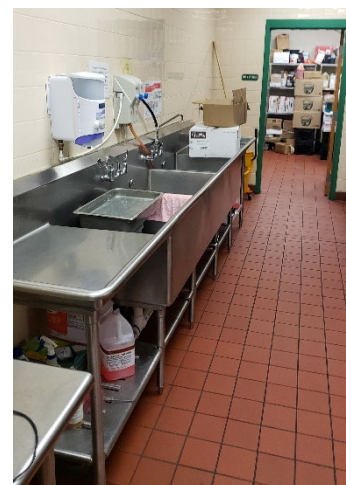
Since most of the cooking for the School is done on site. Cold storage space at this school is inadequate, with only reach-in refrigerator/freezer units. The food service equipment was replaced in 2004 and is approaching the end of its useful life.

- Replace food service equipment.
- Consider enlarging the kitchen as part of a major renovation project.

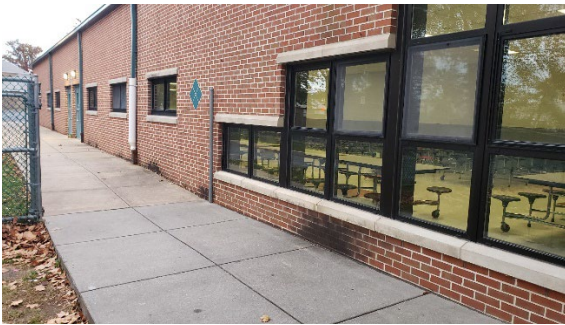
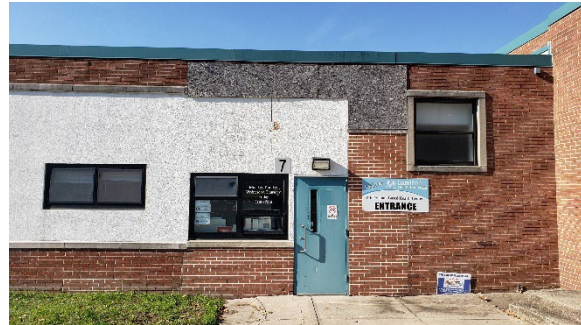
The building exterior consists of modular brick veneer over CMU back-up (no cavity) at the original areas and the 1960 addition areas. Insulated cavity walls with modular brick veneer and CMU back-ups make up the exterior walls in the 2004 additions. Window stools and heads are formed by precast concrete bands. In areas where the roof is drained by gutters and downspouts, the masonry is stained from leaks in the gutters above. Additionally, there is an area on the east side of the building where the wall has been boarded over.

Marks from graffiti with previous attempts at removal are occasionally visible.

Areas of EIFS are cracked and due for repair.

- Brick veneer around the entire façade should be cleaned. Repointing should be done as required, particularly on the areas built pre-2004.
- Joints should be re-caulked.
- Replace or refinish EIFS.
- Repair boarded-up area of masonry, EIFS and precast trim on east side of building.
- Remove graffiti.

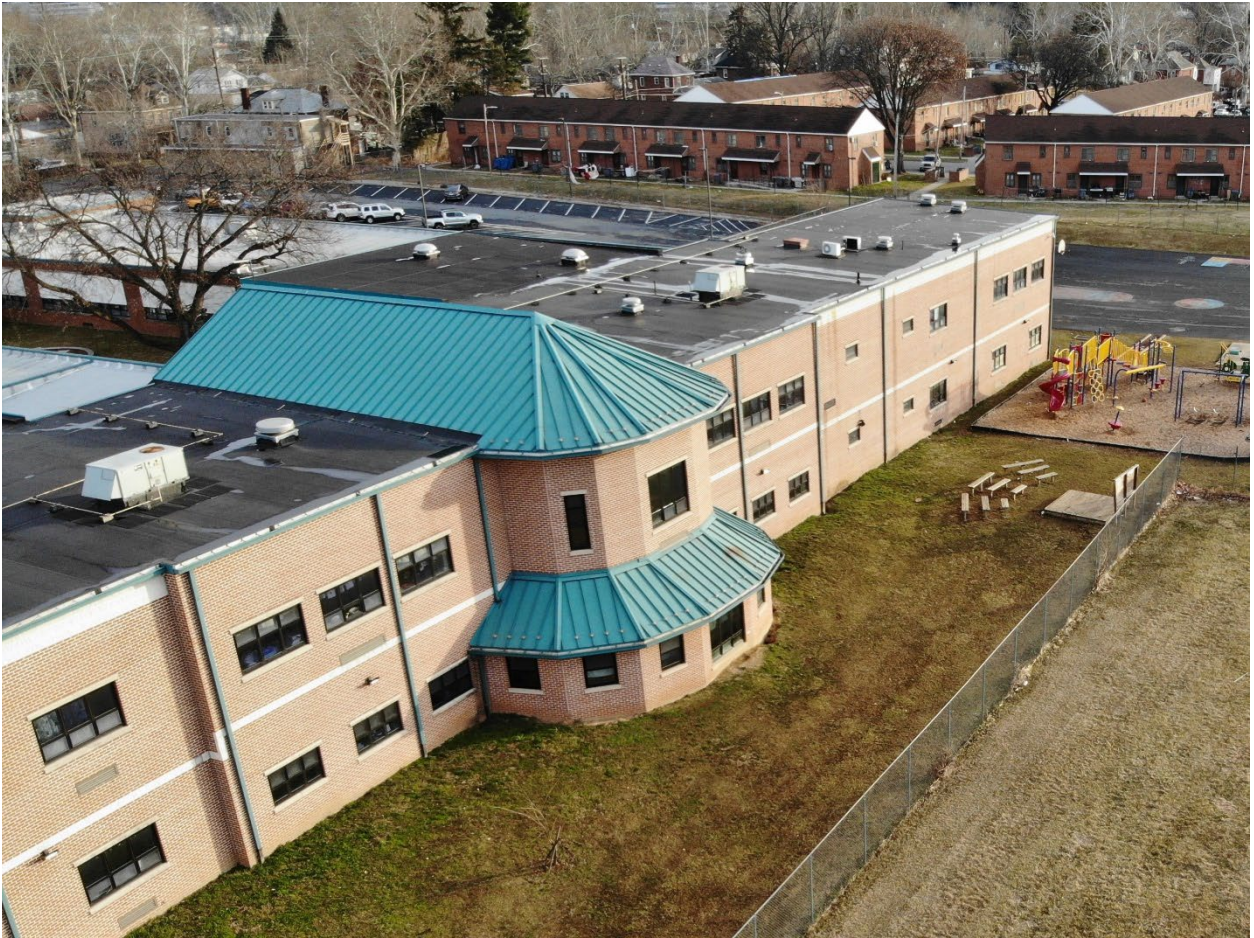
The School has an adhered EPDM roofing system. Parts of the roofing system, over the older portions of the building, date back to the 2004 renovation work. The newer portions of the building have had more recent roof replacements, including a black EPDM roof over classrooms and replacing the sloped, shingled roofs over the entrances and prominent architectural features with standing seam metal. Trim all around the building including gutters and downspouts shows indications of leaks and failures.

- Replace the older membrane roof in its entirety.
- Replace all trim, gutters and downspouts.

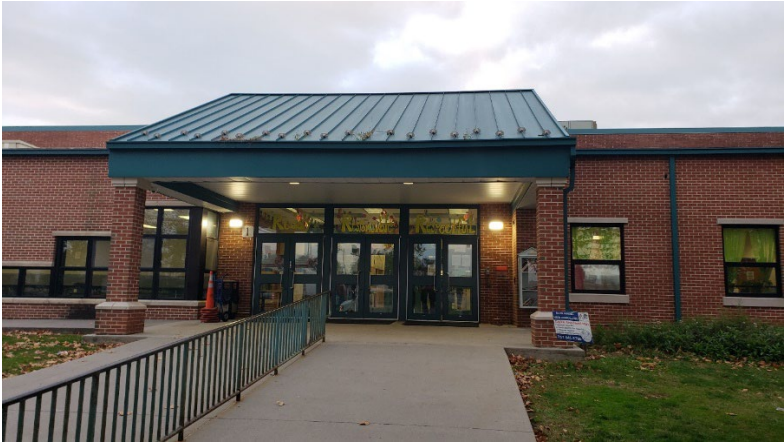
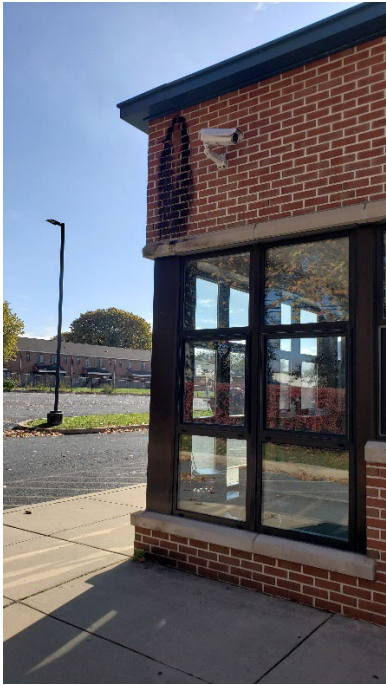
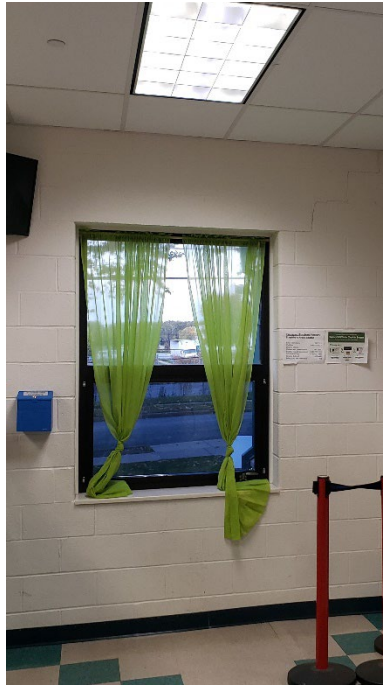
Windows are operable, awning- and hopper-style aluminum windows, which are generally in good condition. The front entrance aluminum entrance system is also in good condition, with only routine maintenance required. Hollow metal doors around the building are due for repainting. The building’s entrance and exit doors have hardware which could allow doors to be chained together, which is a safety and security concern.

- Replace sealants around window and entrance systems.
- Paint hollow metal doors.

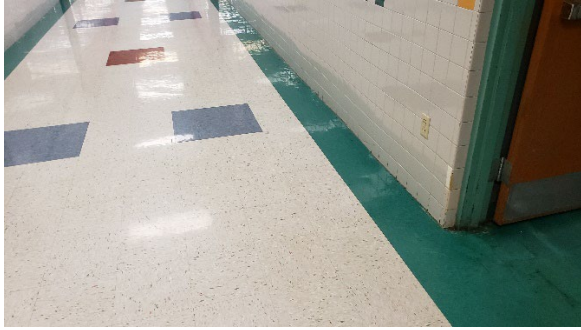
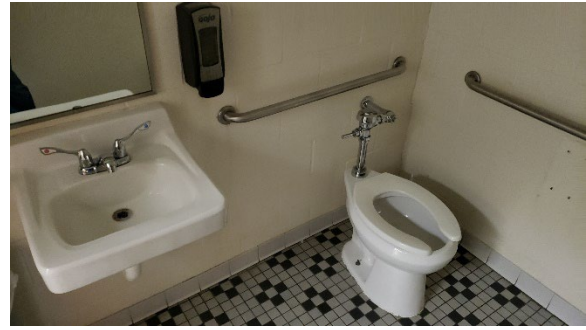
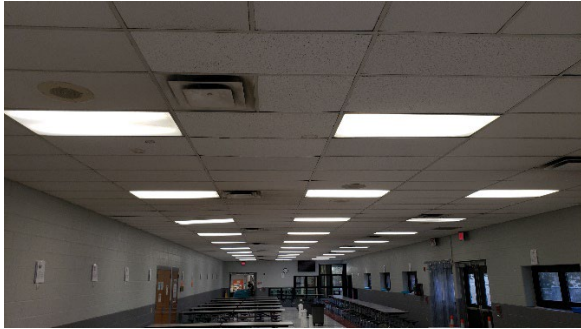
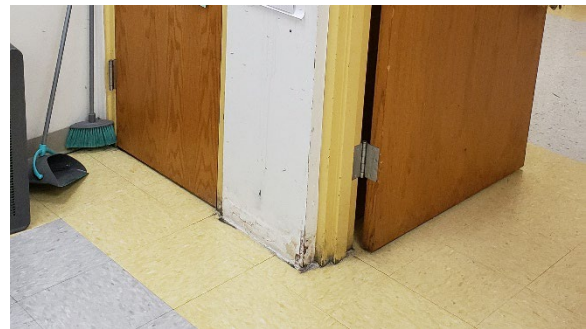
The building has vinyl composition tile (VCT) in the corridors and classrooms, which is in poor condition. The original lobby areas have squares of terrazzo which is in good condition. Toilet rooms have 2" mosaic ceramic tile floors while the Kitchen has quarry tile floors. The gymnasium has a wood floor. Some classrooms have areas of missing wall base.

Interior walls are primarily painted CMU, with some non-load-bearing partitions painted stud/GWB and occasional demountable partitions. Walls in bathrooms have residual mounting anchors from toilet accessories since removed. Most walls throughout are due for cleaning and new paint. Walls in the corridors have a ceramic tile wainscot, below painted GWB. This wainscot is often chipped, especially at corners. Additionally, the wainscot does not have a cove base which results in dirty corners where the wall meets the floor. Gymnasium walls have a glazed structural tile wainscot, which appears to have had previous wall openings infilled. Base trim is missing at most of these locations. The auditorium has plaster walls with wood panel wainscot and stage surround.

Ceilings throughout most of the building are either 2'x2' or 2'x4' suspended ACT. Many ceilings are dirty, stained due to leaks, or slightly warped.

- Replace ceiling tile throughout the entire building.
- Replace ceramic tile wainscot in corridors.
- Replace VCT and resilient base throughout the entire building.
- Replace carpeting in offices.
- Re-paint the entire building.

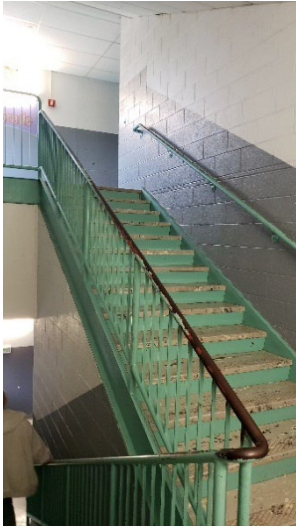
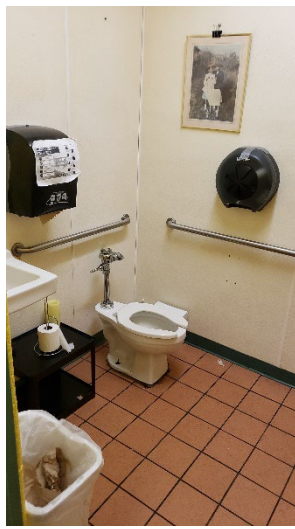
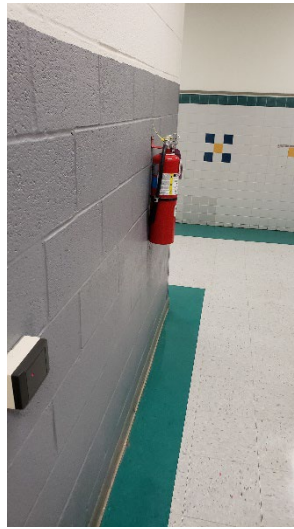
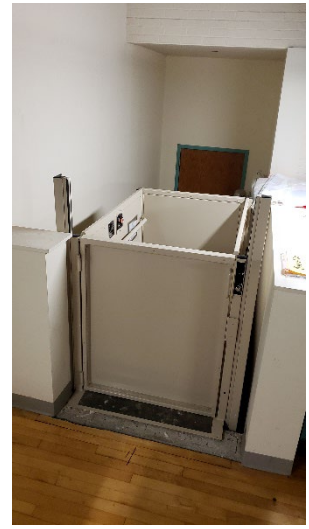
Water closets in single occupant toilet rooms do not have the required fixture clearances around them due to lavatories being installed directly adjacent to them. Grab bars do not meet current ADA requirements, and accessories are not installed within reach range. Faculty toilet rooms are not accessible.

Fire extinguishers are directly mounted to walls which project into paths of travel, an accessibility concern due to blind persons not being able to sense their presence. Similarly, drinking fountains, while many recently replaced, are often located such that they also project into paths of travel.

- Evaluate elevator for any necessary upgrades. Replace elevator communications system.
- Replace steel guard rails/hand rails in stairs to be compliant with current Codes.
- Renovate all non-ADA compliant single occupancy toilet rooms to be ADA compliant.
- Modify all ADA toilet stalls to comply with current code by moving accessories within reach range, and providing ADA compliant grab bars.
- Install semi-recessed fire extinguisher cabinets.

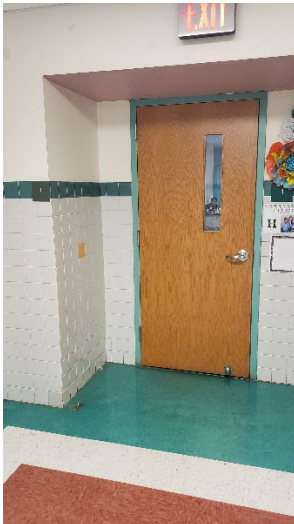
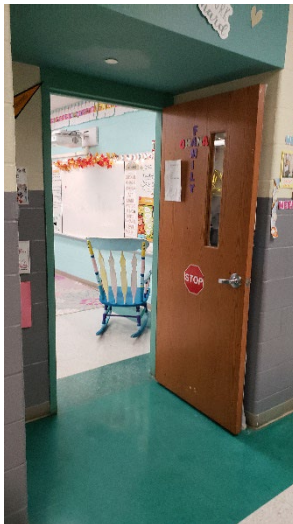
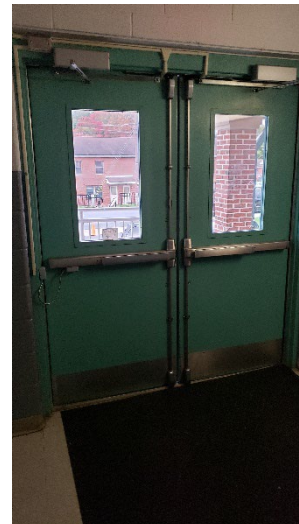
Interior doors are wood, in fair to good condition – there are occasional doors with scratches and many have residue from taping items to the doors. The door hardware is ADA compliant, and in good condition. Stair tower doors and certain corridor doors have wire glass. Hollow metal frames are in need of new paint.

- Replace stair tower and cross corridor doors and hardware.

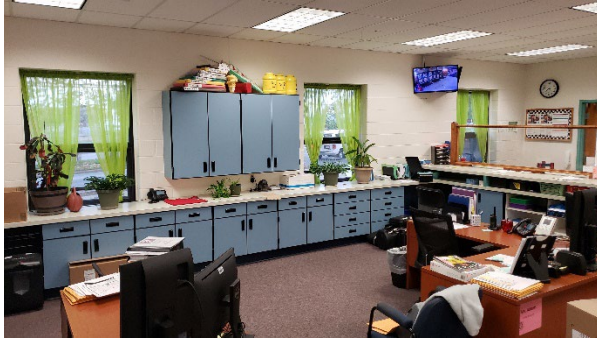
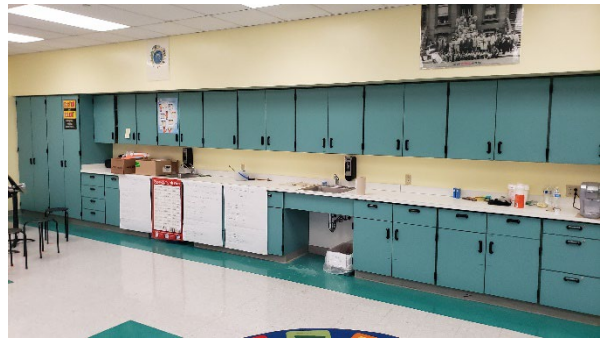
Most of the casework dates from the renovations and additions from the early 2000's. Most casework is in good condition, however there were some areas where edge trim has fallen off. Panels underneath sinks which conceal piping are not present in some classrooms. The front desk in the main office is more worn.

Typical classrooms have built-in shelving along the exterior wall adjacent to the unit ventilators. If the unit ventilators are removed as part of an HVAC upgrade, this casework would need to be infilled or removed and adjacent finishes patched and repaired.

- Repair casework throughout the building where required.
- Replace the main office front desk.
- Consider upgrading the educational casework with a major renovation project.
