Harrisburg School District

District Wide Facility Study

June 12, 2023

Crabtree, Rohrbaugh & Associates
Architects

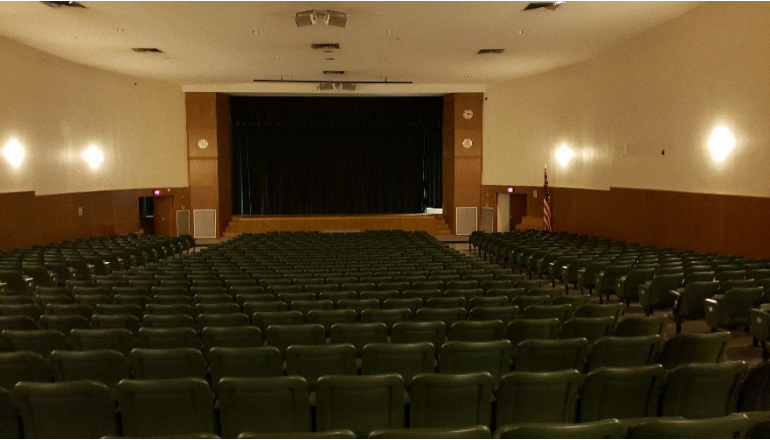
The auditorium seating is original to the building. While still in fair condition, it is near the end of its useful life. The auditorium stage lacks theatrical lighting for performances. The PA system is antiquated.

The gymnasium equipment is also original to the building. The basketball goals are fixed to the walls and not adjustable. Wall pads are due for replacement. Bleachers were removed during the renovations in the early 2000's.

- Install new auditorium theatrical lighting and audio systems.
- Replace gymnasium equipment.

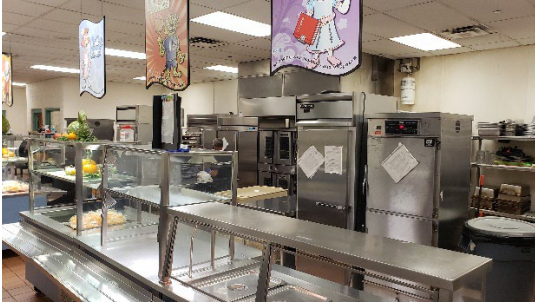
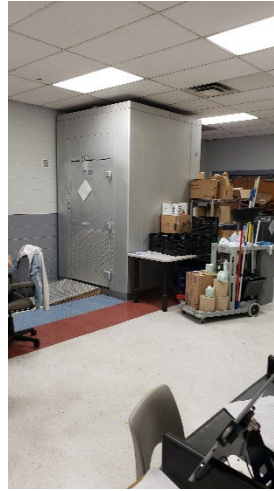
The cooking for Foose Elementary is done on site. Cold storage space at this school is inadequate, with small refrigerator/freezer units located within the cafeteria area. The food service equipment was replaced in the early 2000's and is approaching the end of its useful life. Dry storage space is also limited.

- Replace food service equipment.
- Consider enlarging the kitchen as part of a major renovation project.

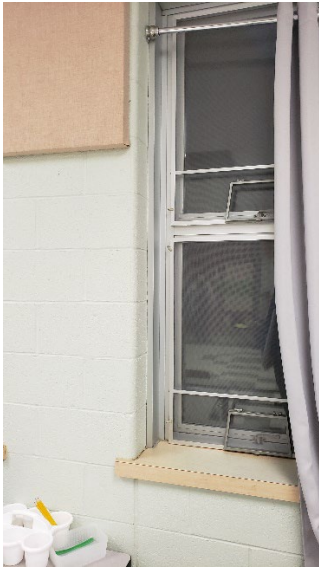
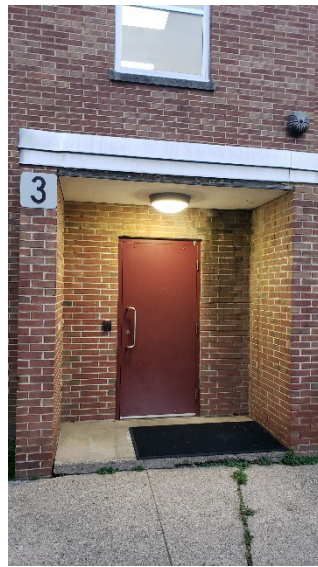
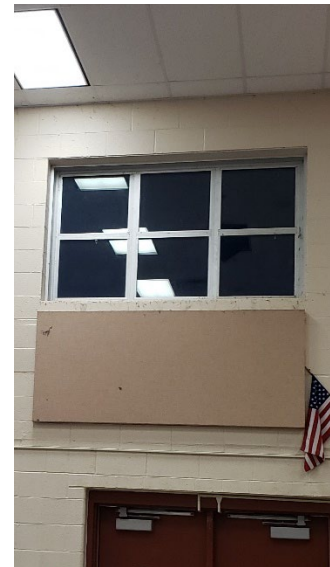
Windows are operable awning style aluminum windows with insulated glass. Entrances are aluminum storefront glazing systems. Doors and windows appear to be in good condition, except for issues with the sill details previous mentioned. Exterior double doors at entrances/exits should have pulls replaced so that doors cannot be chained together – a safety/security concern.

- Provide new sealant around windows.
- Replace exterior door hardware.

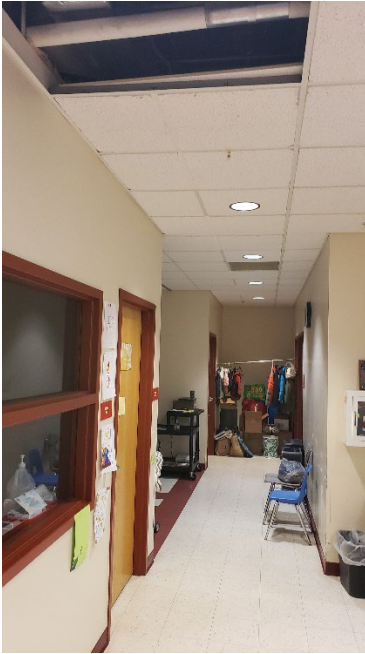
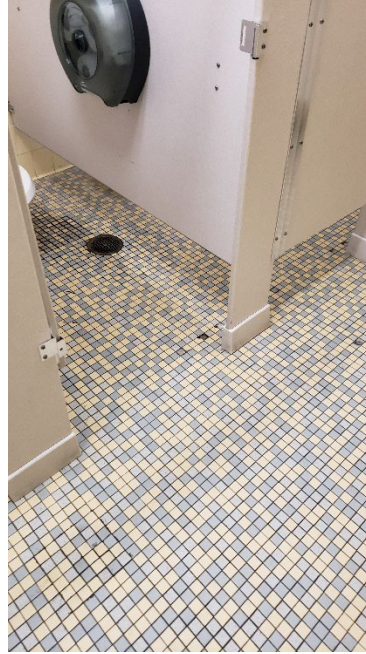
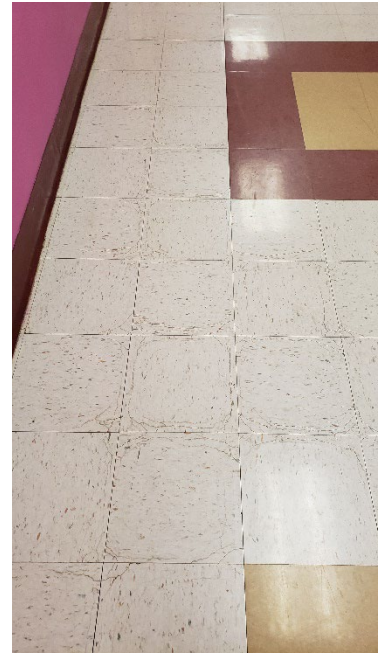
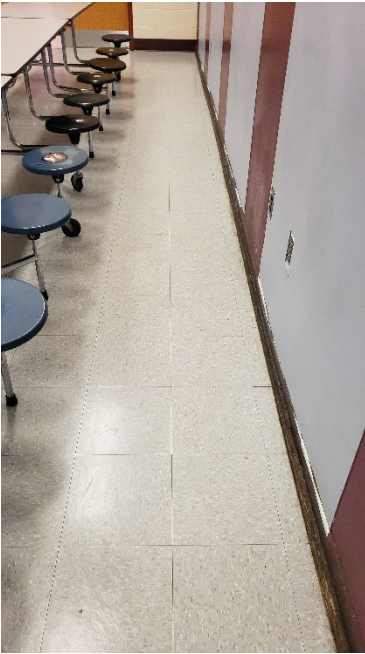
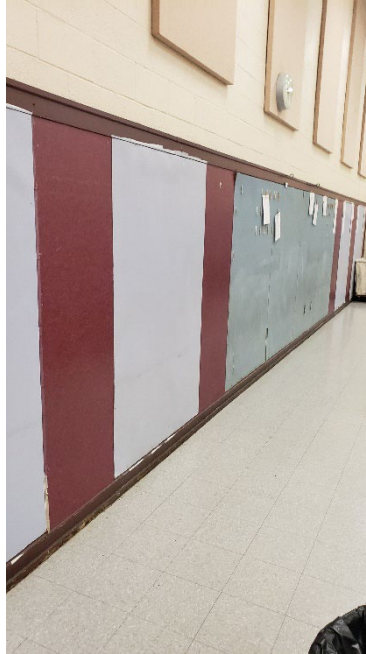
The building has vinyl composition tile (VCT) in the corridors, classrooms, multi-purpose room (cafeteria) and nurse's suite which is in poor condition. The main office area and library are both carpeted which is due for replacement. Toilet rooms have 2"x2" or 1"x1" ceramic mosaic tile. Rooms with the 1"x1" tile, in the older areas of the building, are in poor condition. The gymnasium floor is a floated wood flooring system which is also due for replacement, particularly due to some water damage from leaking mechanical units above. The stage floor is also wood and due for replacement.

Interior partitions are a combination of painted CMU as well as painted GWB/plaster, while toilet rooms are finished with either painted CMU or glazed ceramic tile. Toilet room walls have residual wall anchors from accessories since removed. Most corridors walls (painted CMU and painted-over tile) are very dirty and due for cleaning and repainting. Wood wall base and trim and wall panels in the multi-purpose room shows years of wear and should be removed/replaced. Wood floor in gymnasium has been damaged from HVAC equipment leaks.

Ceilings are generally systems of suspended acoustical ceiling tiles, of various styles. The library also has some wood trim at the ceilings. Ceilings are in fair condition, with the corridors and public areas and toilet rooms particularly dirty, damaged, or stained due to leaks.

- Replace ceilings in conjunction with HVAC replacement
- Replace carpet flooring in library and office areas.
- Replace 1"x1" ceramic mosaic tile in bathrooms.
- Replace all VCT flooring throughout the entire building.
- Remove/replace base/trim and wall panels in the multi-purpose room
- Replace gymnasium wood floor.
- Clean and repaint all interior walls.

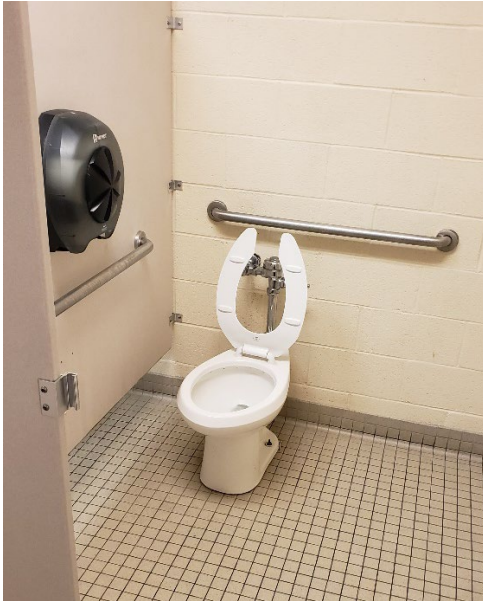
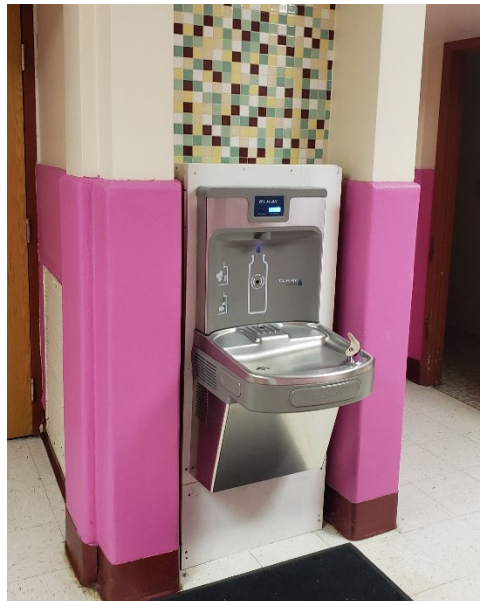
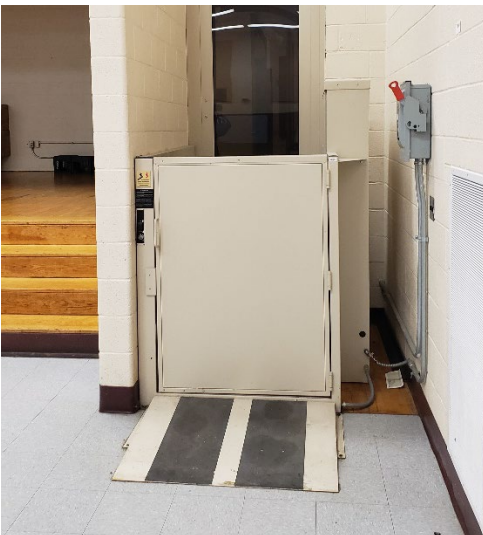
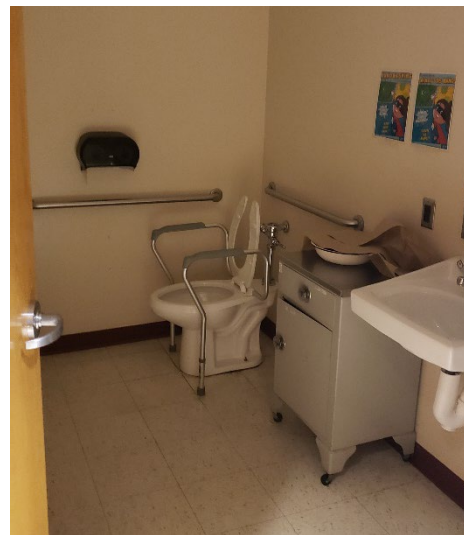
Water closets in accessible toilet stalls do not have the required grab bars for current ADA requirements, and accessories are not installed within reach range. Faculty toilet rooms are not accessible. Individual toilet rooms in kindergarten classrooms are not accessible.

Drinking fountains, while many recently replaced, are often located such that they project into paths of travel, an accessibility concern due to blind persons not being able to sense their presence.

- Evaluate elevator for any necessary upgrades. Replace elevator communications system.
- Renovate all non-ADA compliant single occupancy toilet rooms to be ADA compliant.
- Modify all ADA toilet stalls to comply with current code by moving accessories within reach range, and providing ADA compliant grab bars.

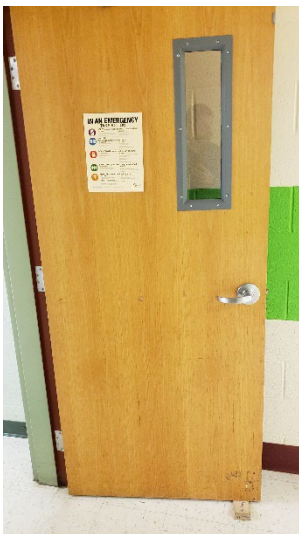
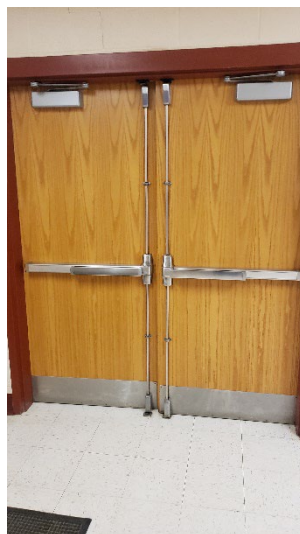
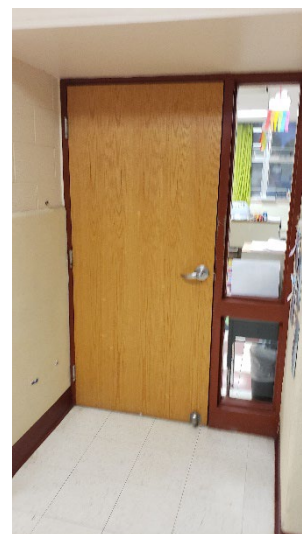
Interior doors are primarily wood set in hollow metal frames. Many frames are due for repainting. Doors generally are in fair to good condition.

- Repaint hollow metal doors and frames.

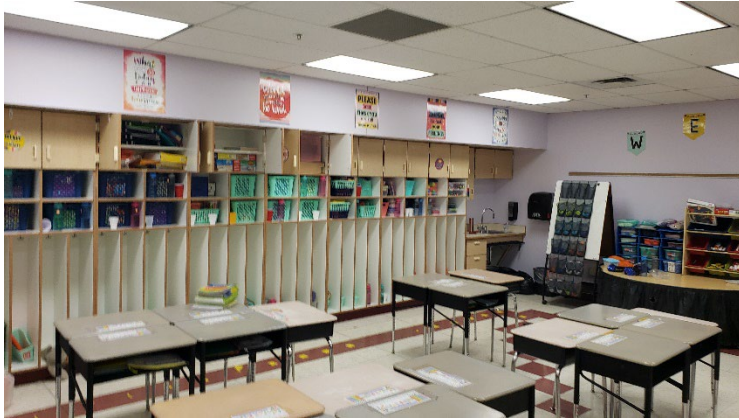
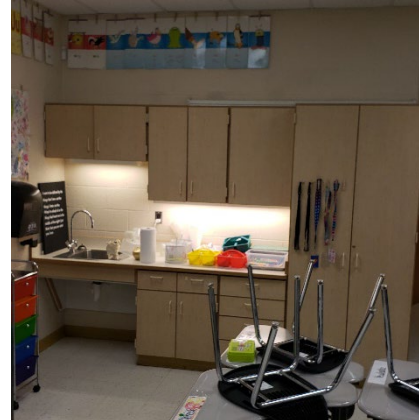
Most of the casework dates from the additions and renovations project in 2002. Casework is in good condition. Where sinks occur in classrooms, the sloped panel underneath the sink should be provided where missing.

Typical classrooms have built-in shelving along the exterior wall adjacent to the unit ventilators. If the unit ventilators are removed as part of an HVAC upgrade, this casework would need to be infilled or removed and adjacent finishes patched and repaired.

- Replace sloped panels under classroom sinks where missing.

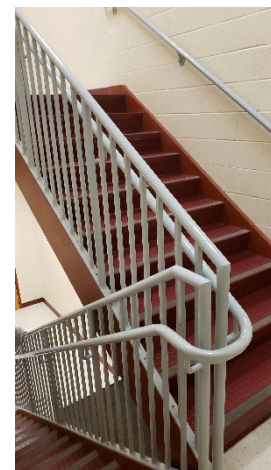
Acoustical wall pads in the multi-purpose room are heavily stained and should be replaced. The gymnasium has one main court and two side courts for a total of six basketball goals, which are in good condition. Wall pads in the gymnasium are in good condition. Corridor lockers are in good condition. Handrails and guard rails in stairways are due for repainting. Theatrical Equipment at the multi-purpose room stage is insufficient for performances. The stage floor is also in poor condition and should be replaced.

- Replace the acoustical wall panels in the multipurpose room.
- Replace multi-purpose room stage floor and risers.
- Provide theatrical package for elementary performances.

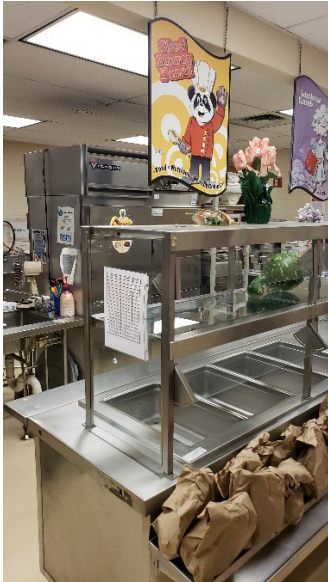
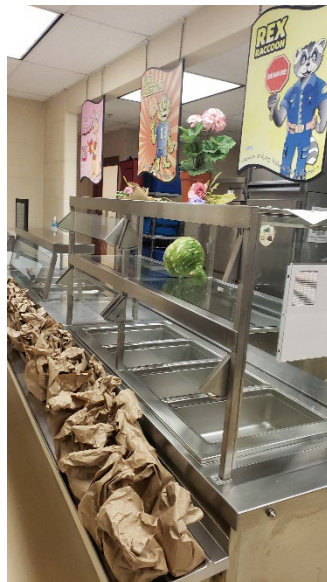
Since most of the cooking for the School District’s elementary schools is done at a remote facility, the kitchen at Melrose Elementary functions as a warming kitchen. Cold storage space at this school is inadequate, with small refrigerator/freezer units located separate from one another within the kitchen. The kitchen office shares space with the dry storage area. The food service equipment was replaced in 2002 and is approaching the end of its useful life.

- Replace food service equipment.
- Consider enlarging the kitchen as part of a major renovation project.

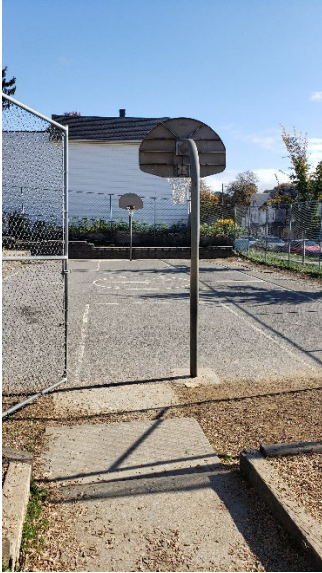
In the southeast corner of the building along Derry and Berryhill Streets is a soft surface playground. The play equipment appears to be relatively new and in good condition. The other soft-surface play area on the adjacent property also has relatively new equipment in good condition. The adjacent hard surface area with basketball goals is in fair condition with lines worn down.

- Re-stripe the hard surface play area.

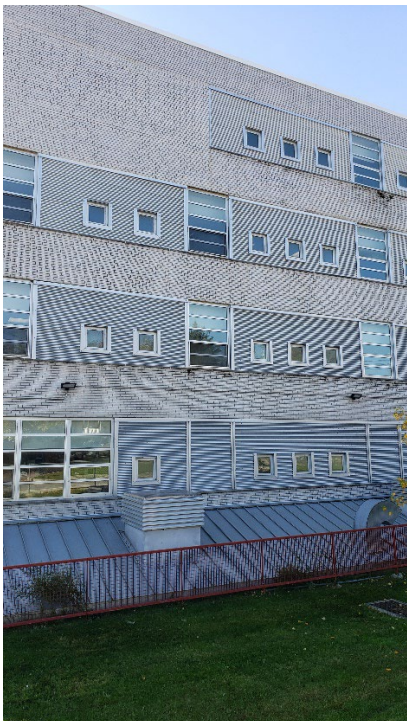
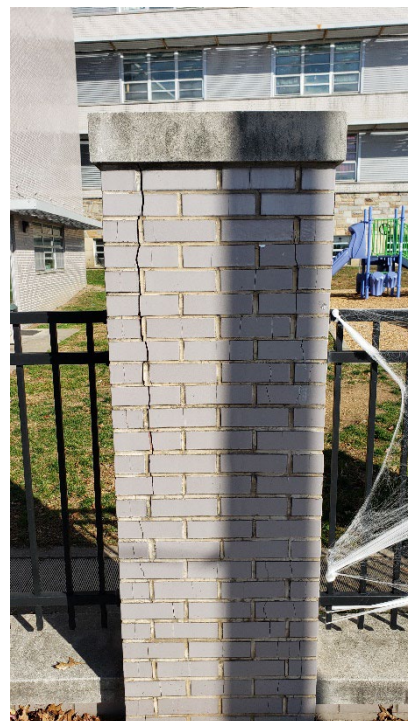
The original building is a brick veneer façade but lacks a cavity and does not appear to be adequately flashed. The north side of the building is particularly weathered, showing dirt as well as growth of organic material on masonry and precast window sills. Brick is cracked and chipped in several areas. The original windows have been replaced and stretches of the façade replaced with metal panels. Sun shades on the south and east sides are showing signs of weathering, with the outriggers being significantly rusted. Sealants are cracked and due for replacement. The masonry piers that form the fence which encloses the soft-surface playground is significantly cracked, with veneers generally beyond repair.

- Brick veneer at north ward facing sides should be cleaned. All precast elements should be cleaned. Repointing should be done as required.
- Joints should be re-caulked.
- Sun shades should be replaced with material not subject to oxidization.
- Masonry piers around playground should be replaced.

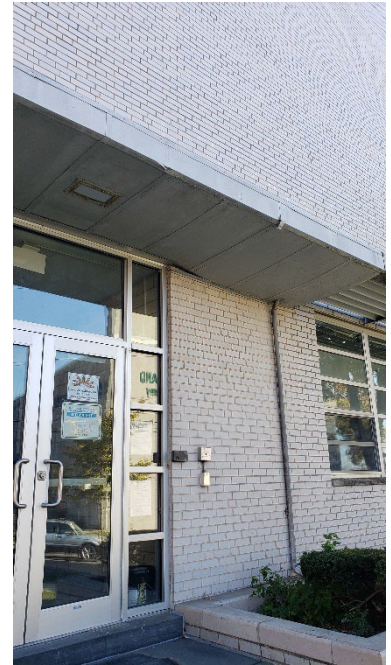
All of the membrane roofing is at the end of its useful life and is due for replacement.

Canopies around the building show various levels of disrepair. The main entrance is in the best condition, with the supporting steel due for new paint. The canopies to the sides of the buildings have soffits which are sagging and fascia trim is due for replacement.

- Replace roof in its entirety.
- Replace trim and soffits at side building canopies.

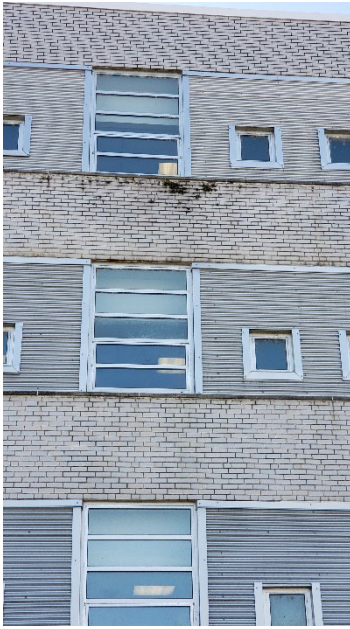
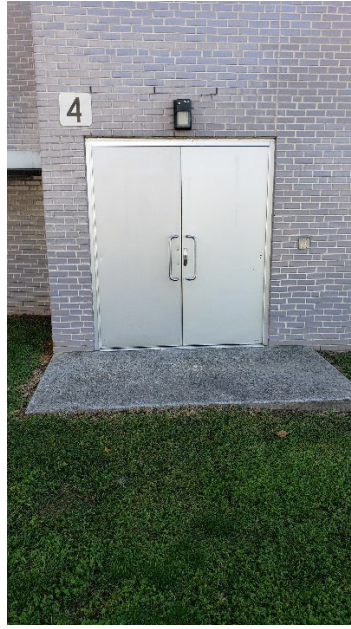
Windows are operable, hopper style aluminum storefront windows in generally good condition. Service doors are aluminum and have been recently replaced. Aluminum entrances are also in good condition, with only routine maintenance required. Exterior door hardware could allow double doors to be chained together, which is a safety and security concern.

- Replace sealants around window and entrance systems as part of routine maintenance.
- Replace all exterior door hardware.

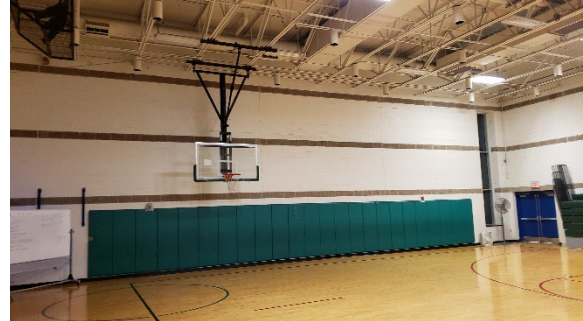
The building is a 5-story steel frame structure with CMU backup. The basement/ground floor level is slab on grade. The first through fourth floors are concrete slab on steel deck supported by steel joists and beams.

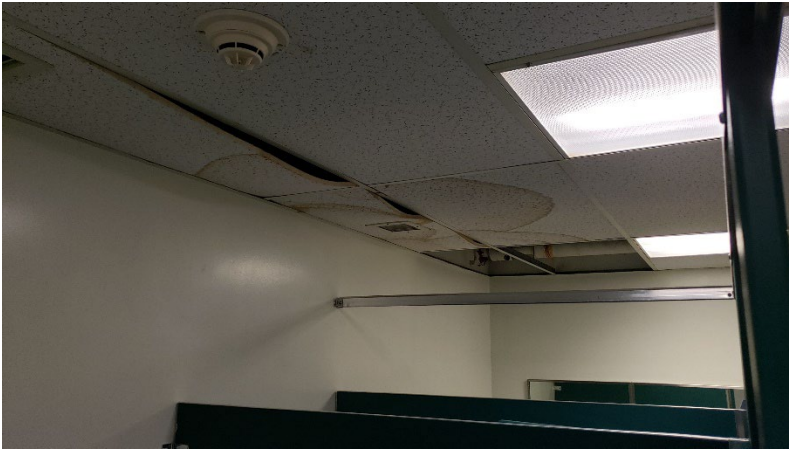
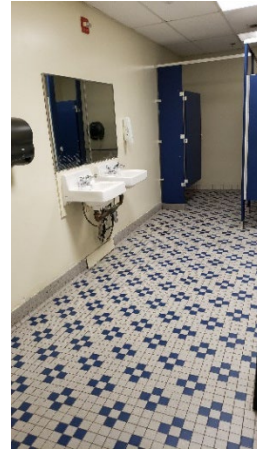
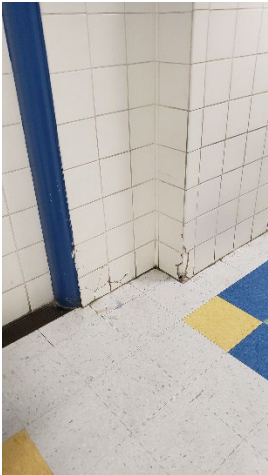
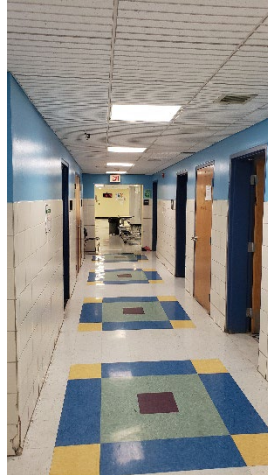
The building has vinyl composition tile (VCT) in the corridors, classrooms, faculty work rooms and cafeteria which is in poor condition. Resilient wall base is missing in some areas. Carpet in the library was recently replaced. Toilet rooms have 2"x2" mosaic ceramic tile in fair condition.

Interior non-loadbearing walls are mainly painted GWB. Corridors and public areas have ceramic tile wainscots, which is cracked in many locations, particularly at the lower two courses of the 6" tiles. It also lacks a cove base where it meets the floor, resulting in dirty base joints.

Ceilings are primarily suspended ACT, although styles vary. Many ceilings are sagging, dirty, or damaged.

- Replace ceiling tile throughout the entire building, and consolidate to a single system of ACT.
- Replace lower two courses of ceramic tile wainscot in hallways.
- Replace all VCT.

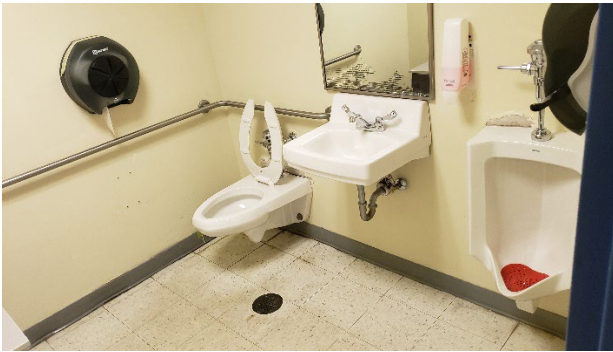
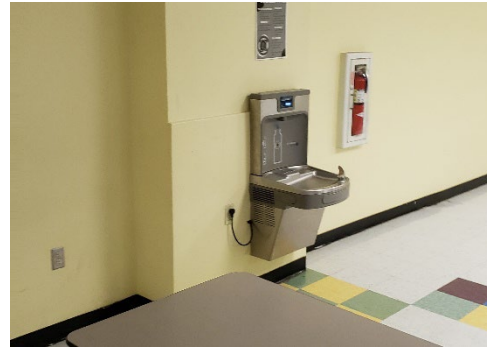
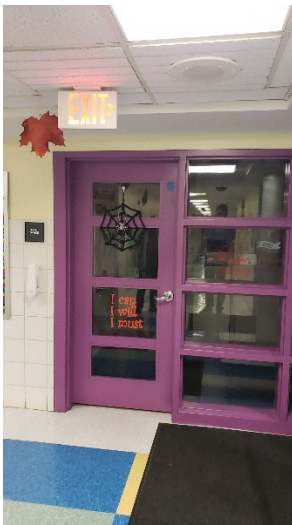
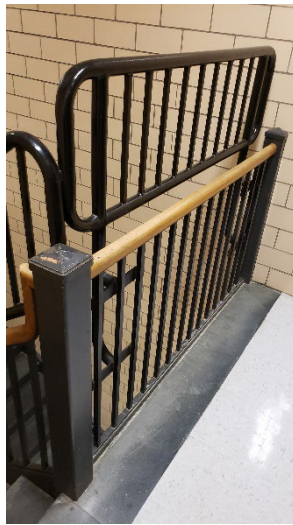
Drinking fountains, while many recently replaced, are often located such that they also project into paths of travel. This is an accessibility concern due to blind persons not being able to sense their presence.

Many glass vision panels and sidelights contain wire glass, which is no longer permitted by the Code. Cross-corridor and egress stair access double doors have equal leaves that are 30 inches wide. Accessibility requires that at least one leaf be 36 inches wide.

- Evaluate elevator for any necessary upgrades. Replace elevator communications system.
- Replace the wooden guard/handrail around the stairs and landing at the main entrance with a new guard and handrail that is compliant with current code.
- Renovate all non-ADA compliant single occupancy toilet rooms to be ADA compliant.
- Modify all ADA toilet stalls to comply with current code by removing the lavatories adjacent to the water closets to allow proper clearances at the water closets, moving accessories within reach range, and providing ADA compliant grab bars.
- Replace doors in rated stair towers with glazing to be safety glass (no wire glass).
- Replace cross corridor double doors smaller than 6' in total width so that one leaf is at least 36 inches wide.

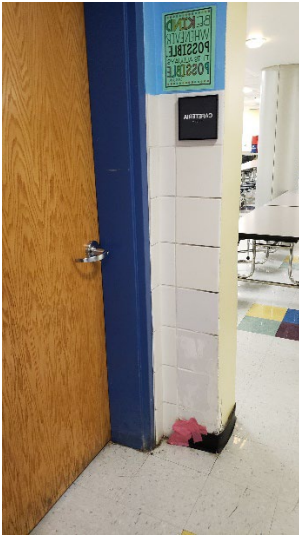
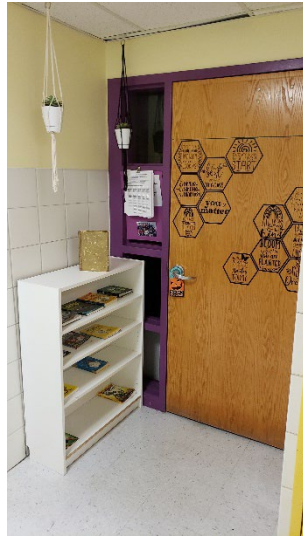
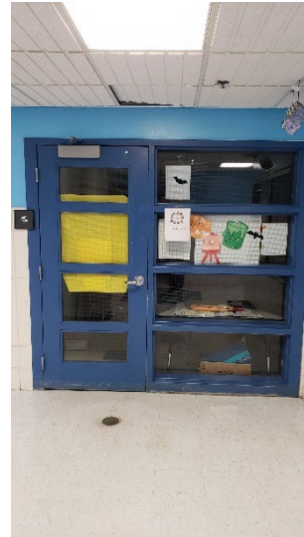
Interior doors are either wood or hollow metal, all in hollow metal frames. Doors and frames are generally in good condition. Refer to Code and Accessibility section above regarding wire glass.

- Paint hollow metal doors and frames as part of a building-wide finish upgrade project.

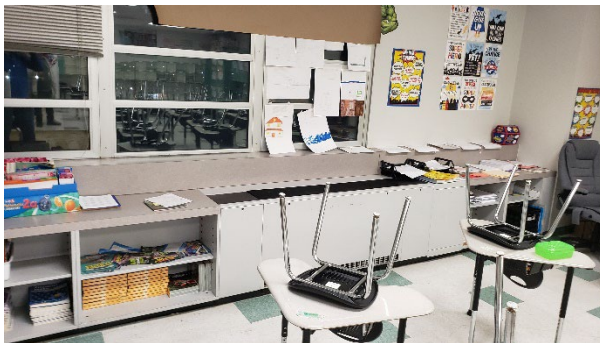
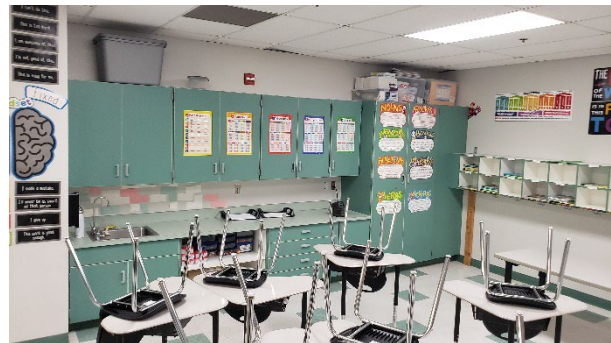
Most of the casework dates from the 1999 renovations and is in fair condition. Cabinets and countertops in classrooms are missing their veneer on their edges. Library furniture is in good condition.

Typical classrooms and corridor areas have built-in shelving / countertops along the exterior wall adjacent to the unit ventilators. If the unit ventilators are removed as part of an HVAC upgrade, this casework would need to be infilled or removed and adjacent finishes patched and repaired.

- Replace educational casework throughout the building's classrooms.

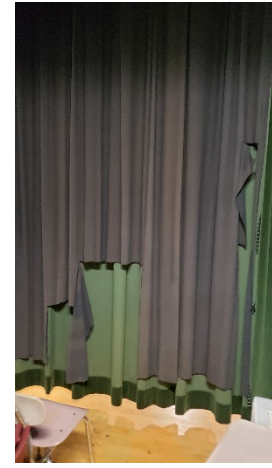
The multipurpose room has (1) half main basketball courts and (1) side court and are in good condition. Bleachers also appear to be in good condition. The stage curtains are torn and due for replacement. Lockers are generally in good condition.

- Replace the stage curtains.

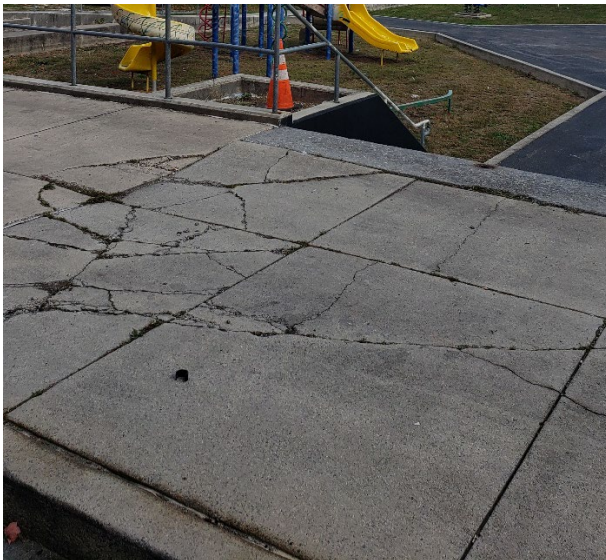
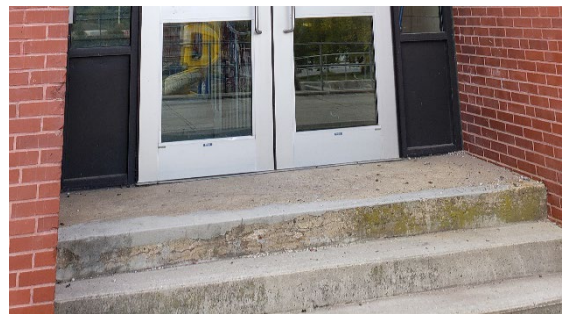
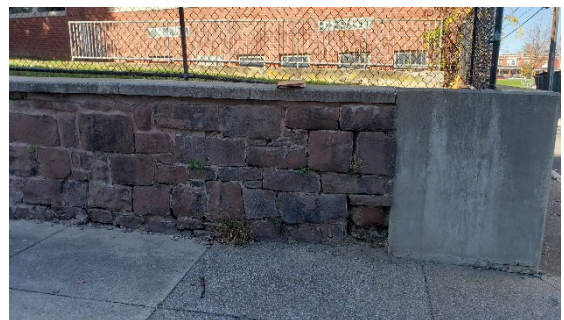
There are no on site vehicular parking or drop-off areas. Parking is curbside on the streets only. Sidewalks around the building and exterior staircases are in poor condition and numerous areas require replacement. The stone retaining wall on the south side of the property requires mortar repair.

- Replace damaged concrete sidewalks.
- Parge concrete stair risers.
- Repair mortar at stone retaining wall.

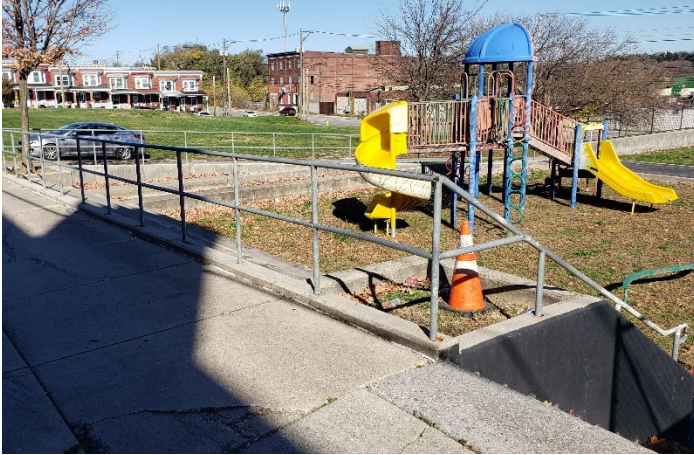
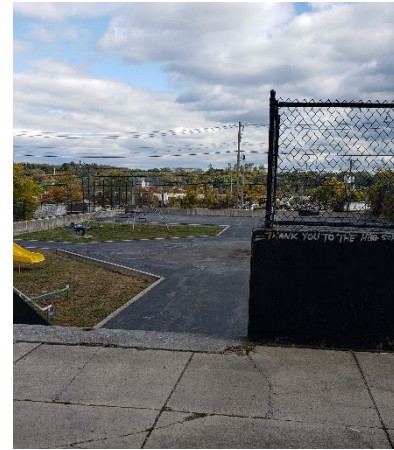
There is a play area across Wallace Street from the school, which is not fully fenced in. Additionally, the guard rails which are installed for fall protection should be replaced with a picketed guard rail with limited opening sizes compliant with current Codes. The playground equipment is in fair condition, with some pieces newer than others. There is a significant hard surface play area as well.

- Replace guard rails with fence for better security and fall protection.

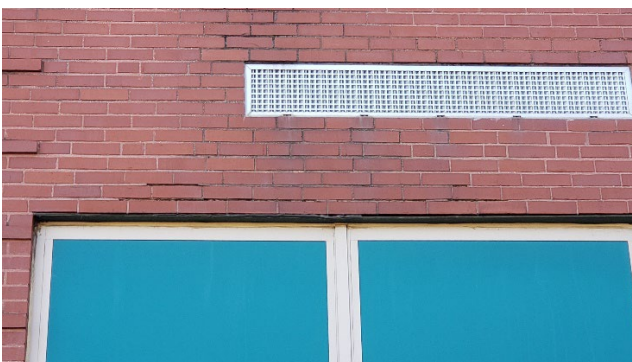
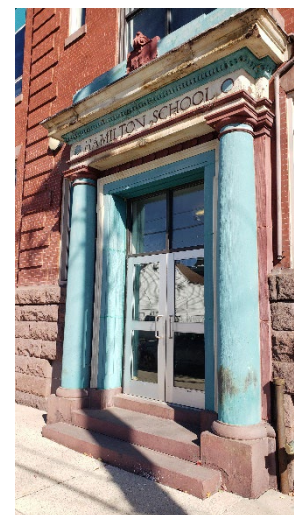
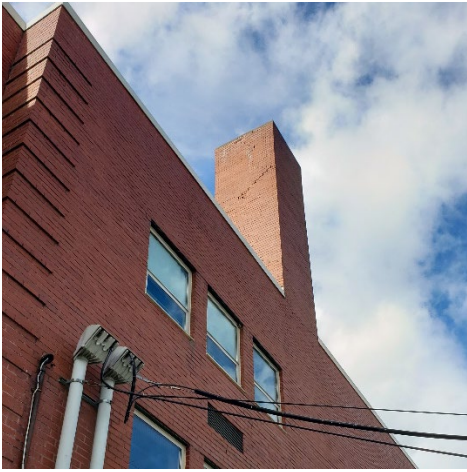
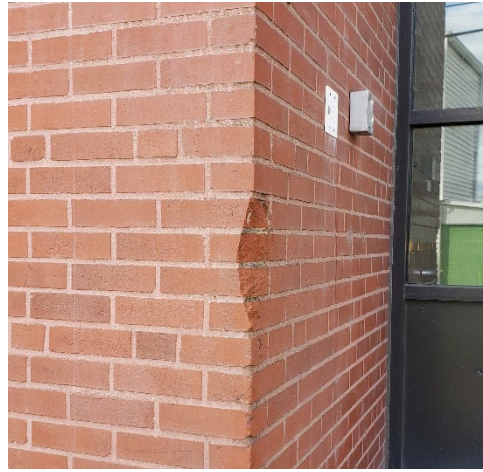
The original building is a brick veneer façade but lacks a cavity and does not appear to be adequately flashed. The north side of the building is particularly weathered, showing a need for repointing and weather proofing. Brick is cracked and chipped in several areas. Sealants are cracked and due for replacement. There is a known water leakage problem on the north side that is causing damage to interior finishes. On the east side, the chimney shows significant cracks in the brick veneer. Brick veneer corners are chipped. Precast concrete trim around entrances is dirty. Painted features in the original building are due for new coats.

- Brick veneer around the entire façade should be cleaned. Repointing should be done as required, with particular attention paid to areas above windows.
- Repair Masonry around chimney.
- Joints should be re-caulked.
- Clean precast features.
- Apply new coats to painted areas.

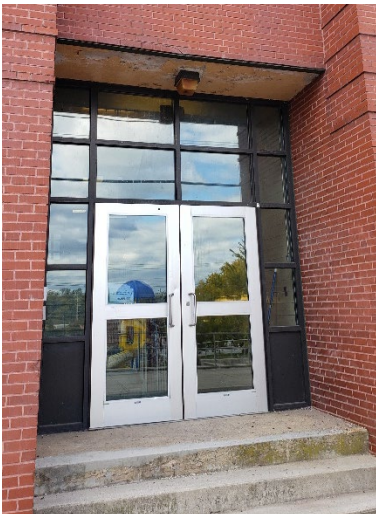
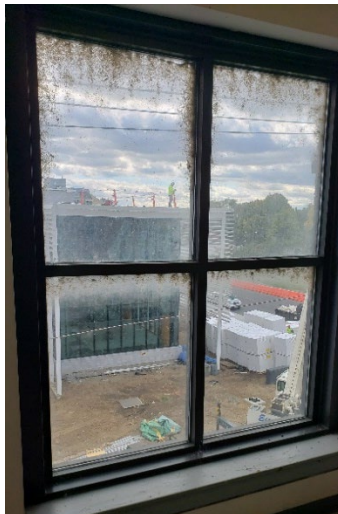
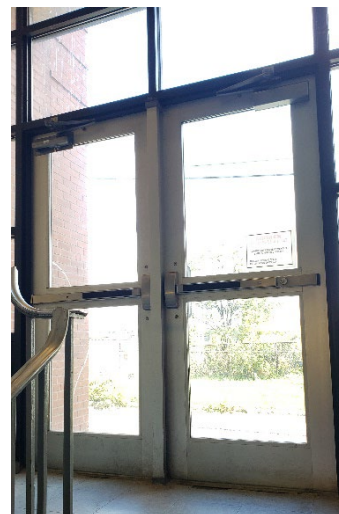
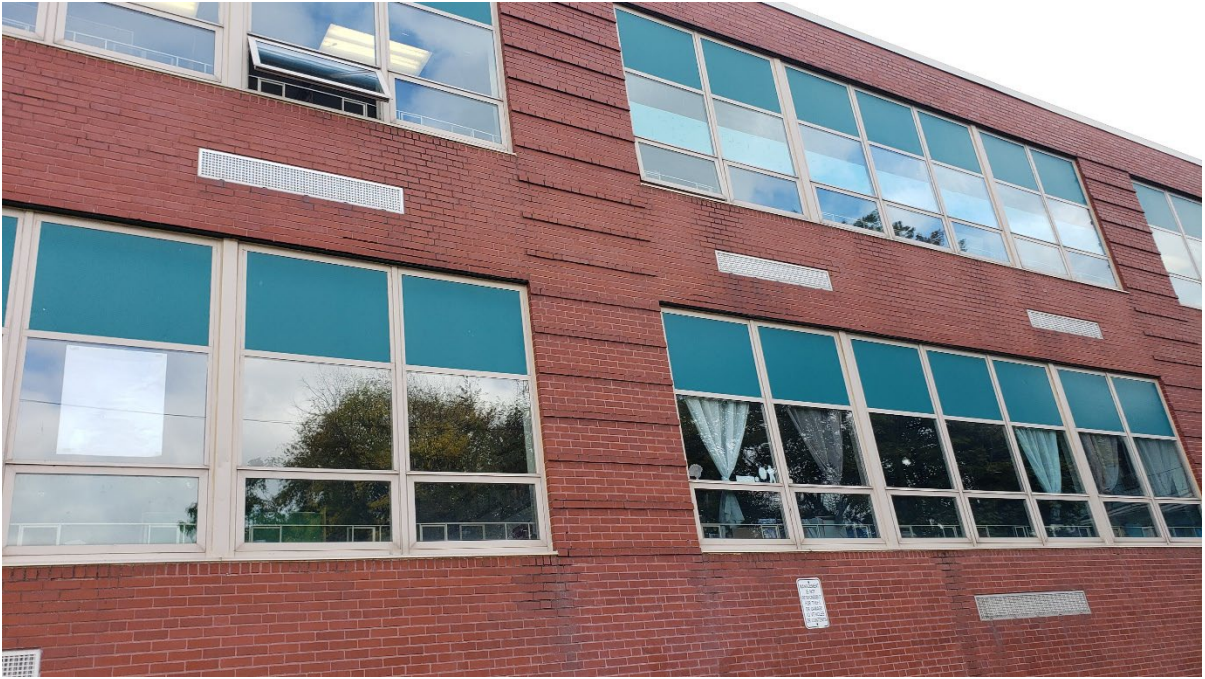
Windows are operable, awning style aluminum storefront windows. The windows have spandrel panels which are damaged in places and may be contributing to the interior leakage problems. Service doors are steel/hollow metal and require new finish coats. Aluminum entrances are also in good condition, with only routine maintenance required.

- Consider a window replacement as part of a comprehensive renovation project.

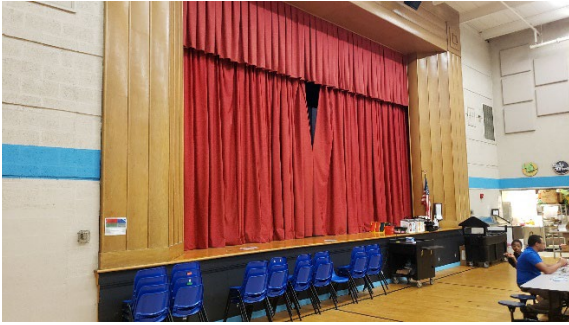
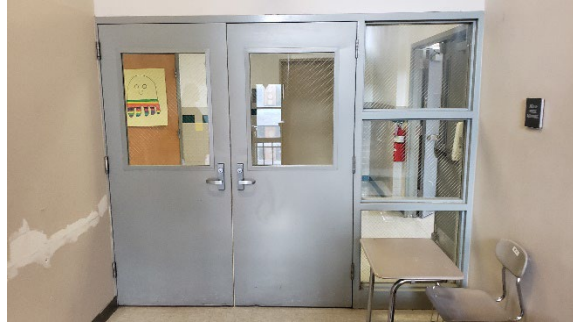
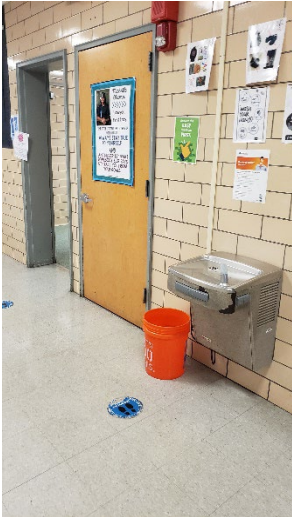
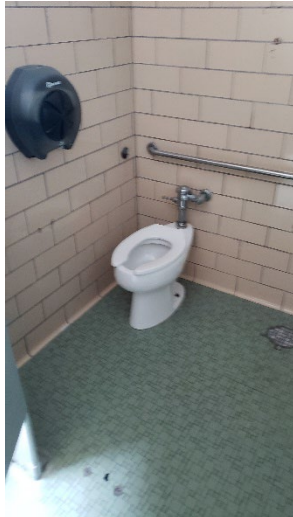
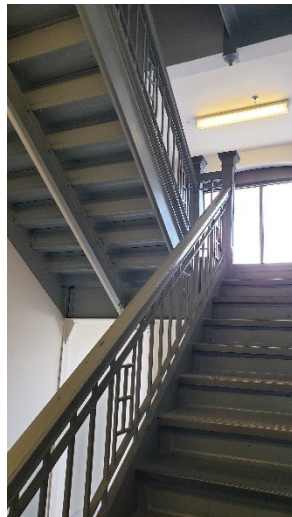
Many glass vision panels and sidelights contain wire glass, which is no longer permitted by the Code.

The stage is not wheelchair accessible.

- Evaluate elevator for any necessary upgrades. Replace elevator communications system.
- Replace the guard/handrail around the stairs and landing at the main entrance with a new guard and handrail that is compliant with current code.
- Renovate all non-ADA compliant single occupancy toilet rooms to be ADA compliant.
- Modify all ADA toilet stalls accessible by elevator to comply with current code by moving accessories within reach range, and providing ADA compliant grab bars.
- Provide accessible means to stage.
- Replace glazing to be safety glass (no wire glass) at stair tower doors.

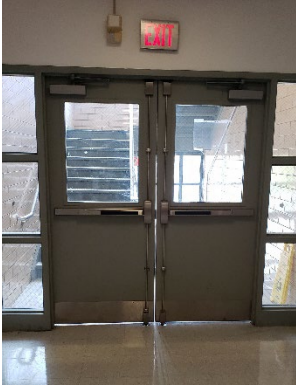
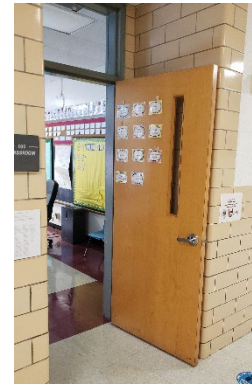
Interior doors are either wood or hollow metal, all in hollow metal frames, some with decorative trim. Doors and frames are generally in good condition. Refer to Code and Accessibility section above regarding wire glass.

- Paint hollow metal doors and frames as part of a building-wide finish upgrade project.

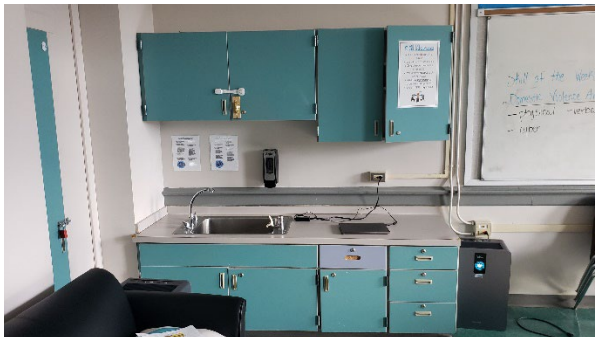
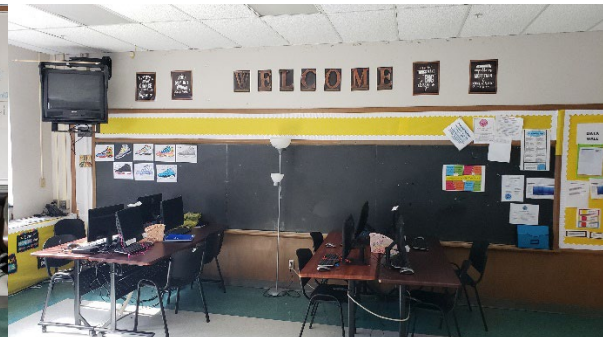
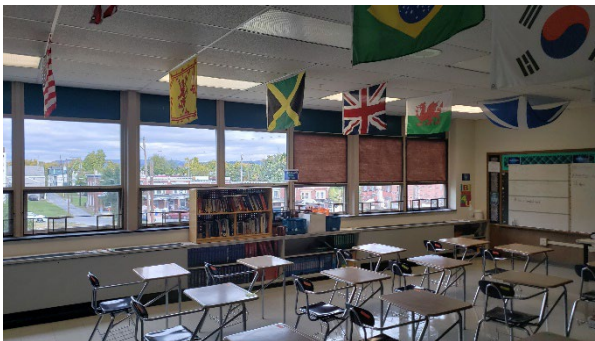
Most of the casework dates from the 1998 renovations and is in fair condition. Some hardware has been fitted with make-shift pulls, and units with sinks are not ADA compliant. There are also some rooms containing casework original to the building construction. There are also rooms that still have slate chalk boards.

Typical classrooms and corridor areas have built-in shelving / countertops along the exterior wall adjacent to the unit ventilators. If the unit ventilators are removed as part of an HVAC upgrade, this casework would need to be infilled or removed and adjacent finishes patched and repaired.

- Replace educational casework throughout the building.

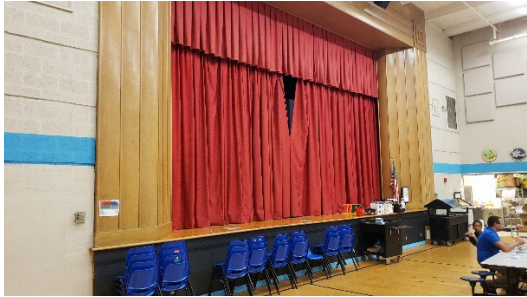
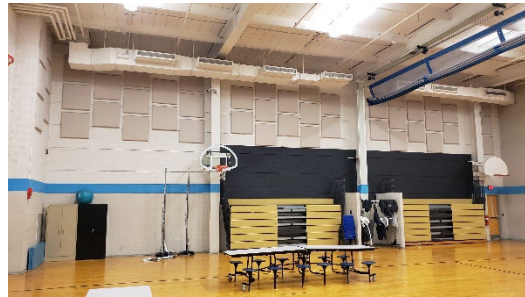
The multipurpose room has basketball goals, but the space is not well suited for basketball activity due to walls and columns in close proximity to court edges and backstops. The stage and stage equipment is in fair condition, but needs side curtains or cyclorama to limit views sidestage from the front of house.

- Use of space for basketball should be reconsidered.

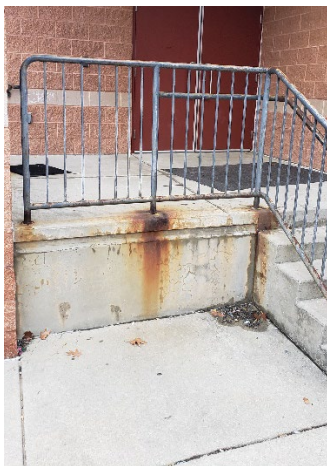
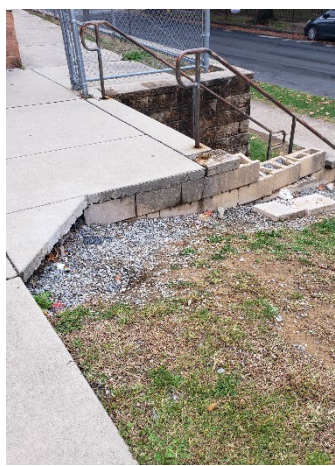
Sidewalks around the property are in good condition, however retaining walls around concrete stairs are deteriorating and should be replaced. Many galvanized handrails on site are also deteriorating and should be replaced.

- Modify parking to permit accessible spaces to directly access main entrance.
- Seal coat other areas of asphalt paving as part of ongoing maintenance.
- Replace dilapidated retaining walls.
- Replace corroding steel handrails.

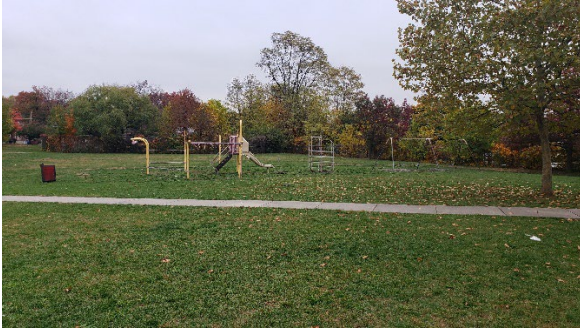
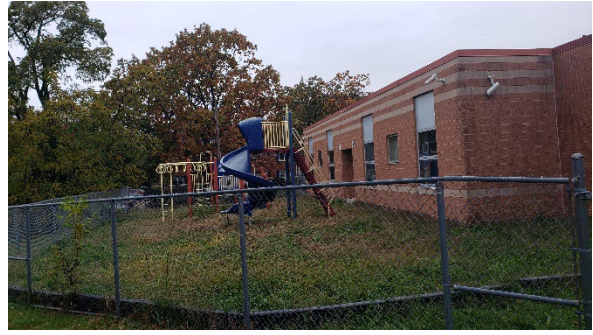
Athletic facilities are on campus serving Harrisburg High School – John Harris. There is also some playground equipment left over from the School’s use as an elementary education facility. This equipment is no longer heavily used and should be considered for removal after completion of the elementary level realignment.

- None at this time.

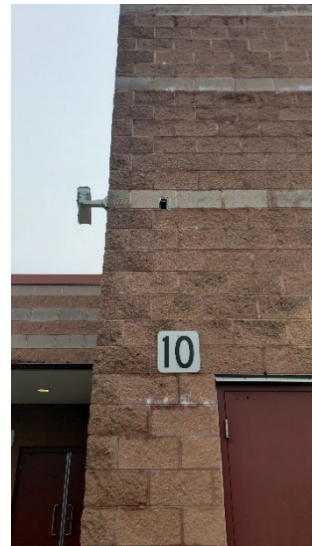
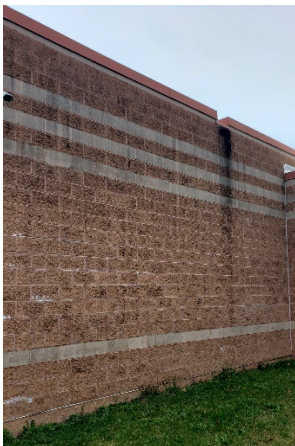
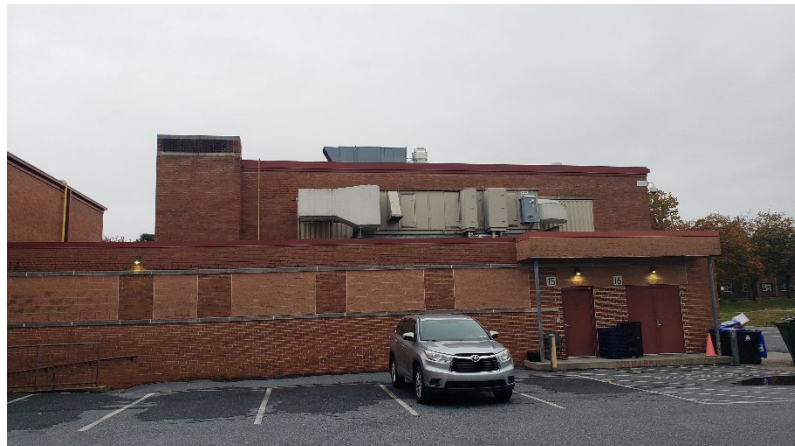
The exterior walls made up of a combination of modular brick and split face and ground face CMU. The entire façade is extremely dirty and due for cleaning all around.

- Clean the exterior masonry all around.

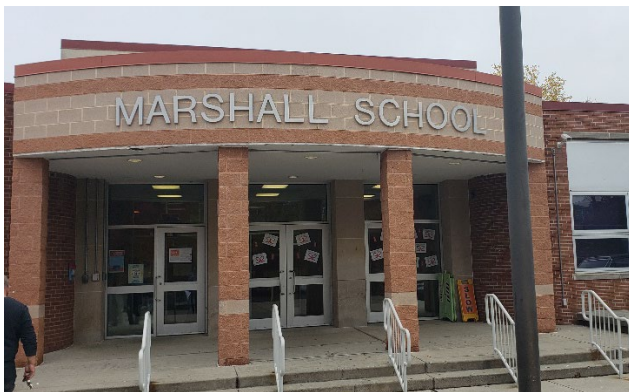
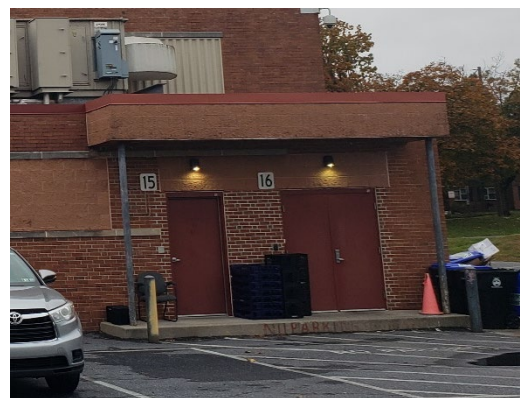
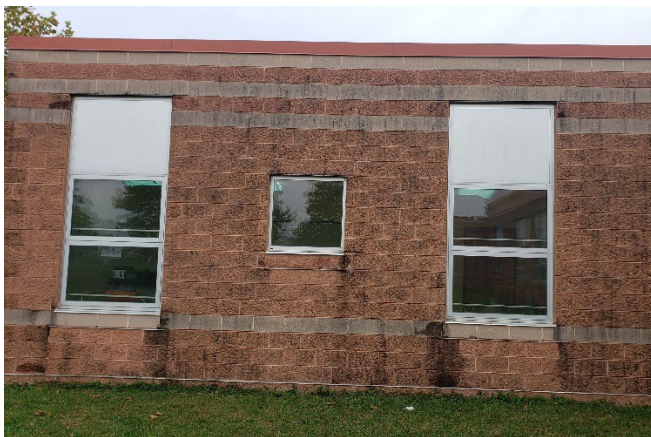
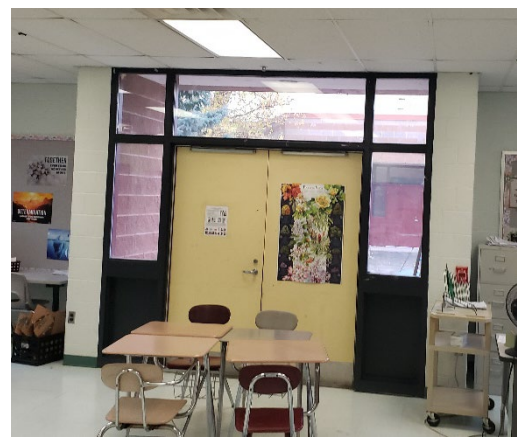
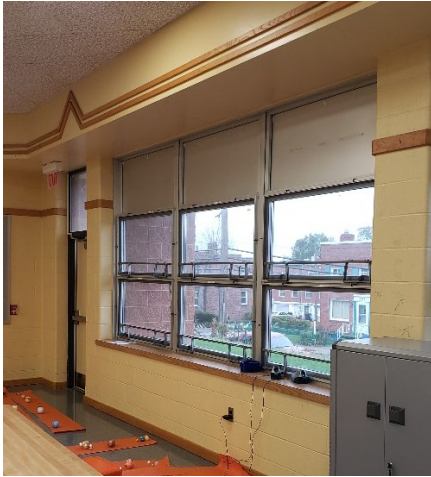
The main entrance is aluminum storefront. Elsewhere, exterior doors and entrance systems are mainly operable aluminum windows set into aluminum frames. The windows are in good condition.

In addition to the aluminum doors in the main entrance storefront, other doors around the perimeter of the building are painted hollow metal, mostly in good condition. Door hardware at exterior doors could allow double doors to be chained together which is a safety and security concern.

- Replace door hardware on exterior doors which do not have levers.
