Harrisburg School District

District Wide Facility Study

June 12, 2023

Crabtree, Rohrbaugh & Associates
Architects

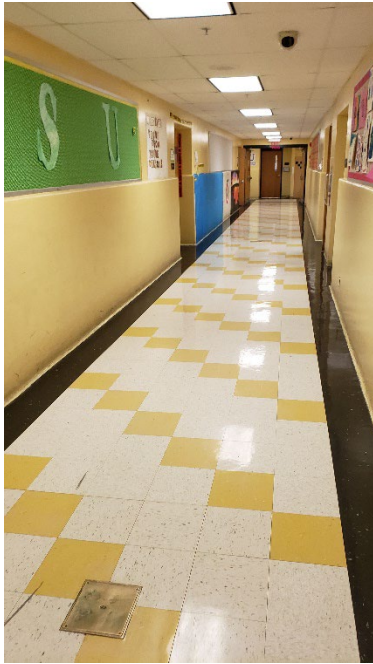
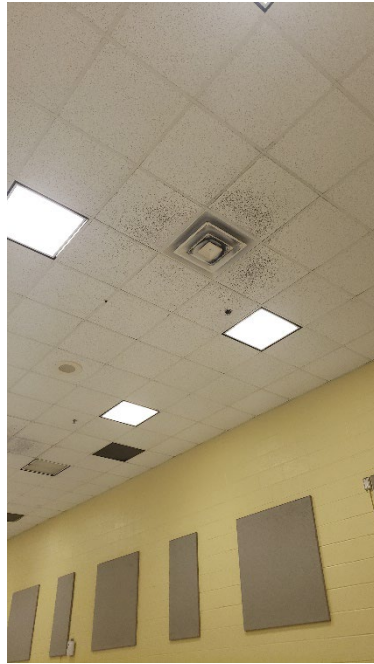
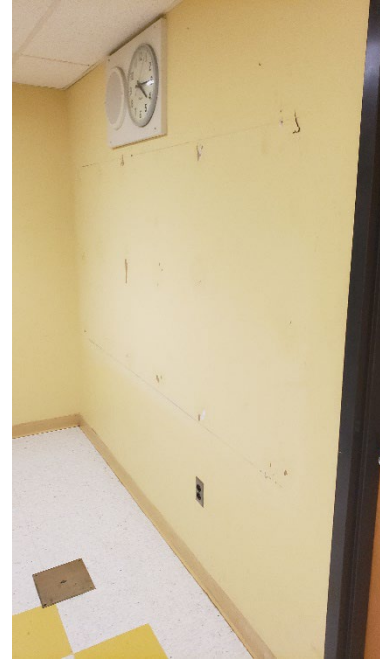
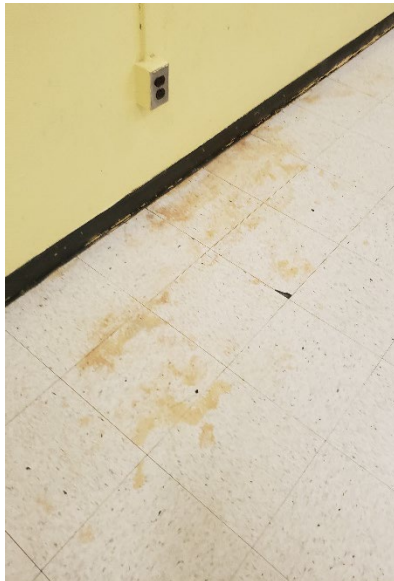
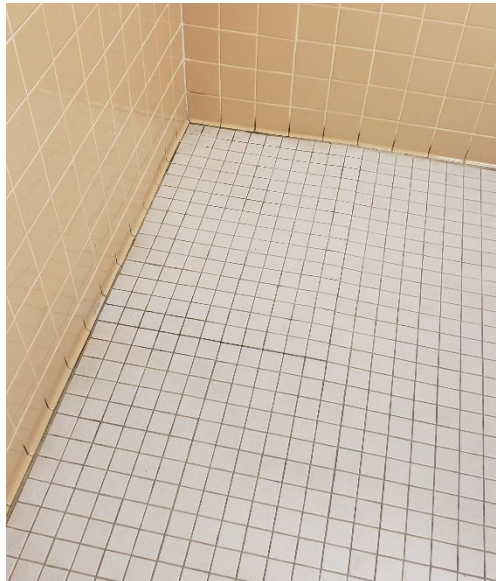
Wall finishes throughout the building include painted CMU, painted plaster and GWB. Original hallways have a glazed tile wainscot which have been coated and painted over. Toilet rooms are finished with glazed ceramic tile, which need to be patched in some locations. The walls are dirty, with paint chipped off in many locations, especially in classrooms. The auditorium walls are plaster with wood panel wainscot and stage surround.

Floor finishes include terrazzo, VCT, sealed concrete, wood athletic flooring, and epoxy in the kitchen and locker rooms. There is carpet in the administration suite. Toilet rooms have mosaic ceramic tile floors, a couple in need of patching, while some single-user toilet rooms have VCT. Resilient wall base in several areas is damaged or missing and should be replaced. VCT in classrooms is dirty, often with large gaps between tiles and should be replaced.

The majority of the building has acoustical ceiling tile. Much of the lay-in tile is sagging from age or damaged from leaks. ACT in the cafeteria, auditorium and maker space is very dirty from the HVAC system. Additional ceiling finishes include painted plaster and exposed painted structure.

- Replace all VCT throughout the building.
- Repair and repaint damaged areas of plaster where they occur.
- Repaint all interior walls.
- Replace Acoustical Ceiling Tile.
- Replace carpet in office.

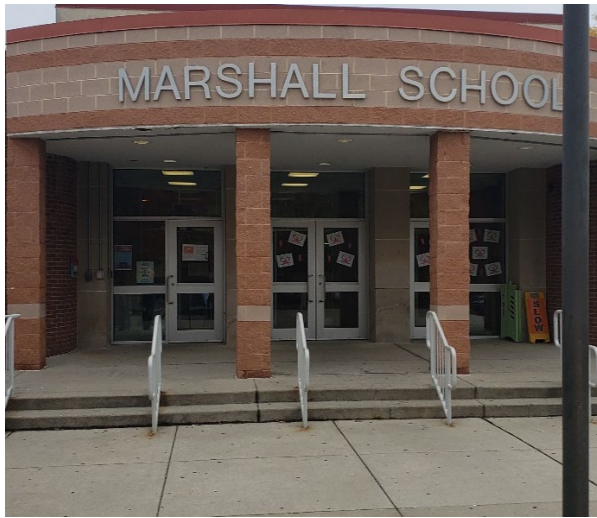
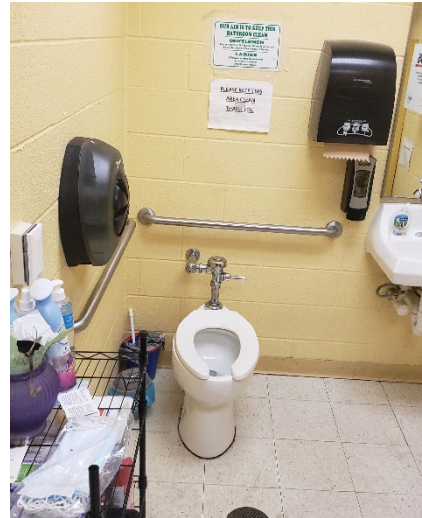
Water closets in single occupant toilet rooms and multiple-occupant toilet rooms do not meet current ADA requirements due to insufficient grab bars and accessories not installed within reach range. Single occupant toilet rooms do not meet ADA requirements due to sinks being located directly next to toilets.

- Renovate all non-ADA compliant single occupancy toilet rooms to be ADA compliant.
- Modify all ADA toilet stalls to comply with current code by moving accessories within reach range, and providing ADA compliant grab bars.

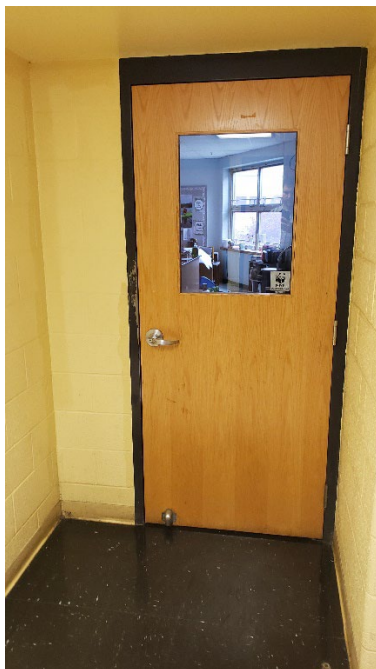
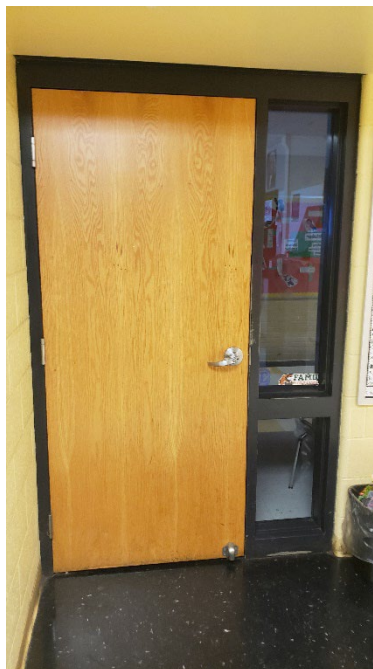
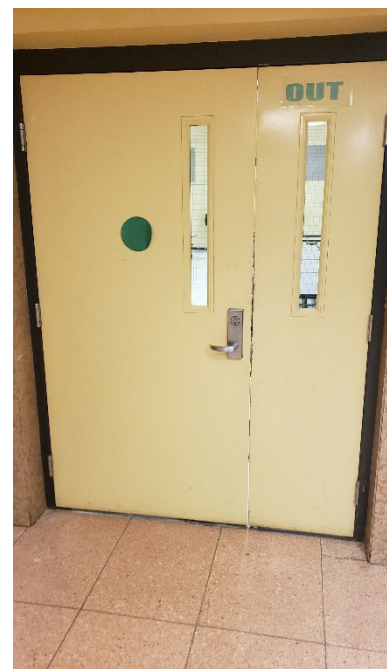
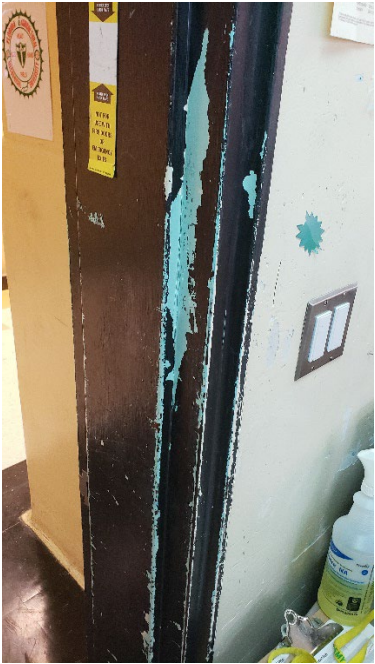
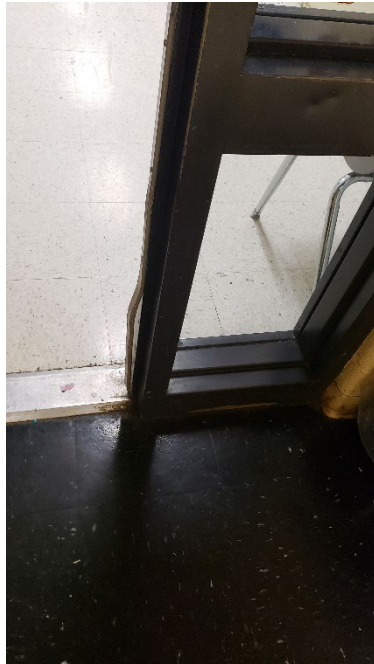
The majority of classroom doors are solid wood doors in hollow metal frames. Doors are generally in good condition. Hollow metal frames need to be repainted.

- Paint hollow metal frames along with building-wide interior painting.

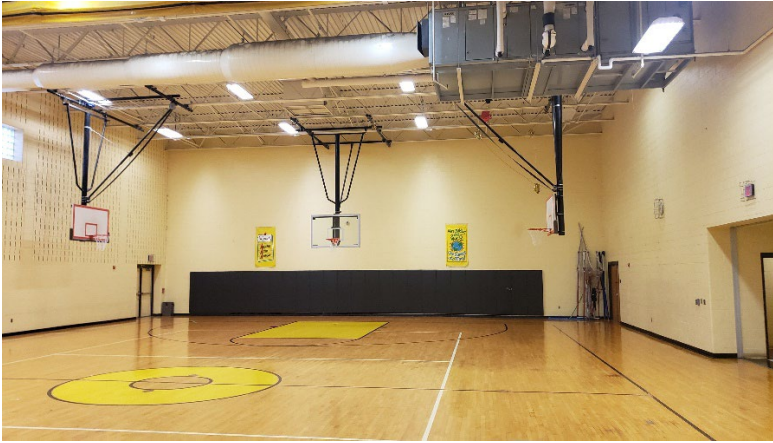
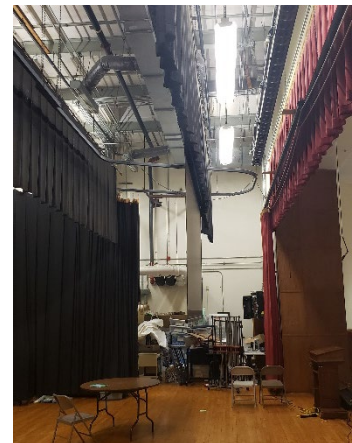
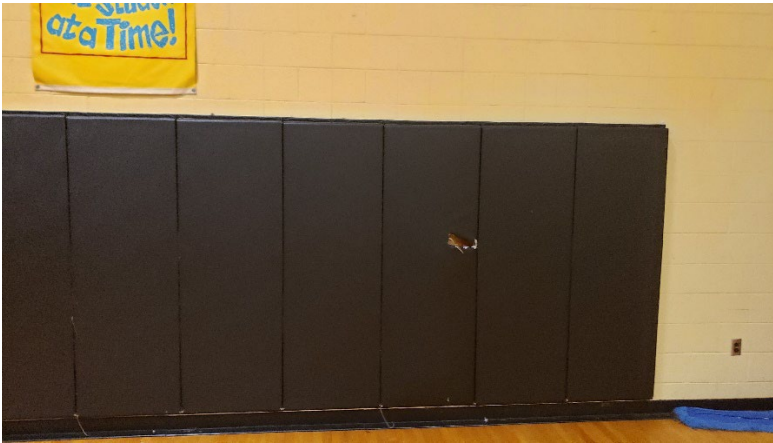
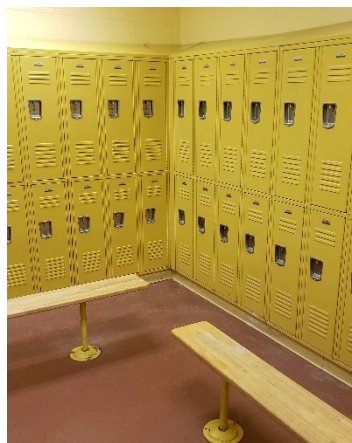
The theatrical equipment on the stage appears to be in good condition. The seating in the auditorium is original to the building and due for replacement.

Gymnasium equipment is in good condition, except for wall pads which are showing signs of wear and tear and should be replaced.

- Replace the auditorium seating.
- Replace gymnasium wall pads.

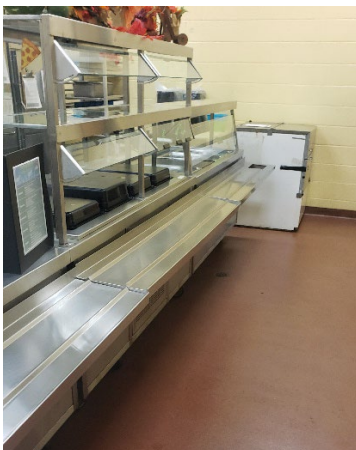
The cooking for Marshall Academy is done on site. Cold storage space at this school is inadequate, with small refrigerator/freezer units located within the cafeteria area. The food service equipment was replaced in the early 2000's and is approaching the end of its useful life. Dry storage space is also limited.

- Replace food service equipment.

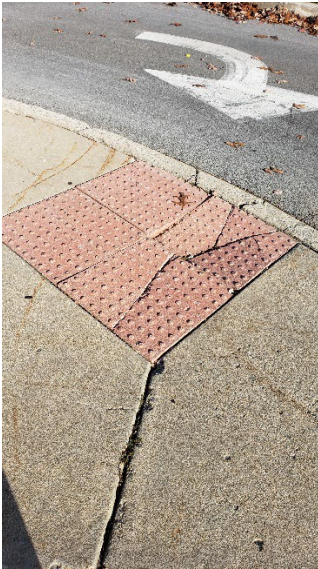
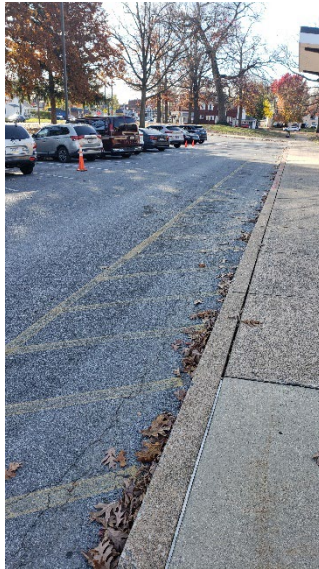
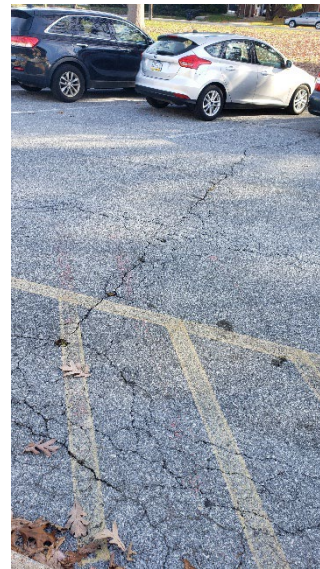
Asphalt pavement is in fair to poor condition, with significant cracking and faded striping. Concrete sidewalks are in good condition, with occasional areas in need of repair, including at the curb cuts for wheelchair access. At the north entrance near the gymnasium, the asphalt drive and concrete sidewalk are level with the first floor elevation with bollards only partially blocking cars from driving onto the sidewalk. Additional bollards should be added.

- Replace damaged portions of concrete sidewalk, including at curb cuts.
- Mill and overlay asphalt paving areas, and restripe.
- Add additional bollards outside the north (gymnasium) entrance.

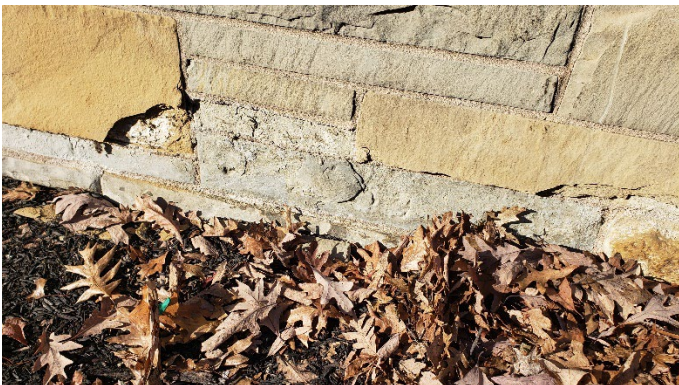
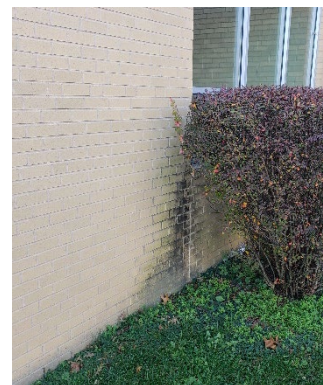
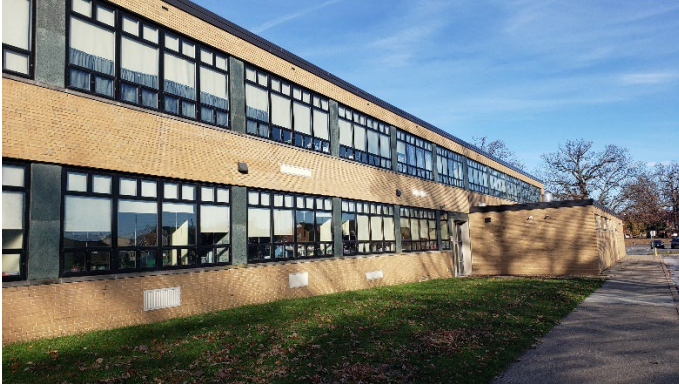
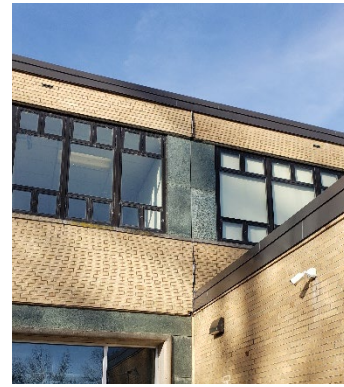
The building exterior consists of masonry walls with modular brick veneers. Walls in the 2006 addition are load-bearing masonry cavity walls. Portions around the main entrance and southward around the semi-circular music classroom are ashlar stone veneer. Some stone veneer, particularly near grade, has spalled off. Window stools are precast concrete, many of which are dirty or stained. The masonry veneer is generally in good condition, although it is stained from water run-off in a few areas, and older portions due for repointing.

- Brick veneer should be cleaned around stained areas. Repointing should be done as required.
- Joints should be re-caulked.
- Repair or replace spalled stone veneer.

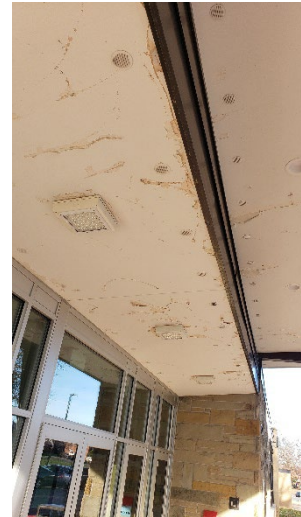
Most overhangs around the building have soffits which are water damaged and/or are in need of new finish layers due to the surface peeling away. Some of the fascia trim at a service bay is also damaged from being hit by larger trucks backing into it. Other trim at the semicircular music room is also damaged.

- Clean all soffits, replace damaged areas and overcoat entire soffits with acrylic based coating or other suitable coating.
- Replace damaged fascia/trim.
- Replace 2005 era roof in 3-4 years time.

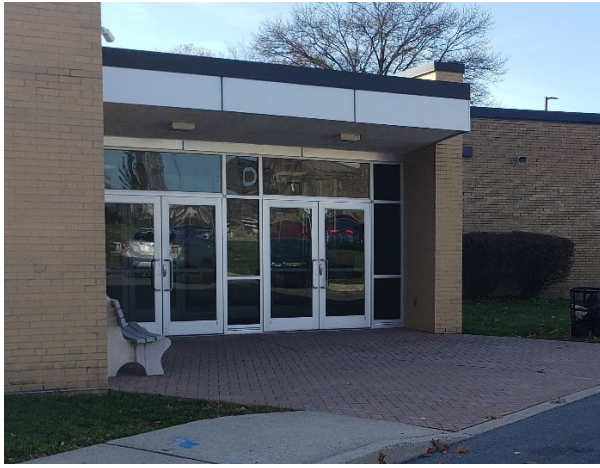
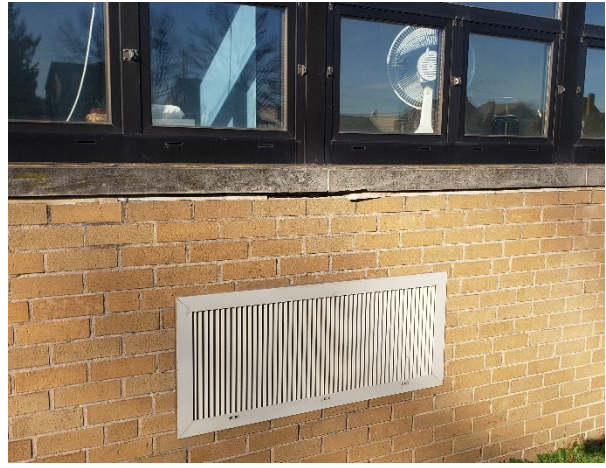
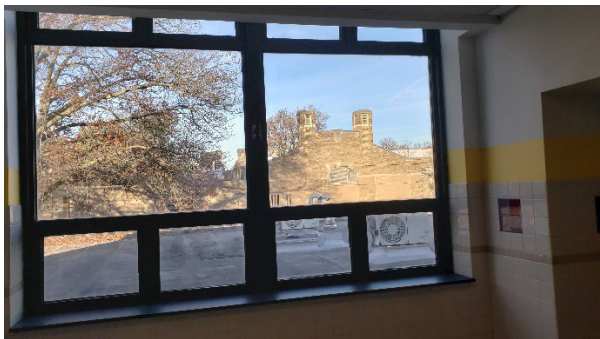
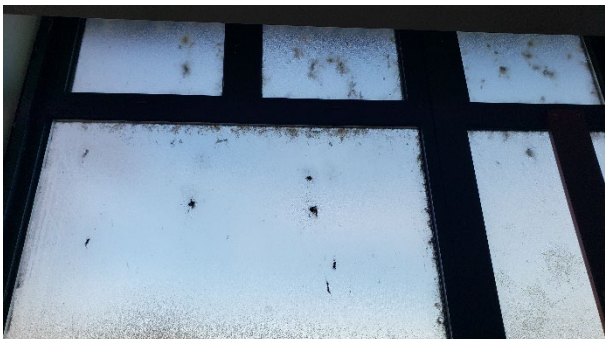
Typical window systems throughout the building are operable, awning-style aluminum projection windows. The windows are supposed to have levers to allow operation but these levers have been generally removed over time. Windows all around the building are due for extensive cleaning. Sealants around windows should be replaced.

Entrance systems are aluminum storefront systems. Exterior double doors have pulls on each leaf which could result in being chained together from the outside – a safety and security concern.

- Clean all windows as part of ongoing maintenance.
- Repair operable crank levers.
- Replace all sealants around windows.
- Replace exterior double door hardware/pulls.

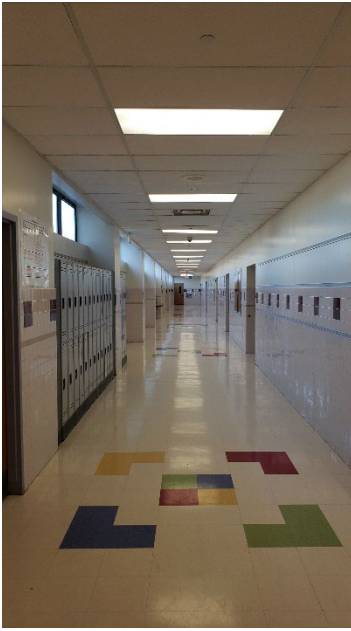
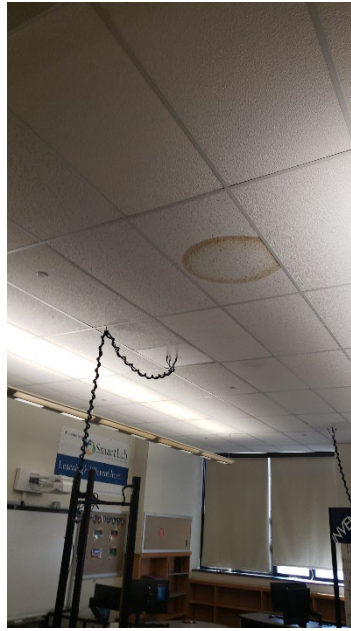
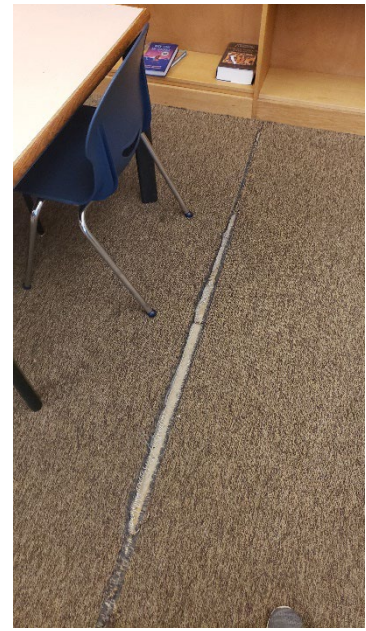
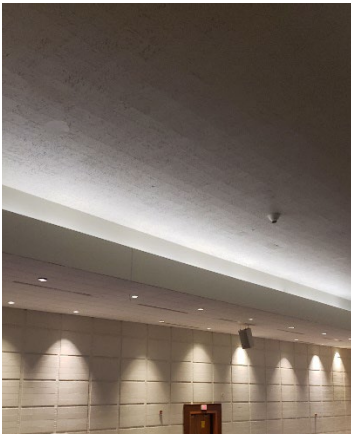
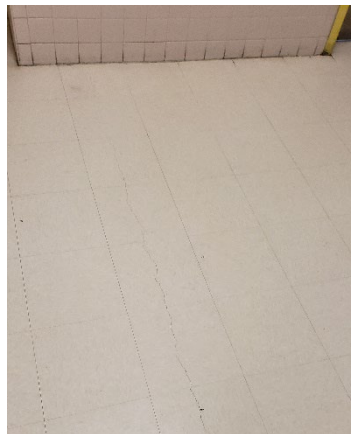
The building has vinyl composition tile (VCT) in the corridors and classrooms, which is in fair condition, although very dirty in some areas, and cracking in various locations. The lobby has porcelain tile flooring which is in fair condition, but cracked at expansion joints. Flooring in toilet rooms is ceramic mosaic tile, while in the kitchen the flooring is quarry tile, all in good condition. The wood floor in the multi-gymnasium is in good condition. Office areas and the media center have carpeting in fair to poor condition. Transition strips are often missing throughout the building, resulting in VCT getting chipped at flooring changes. Stairs and risers are missing their rubber coverings in corridors as well as in the semi-circular music classroom. The VCT flooring at the auditorium, and corridor ramps/stairs is particularly old and due for replacement.

Interior walls are a combination of mostly painted GWB/plaster and painted CMU, while the corridors have a ceramic tile wainscot. The GWB/plaster walls have chipped or are scuffed in numerous locations. The ceramic tile wainscot is damaged in some areas, particularly where door handles hit the wall and on outside corners. Many corridors do not have a cove base which results in dirty corners where the wall meets the floor. Many walls are due for cleaning and re-paint. Ceramic tile wainscots are in the toilet rooms. These wainscots often have stained grout and residual drywall mounting anchors from toilet accessories since removed.

Ceilings throughout most of the building are primarily 2'x4' suspended ACT. Many ceilings are dirty, stained due to leaks, or slightly warped. The auditorium ceilings include concealed spline suspended ceiling tiles.

- Replace ceiling tile throughout the entire building.
- Install wall base where missing/with VCT replacement.
- Replace VCT throughout the entire building.
- Replace carpeting in offices and library.
- Re-paint the entire building.

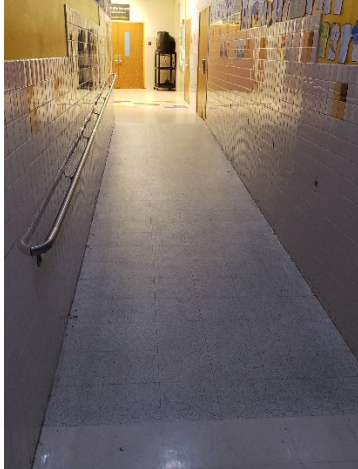
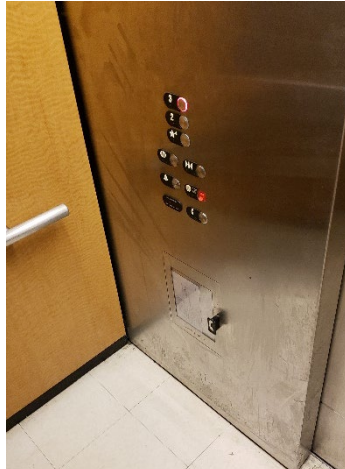
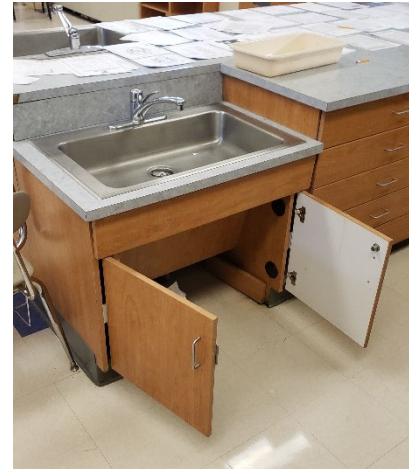
The stage does not have wheelchair lift access, requiring persons to go to the hallway to reach the stage if using a wheelchair. Furthermore, the ramps in the hallways are steeper than allowed by Code and missing handrails.

Water closets in single-user toilet rooms do not have the required fixture clearances around them. The accessible toilet stalls in multi-user toilet rooms do not have grab bars meeting current ADA requirements, and accessories are not installed within reach range. Multi-user toilet rooms with 6 or more toilet fixtures do not have an ambulatory-accessible stall.

Sinks in classrooms are not accessible – panels have been added which close off the wheelchair space and are locked closed.

- Evaluate elevator for any necessary upgrades and replace communications system.
- Replace missing handrails.
- Add wheelchair lift for direct stage access from the auditorium.
- Modify all ADA toilet stalls to comply with current code by providing ample clearance at water closets, moving accessories within reach range, and providing ADA compliant grab bars. This includes establishing ambulatory-accessible stalls where required.

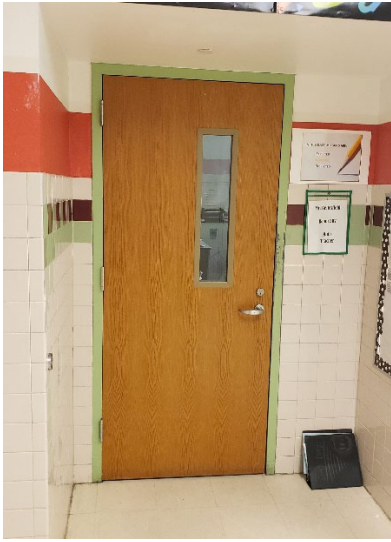
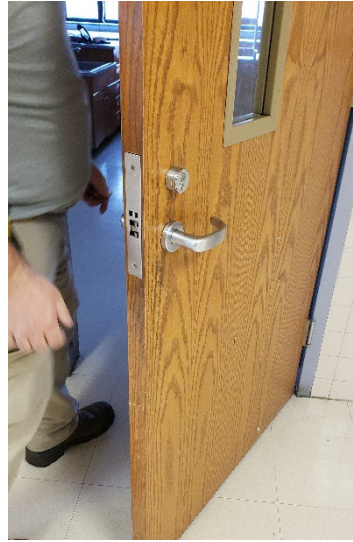
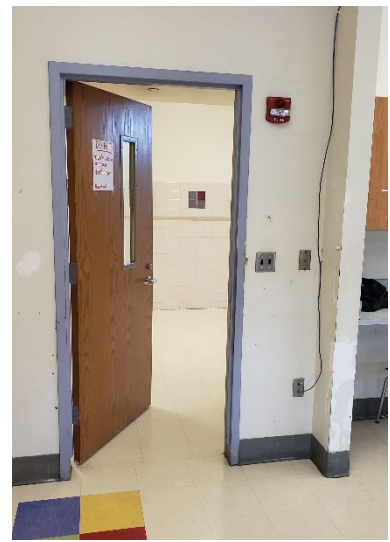
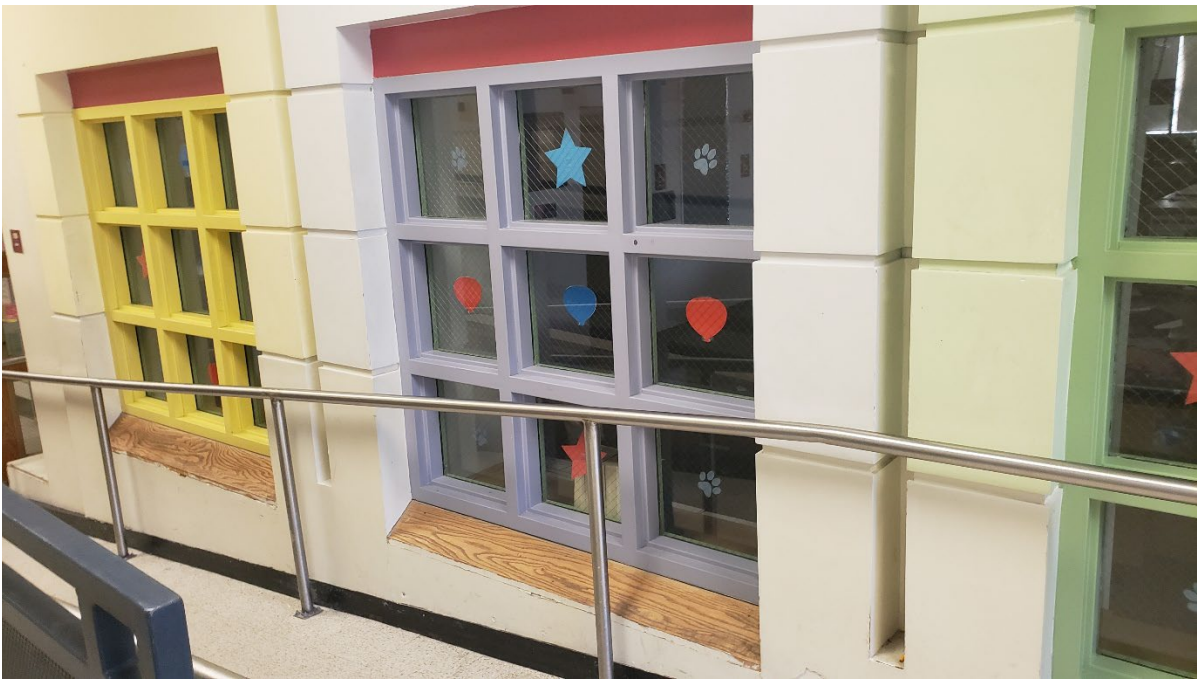
Most interior doors are wood with ADA-compliant hardware in fair to good condition, with hollow metal frames. Some doors have scratches and residue which remains from items being hung/taped to them over the years. Hollow metal doors and frames are in fair condition, most requiring painting.

- Scrape and repaint hollow metal frames with building wide interior painting.

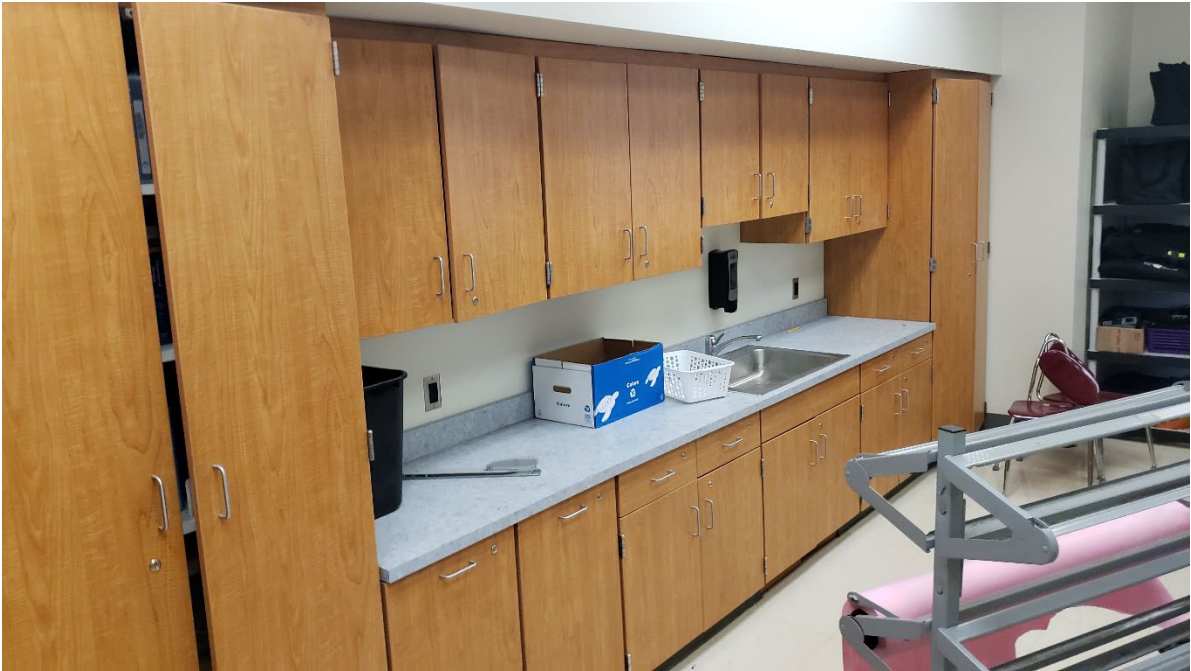
Most of the casework dates from the 2006 renovation. While generally in fair condition, countertops are often delaminating and should be replaced.

Typical classrooms have built-in shelving along the exterior wall adjacent to the unit ventilators. If the unit ventilators are removed as part of an HVAC upgrade, this casework would need to be infilled or removed and adjacent finishes patched and repaired.

- Consider replacing countertops.
- Modify casework at sinks to be ADA compliant.

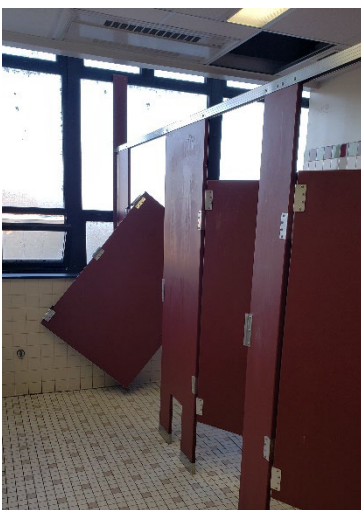
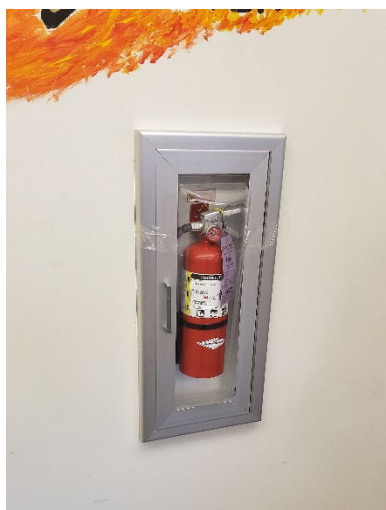
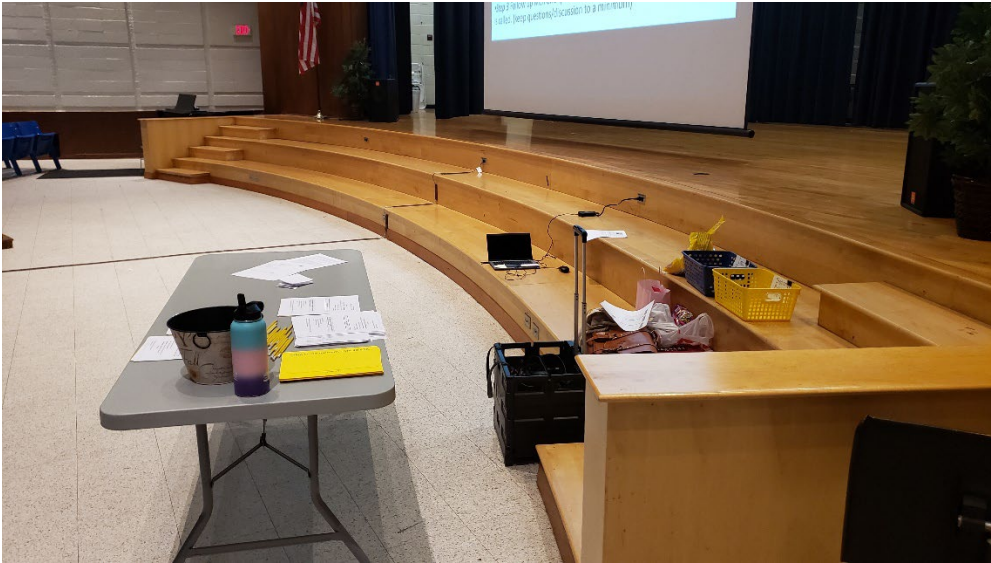
Display cabinets in corridors are missing their operable glass doors. Some fire extinguishers are missing the clear 'bubble' within their cabinet doors.

Toilet Partitions are damaged in areas and have markings/graffiti in numerous locations. Lockers are generally in good condition.

- Replace toilet partitions.
- Replace fire extinguisher cabinets

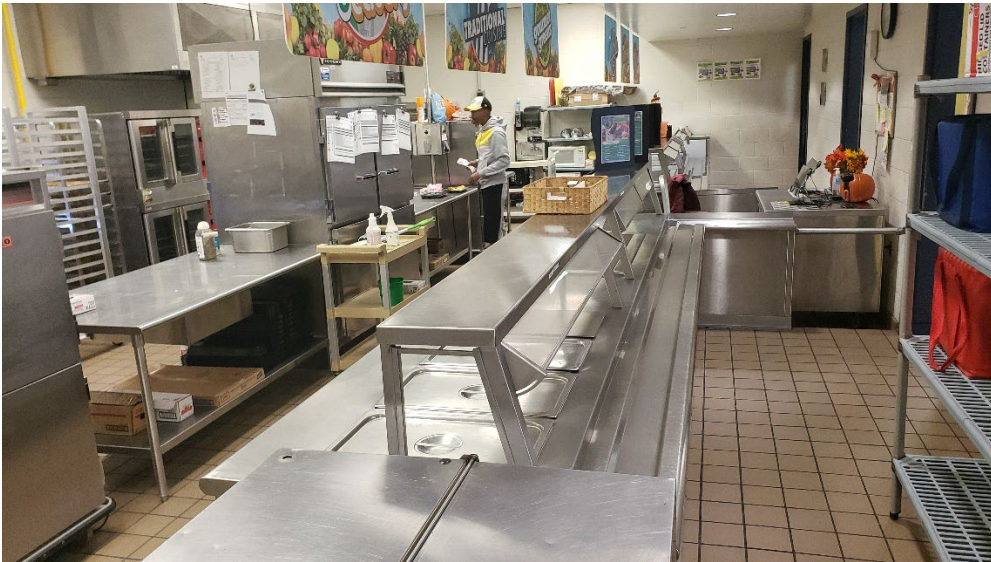
The cooking for Camp Curtin Academy is done on site. The food service equipment was replaced in 2006 and is in fair to good condition, except for the coolers which requires more immediate replacement.

- Replace refrigerator/freezer as needed.
- Replace kitchen equipment in 4-5 years.

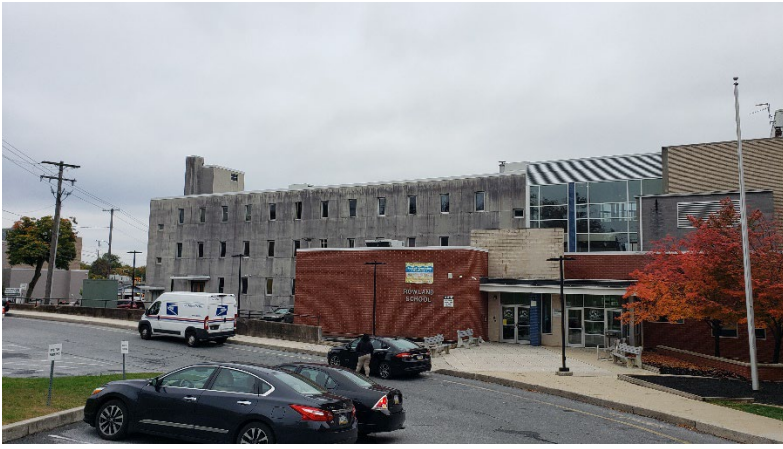
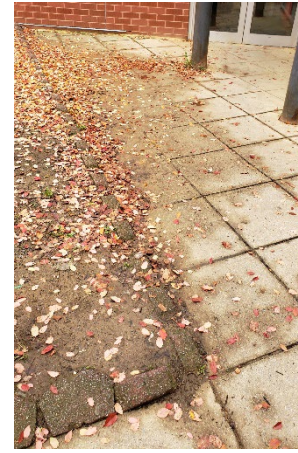
There are two other small parking lots, one to the west of the building, fed off of Derry Street, and another between the building and the drop-off loop accessed from South Nineteenth Street. There is also a bus drop-off area fed off of Swatara Street to the northwest. Total site parking accommodates approximately 40 vehicles. Paved asphalt areas are in fair condition. Sidewalks around the building are in good condition.

- Seal coat asphalt paving as part of ongoing maintenance.

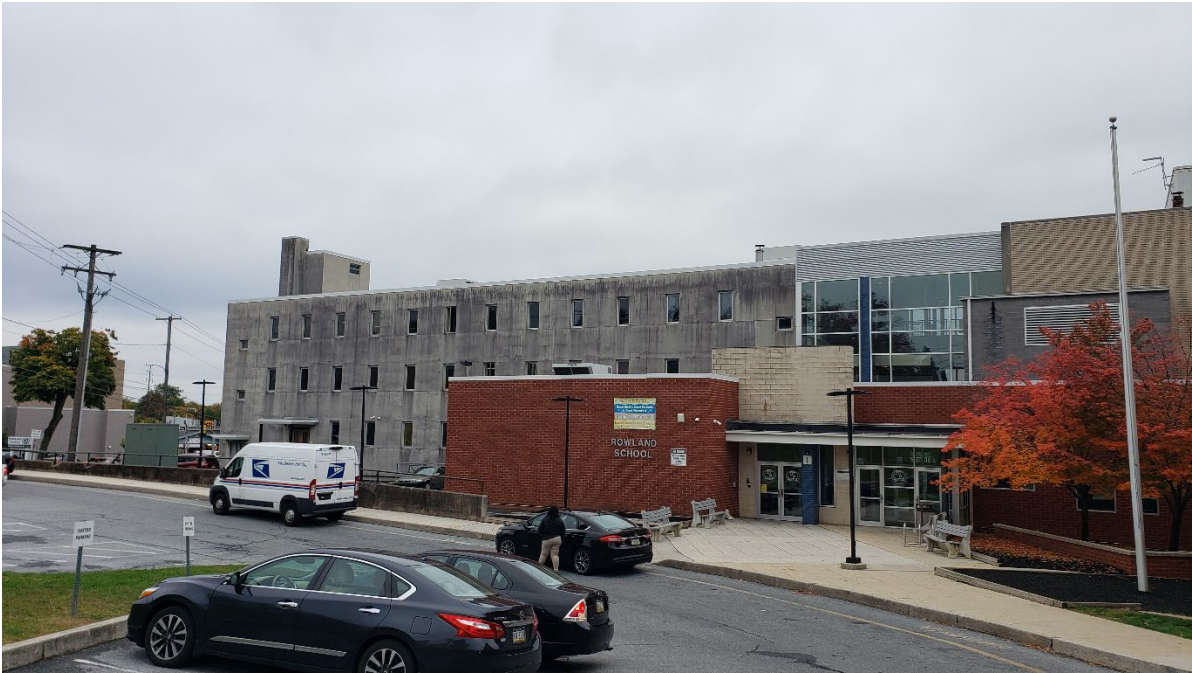
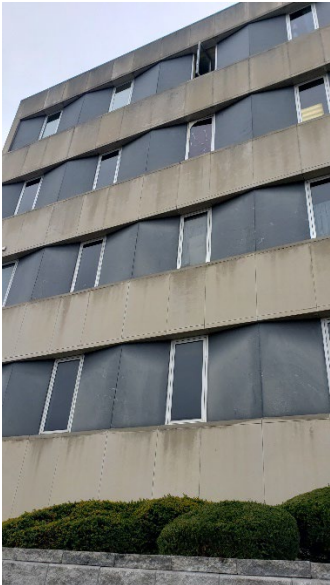
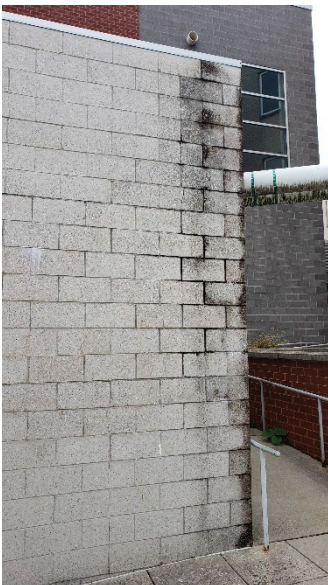
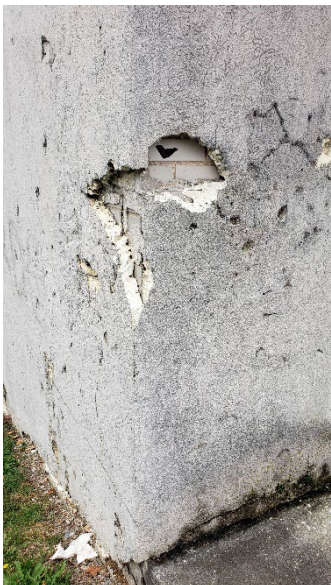
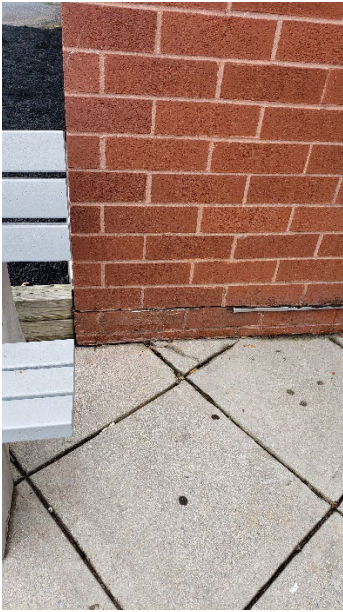
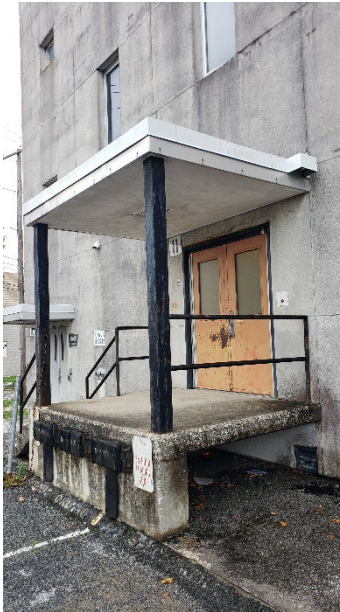
The exterior walls are primarily brick at the 1999 additions, and precast paneling and exterior insulation and finish system (EIFS) at the older portions of the building. Most masonry and precast paneling is in good condition, however there is a location of finished CMU being damaged and other masonry being stained from a leaking gutter. The CMU damage, located near the main entrance, appears to be missing the metal coping at the top which would protect it from water infiltration. Additionally, portions of the paneling and masonry are broken away at the loading dock. The EIFS is in generally poor condition, with extensive mildew backup and finish coats being worn away or damaged, thus leaving the insulation and mesh exposed. Other areas the EIFS is entirely torn away, exposing the masonry behind.

There are steel elements around the building, such as the columns at the entrance and the woven steel rod security panels over the gymnasium windows, which are due for new coatings/paint.

- Repair Exterior Insulation and Finish System.
- Clean stained masonry and precast paneling.
- Replace damaged exterior veneer CMU where damaged.
- Re-caulk joints in masonry and precast concrete.
- Paint steel elements.

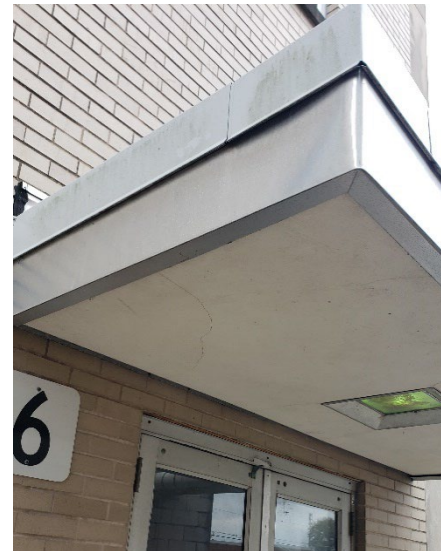
The black EPDM roof is at the end of its useful life and is due for replacement.

Soffits at overhanging canopies around the building are in need of repair. The front entrance has missing sections of the linear metal soffit, while other canopies with an acrylic coated or plaster soffit are cracked, torn away, or otherwise damaged.

There is a section of the building near the main entrance which has gutters and downspouts. The gutter appears to be leaking in one area which is the cause of staining on the masonry wall below it.

- Repair damaged soffits.

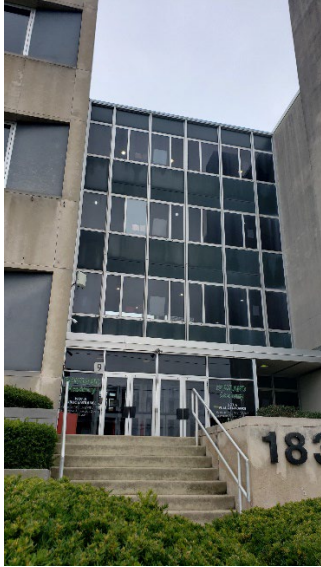
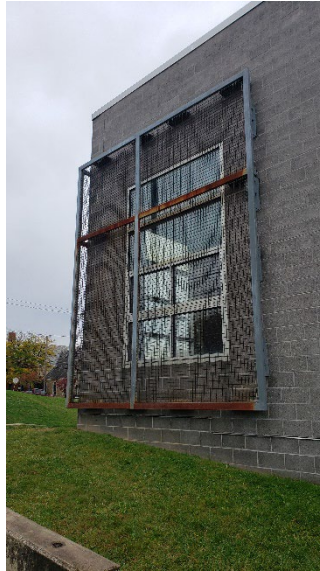
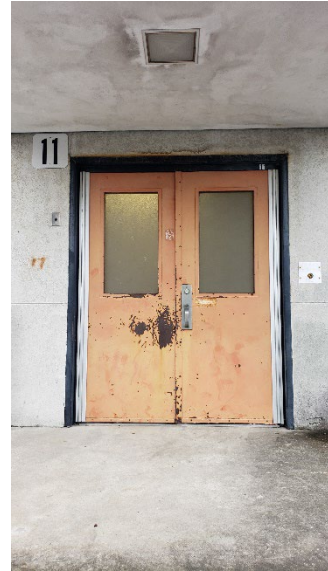
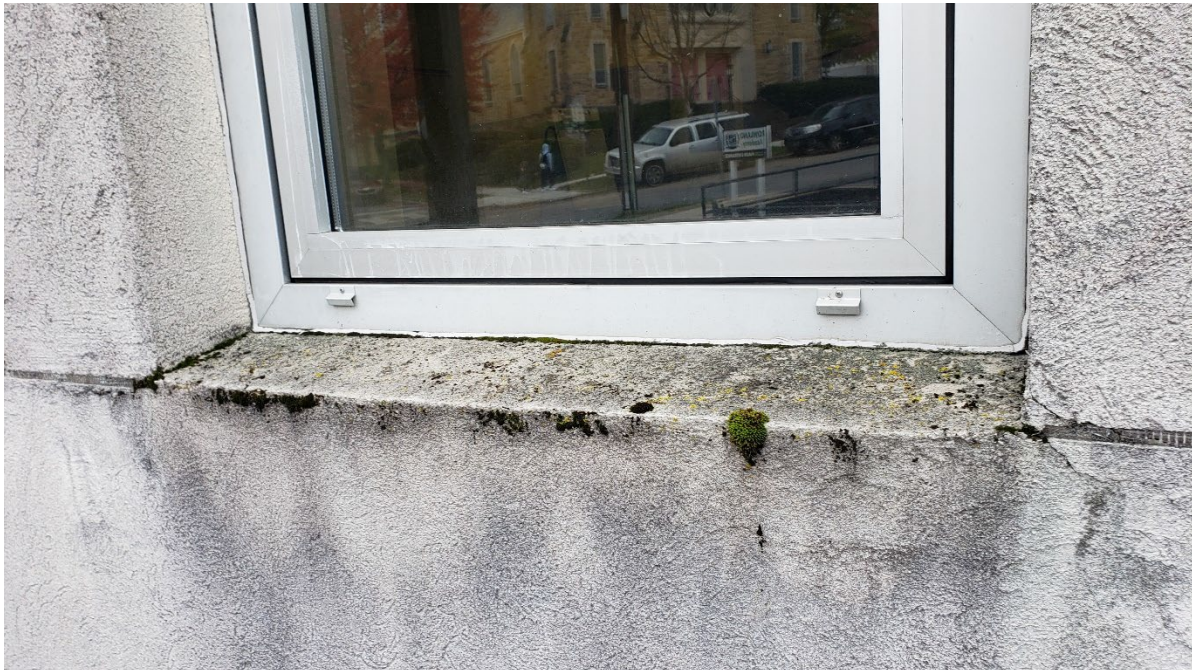
Windows in the newer areas of the building are aluminum storefront and curtainwall systems in good condition. Elsewhere, exterior windows are aluminum casement windows. The casement windows showed signs of age, with the operable portions no longer sealing with fixed portions when closed. Perimeter sealants around all window types is due for replacement.

The door pulls in the entrance doors should be replaced at double doors, so that doors cannot be chained together from the outside.

Service doors are hollow metal or steel and are in poor condition.

- Replace operable casement windows.
- Replace hollow metal / steel service doors.
- Replace door pulls at double doors so doors cannot be chained together from the outside.

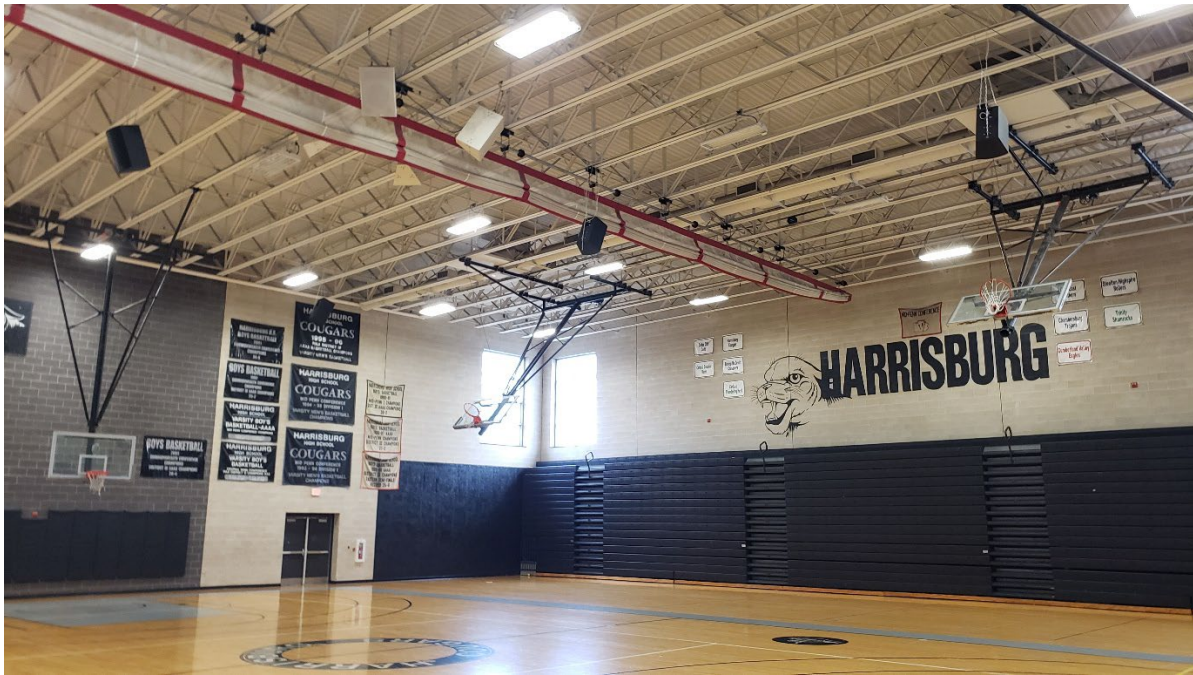
The original, four-story plus basement building is constructed mainly of steel frame construction with roof and floor slabs supported by steel joists and beams. The newer construction from 1999 is a combination of steel frame and masonry load-bearing. The structure appears to be in sound condition.

- None at this time.

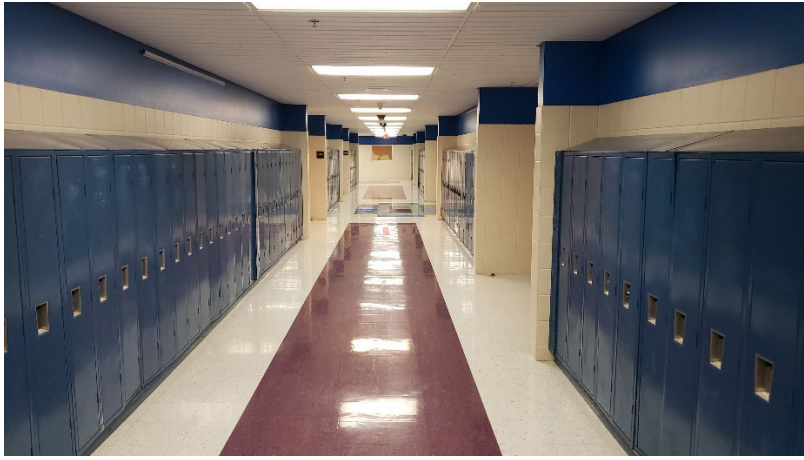
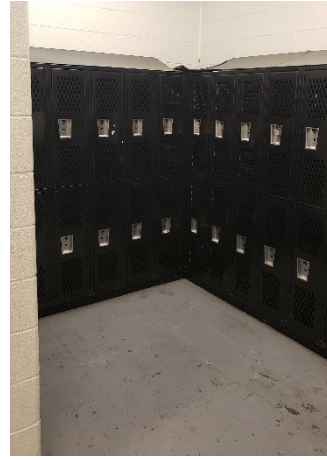
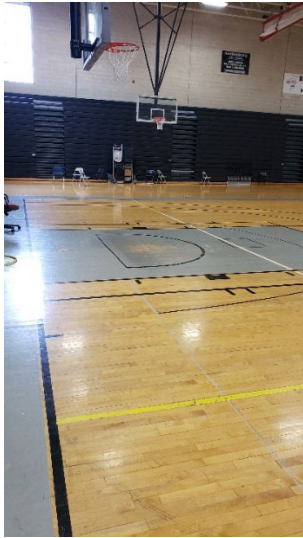
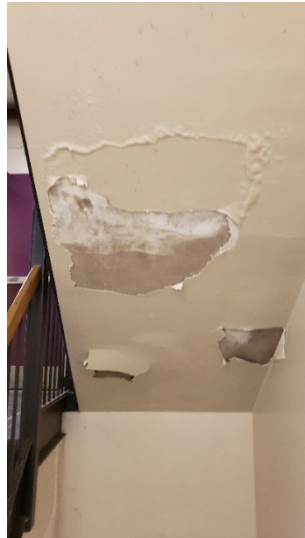
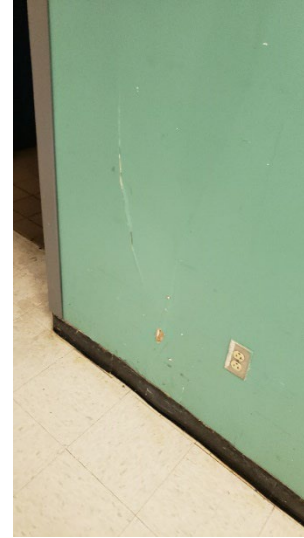
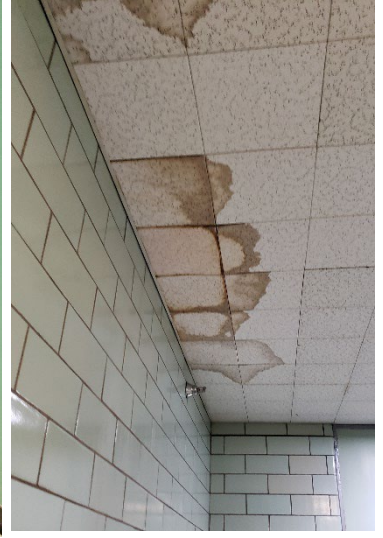
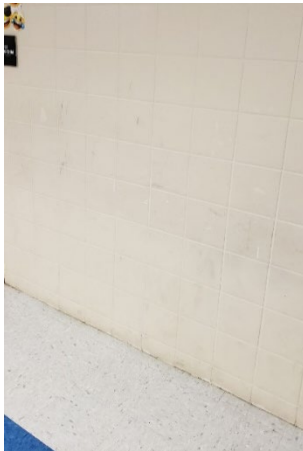
Wall finishes throughout the building include painted CMU and decorative masonry, structural glazed tile at stairways, painted plaster and GWB, and limited amounts of wood paneling in the corridors. Most of the finishes are in fair condition, however there are areas where the paint is peeling off of the plaster/GWB. There are ceramic tile wainscots in the toilet rooms and corridors. The corridor wainscots were painted over and the paint is wearing off from scratching and other causes. Some stud/GWB walls in corridors is bowed and should be replaced. Most corridor walls do not have a cove base which causes difficulty in cleaning and results in dirty corners where walls meet floors.

Floor finishes include terrazzo, VCT, sealed concrete, wood athletic flooring, and quarry tile in the kitchen. There is carpet in the library and administration suite. VCT is in fair condition, but shows a lot of scuffs and dirt from years of wear. VCT is also cracked and/or chipped in areas. The library has been re-carpeted recently with new carpeting. The wood floor in the 1999 gym is in fair condition, needing to be sanded and refinished. Gym locker rooms have painted concrete floors which need to be repainted. Stairs have rubber treads and painted risers – risers are due for repainting.

The majority of the building has lay-in acoustical ceiling tile of various styles. Much of the lay-in tile is sagging from age or water damaged. Additional ceiling finishes include painted plaster, metal suspended panels, concealed spline suspended systems in stairwells and exposed painted structure. On the ground floor, there are areas of plaster that show evidence of moisture damage.

- Repair and repaint damaged areas of plaster/GWB where they occur.
- Replace ceiling tile throughout the building.
- Repaint walls throughout the building.
- Sand and refinish gymnasium floors.
- Repaint coated concrete floors in locker rooms.
- Install wall base at walls where missing.
- Consider replacing VCT throughout as part of a comprehensive renovation project.
- Replace concealed spline ceilings in stairwells with lay-in ceilings
