Harrisburg School District

District Wide Facility Study

June 12, 2023

Crabtree, Rohrbaugh & Associates
Architects

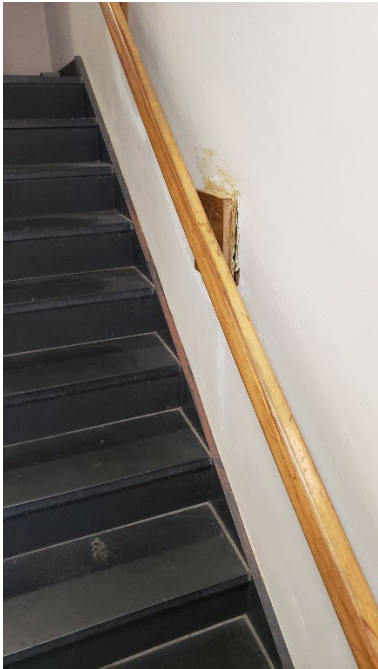
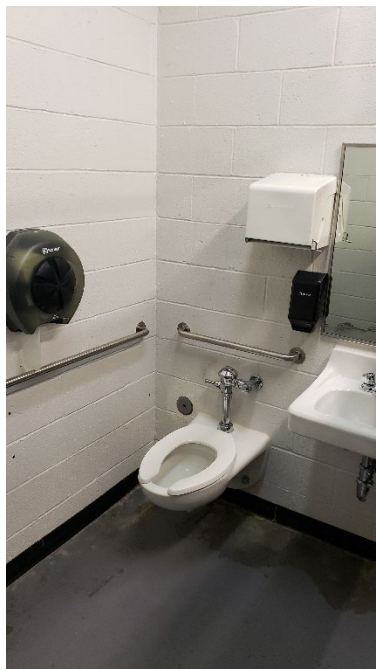
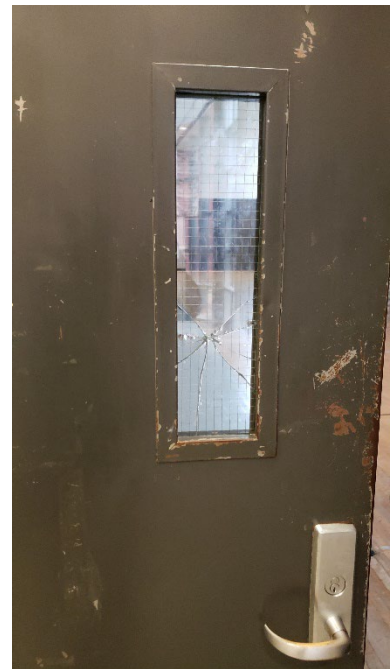
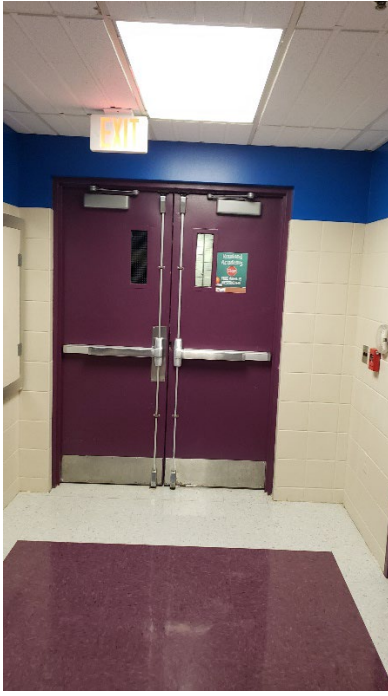
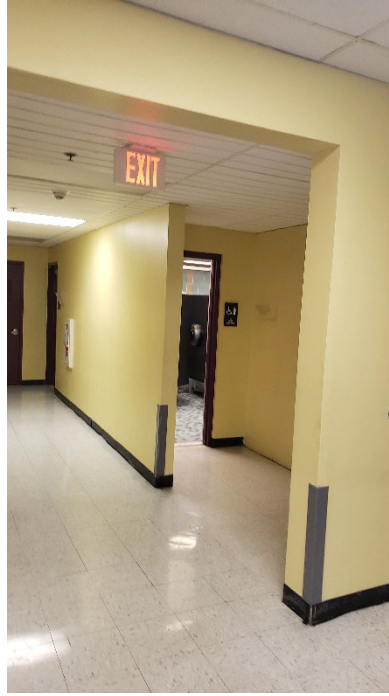
There are two elevators, which have operational issues. The District's elevators are not known to be upgraded in recent history and should therefore be evaluated for improvements or replacement. All elevators in the School District have pots lines to the machine rooms, which should be replaced with more reliable and current communications technology.

Drinking fountains, while many recently replaced, are often located such that they project into paths of travel, an accessibility concern due to blind persons not being able to sense their presence.

Doors and vision panels have wire glass, which is no longer permissible in educational facilities. Some cross-corridor sets of double doors each about 30 inches wide. Accessibility codes require at least one leaf to be 36 inches.

Both Elevators were not operational at the time of building walkthrough.

- Replace handrails and guard rails in stairwells to comply with the IBC and ADA guidelines.
- Renovate all non-ADA compliant single occupancy toilet rooms to be ADA compliant.
- Modify all ADA toilet stalls to comply with current code by removing the lavatories adjacent to the water closets to allow proper clearances at the water closets, moving accessories within reach range, and providing ADA compliant grab bars.
- Evaluate elevators for any necessary upgrades and replace communications system.
- Replace doors and vision panels containing wire glass.
- Replace double doors so that at least one leaf is 36 inches wide.
- Reconfigure toilet rooms to eliminate line of site concerns.

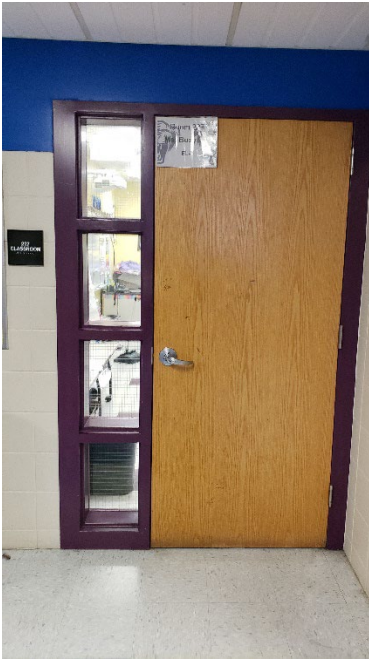
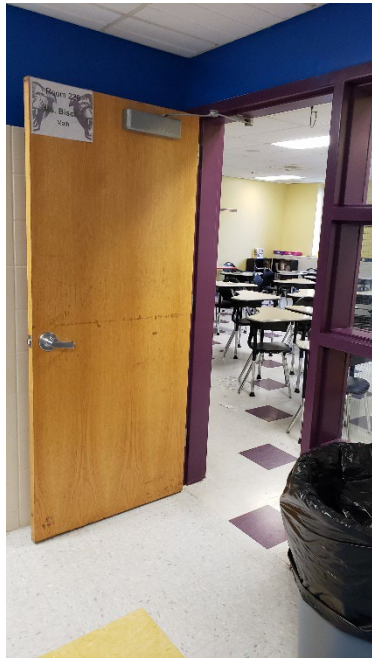
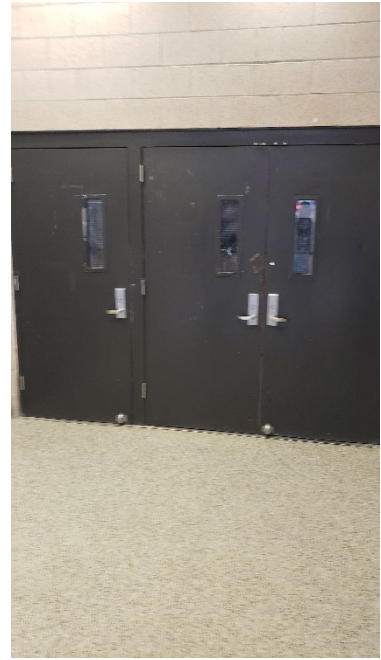
Doors throughout the building are hollow metal or wood set in to hollow metal frames. Vision panels in doors have wire glass which is no longer permissible in educational facilities. Some hollow metal doors and frames around the 1999 gymnasium addition are in poor condition, with broken glass, dents and flaked off paint.

- Replace doors and vision lites containing wire glass.
- Replace damaged hollow metal doors and frames.

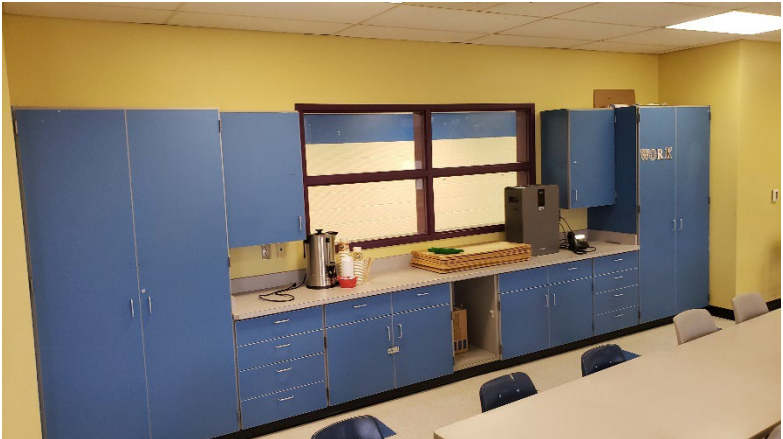
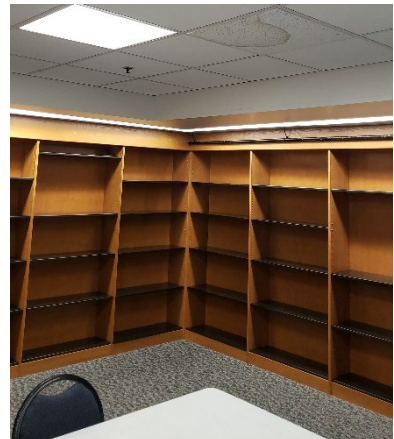
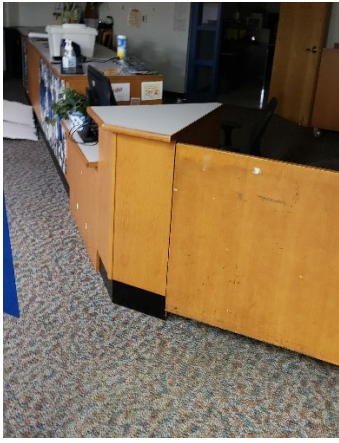
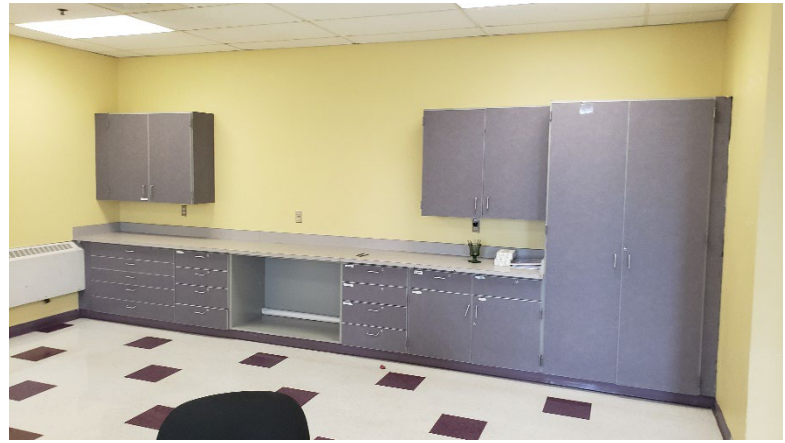
Casework throughout the building was replaced during the 1999 renovations. Casework is in fair condition, with countertops being particularly poor and delaminating. Some casework has missing drawers and panels. Hardware is bent or no longer secure to panels.

- Replace built-in casework throughout the building.

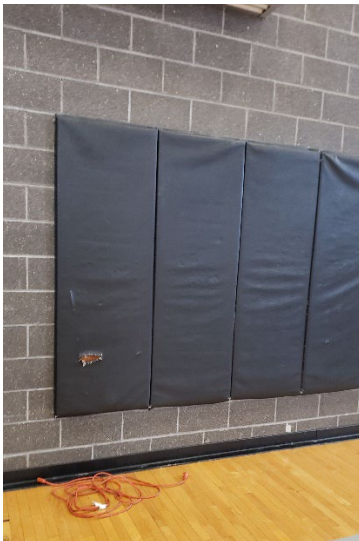
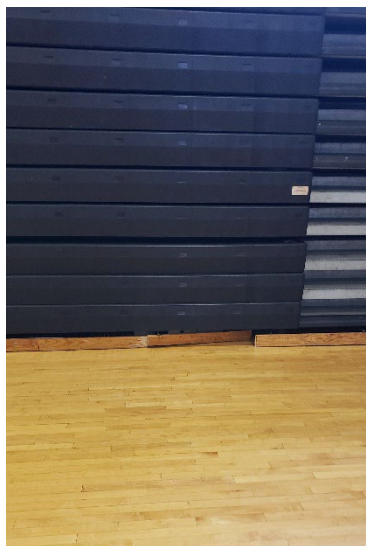
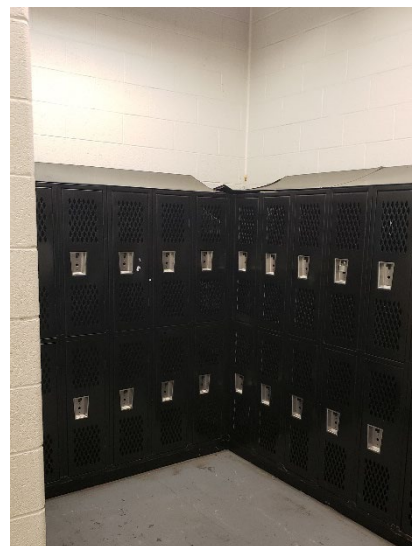
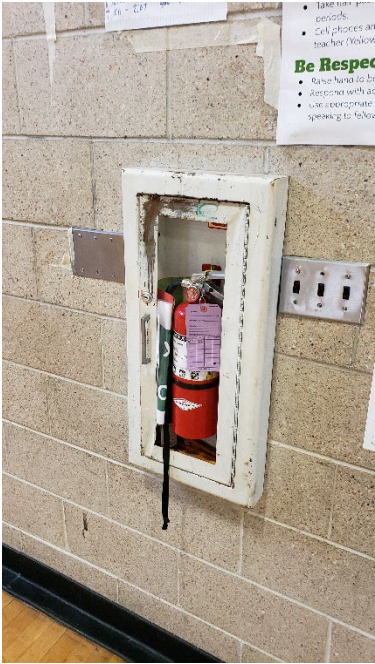
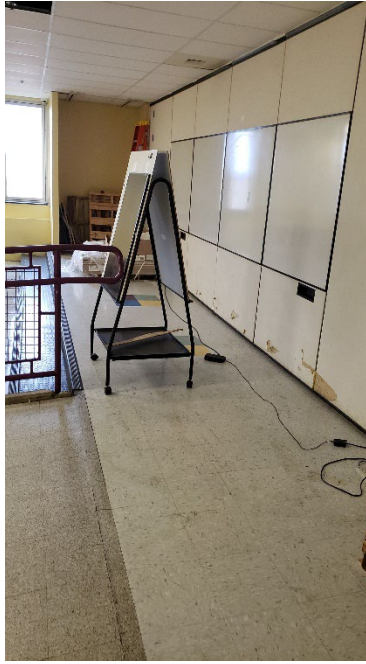
The bleachers are in good condition except for a couple locations of damaged base trim. Athletics equipment in the gymnasium is in good condition, except for wall pads which are torn in some locations.

There is an operable partition at the cafeteria platform which has damaged panel finishes.

Lockers throughout the building were replaced in 1999, but are in poor condition

Fire extinguisher cabinets are damaged throughout the building.

- Replace the broken base trim in bleachers.
- Replace gymnasium wall pads.
- If an operable partition is still desired at the cafeteria platform, it should be replaced. Otherwise, consider replacing with permanent wall or eliminate a wall altogether.
- Replace lockers throughout the building.
- Replace fire extinguisher cabinets throughout the building.

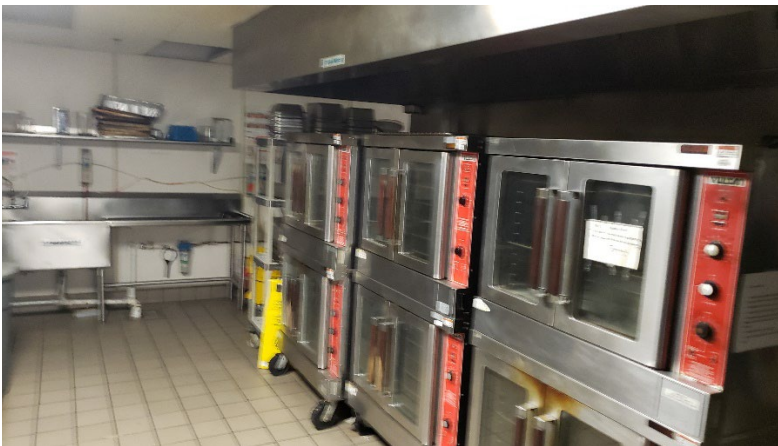
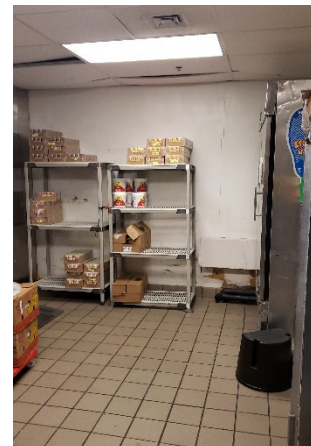
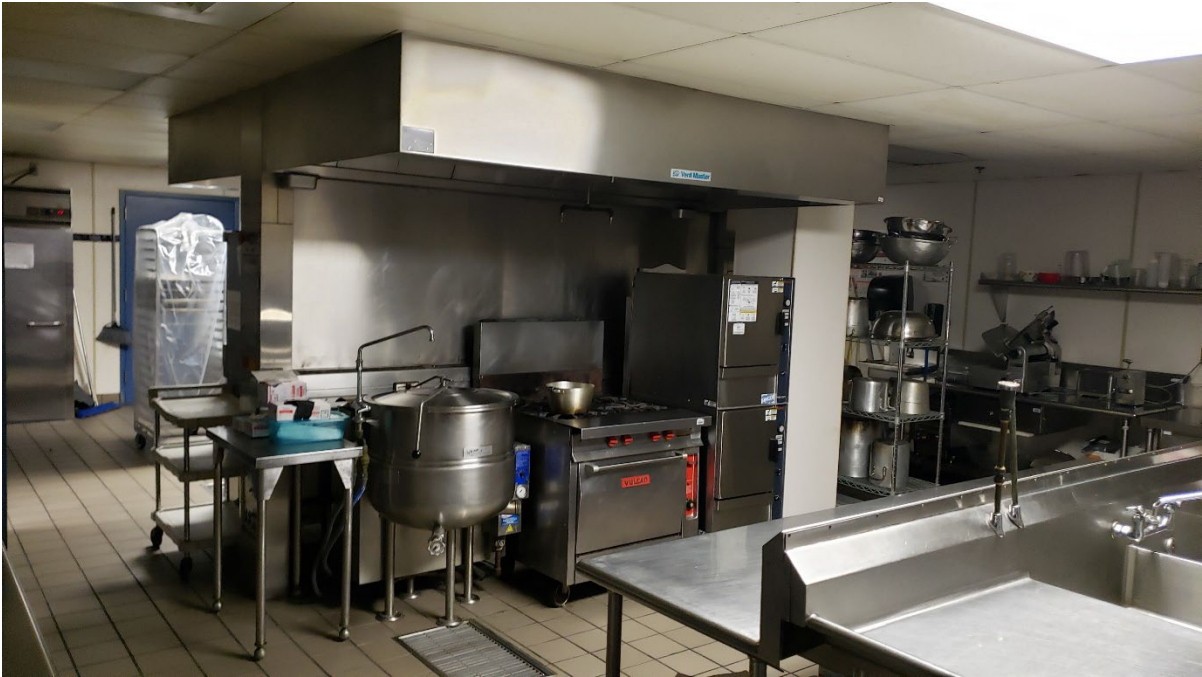
The majority of the food service equipment was replaced as part of the 1999 renovation and should be considered for replacement as part of a renovation project. The walk-in freezers and coolers are in poor condition and should be replaced.

- Replace food service equipment and walk-in cooler/freezers.

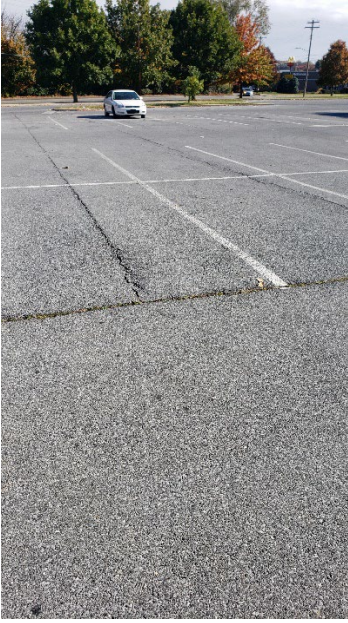
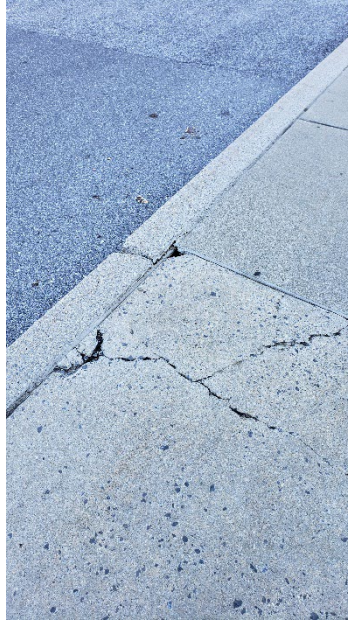
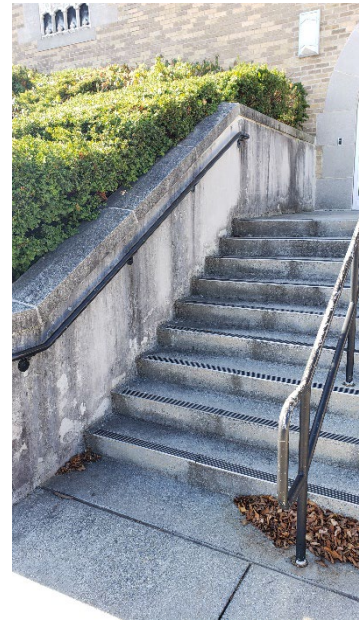
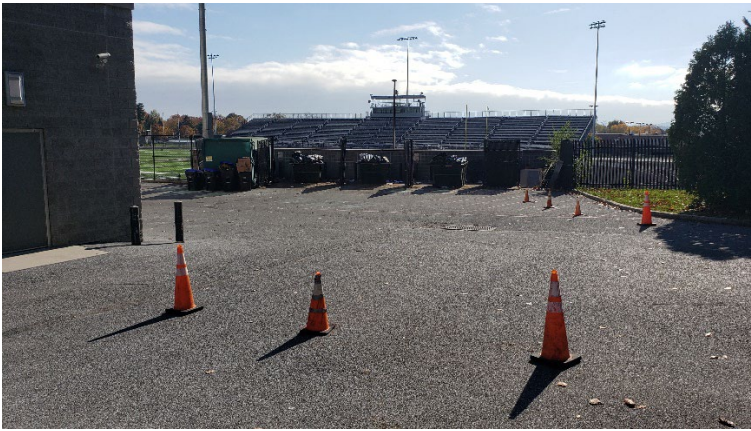
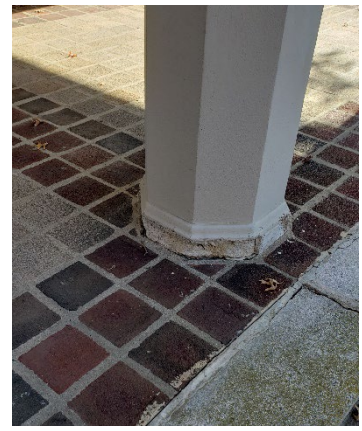
Vehicular access to the site is from both Market Street and South 25th Street. There are ADA accessible parking spaces in each of the parking areas, as well as accessible routes from the parking spaces to the building entrances. The parking lots, including the lot adjacent to the field house, accommodate 317 vehicles. The asphalt paving around the building is in fair condition. Generally, the concrete sidewalks are in good condition, although there are a few cracked flags and other areas in need of new sealant between flags. Concrete retaining walls adjacent to stairs and ramps are spalling in several locations.

- Seal coat asphalt paving as part of ongoing maintenance.
- Replace damaged/cracked flags of concrete sidewalk.
- Replace sealant between flags of concrete as part of ongoing maintenance.
- Repair spalling concrete stair retaining walls.

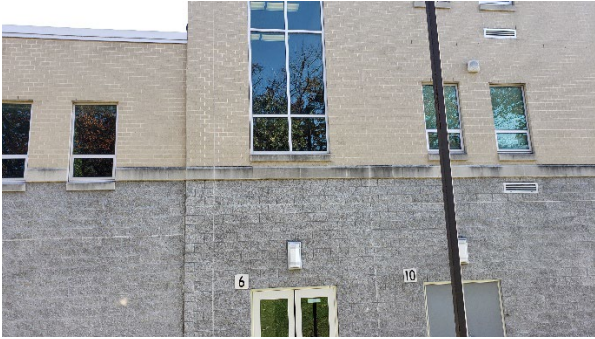
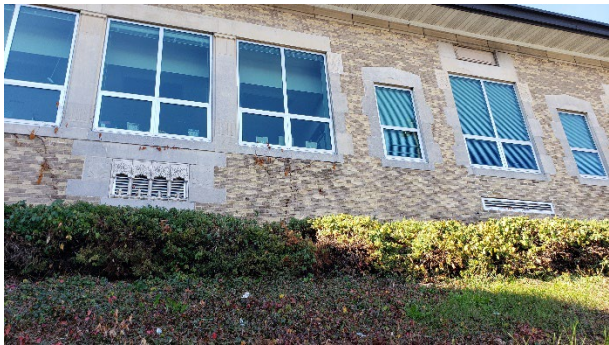
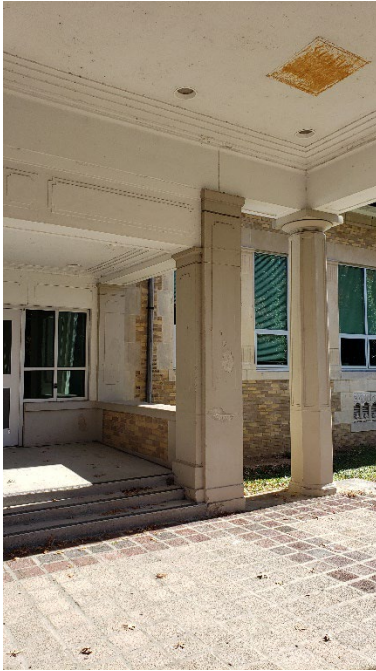
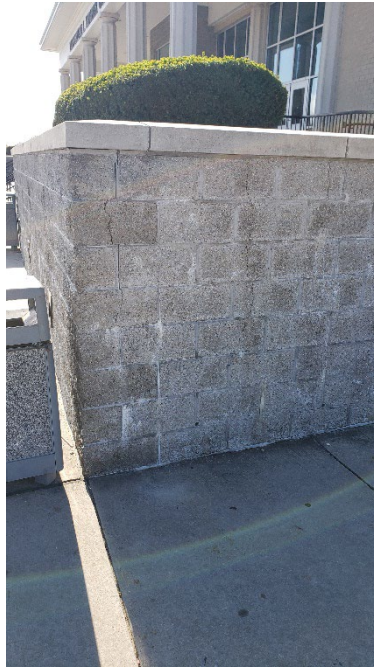
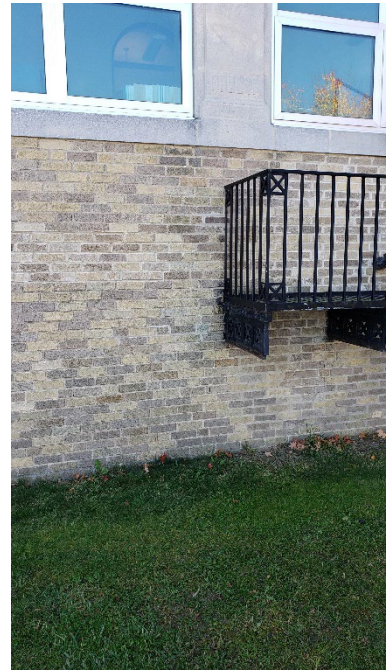
The building’s exterior consists mainly of brick veneer with precast architectural concrete accents. The newer wing of the building also has ground face CMU veneer at the lower level. Both are in good condition throughout, although the precast accents require cleaning as part of the building’s ongoing maintenance.

The CMU retaining walls near the gymnasium entrance are cracking and have efflorescence – signs that the walls do not properly drain moisture.

Painted areas (columns, box beams, etc.) at overhangs and canopies require scraping and repainting. Some trim needs to be repaired.

- Repair gymnasium entrance retaining masonry walls.
- Clean masonry and precast features.

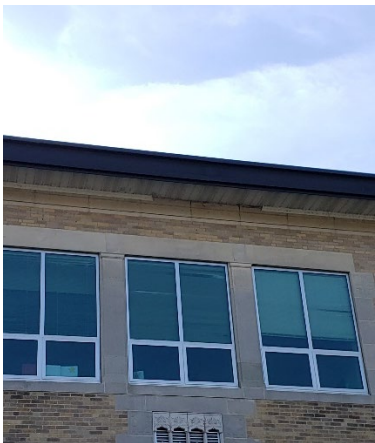
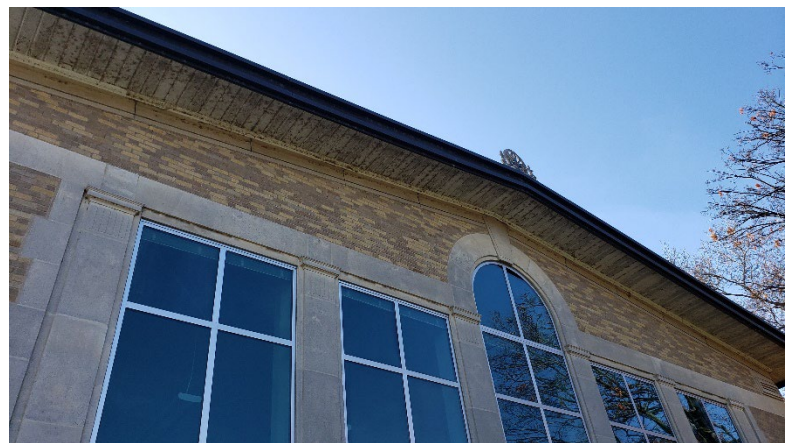
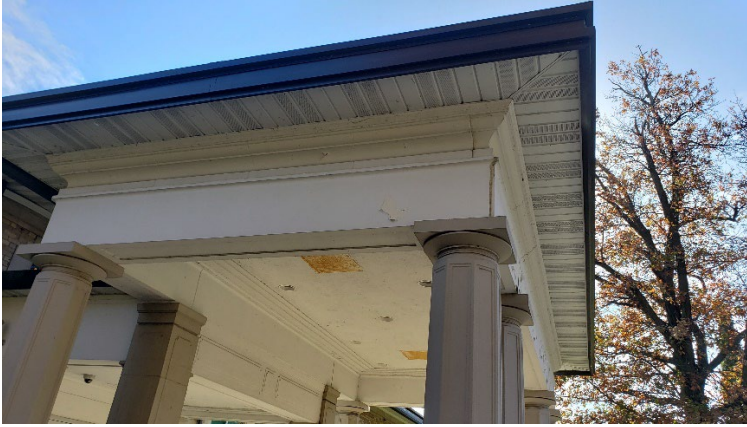
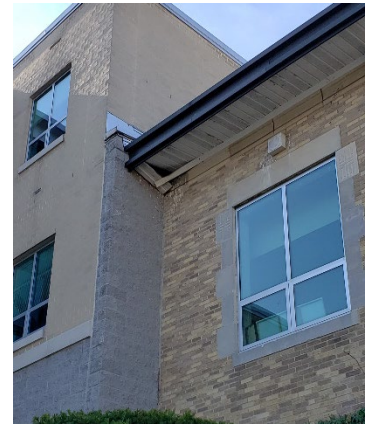
The majority of the roof is an adhered EPDM membrane roofing system, with some areas also a ballasted system. The roof will be due for replacement in 4-6 years.

Soffits around the building are in need of cleaning and missing trim pieces need to be replaced.

- Clean soffits, and repair/replace trim where damaged or missing.

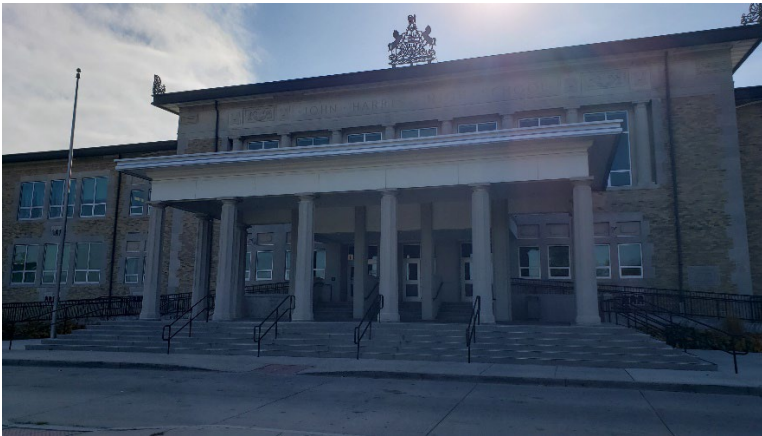
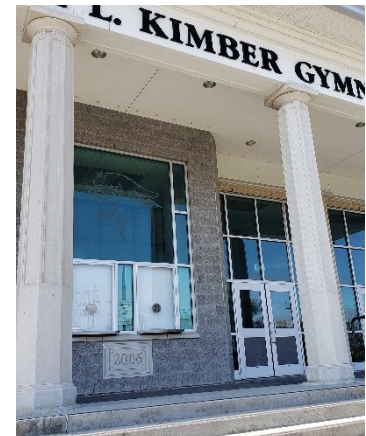
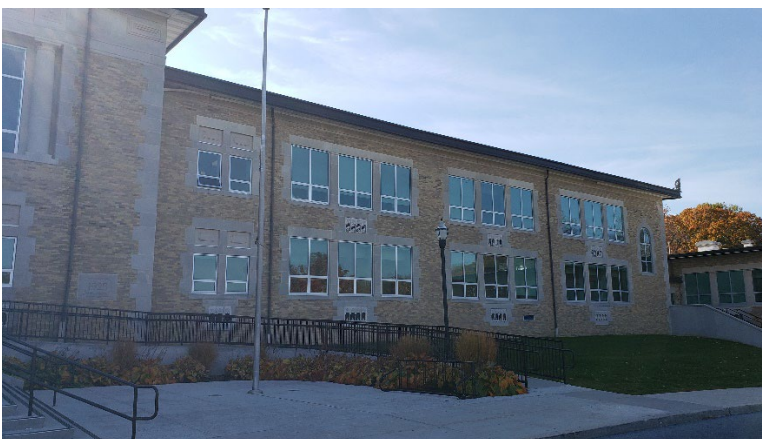
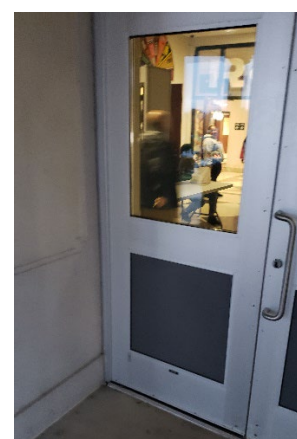
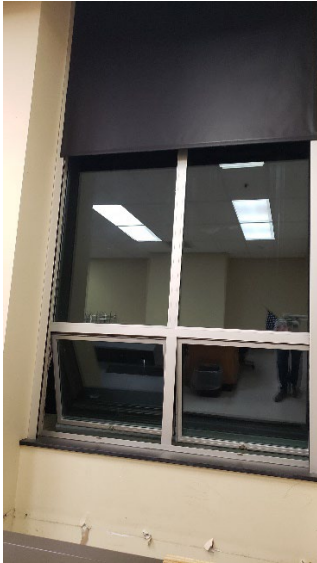
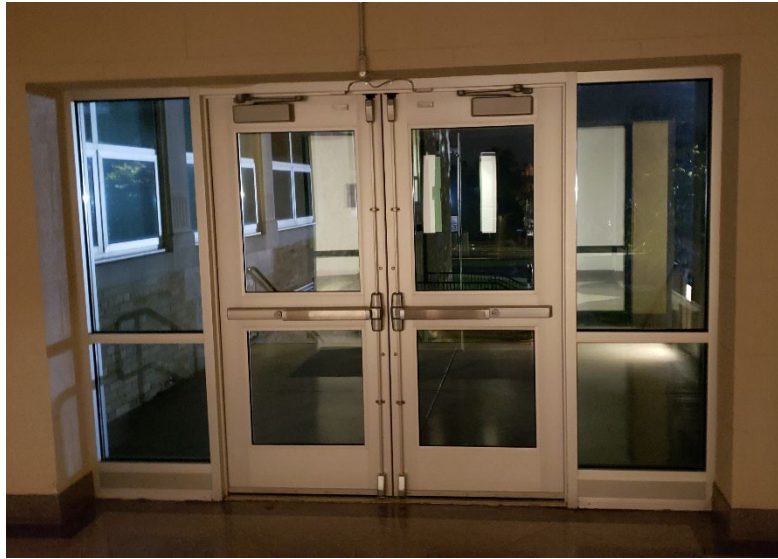
The exterior aluminum windows and storefront entrances were replaced in 2005 and are in good condition. Classroom windows have operable awning style vents. The exterior entrances/exits have double doors with pulls on each leaf which is a security/safety concern because the doors could be chained together.

- Replace hardware at double door entrances/exits.

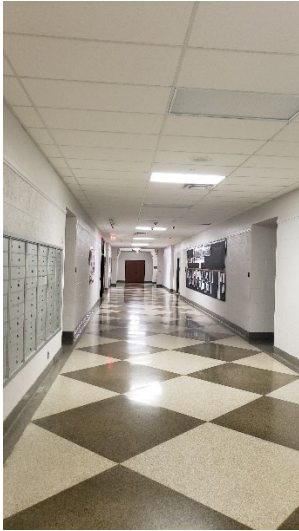
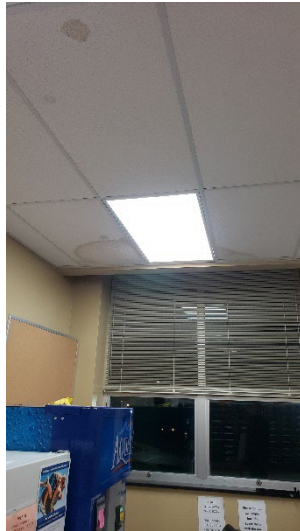
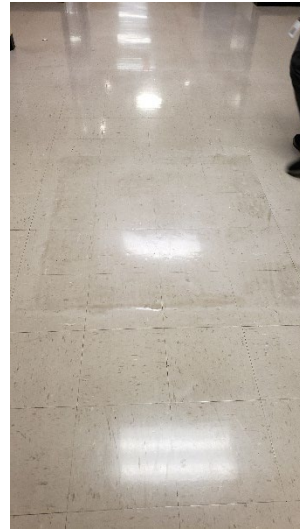
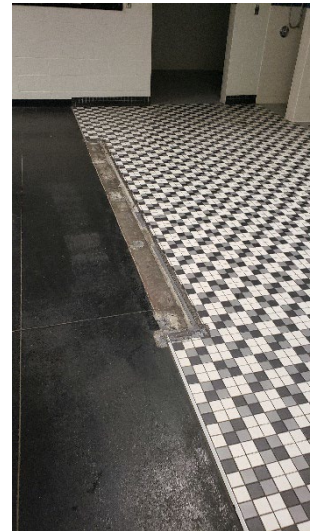
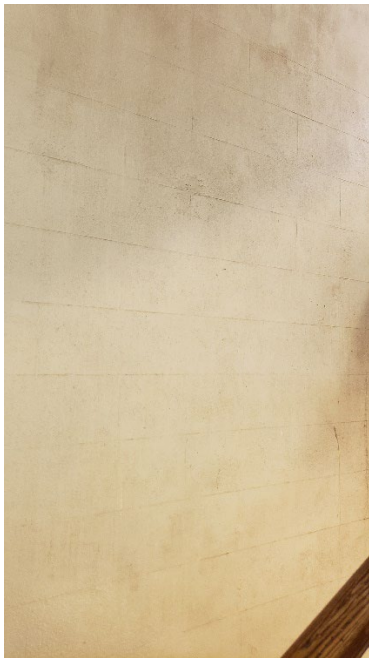
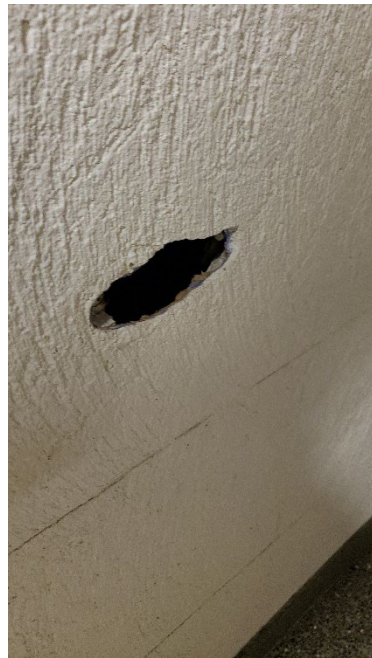
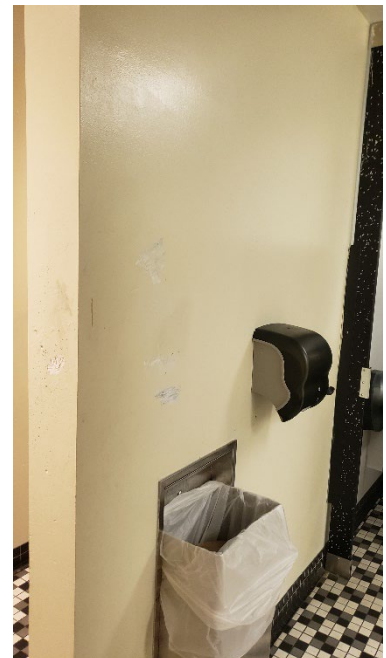
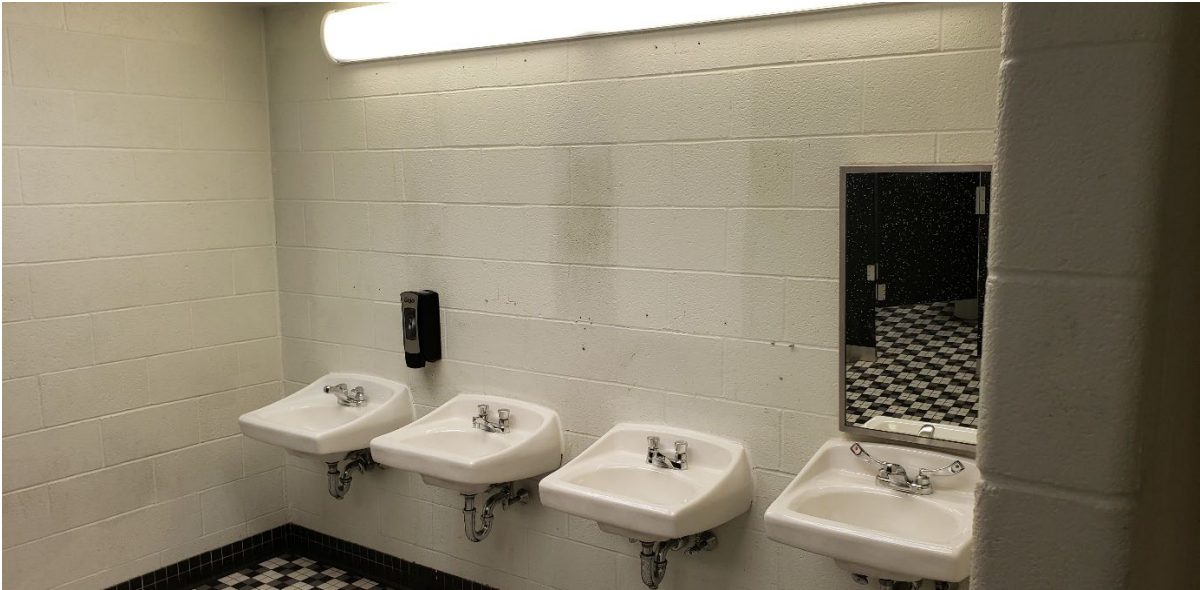
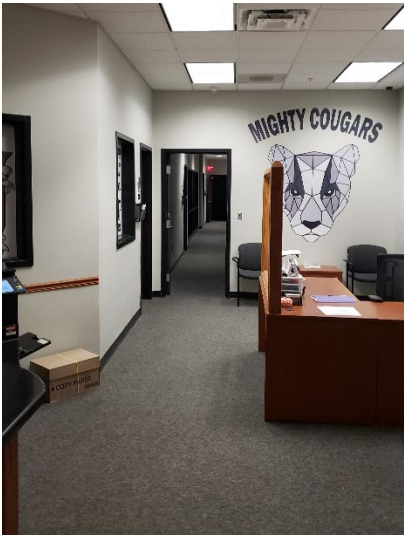
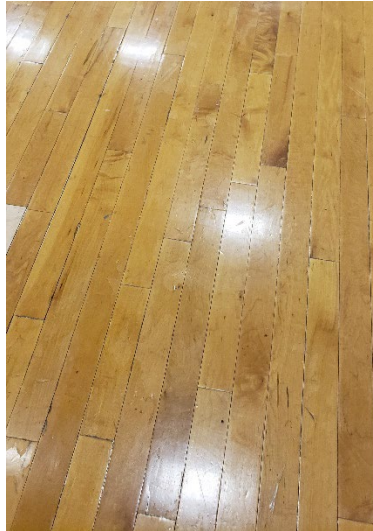
Wall finishes throughout the building include plaster applied to masonry and stud walls, gypsum board, painted CMU in the 2005 addition, and wood paneling in the auditorium. Locker room shower areas have glazed ceramic tile finishes. Plastered corridor walls have areas of damage which should be repaired, commonly at corners and where door hardware hits the wall. Painted CMU walls in toilet rooms are particularly dirty, and also contain residual wall anchors from previously removed toilet accessories. Plaster/GWB walls within many classrooms have areas requiring paint touch-ups due to items being hung and removed from the walls. The gymnasium walls are due for new paint finishes.

Floor finishes include terrazzo in the original building corridors, VCT in the classrooms and 2005 addition corridors; mosaic ceramic tile in toilet rooms and locker rooms, wood athletic flooring in the gymnasium, and carpet tile in the administration suite, auditorium, media center and select classrooms. The carpeting is in good condition in most spaces, but auditorium carpeting is due for replacement. Also in the auditorium is painted concrete which is due for refinishing. The terrazzo in the corridors has cracks in several areas. Transitions in locker rooms where ceramic tile abuts other flooring need to be repaired. VCT is in fair condition, with certain rooms and areas requiring VCT replacement due to delamination or damaged tile. The floated wood gymnasium floor is due for replacement.

The majority of the building has lay-in acoustical ceiling tile which is in fair condition, but should have water damaged tiles replaced. The toilet rooms have painted GWB ceilings. The main lobby has painted plaster ceilings.

- Touch-up damaged wall paint in classrooms.
- Repaint bathrooms while properly plugging previous wall anchor areas.
- Repair damaged plaster areas.
- Replace damaged acoustical ceiling tiles.
- Replace carpeting in auditorium.
- Refinish painted concrete in auditorium along with seating replacement.
- Replace gymnasium floor.

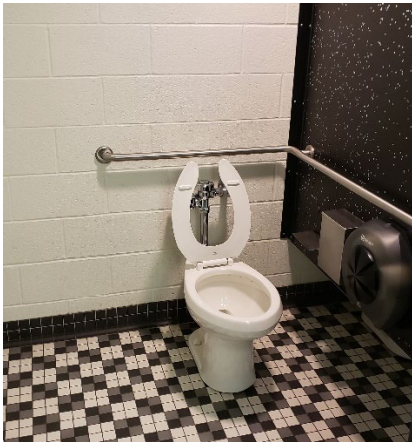
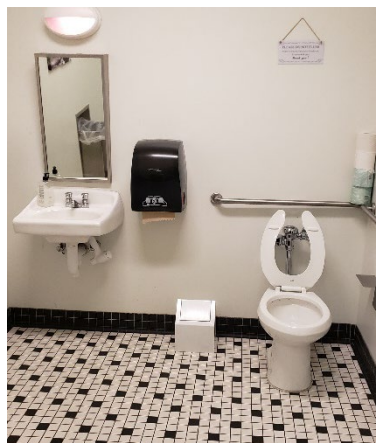
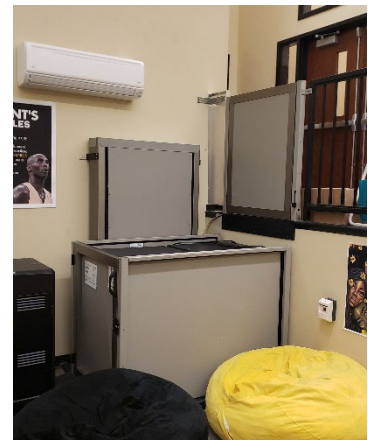
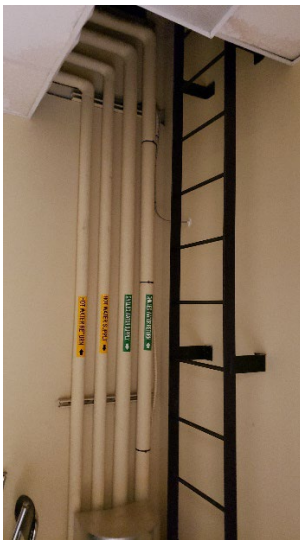
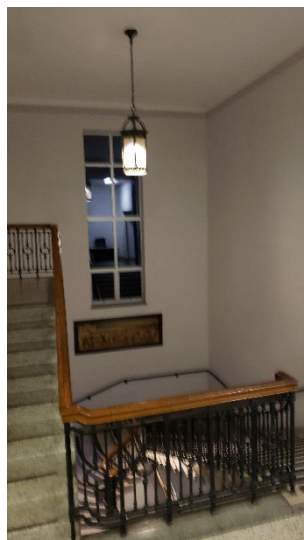
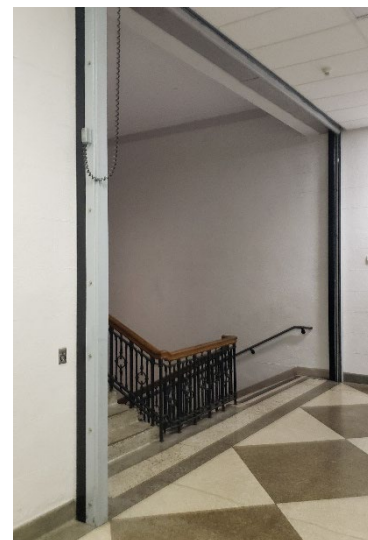
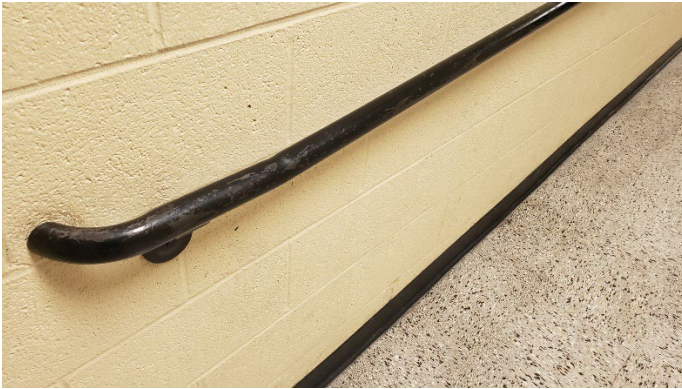
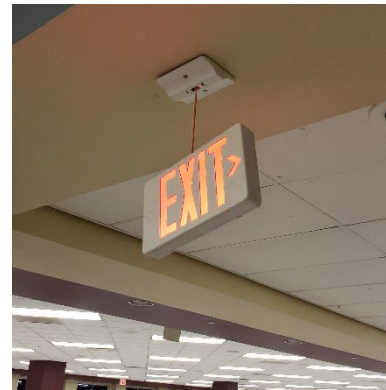
Drinking fountains, while many recently replaced, are often located such that they project into paths of travel, an accessibility concern due to blind persons not being able to sense their presence.

Accessible sinks where they occur within classrooms lack the required knee and toe clearance underneath.

- Evaluate elevators for any necessary upgrades and replace communications technology.
- Replace the guard/handrail around the stairs with a new guard and handrail that is compliant with current code.
- Renovate all non-ADA compliant single occupancy toilet rooms to be ADA compliant.
- Modify all ADA toilet stalls to comply with current code by moving accessories within reach range and providing ADA compliant grab bars.

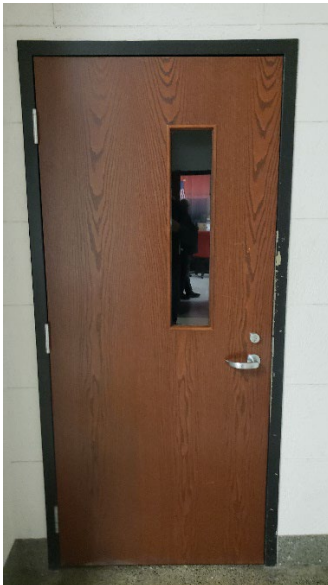
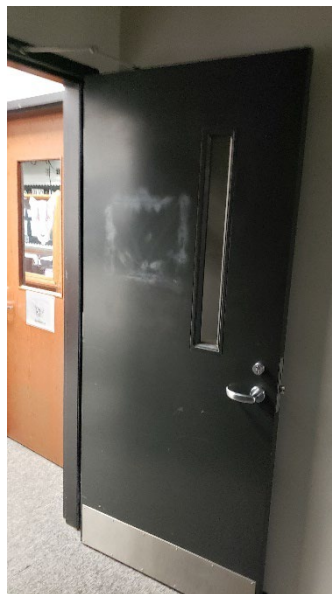
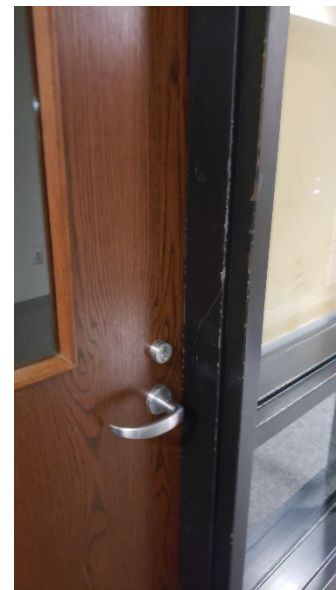
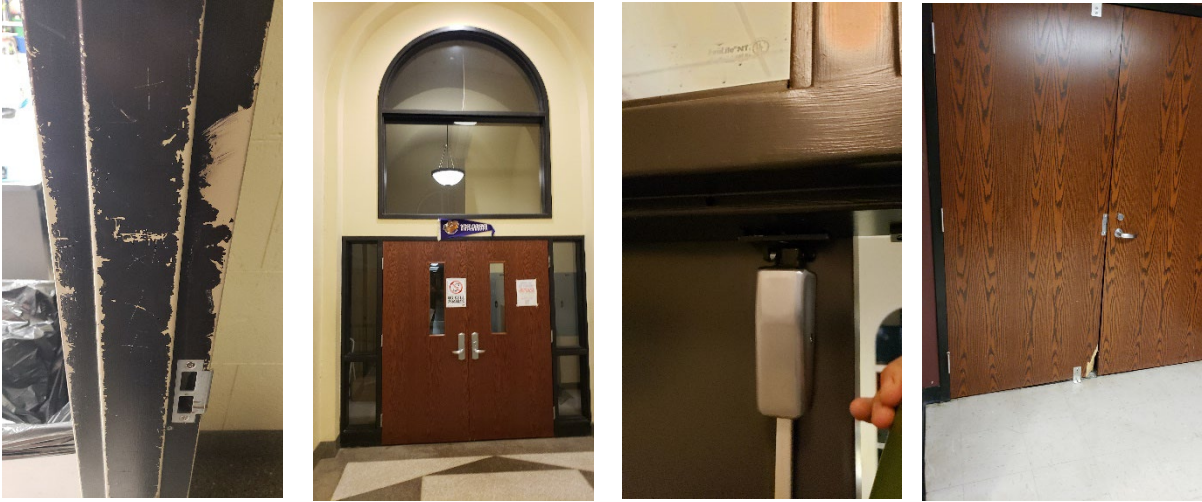
Interior wood doors throughout the building mainly date from 2005 and are in generally good condition. A few doors have damage which may require the door to be replaced. Door hardware is lever-style and appears to be ADA compliant. Hollow metal doors and frames should be repainted.

- Replace damaged doors.
- Scrape and repaint hollow metal doors and frames.

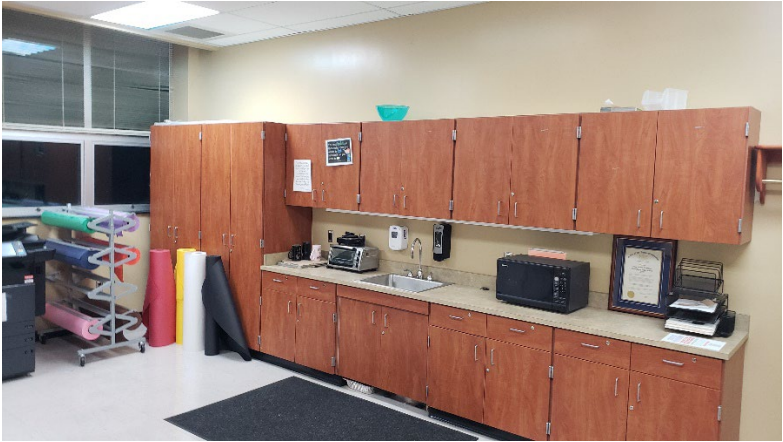
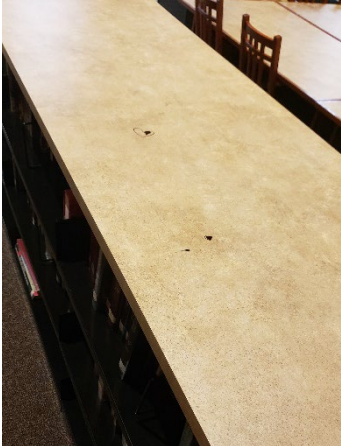
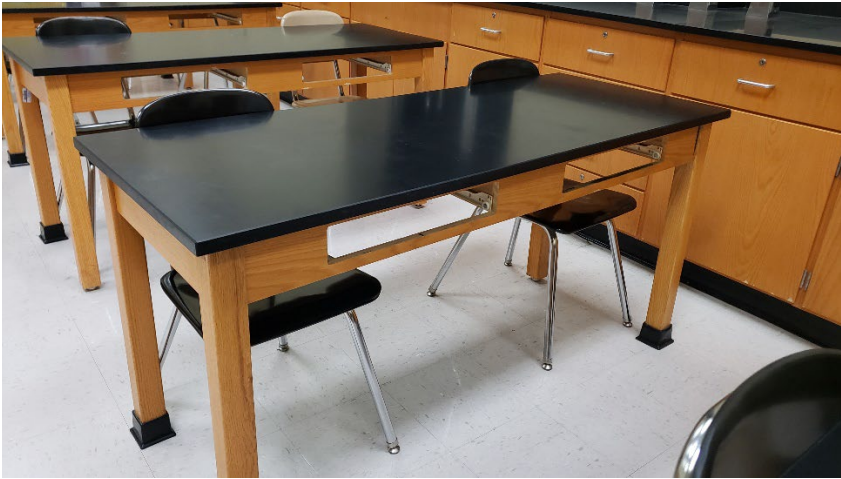
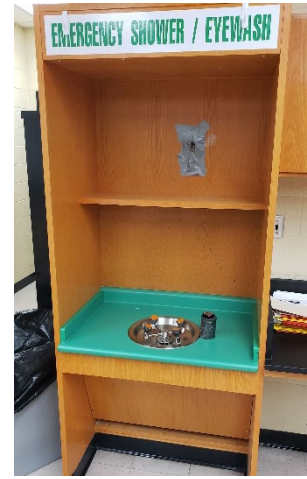
Built-in casework throughout the building was replaced in 2005, as was the library furniture. Most is in good condition, however drawers are missing from tables in science labs (perhaps purposefully). Library furniture has been particularly heavily used and is due for replacement. Locations where sinks occur in casework should be modified where required to have an accessible location per current accessibility standards.

- Replace drawers in science labs if desired.
- Modify casework where accessible sinks are required.
- Replace library furniture.

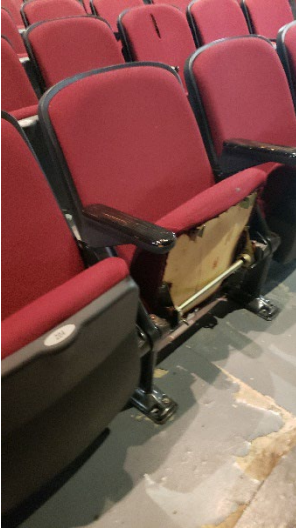
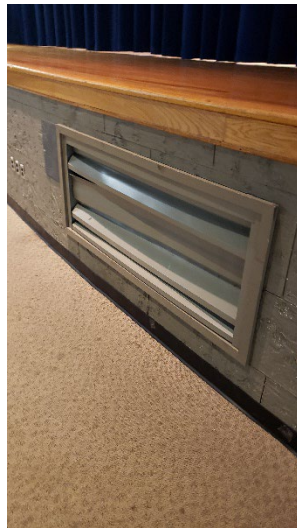
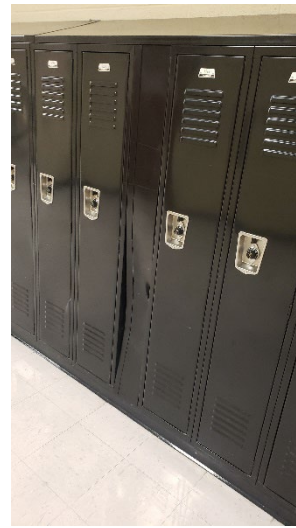
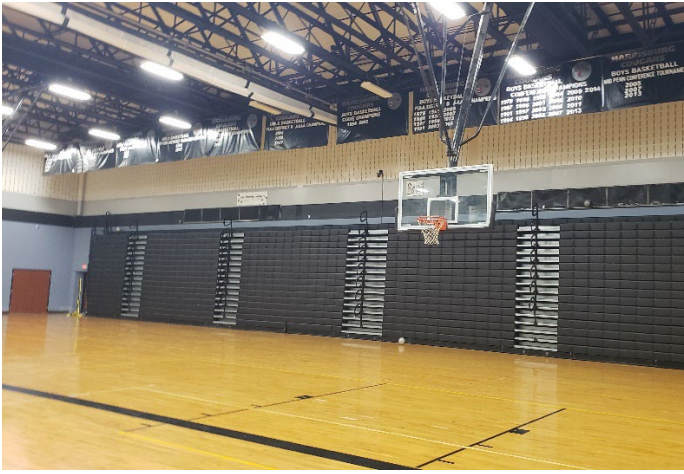
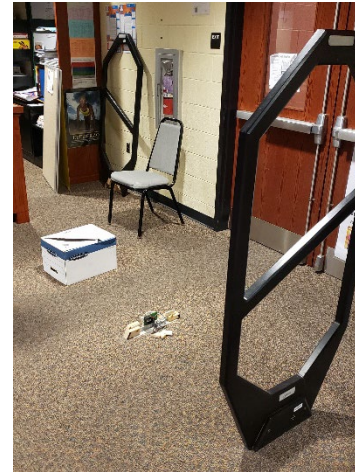
Lockers in hallways are in fair condition, with certain areas requiring repair. These areas mostly are where infill panels occur between lockers. Auditorium seating is due for replacement – many chairs are damaged or have missing parts. The theatrical equipment is in good condition, as is the gymnasium equipment. The library is missing portions of its theft prevention system. Gymnasium equipment – wall pads, specifically – needs to be replaced.

- Replace auditorium seating.
- Replace library theft protection devices.
- Replace damaged locker infill panels.
- Replace gymnasium wall pads.

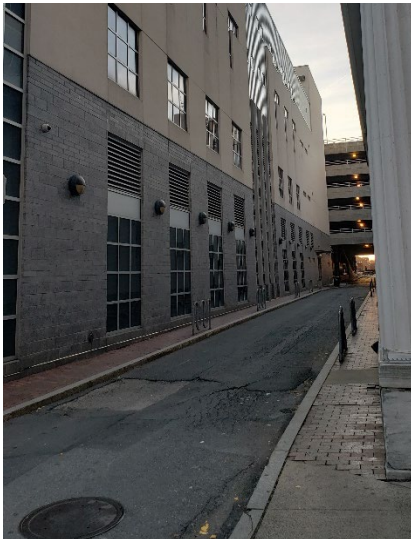
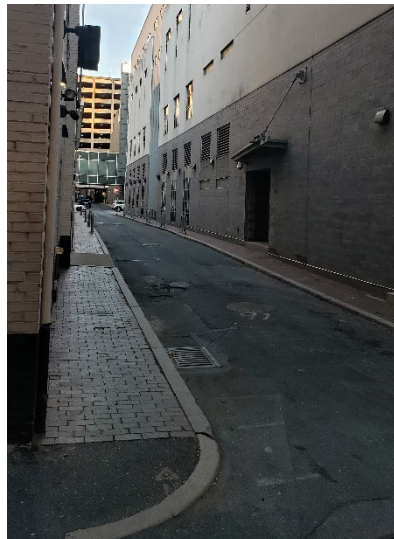
There are no parking areas or drives on the property. Walkways are minimal, surrounding the property on three sides, in good condition.

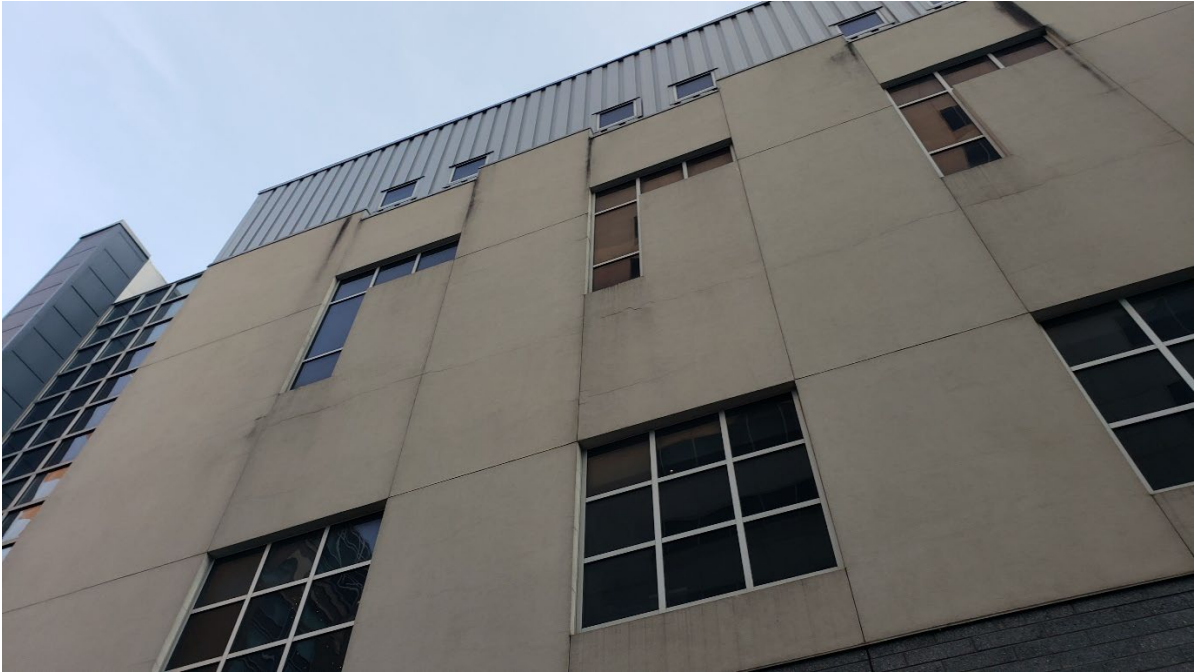
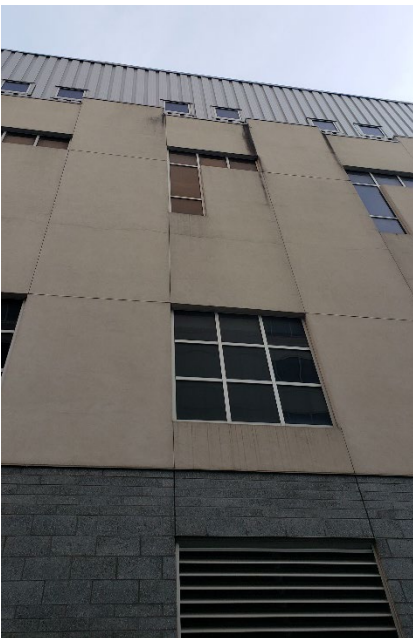
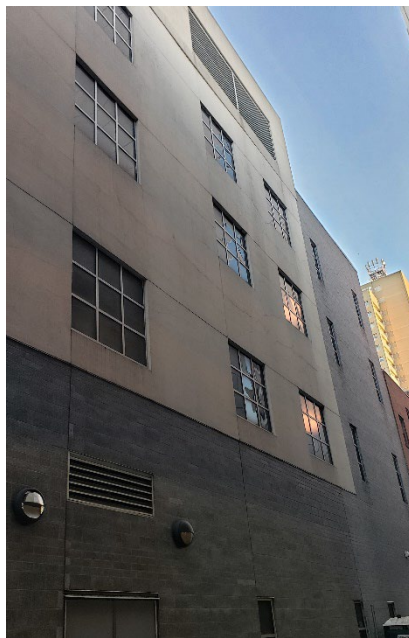
The building's exterior consists of masonry veneer, metal panel and exterior insulation and finish system (EIFS). The masonry and metal panel are in good condition, and the EIFS is in fair condition but in need of cleaning.

- Clean EIFS.

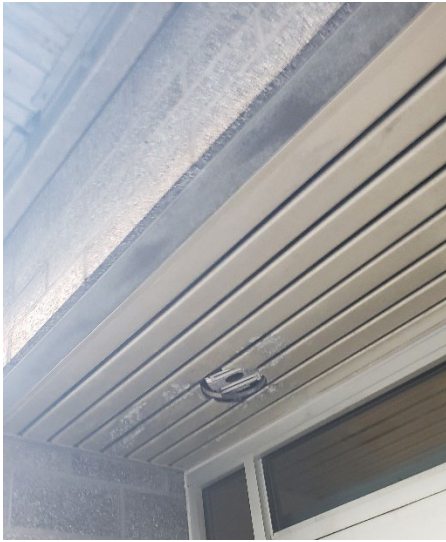
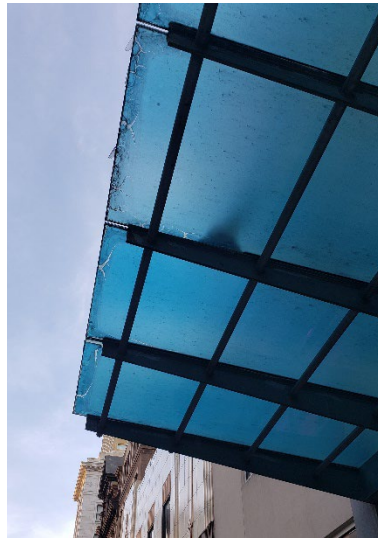
The building's membrane roof is approaching the end of its useful life, with replacement likely required in the next 4-8 years. There is also a steel and glass canopy over the front entrance which should be cleaned as part of the District's regular maintenance plan.

- Replace membrane roof in the next 4-8 years.
- Clean the steel and glass canopy as part of the District's regular maintenance plan.
