Harrisburg School District

District Wide Facility Study

June 12, 2023

Crabtree, Rohrbaugh & Associates
Architects

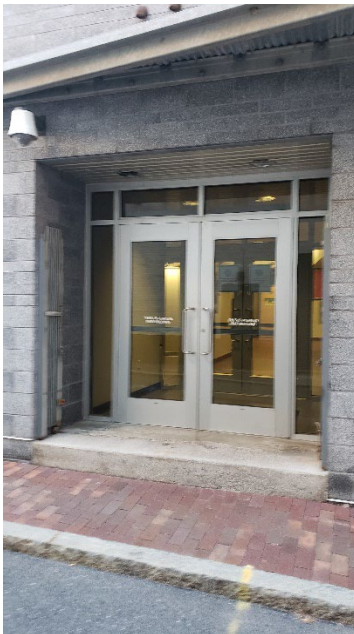
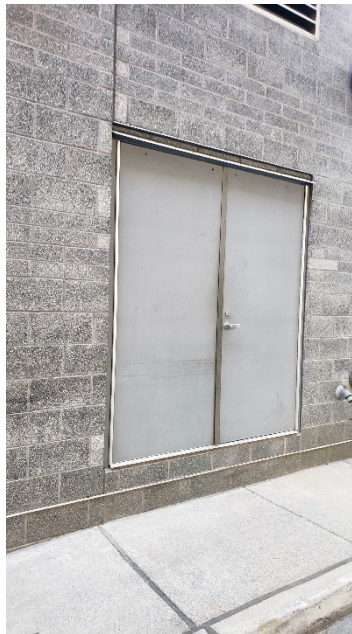
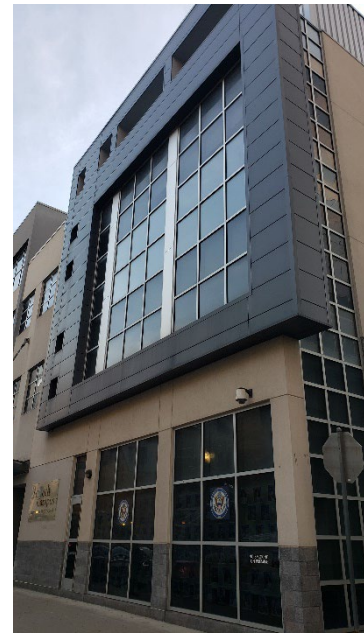
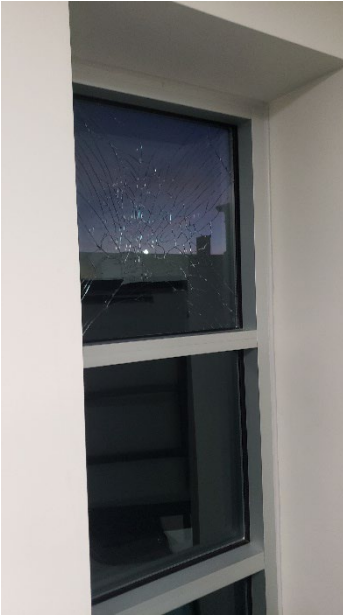
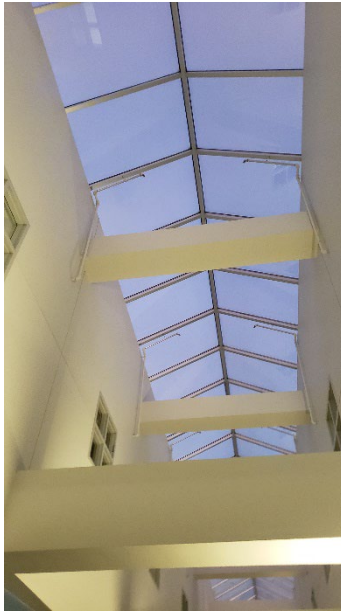
The exterior aluminum storefront and curtain wall entrances/frames were replaced in 2004 and are in good condition. Some windows are cracked and should be replaced. The aluminum entrance and exit doors have hardware which could allow the doors to be chained together which is a safety/security concern.

- Repair cracked window(s)
- Replace door hardware at main entrance and exits.

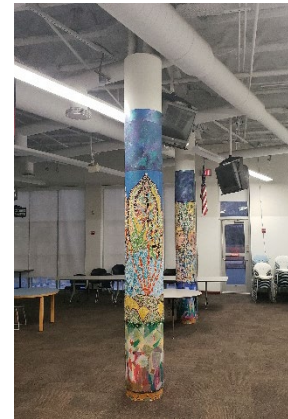
The building has a steel frame structure, with steel columns supporting steel beams and open web joists. Interior partitions are primarily stud and gypsum wallboard partitions. The structure appears to be in sound condition.

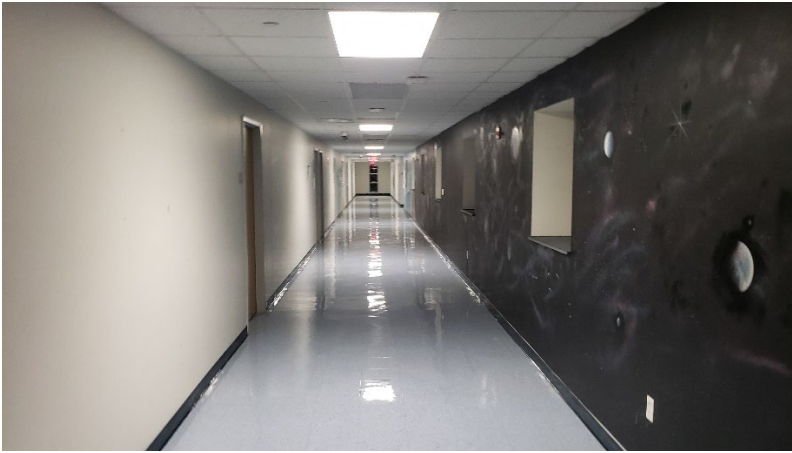
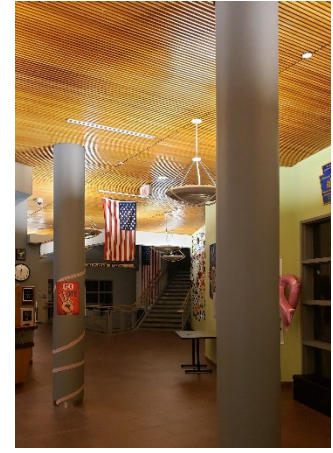
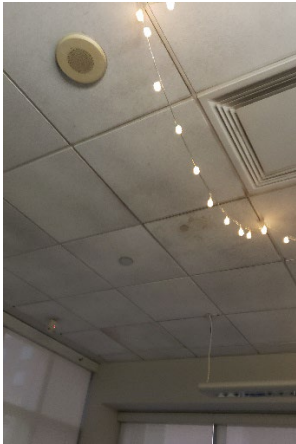
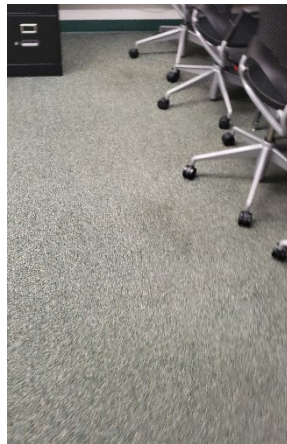
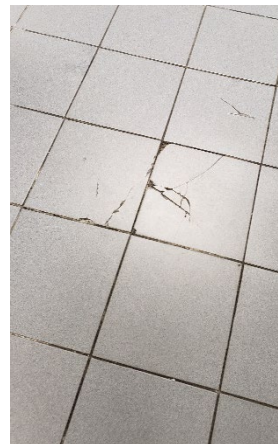
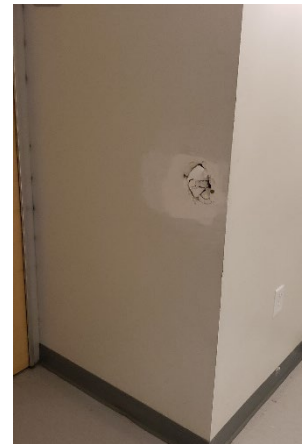
Wall finishes throughout the building include painted gypsum wall board, ceramic wall tile in restrooms. Walls are in fair condition, but are frequently scuffed or marked.

Floor finishes include tile in the main lobby, VCT in classrooms and corridors, carpet in the main office and several classrooms, mosaic ceramic tile in toilet rooms, and porcelain tile in the kitchen. Upper level corridors have epoxy floors, which is occasionally cracked. Carpeting, tile form in offices and broadloom in classrooms, is all due for replacement. The porcelain tile in the main lobby is chipped in several locations. VCT on the whole is in fair condition, but some classrooms are scuffed sufficiently enough to merit replacement.

The majority of the building has lay-in acoustical ceiling tile of various styles which is in fair condition, with many tiles in need of replacement due to leaks or being very dirty. Some spaces, such as the first floor media center and some labs, have exposed structure ceilings. The main lobby has panelized acoustical wood grille ceiling in good condition.

- Paint classrooms as needed.
- Replace VCT in classrooms as needed.
- Replace acoustical ceiling tiles throughout.
- Repair GWB partitions as needed.
- Replace carpet in classrooms and offices.
- Replaced damaged porcelain tiles.

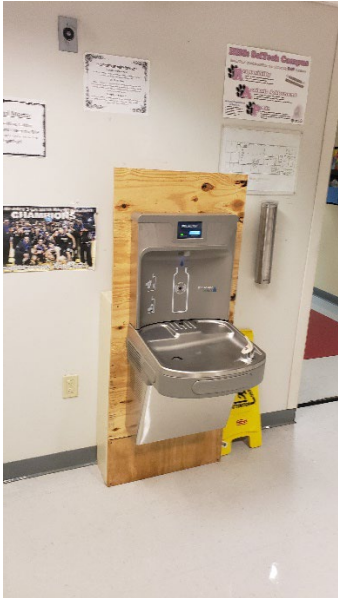
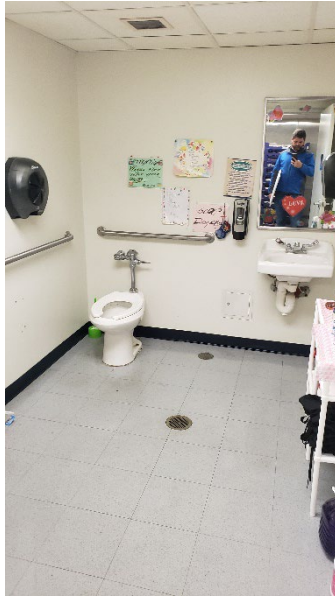
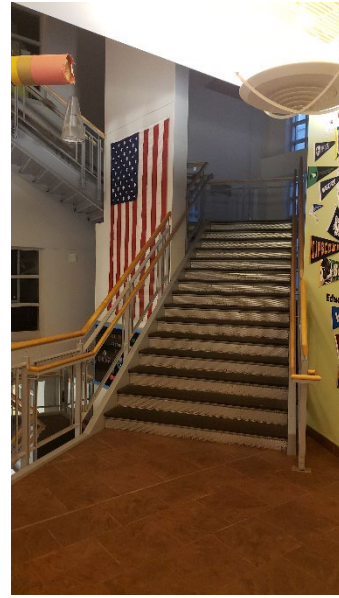
Grab bars and dispensers in accessible toilet compartments do not meet current ADA requirements. Most single-occupant toilet rooms have sinks located too close to the toilet. The building has two elevators connecting the main floor levels.; both of which were installed during the 2004 renovations.

Drinking fountains, while many recently replaced, are often located such that they project into paths of travel, an accessibility concern due to blind persons not being able to sense their presence.

- Evaluate elevators for any necessary upgrades and replace communications technology.
- Upgrade grab bars and accessible toilet compartments and single occupant rooms to meet current ADA requirements.
- Reconfigure single occupant toilet rooms to meet current accessibility standards.
- Remount or replace plumbing fixtures as required to comply with accessibility.

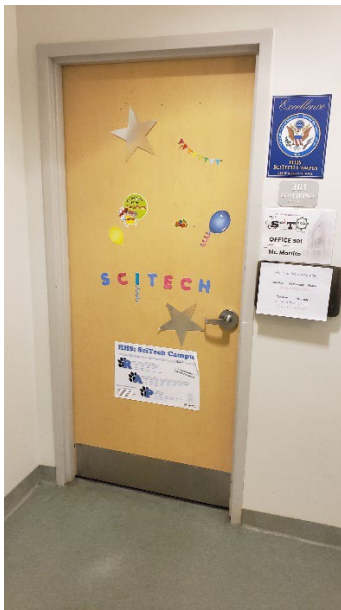
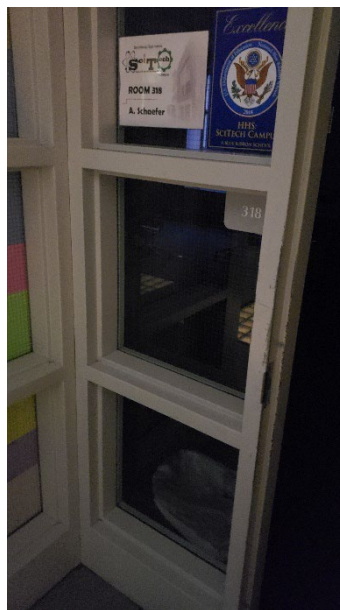
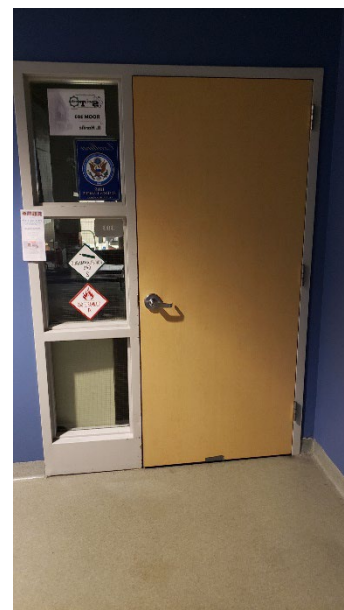
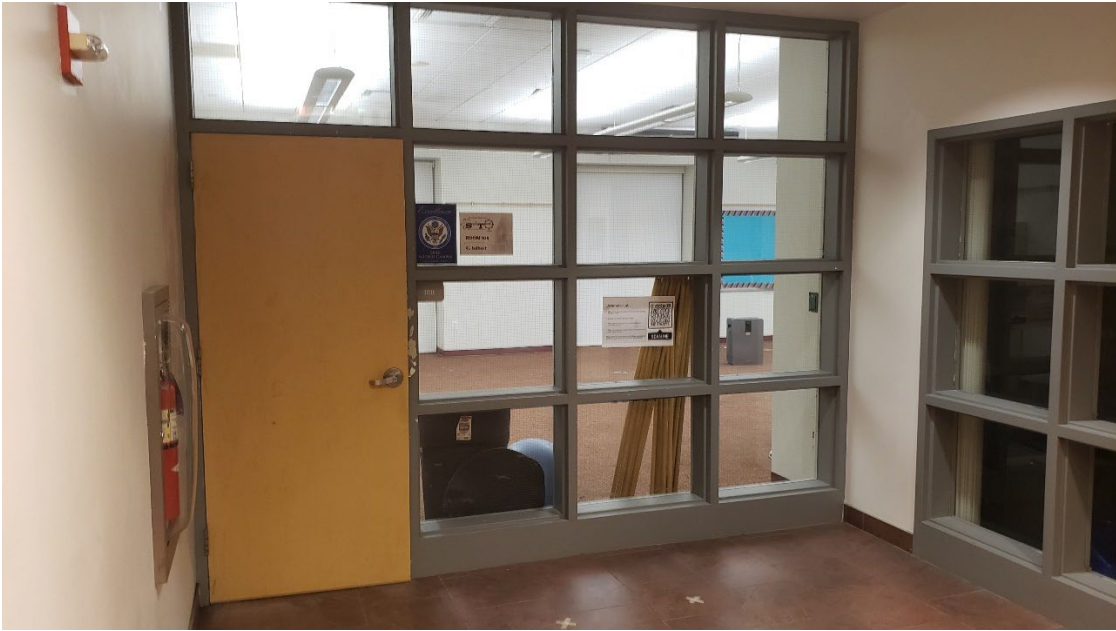
Interior wood doors throughout the building mainly date from 2004 and are in good condition. Most hollow metal frames are in need of new coats of paint. Most hollow metal frames with vision lites have wire glass panels.

- Replace wire glass infills as part of a major renovation.
- Paint hollow metal frames.

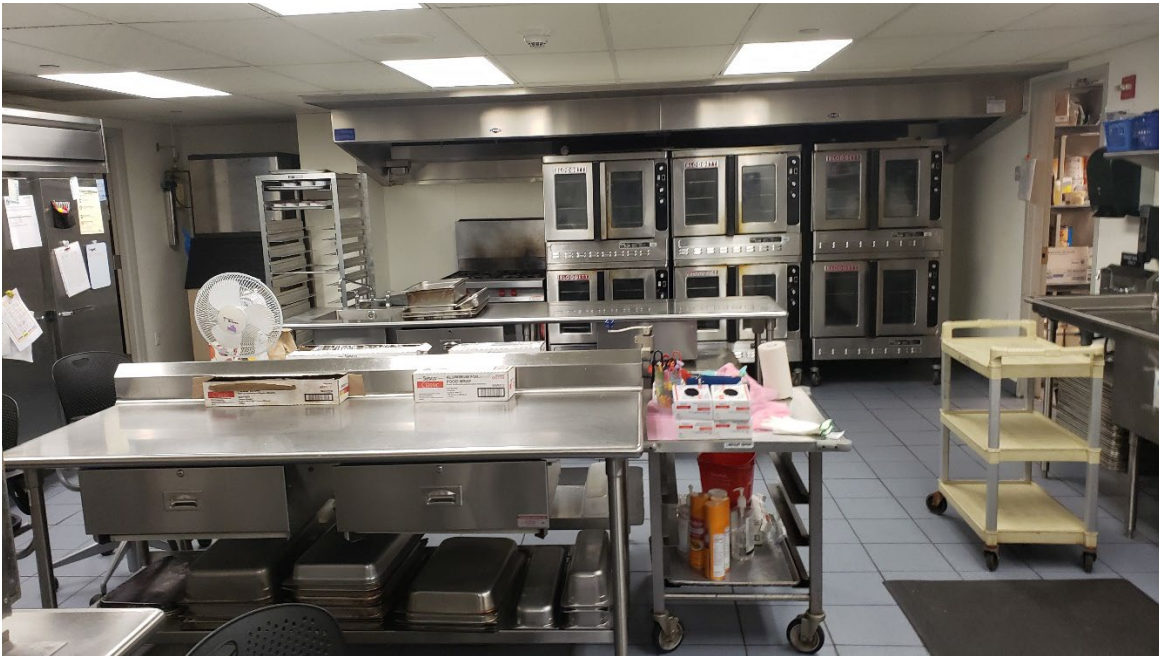
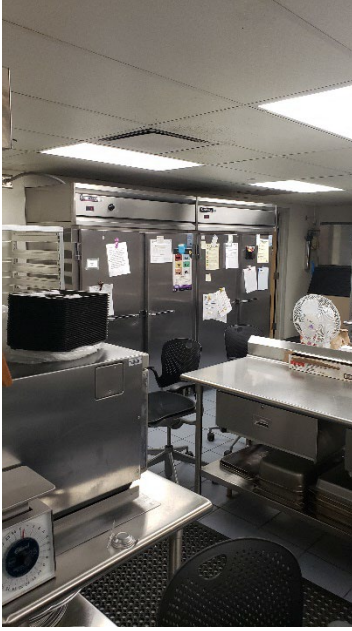
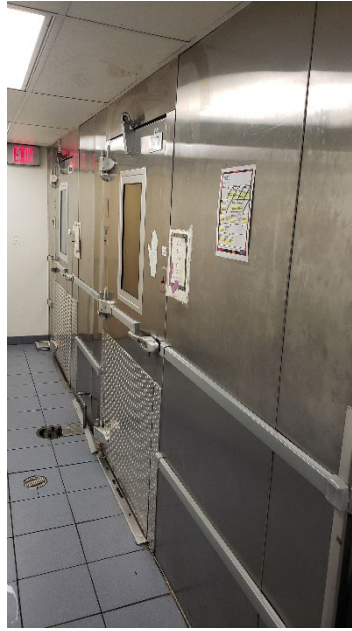
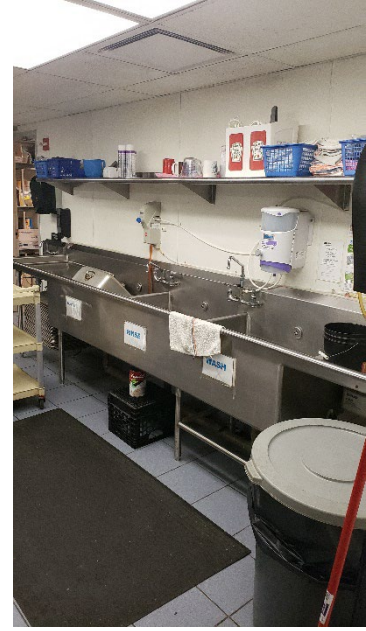
All kitchen equipment was entirely replaced in 2004 and will generally be due for replacement in 3-5 years. The walk-in cooling equipment should be evaluated for more immediate replacement.

- Evaluate the walk-in refrigerator and freezer for possible replacement.
